State of Washington Department of Ecology
 Central Regional Office
PERMIT COMPLIANCE INSPECTION REPORT

Inspection Date: 03/23/2022	NPDES Permit #: WAG505215	County: Chelan	Receiving Waters: N/A	Inspector(s): Stephanie Giesin	Facility Type: Sand and Gravel
Weather at time of inspection: Overcast 48°			Discharges to: Surface Water <input type="checkbox"/> Ground Water <input checked="" type="checkbox"/>		
Announced? <input checked="" type="checkbox"/> Yes <input type="checkbox"/> No		Reason: <input checked="" type="checkbox"/> Routine <input type="checkbox"/> Compliant ERTS #: <input type="checkbox"/> Enforcement <input type="checkbox"/> Other:			
Inspection Type: <input type="checkbox"/> Inspection w/sampling <input checked="" type="checkbox"/> Inspection w/o sampling <input type="checkbox"/> Follow-up <input type="checkbox"/> Coverage Inspection <input type="checkbox"/> Technical Assistance Visit

Name and Location of Facility Inspected Chelan Sand & Gravel Howard Flats Super Pit 120 Howard Flats Rd Chelan, WA 98816 Less than a mile northeast of Lake Chelan Airport	Entry Time 8:54 AM	Permit Effective Date 4/01/2021
	Exit Time 10:16 AM	Permit Expiration Date 3/31/2026
Name(s) of On

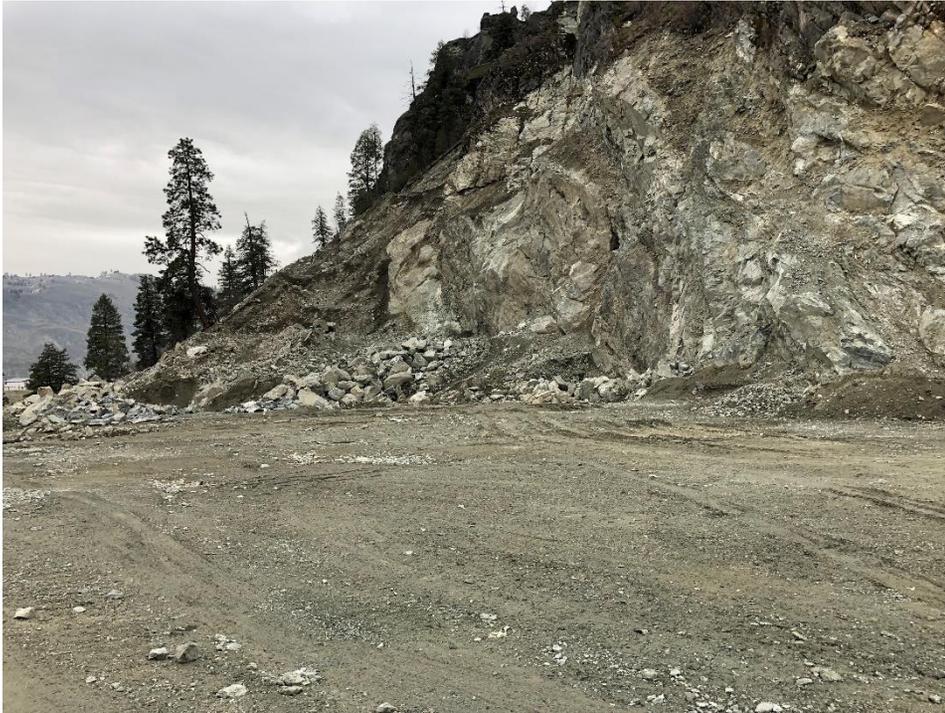
We followed David and Thomas up to the mining face on the west side of the pit (Photo 1). David commented that he does not want to mine into the hillside anymore because of safety concerns. Looking east we could see the reclaimed area that still needs to be seeded (Photo 2) and the area they are currently crushing (Photo 3).

Photo 1
West end of pit mining face

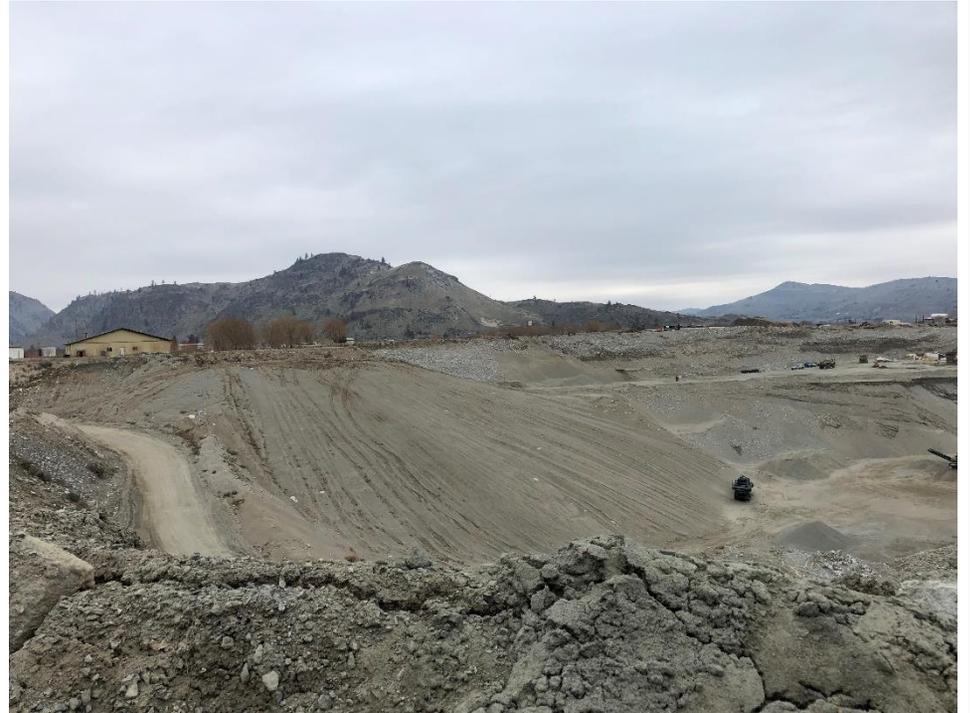
Photo 2
Reclaimed slope – still needs seed

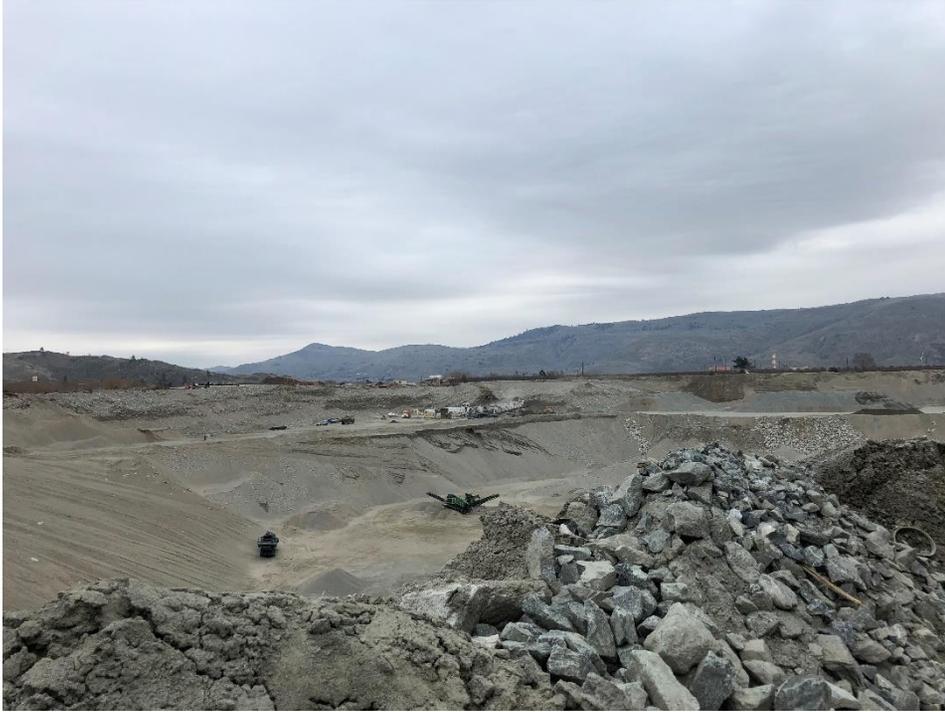
Photo 3

Area where they are currently crushing – screen on pit lowest pit floor

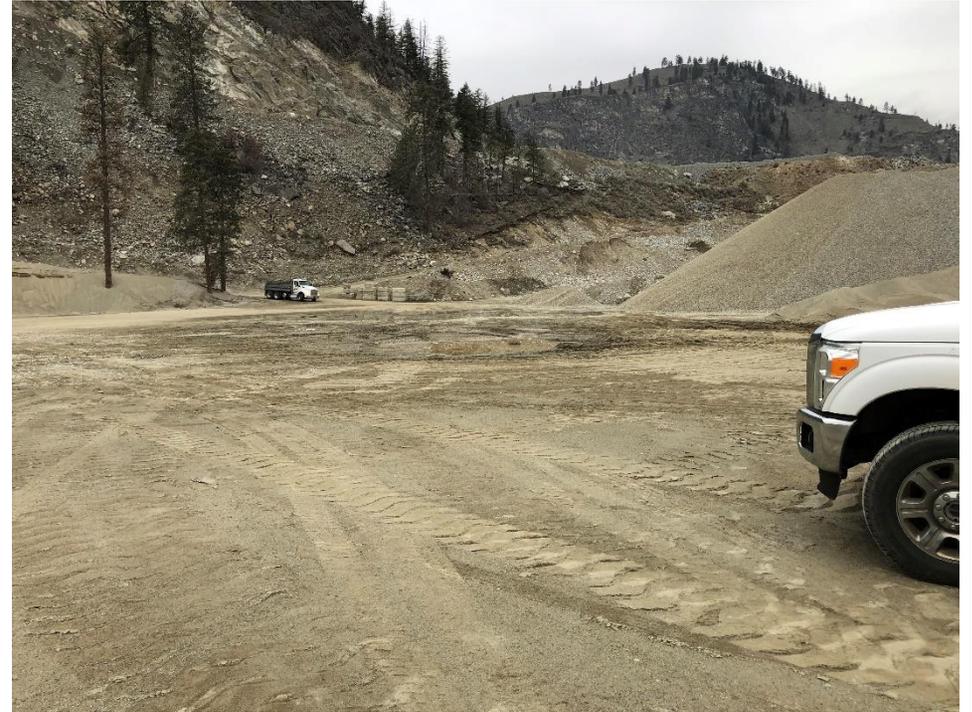
Photo 4

From there we drove down to the bottom of the pit, where there are a few puddles from snowmelt (Photo 4). We drove up by the crusher and David showed Jefferson and I the jaws and cones that break down the rock and separate them into different piles (Photo 5). Near the crusher is oil within secondary containment (Photo 6).

Pit floor with puddles from snowmelt

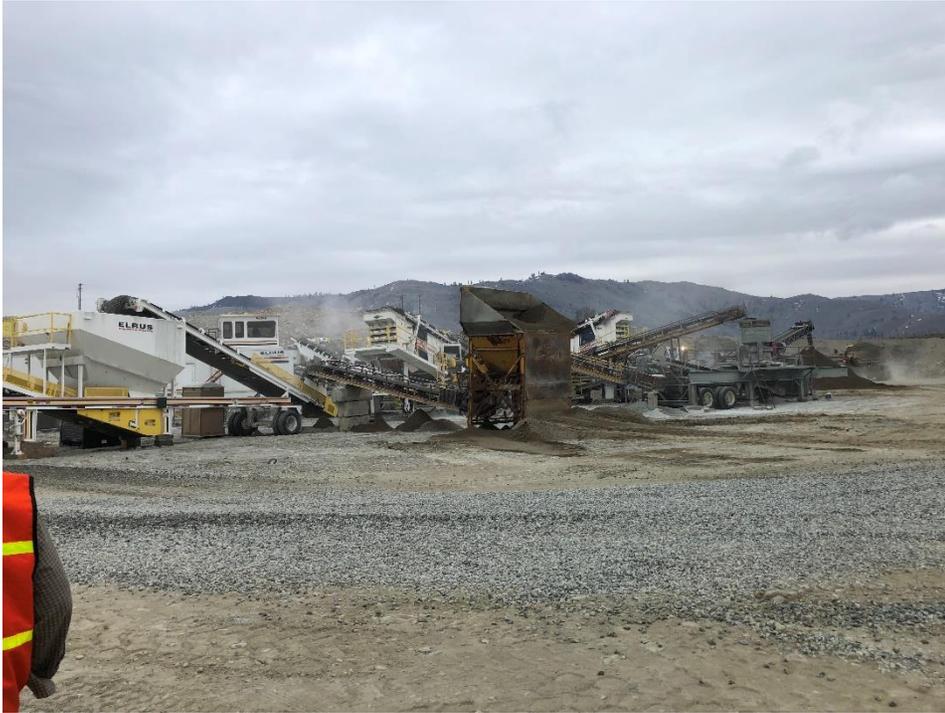
Photo 5
Crusher

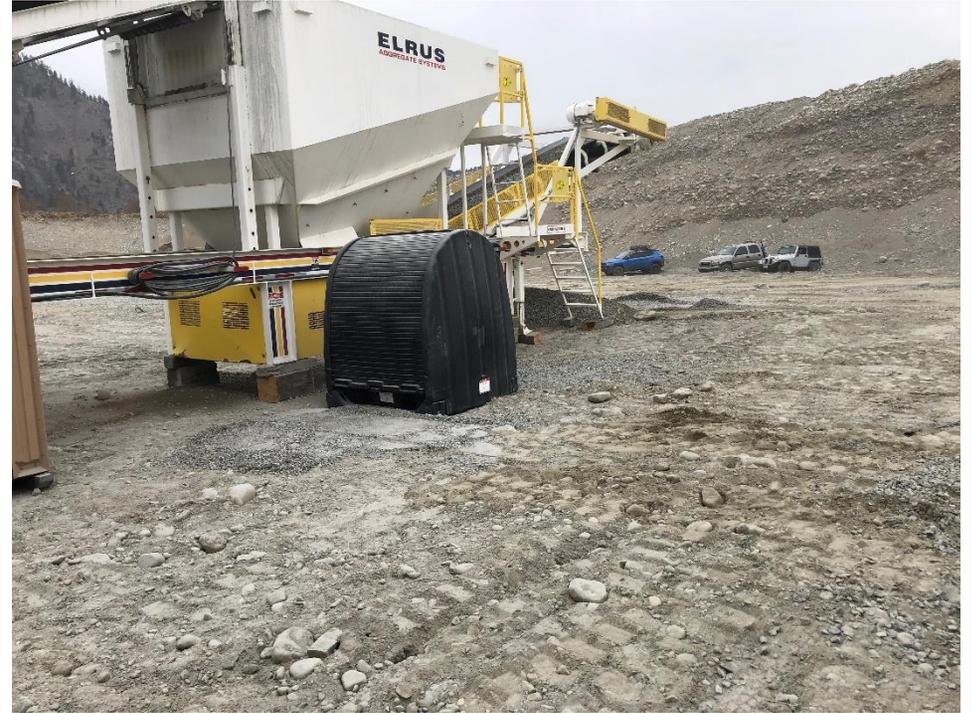
Photo 6
Oil in secondary containment

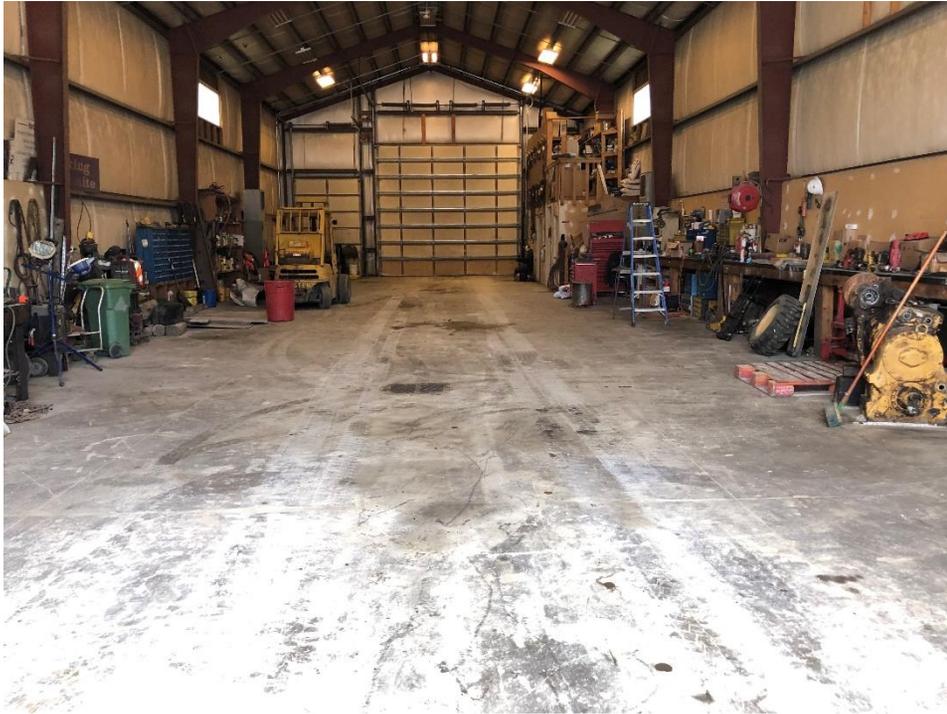
Last, we drove up to the maintenance shed (Photo 7). Liquids are within secondary containment (Photo 8) and there is a drain to an oil water separator.

Photo 7
Maintenance shed with drain to oil water separator

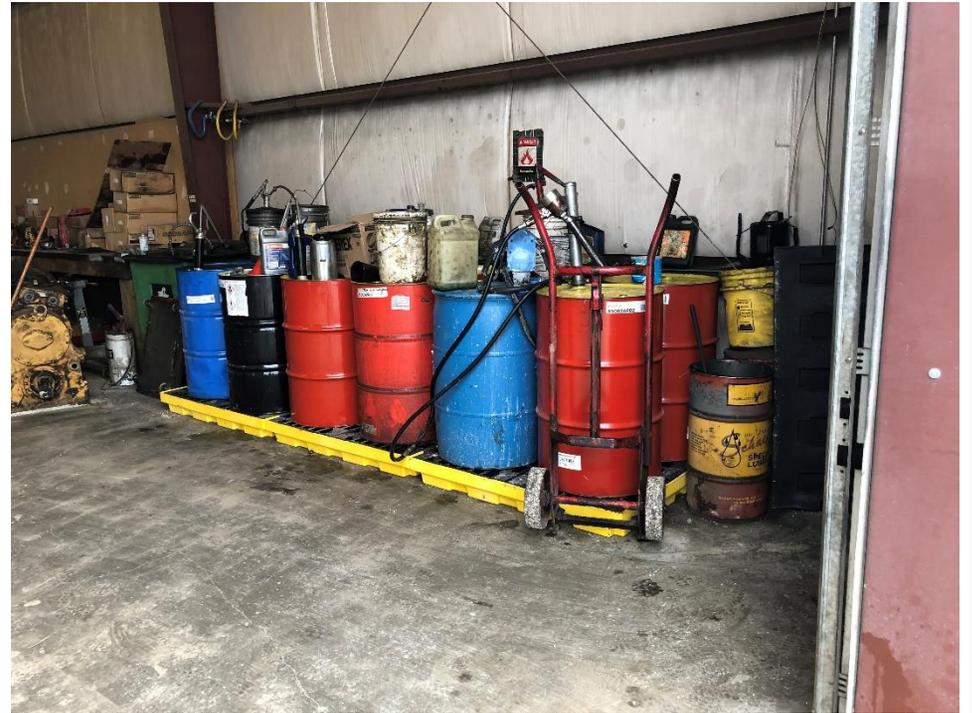
Photo 8
Liquids in secondary containment
