STATE OF WASHINGTON
DEPARTMENT OF ECOLOGY

Re: Industrial Stormwater General Permit National Pollutant Discharge Elimination System
(NPDES) inspection (WAR002223)

Enclosures: Industrial Stormwater General Permit NPDES inspection report (WAR002223)
PhotoLog

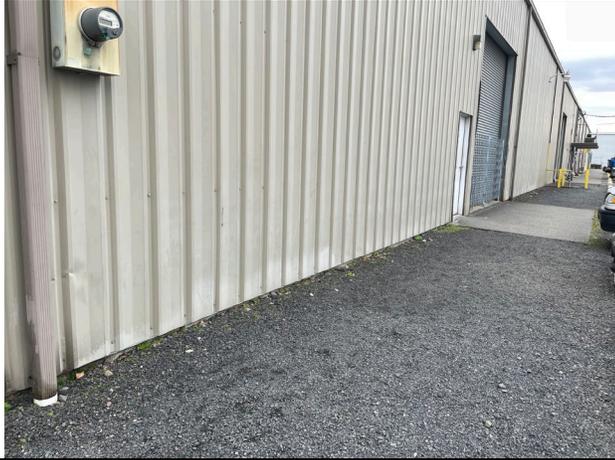
Photo 1 of 10: Gutter drains have downspouts for infiltration of roof runoff.

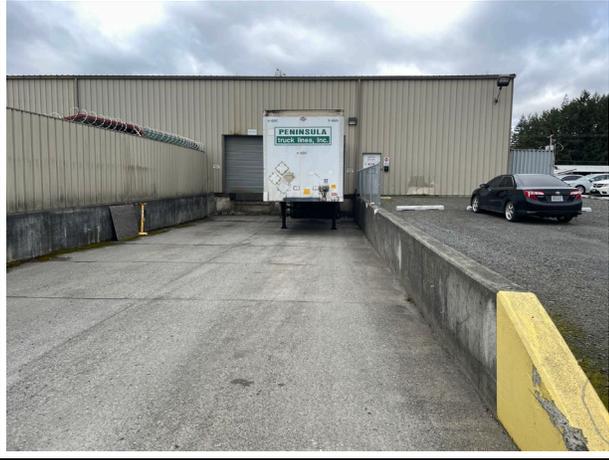
S8. – Corrective Actions – The facility triggered a Level 1 Corrective Action for zinc in Q2 2021, and a Level 1 Corrective Action for turbidity in Q3 2021. They implemented monthly sweeping in the yard and paved areas, cleaned the loading dock area, and plan to have sediment removed from the sump and trench drain around the loading dock in early 2022.

Photo 2 of 10: The back loading dock has been identified as an area where sediment accumulates leading to turbid discharges.

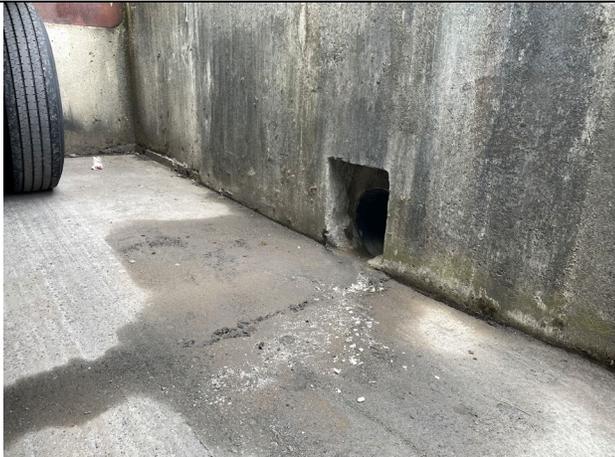
Photo 3 of 10: Drain at the bottom of the loading dock.

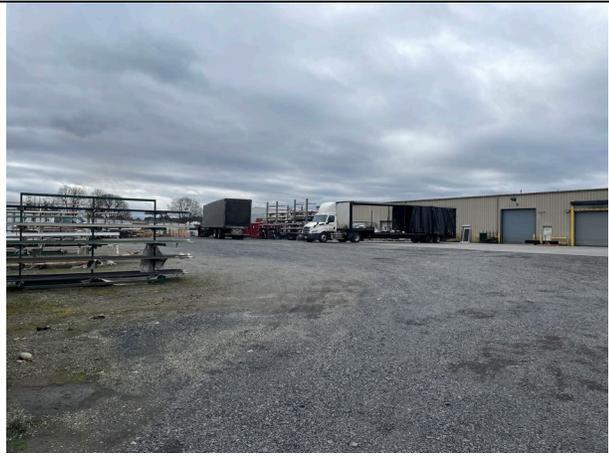
Photo 4 of 10: View of the yard on the eastern edge of the facility.

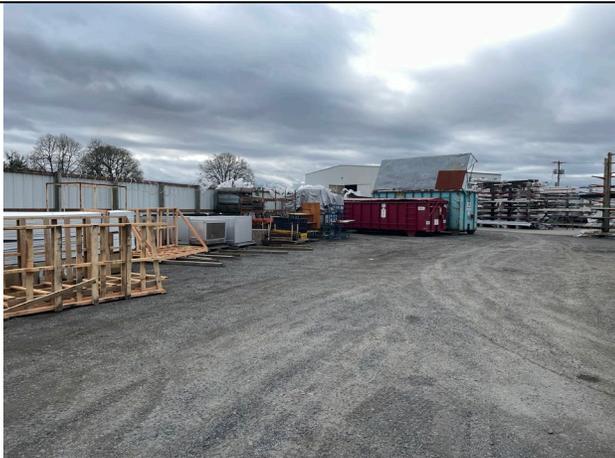
Photo 5 of 10: There is some outdoor storage of various materials.

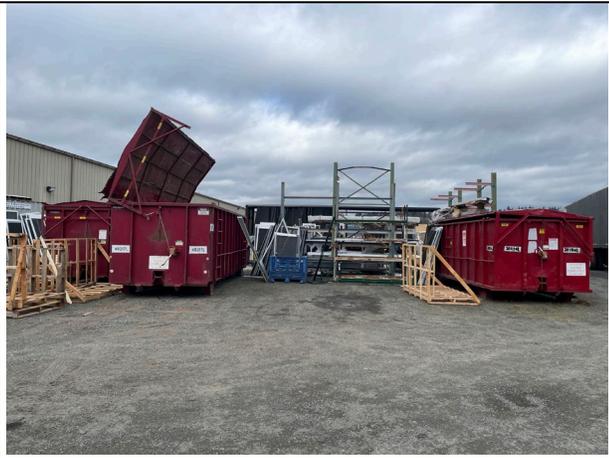
Photo 6 of 10: The dumpsters have lids.

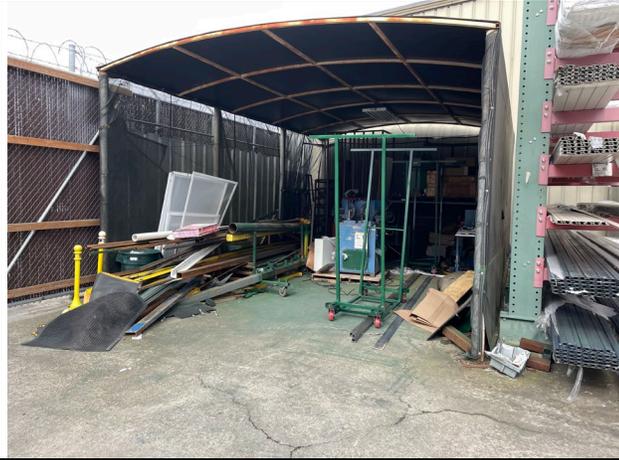
Photo 7 of 10: Scrap metal is stored under cover.

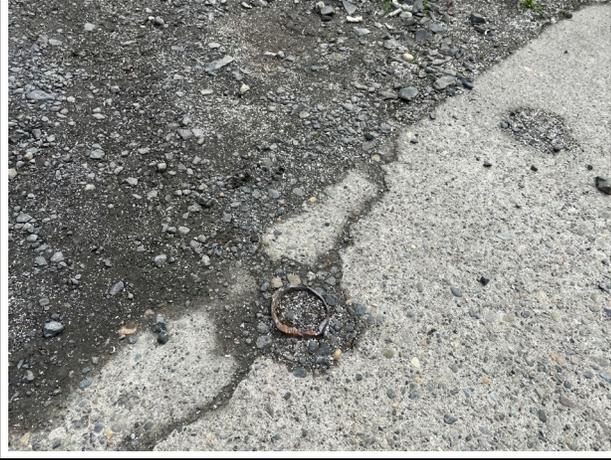
In the storage area at the southern end of the facility, there is a large garage door to the main building, which was open during the inspection. I observed small metal shavings on the ground outside of this door (photo 8). I explained that the shavings were a potential source of pollution that should be focused on.

Photo 8 of 10: There are some metal shavings on the ground outside the garage door on the southern end of the building.

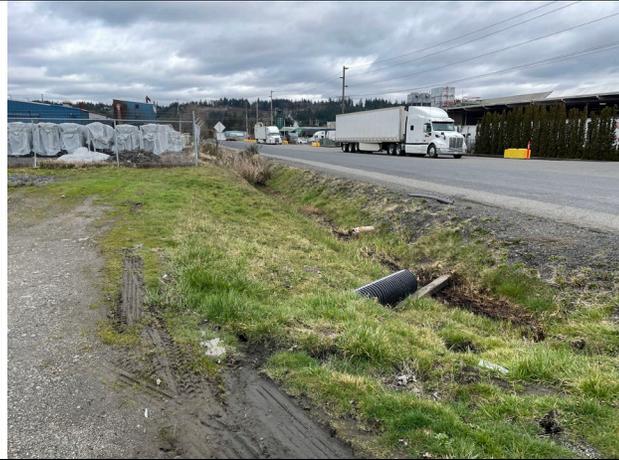
Photo 9 of 10: One of two discharge points into the county ditch.

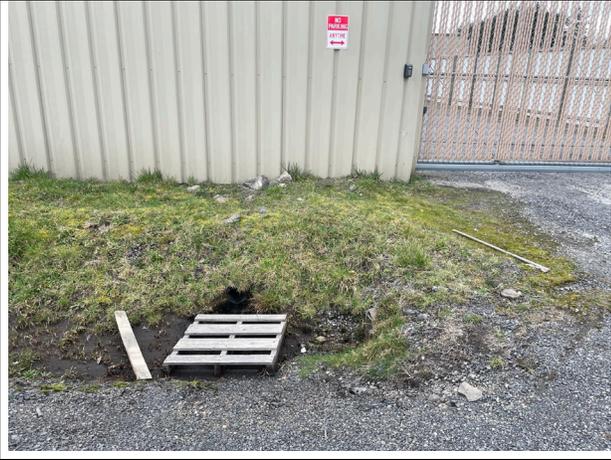
Photo 10 of 10: The second discharge point into the county ditch.
