STORMWATER COMPLIANCE INSPECTION REPORT				WADOE Stormwater Compliance Inspection Form										
	State of Washington Department of Ecology 15700 Dayton Avenue N., Shoreline, WA 98133				Phone: (206) 594-0000										
Section A: General															
Inspection Date: 4/5/2022	NPDES Permit #: WAR310172	County: King	Receiving Waters: Snoqualmie Mill Wetland	Inspector(s): Dennis Lee	Facility Type: Industrial										
Discharges to: Surface Water <input checked="" type="checkbox"/> Ground Water <input type="checkbox"/>				ANNOUNCED Inspection											
Section B: Facility															
Name and Location of Site Inspected			Entry Time	Permit Effective Date											
Snoqualmie Mill Industrial Areas			9:59 am	04/26/2021											
SE Stearns Rd & SE Haul Rd			Exit Time	Permit Expiration Date											
Snoqualmie, WA 98065			11:34 am	12/31/2024											
On-Site Representative(s): Name(s) / Title(s) / Contact number(s) or E-mail				Additional Participants:											
Mac McInnis 425-442-6002				Ashley Baldwin (Encore Environmental)											
Responsible Official(s)															
Tom Sroufe 249 Main Ave S Ste 107 North Bend, WA 98045 Phone: 425-444-0822		Mac McInnis 249 Main Ave

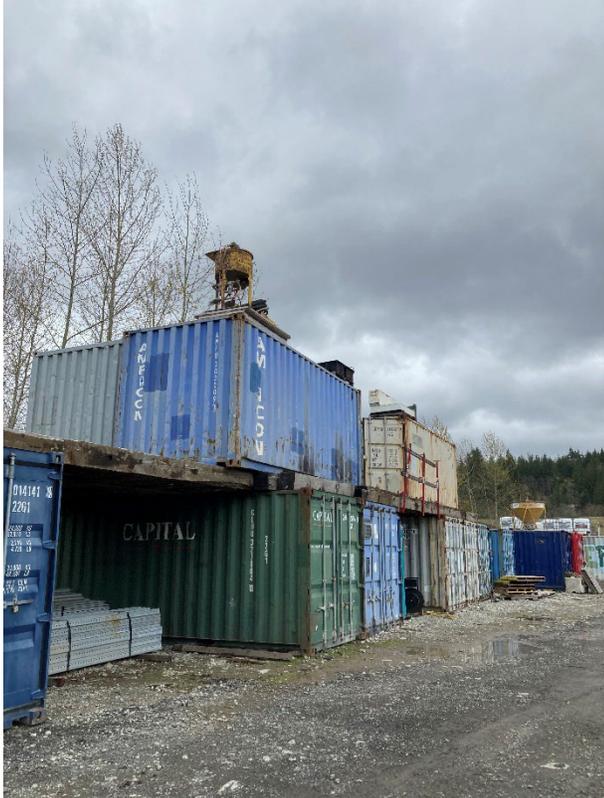
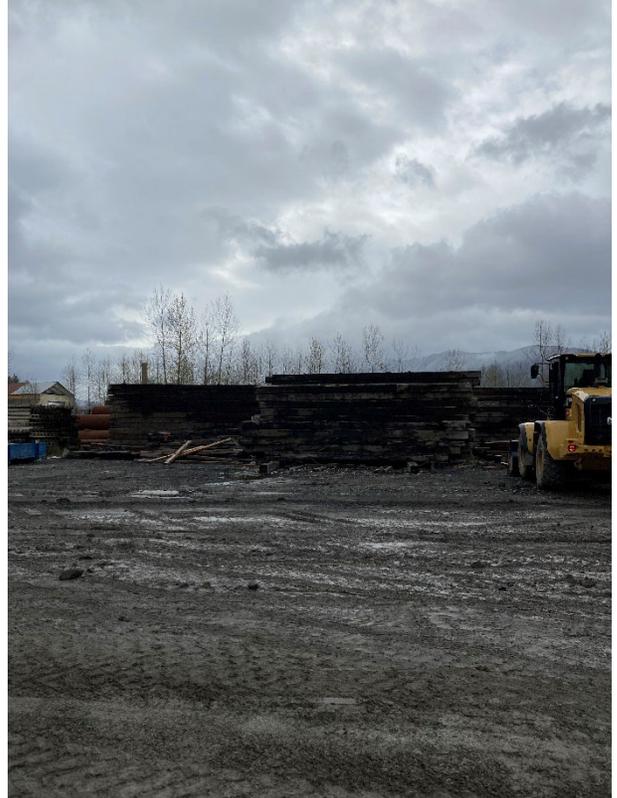
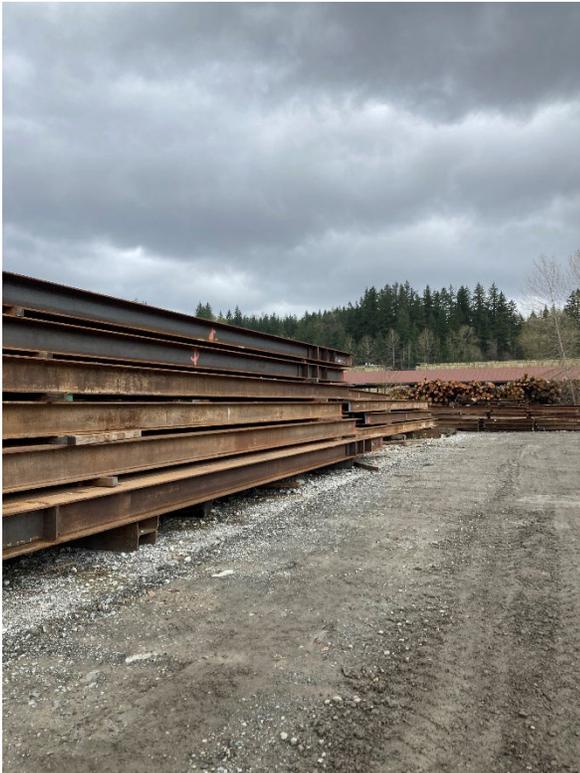
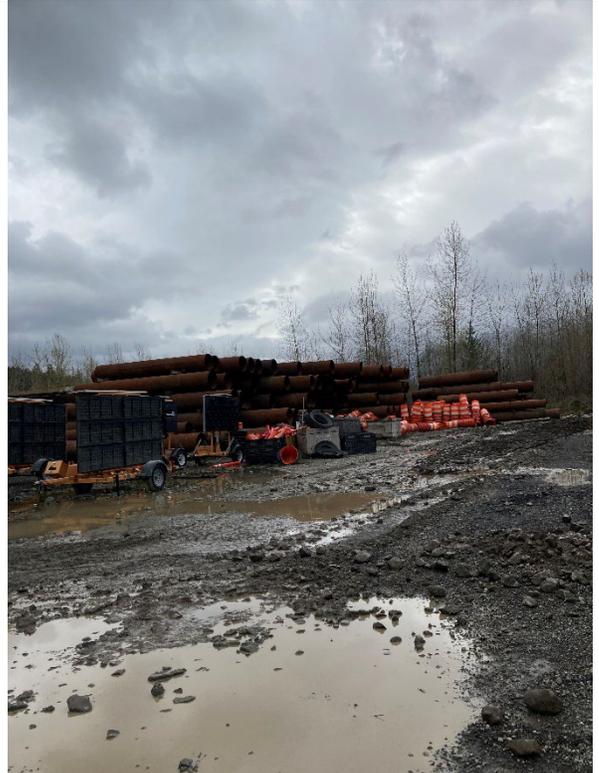
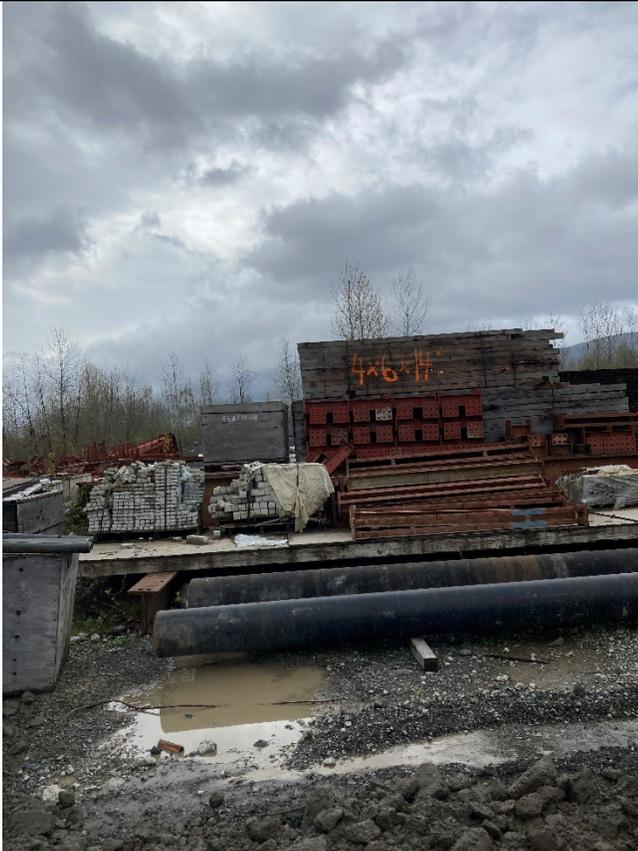
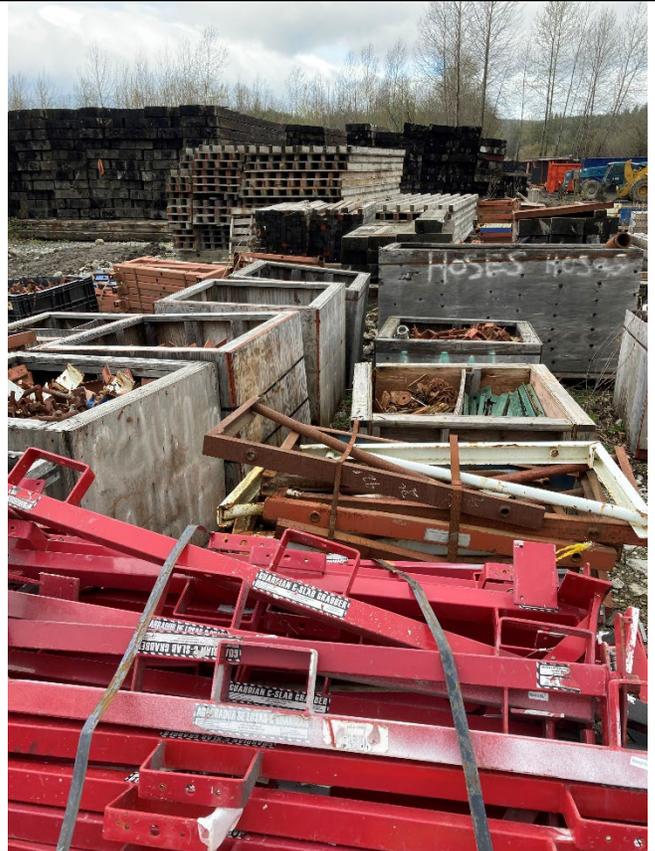
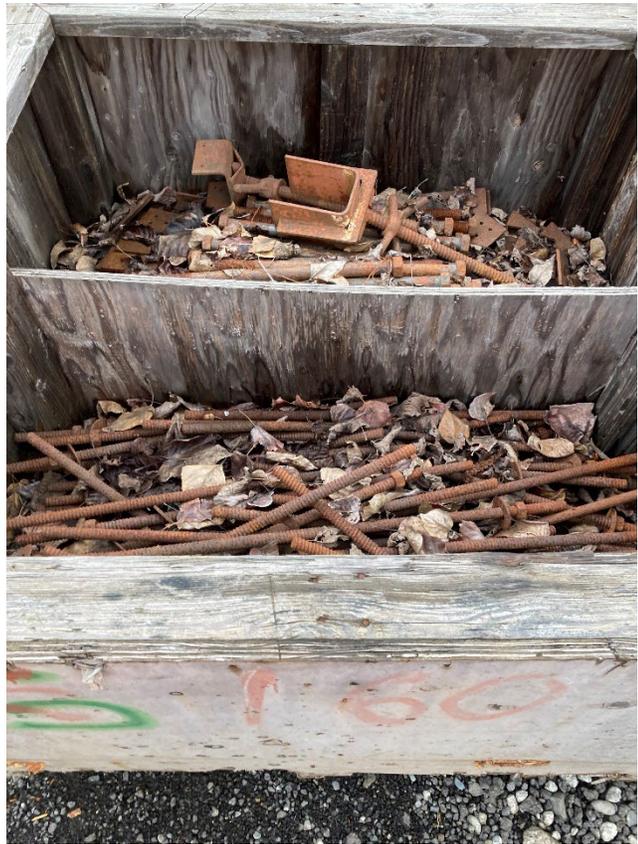
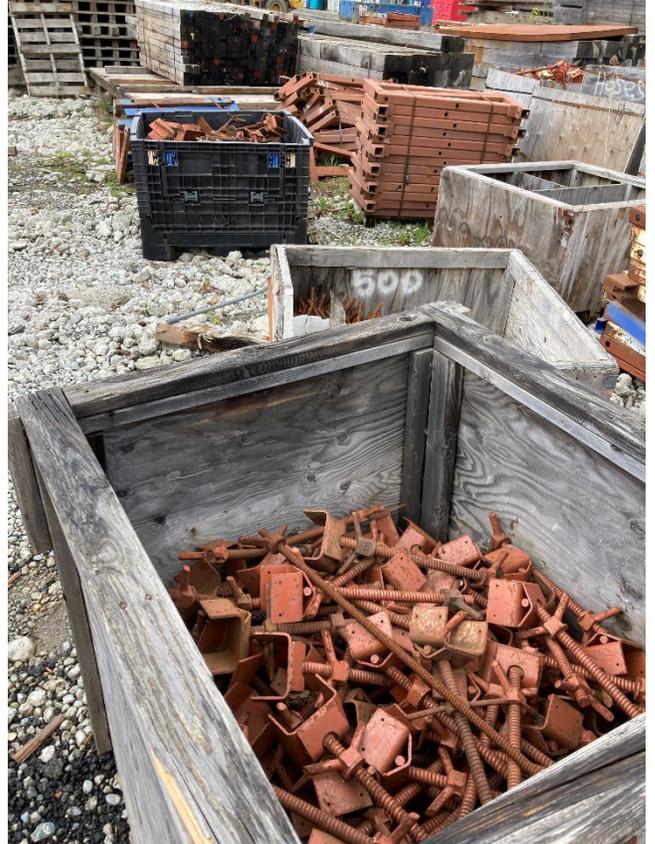
- **Flatiron**
 - **Outdoor Materials and Equipment Storage:** The Inspector observed containers, wooden beams, steel beams, large steel pipes, and other materials stored outdoors (Photos 01-08). While covering large items and materials may be difficult, items in wooden crates should be covered.

Photo 01
Description: Photo of containers / storage.

Photo 02
Description: Photo of wooden beams.

Photo 03
Description: Photo of steel beams

Photo 04
Description: Photo of large pipes.

Photo 05
Description: Photo of pipes, beams, and other materials.

Photo 06
Description: Photo of metallic materials.

Photo 07
Description: Photo of metallic materials.

Photo 08
Description: Photo of metallic materials.

- **Recommendation:** Facility should cover metallic materials in wooden crates located in Flatiron's property.

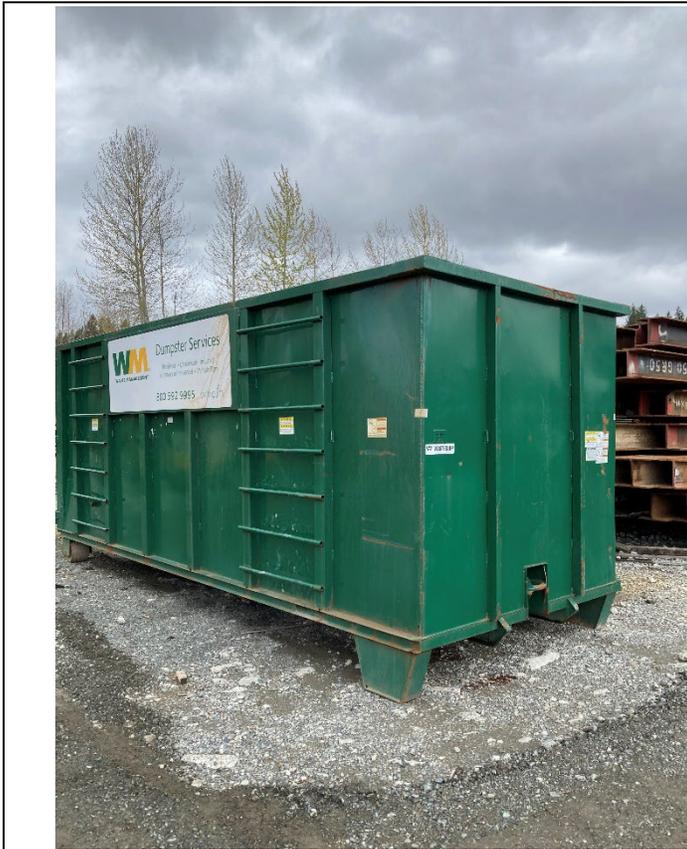
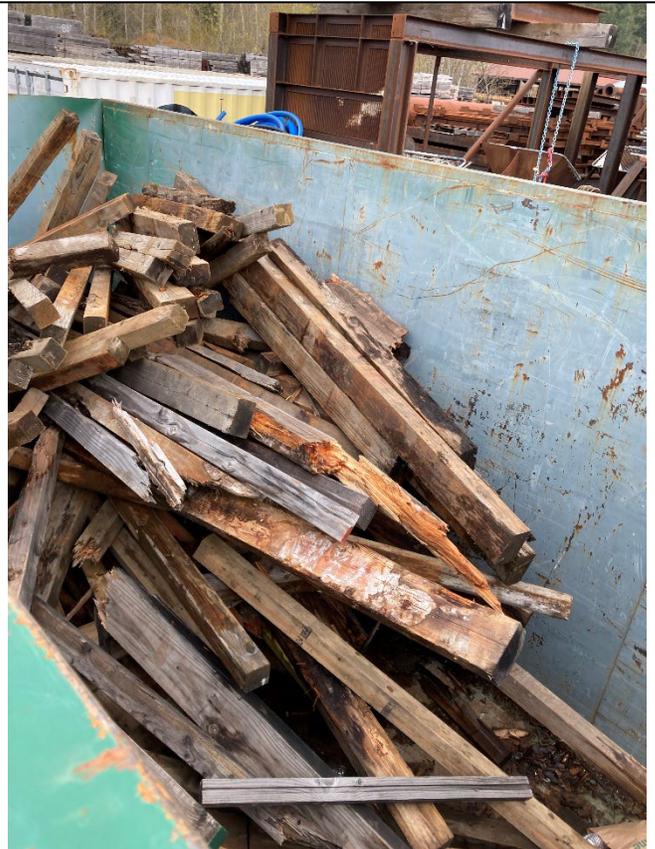
- **Dumpster without Lid:** A dumpster without a lid was observed (Photos 09-10).
- **Merrill & Ring and North Fork**
 - **Catch Basins:** The Inspector observed catch basins (Photo 11) at this section of the property and when inquiring about them with Mac and Ashley, the Inspector was told that the site plans to close the catch basins. Mac and Ashley noted that the system is so old that it completed degraded. The facility attempted to clean the system with a vacuum truck but only dirt/soil appeared to be in the system.

Photo 09
Description: Photo of dumpster without lid.

Photo 10
Description: Photo of contents inside dumpster (Photo 09).

- **VIOLATION and CORRECTIVE ACTION:** Facility does not have storm-resistant lids on their dumpsters and needs to add lids on them. **Snoqualmie Mill has (30) calendar days to complete.**

Permit Condition: In accordance to **permit condition S3.B.4.b.i.2.d**, Permittee shall keep all dumpsters under cover or fit with a storm resistant lid that must remain closed when not in use (tarps are not considered storm resistant).

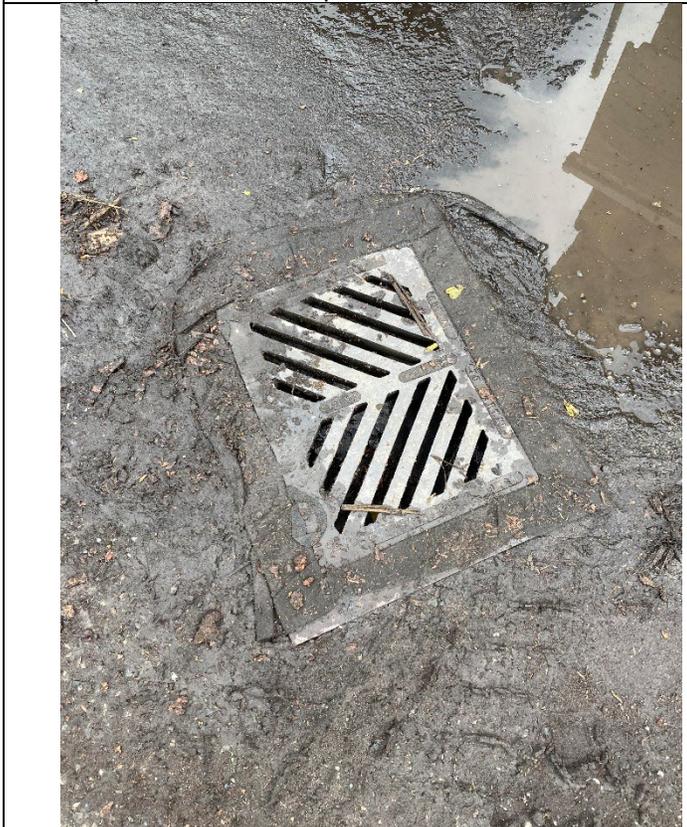
Photo 11
Description: Photo of catch basin at entrance.

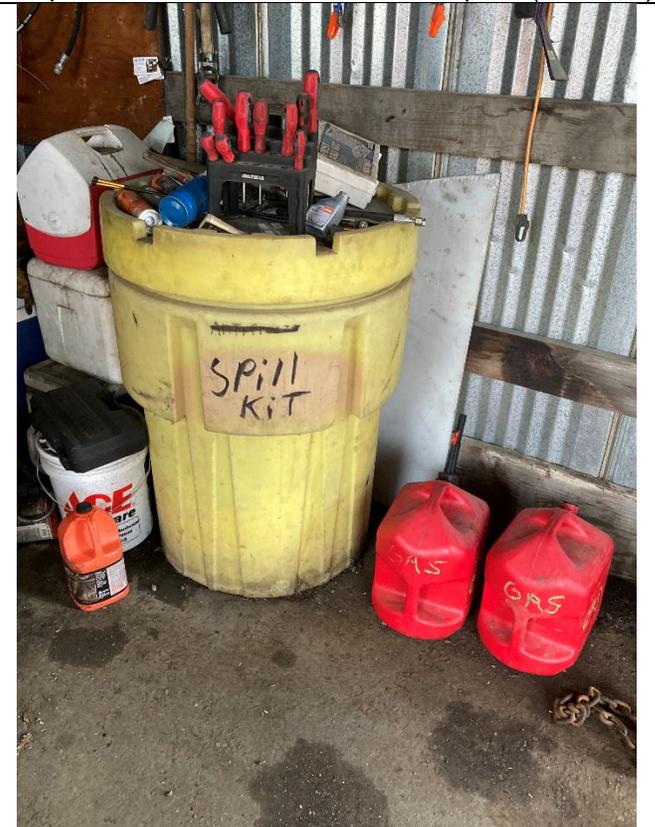
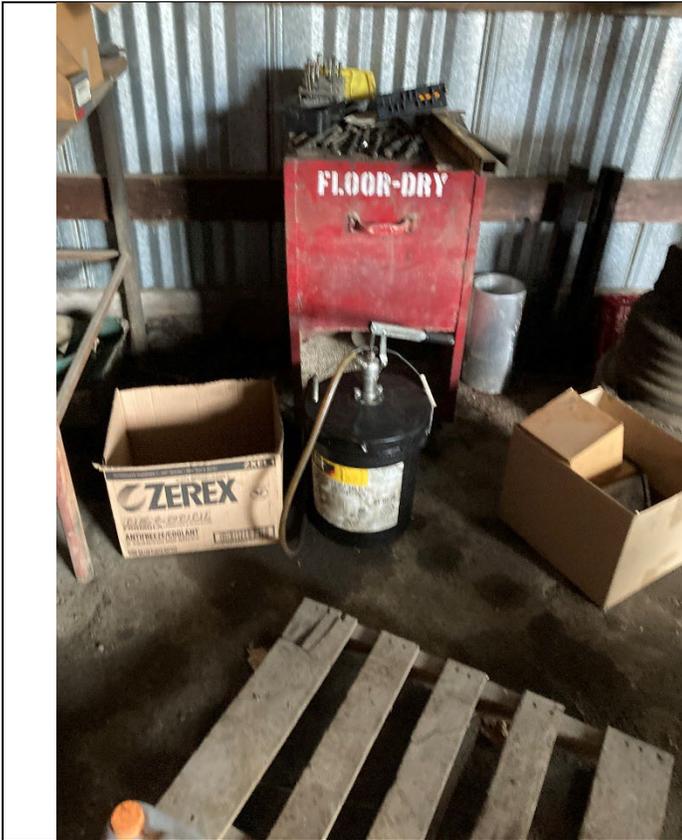
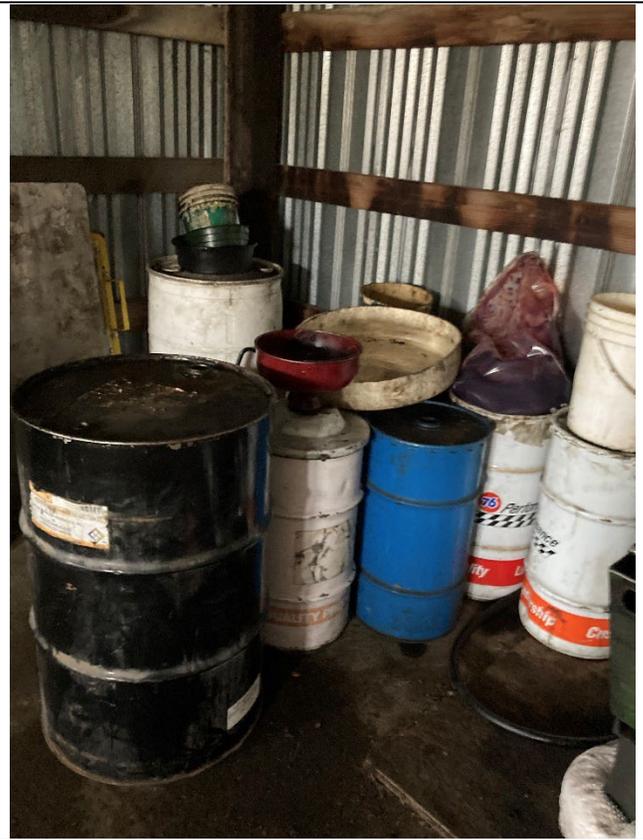
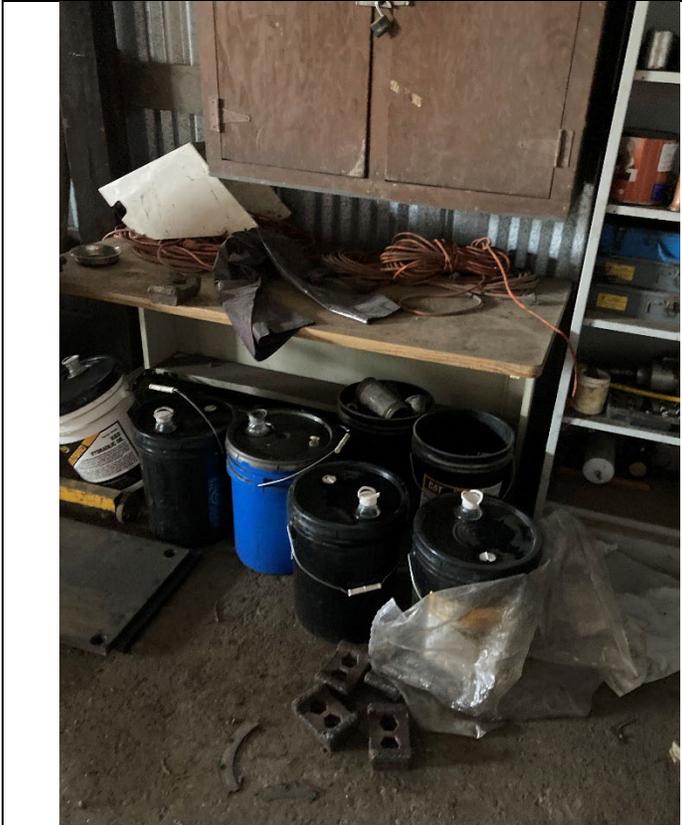
- **Drums and Other Hazardous Fluids without Secondary Containment:** Multiple drums and containers (chemicals, gasoline) were observed without secondary containment inside the maintenance shop (Photos 12-15).

Photo 12
Description: Photo of gasoline without secondary containment.

Photo 13
Description: Photo of chemical container without secondary containment.

Photo 14
Description: Photo of drums without secondary containment.

Photo 15
Description: Photo of buckets without secondary containment.

- **VIOLATION and CORRECTIVE ACTION:** Facility does have secondary containment for drums, totes, and containers containment hazardous liquids and needs to contain as specified in the Permit. **Snoqualmie Mill has (30) calendar days to complete.**

Permit Condition: In accordance to **permit condition S3.B.4.b.i.4.a – b**, the Permittee shall:

- a. Store all hazardous substances, petroleum/oil liquids, and other chemical solid or liquid materials that have potential to contaminate stormwater on an impervious surface that is surrounded with a containment berm or dike that is capable of containing 10% of the total enclosed tank volume or 110% of the volume contained in the largest tank, whichever is greater, or use double-walled tanks.
- b. Prevent precipitation from accumulating in containment areas with a roof or equivalent structure or include a plan on how it will manage and dispose of accumulated water if a containment area cover is not practical.

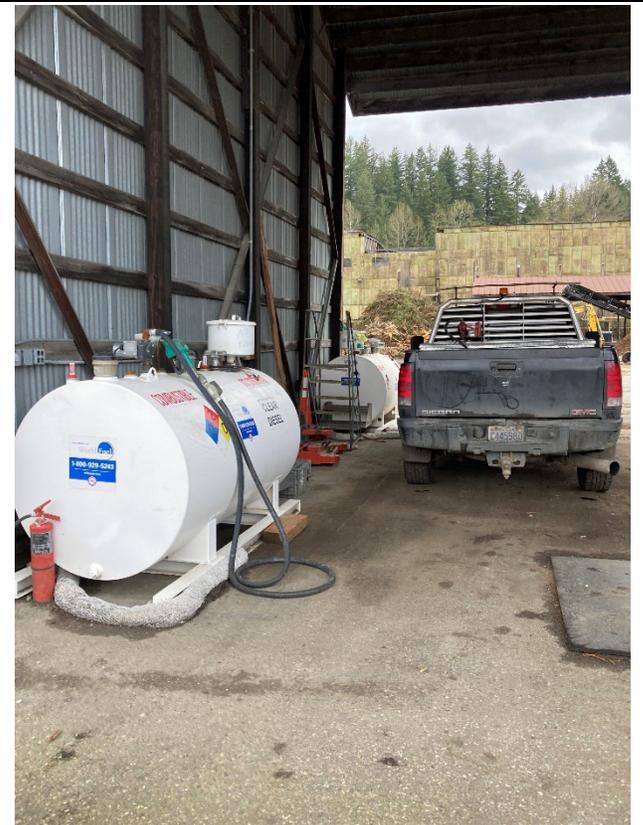
- **Fueling Station with No Drip Pans:** Fueling stations were observed with no drip pans (Photo 16).
 - **Log, Bark, Firewood Storage Yard:** The Inspector observed the storage yard for logs, bark, and firewood (Photos 17-19). The Inspector noticed black-colored water on the ground (Photo 20) and noticed black liquid leaking out of a dumpster (Photos 21-22). Upon observing the contents of the dumpster, the Inspector found bark (Photos 23-24). It is possible that the liquid leaking out of the dumpster is leachate.

Photo 16
Description: Photo of fueling station with no drip pans.

- **VIOLATION and CORRECTIVE ACTION:** Facility does not have / use drips pans during diesel fuel transfer operations and needs to start using drips pans. **Snoqualmie Mill has (30) calendar days to complete.**

Permit Condition: In accordance to **permit condition S3.B.4.b.i.4.f**, the Permittee shall use drips pans or equivalent containment measures during all petroleum transfer operations.

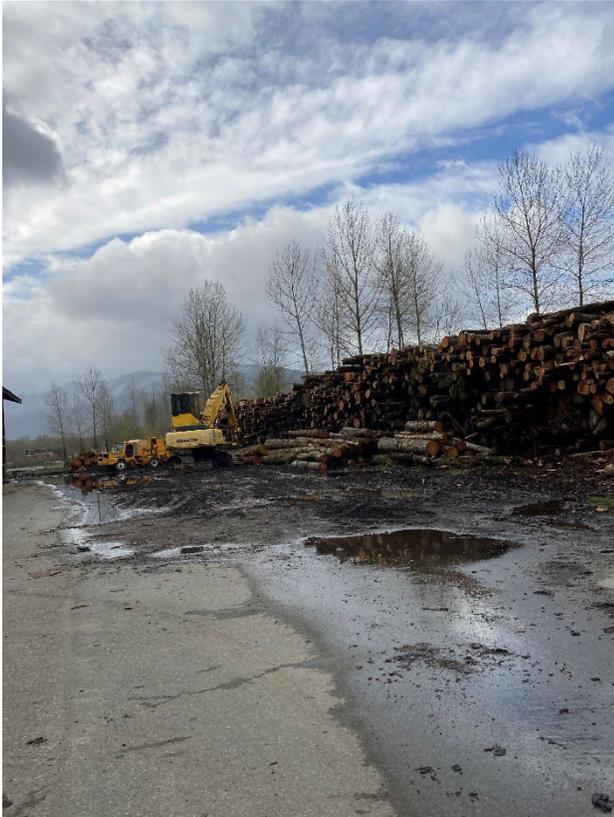
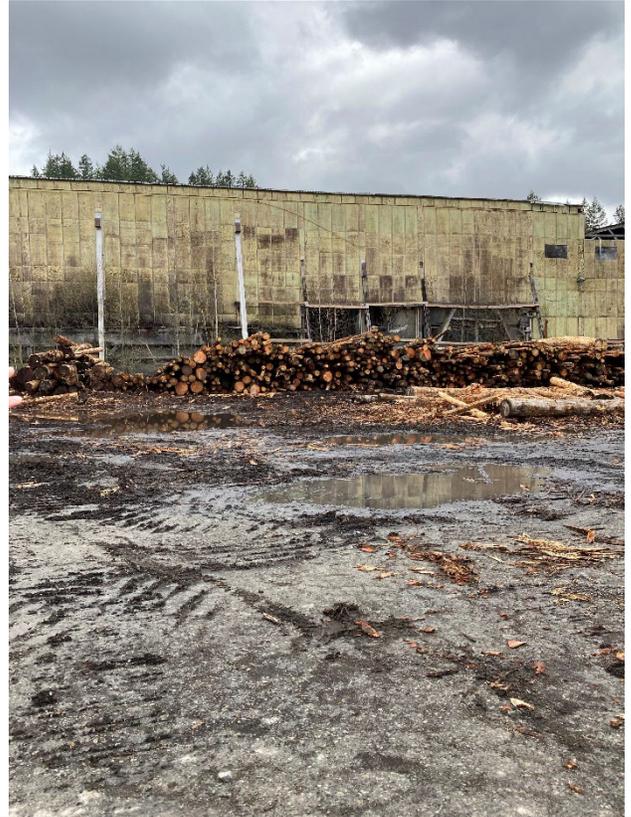
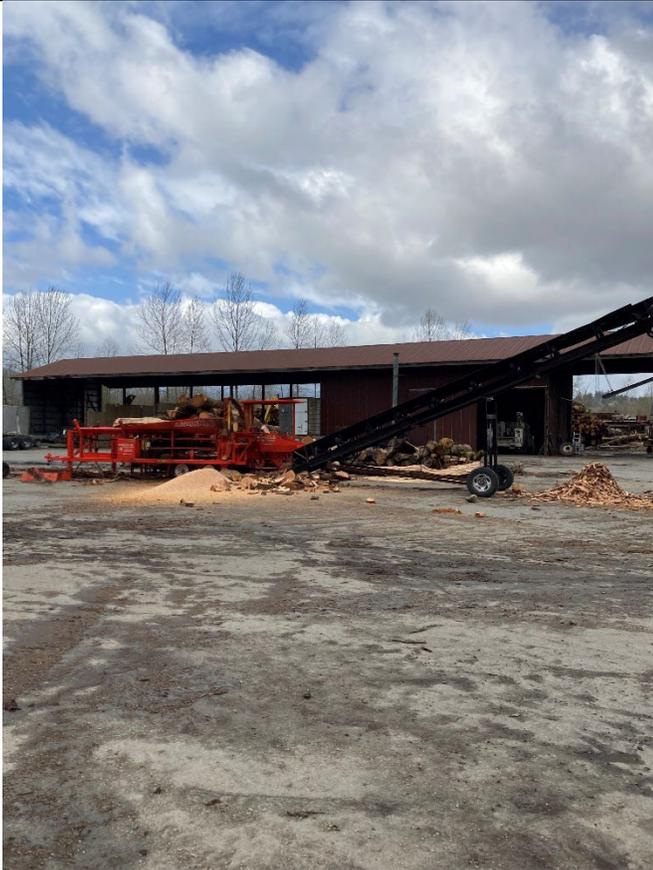
Photo 17
Description: Photo of log storage.

Photo 18
Description: Photo of log storage.

Photo 19
Description: Photo of firewood and wood debris.

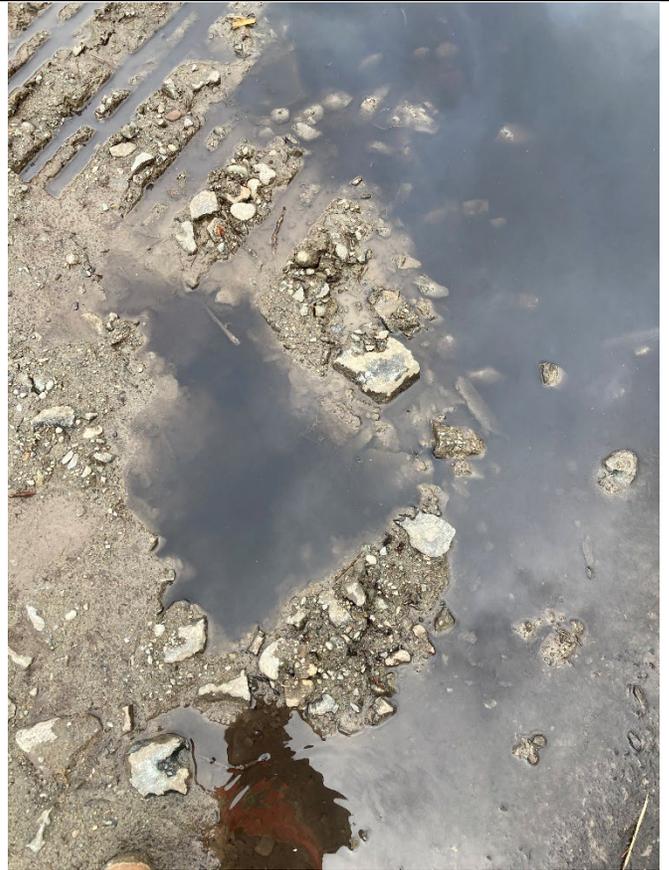
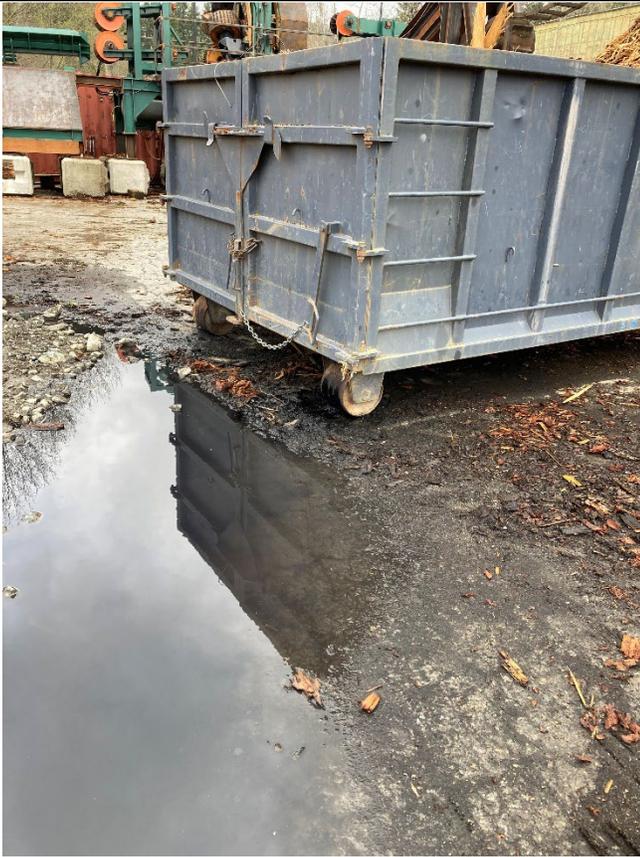
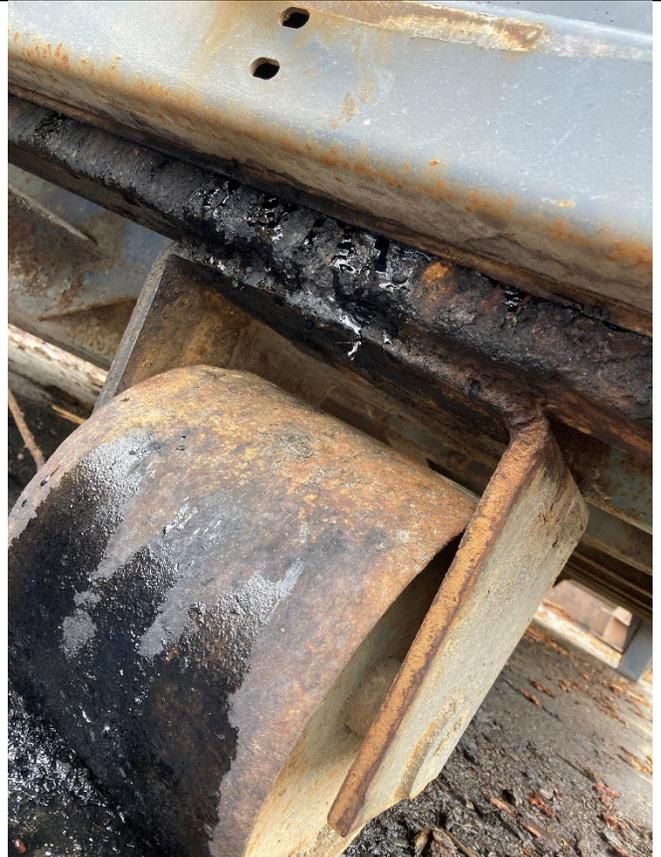
Photo 20
Description: Photo of black colored water.

Photo 21
Description: Photo of black water source.

Photo 22
Description: Photo of black liquid leaking out of dumpster.

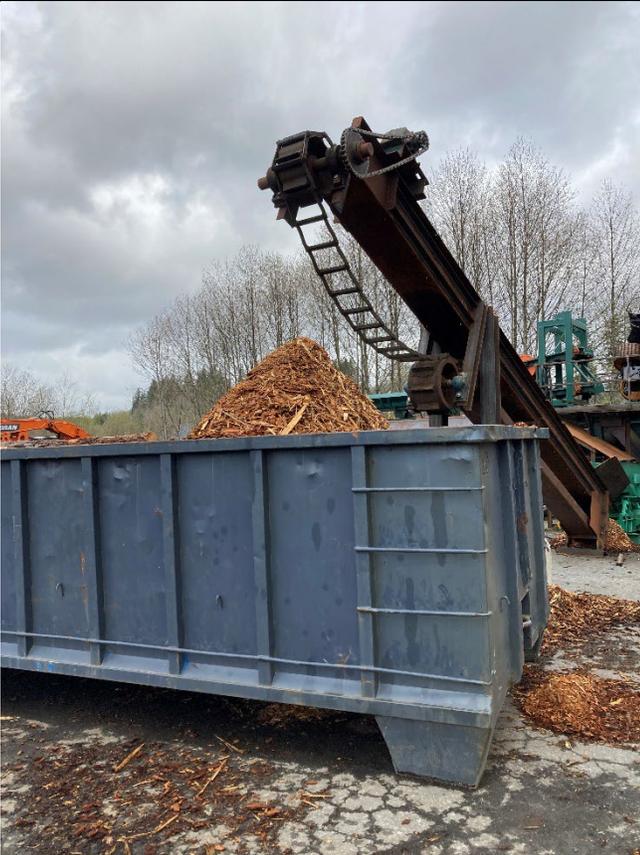
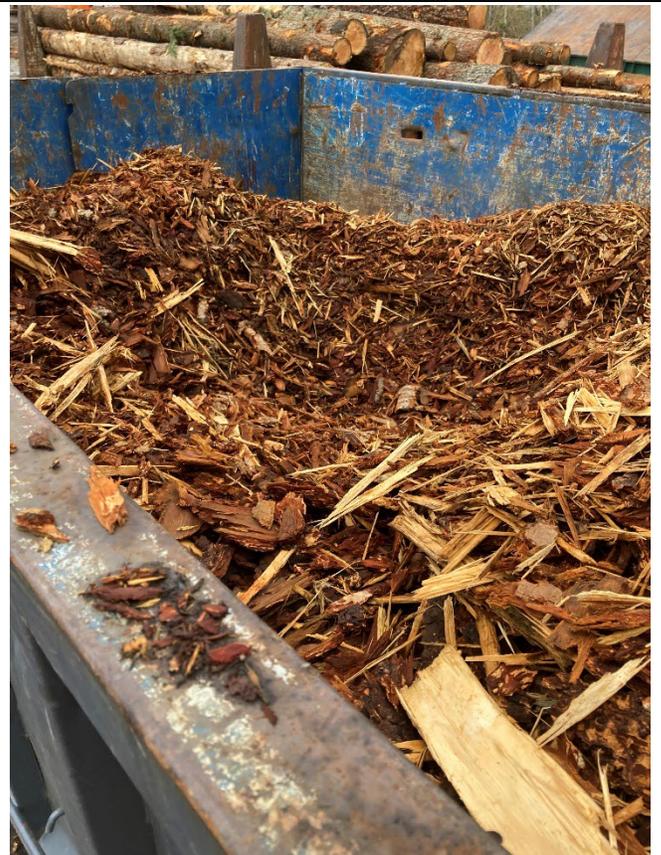
Photo 23
Description: Photo of bark piled in dumpster.

Photo 24
Description: Photo of bark inside dumpster.

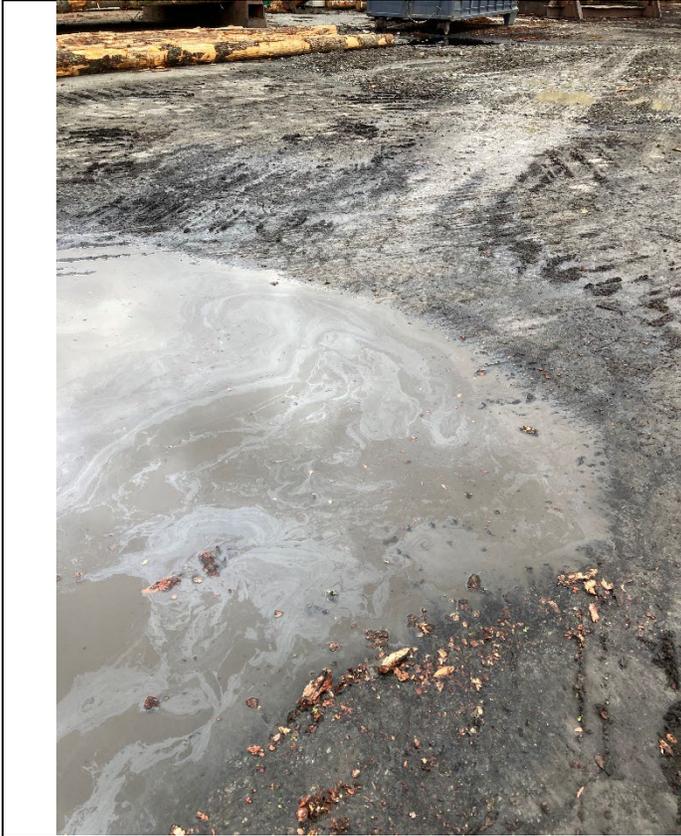
- **Oil Sheen:** The Inspector observed an oil sheen (Photo 25).
- **Hos Bros Construction**
 - **Diesel Fueling Station and Oil Sheen:** A diesel fueling station was observed under cover and within secondary containment at the middle of Hos Bros' property (Photo 26). However, no drips pans were observed and an oil sheen was observed near the fueling station (Photos 27-28). Additional fuel tanks were observed at the east side of Hos Bros' property (Photo 29) – no drip pans were observed.

Photo 25
Description: Photo of oil sheen.

- **CORRECTIVE ACTION:** Facility needs to clean up oil sheens immediately once observed. **Snoqualmie Mill shall implement immediately.**

Permit Condition: In accordance to **permit condition S3.B.4.b.i.3.d**, the Permittee must clean up spills and leaks immediately (e.g., using absorbents, vacuuming, etc.) to prevent the discharge of pollutants.

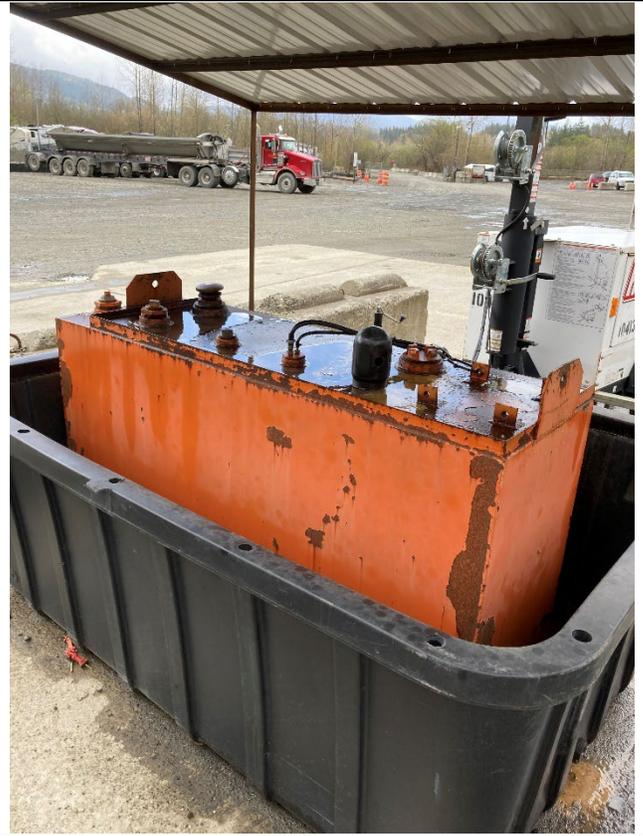
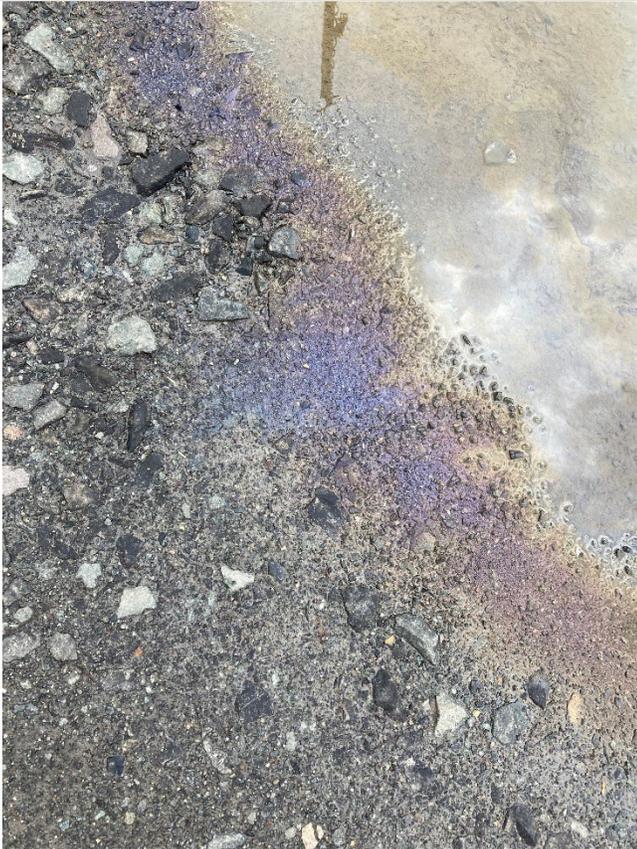
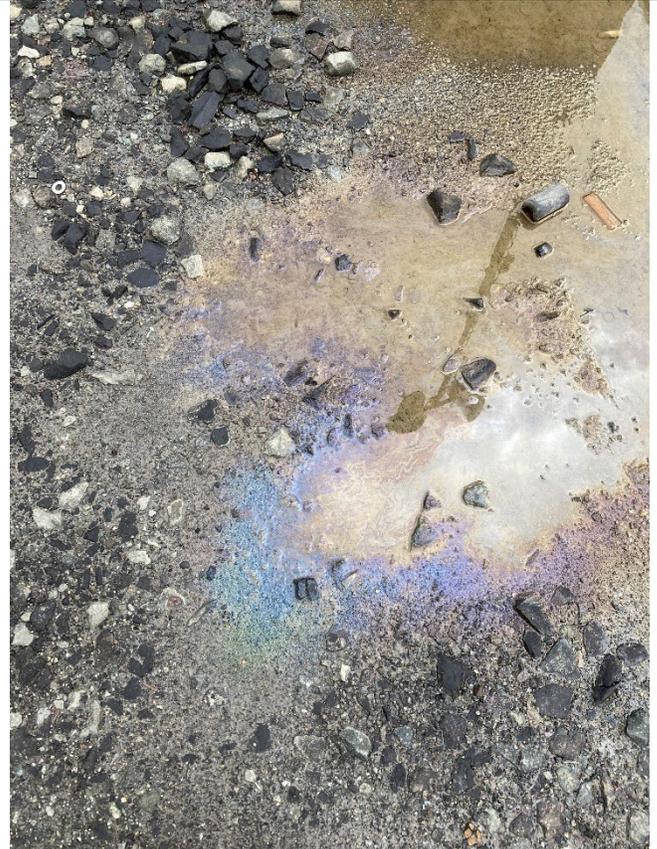
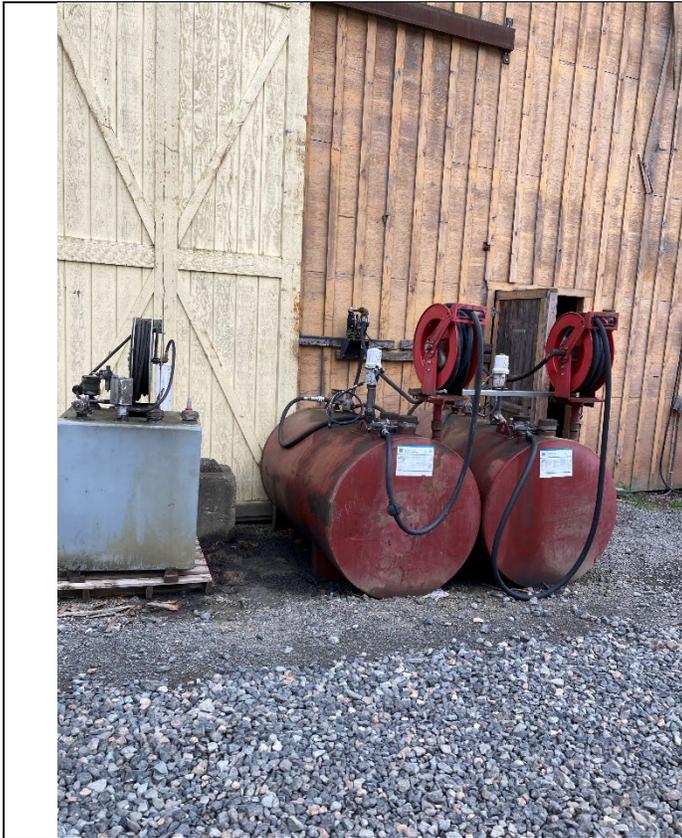
Photo 26
Description: Photo of diesel fuel tank.

Photo 27
Description: Photo of oil sheen.

Photo 28
Description: Photo of oil sheen.

Photo 29
Description: Photo of fuel tanks at east side of part of Hos Bros property.

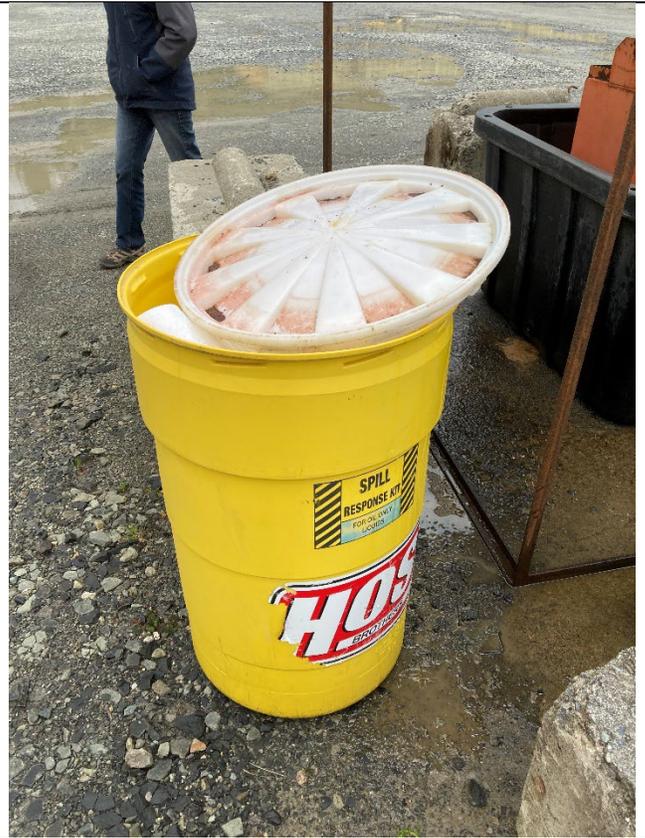
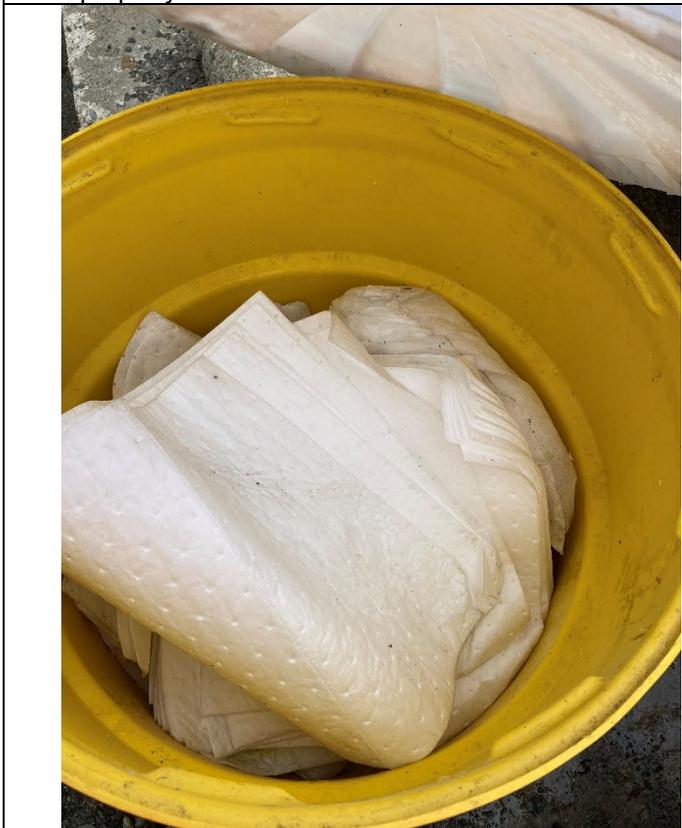
- **Spill Kit:** A spill kit was observed next to the fueling station but it did not contain a non-metallic shovel (Photos 30-31). The Inspector informed both Mac and Ashley that all spill kits must have non-metallic shovels, especially when the facility operates on dirt/gravel ground.

Photo 30
Description: Photo of spill kit next to fuel tank.

Photo 31
Description: Photo of contents inside fuel tank; non-metallic shovel missing.

- **VIOLATION and CORRECTIVE ACTION:** Facility does not have non-metallic shovels in their spill kits and needs to include them in the kits. **Snoqualmie Mill has (30) calendar days to complete.**

Permit Condition: In accordance to **permit condition S3.B.4.b.i.4.c**, Permittee shall locate spill kits within 25 feet of all stationary fueling stations, fuel transfer stations, mobile fueling units, and used oil storage/transfer stations. At a minimum, spill kits shall include:

- i) Oil absorbents capable of absorbing 15 gallons of fuel. Facilities with a Spill Prevention, Control, and Countermeasures Plan (SPCCP) must have enough oil absorbents capable of absorbing the minimum anticipated spill amount or potential discharge volume identified in that plan if more than 15 gallons.
- ii) A storm drain plug of cover kits.
- iii) A non-water containment boom, a minimum of 10 feet in length with a 12-gallon absorbent capacity.
- iv) A non-metallic shovel.
- v) Two 5-gallon buckets with lids.
