STORMWATER COMPLIANCE INSPECTION REPORT				WADOE Stormwater Compliance Inspection Form										
	State of Washington Department of Ecology 15700 Dayton Avenue N., Shoreline, WA 98133				Phone: (206) 594-0000										
Section A: General															
Inspection Date: 4/5/2022	NPDES Permit #: WAR310172	County: King	Receiving Waters: Snoqualmie Mill Wetland	Inspector(s): Dennis Lee	Facility Type: Industrial										
Discharges to: Surface Water <input checked="" type="checkbox"/> Ground Water <input type="checkbox"/>				ANNOUNCED Inspection											
Section B: Facility															
Name and Location of Site Inspected			Entry Time	Permit Effective Date											
Snoqualmie Mill Industrial Areas			9:59 am	04/26/2021											
SE Stearns Rd & SE Haul Rd			Exit Time	Permit Expiration Date											
Snoqualmie, WA 98065			11:34 am	12/31/2024											
On-Site Representative(s): Name(s) / Title(s) / Contact number(s) or E-mail				Additional Participants:											
Mac McInnis 425-442-6002				Ashley Baldwin (Encore Environmental)											
Responsible Official(s)															
Tom Sroufe 249 Main Ave S Ste 107 North Bend, WA 98045 Phone: 425-444-0822		Mac McInnis 249 Main Ave

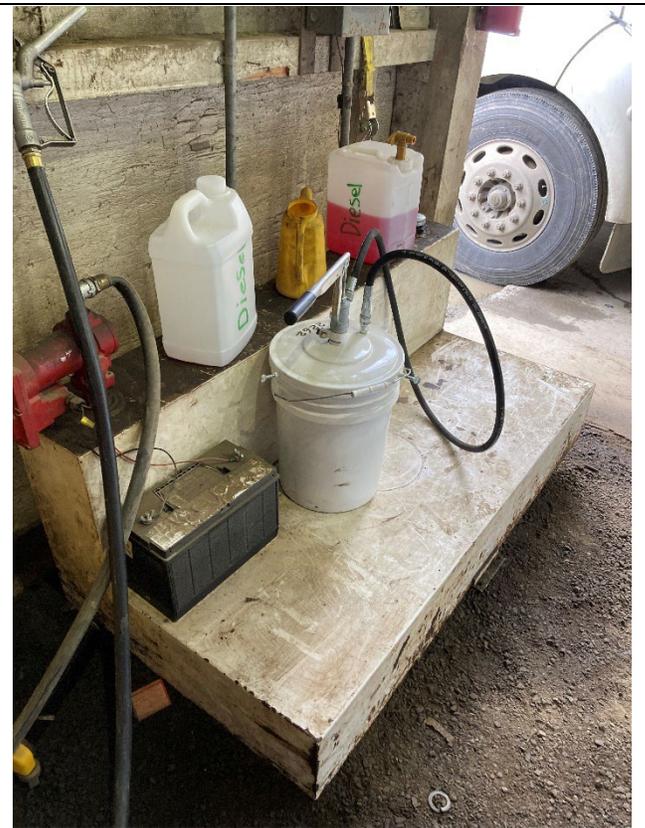
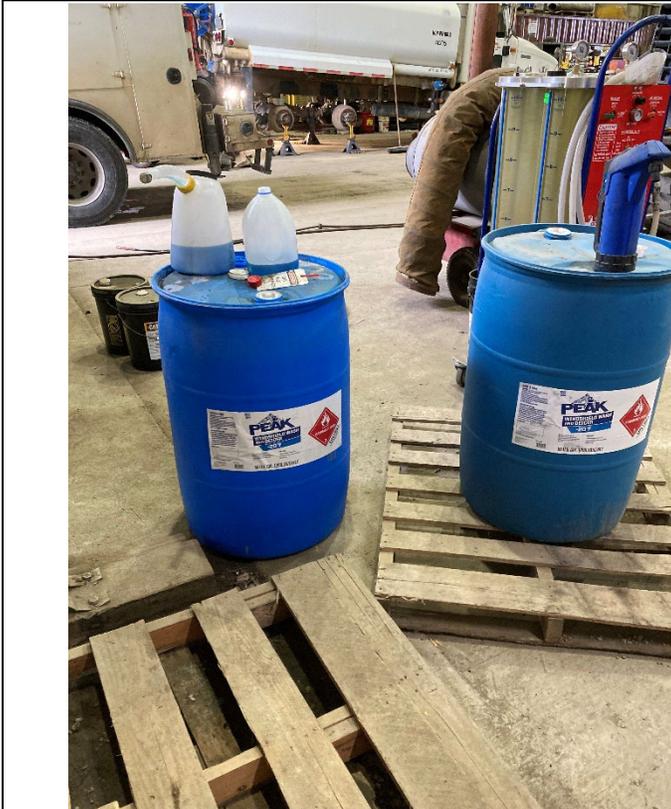
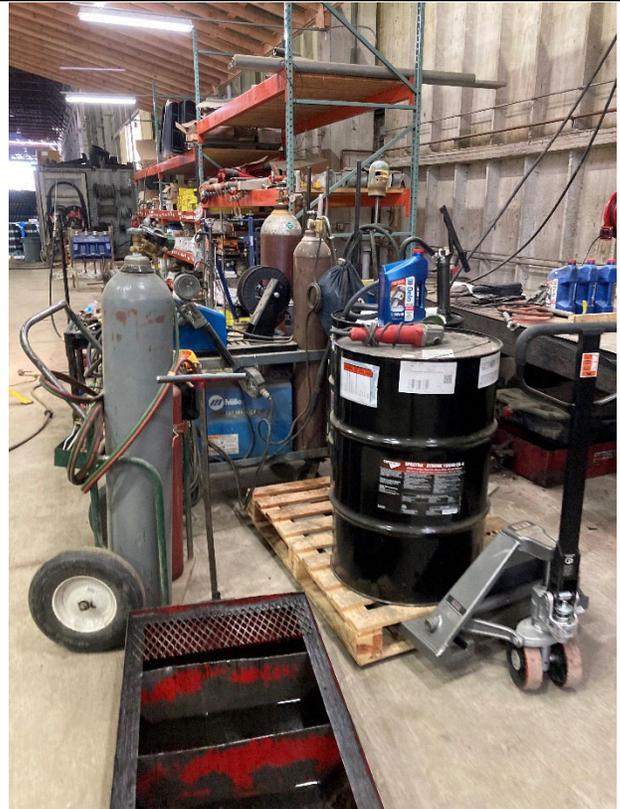
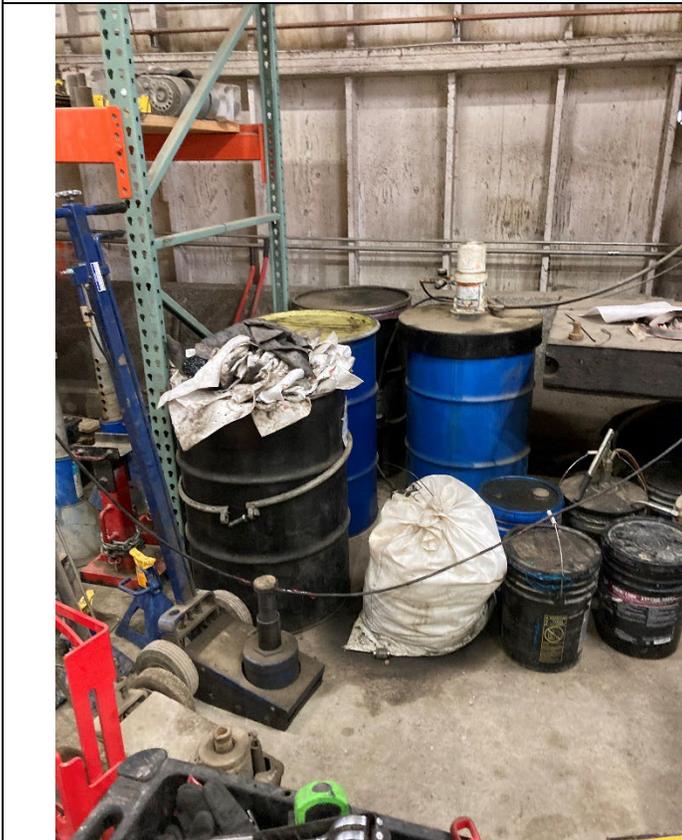
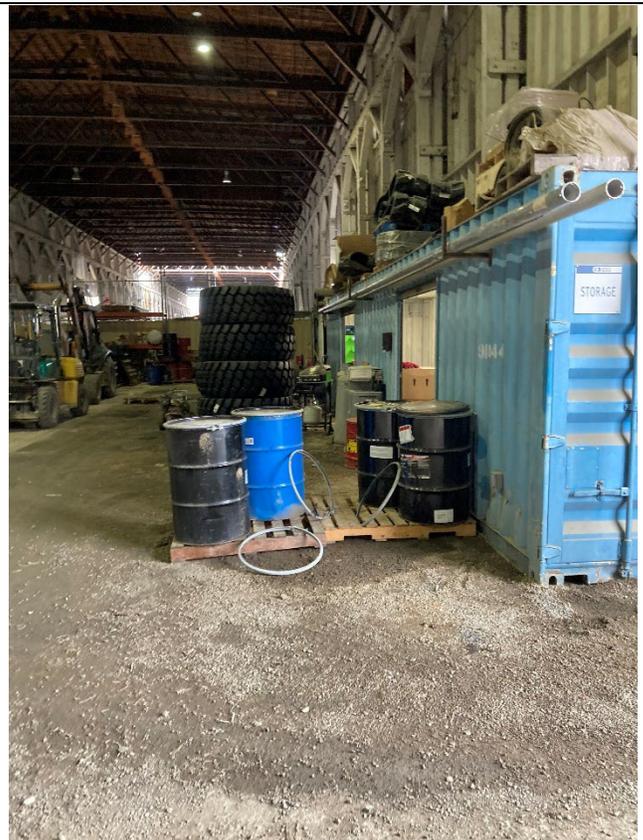
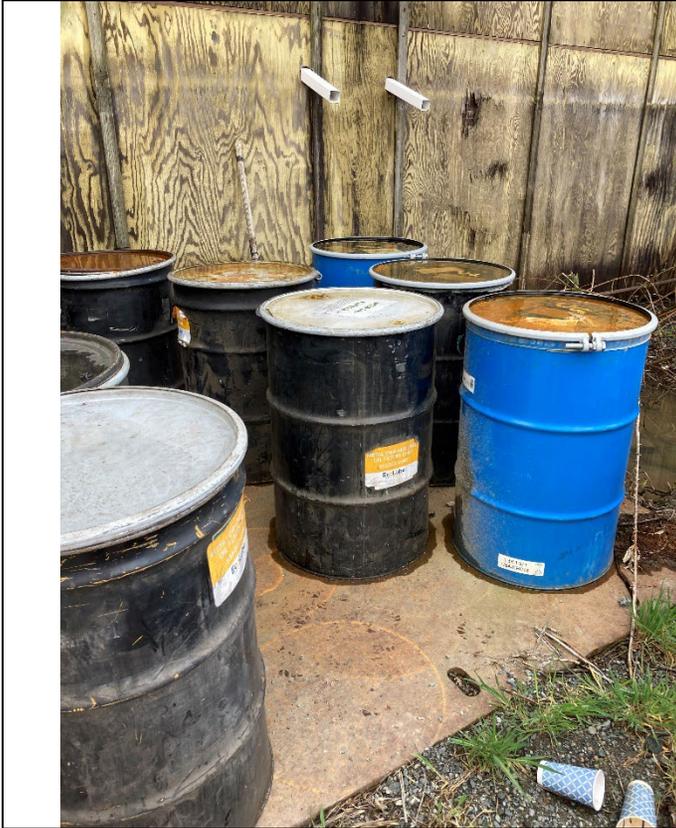
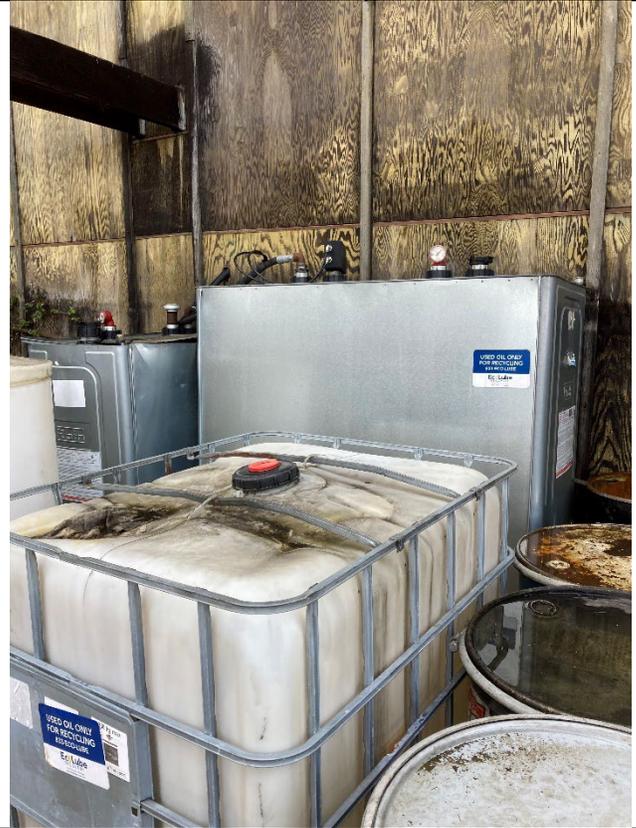
- **Chemical and Oil Storage without Secondary Containment:** Numerous drums and containers were observed without secondary containment inside the shop building (Photos 32-36). Although the items were under cover, the building is old and the floor is a mix of impervious ground and dirt/gravel ground. Upon exiting the building (northwest side of the building), the Inspector observed more drums and totes (used oil) directly next to the building without cover and without secondary containment. The Inspector also observed water in the ditch next to the drums/totes (Photos 37-38).

Photo 32
Description: Photo of containers with diesel without secondary containment.

Photo 33
Description: Photo of drums without secondary containment.

Photo 34
Description: Photo of drum without secondary containment.

Photo 35
Description: Photo of drums and buckets without secondary containment.

Photo 36
Description: Photo of drums without secondary containment.

Photo 37
Description: Photo of drums outside without secondary containment.

Photo 38
Description: Photo of used oil totes without secondary containment.

- **VIOLATION and CORRECTIVE ACTION:** Facility does have secondary containment for drums, totes, and containers containment hazardous liquids and needs to contain as specified in the Permit. **Snoqualmie Mill has (30) calendar days to complete.**

Permit Condition: In accordance to **permit condition S3.B.4.b.i.4.a – b**, the Permittee shall:

- a. Store all hazardous substances, petroleum/oil liquids, and other chemical solid or liquid materials that have potential to contaminate stormwater on an impervious surface that is surrounded with a containment berm or dike that is capable of containing 10% of the total enclosed tank volume or 110% of the volume contained in the largest tank, whichever is greater, or use double-walled tanks.
- b. Prevent precipitation from accumulating in containment areas with a roof or equivalent structure or include a plan on how it will manage and dispose of accumulated water if a containment area cover is not practical.

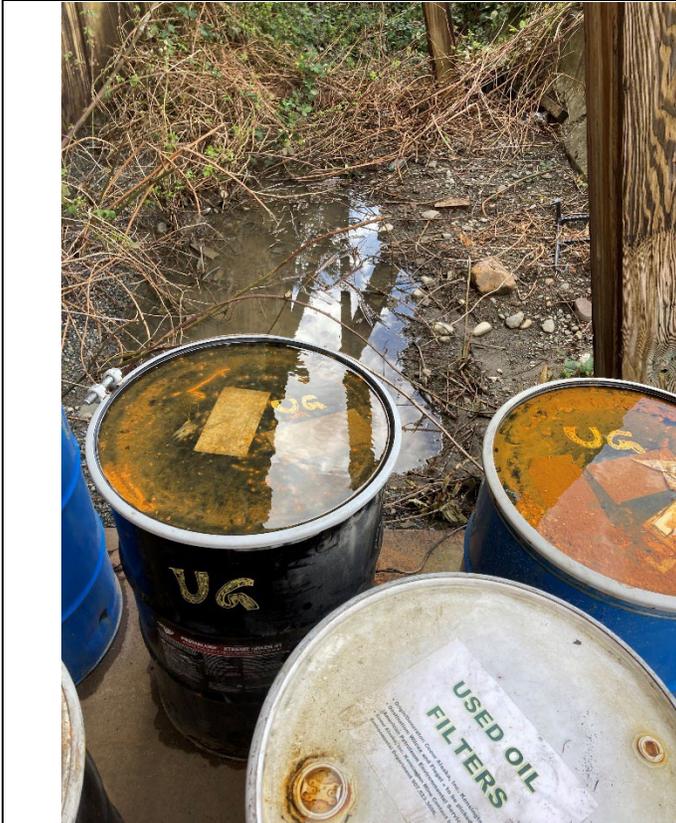
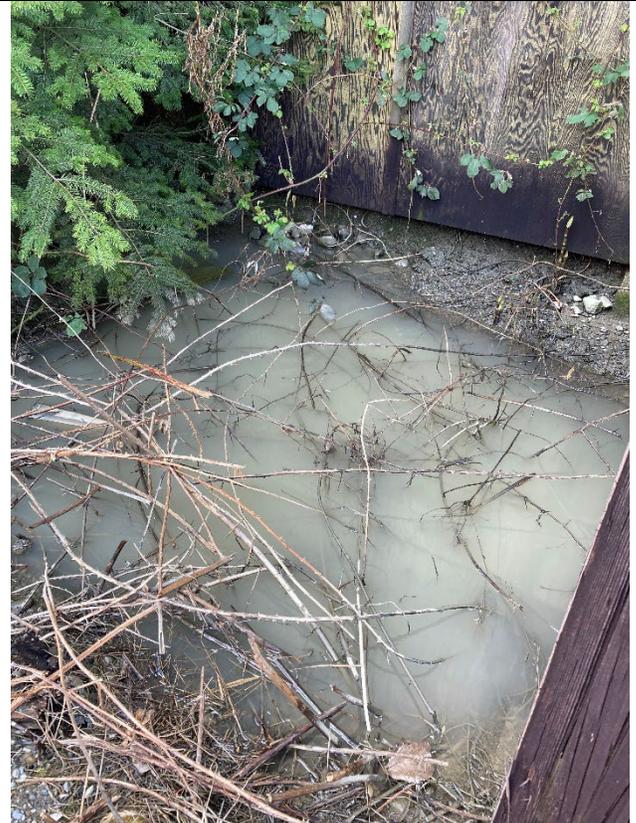
Photo 39
Description: Photo of ditch next to drums.

Photo 40
Description: Photo of ditch next to totes (Photo 38).

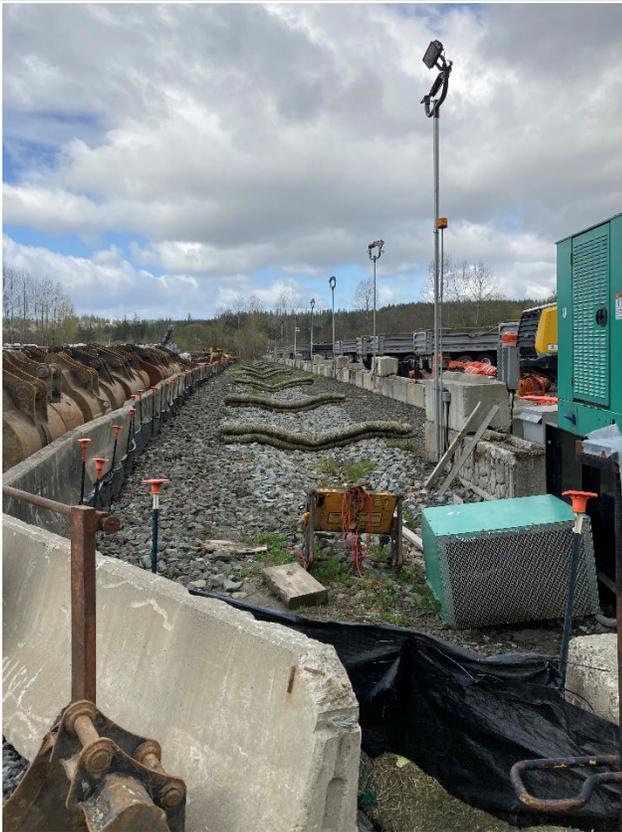
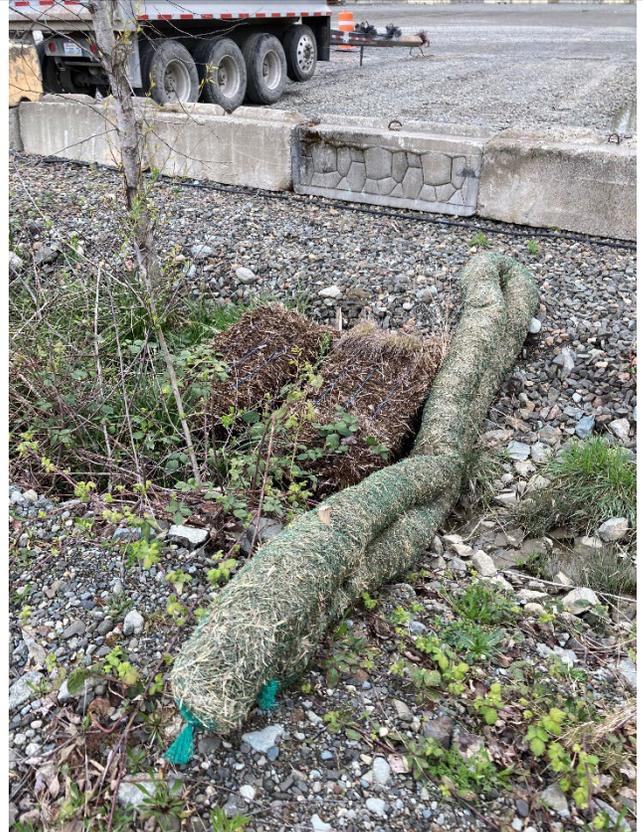
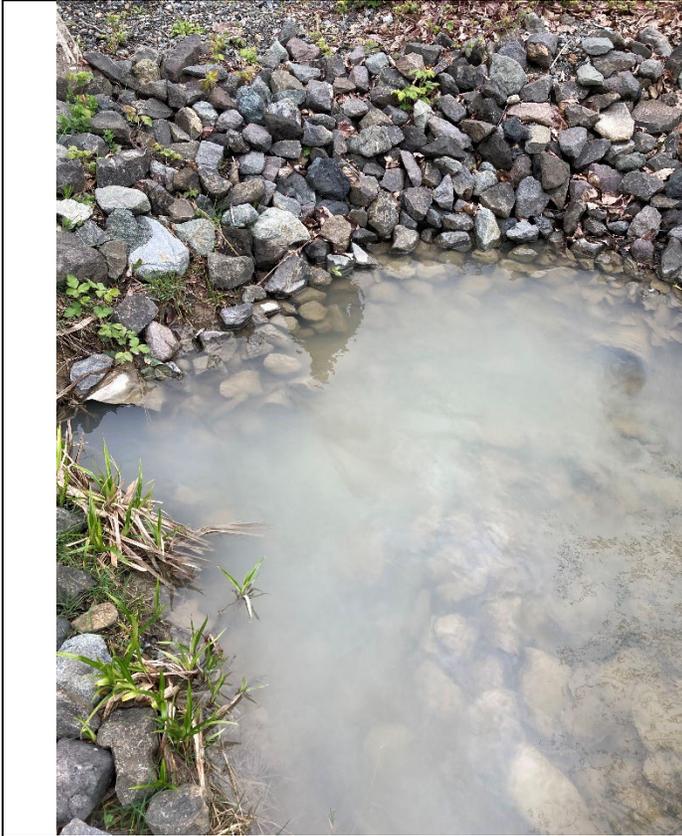
Photo 43
Description: Facing west, photo of rock-lined ditch with silt fences and wattles.

Photo 44
Description: Photo of straw wattles and bales.

Photo 45
Description: Photo of turbid water.

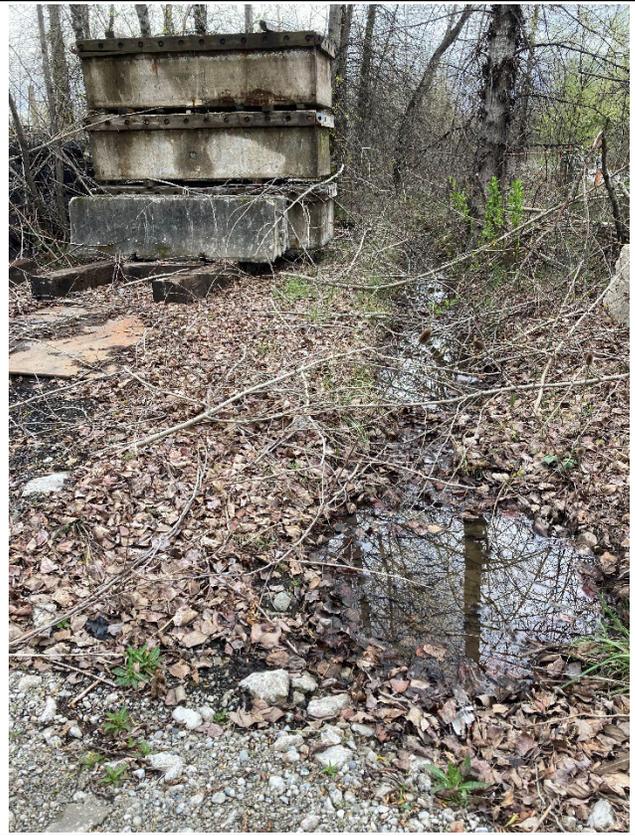
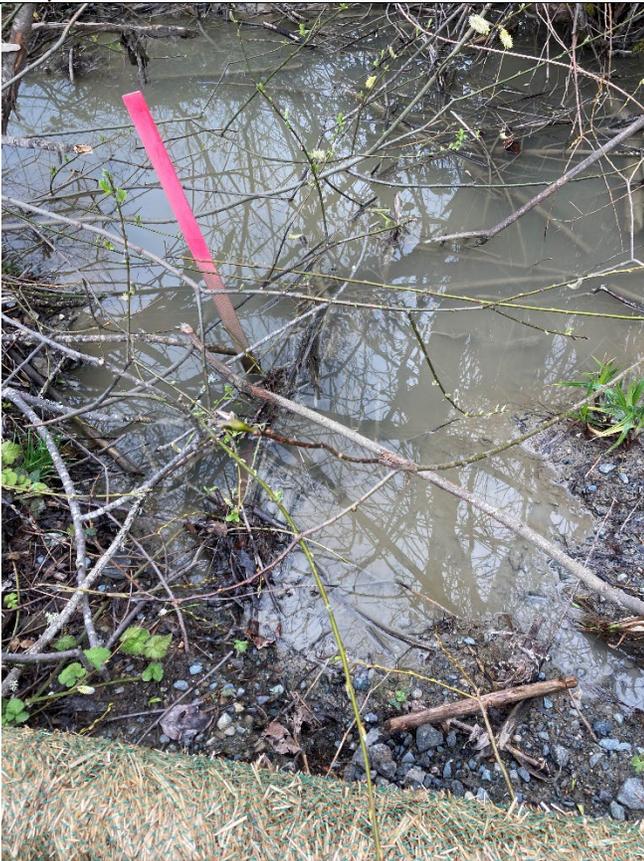
- **Sample Points:** The Inspector observed sample location 01 (Photo 44) and sample location 02 (Photo 45). The Inspector notified Mac and Ashley that due to the sample point being submerged in water, sampling from this point as it currently

stands is of concern because any samples taken would be commingled with water already present in the swale. The facility will need to address the commingling issue at sample location 02.

Photo 46
Description: Facing south, photo of sample location 01.

Photo 47
Description: Photo of sample location 02 marked by pink colored stick.

- **CORRECTIVE ACTION:** Facility currently samples commingled stormwater and needs to sample stormwater associated with Facility's industrial activity. **Snoqualmie Mill has (30) calendar days to complete.**

Permit Condition: In accordance to **permit condition S4.B.2.a**, the Permittee shall designate sampling location(s) at the point(s) where it discharges stormwater associated with industrial activity off-site.
