<h2 style="margin: 0;">STORMWATER COMPLIANCE INSPECTION REPORT</h2> <p style="margin: 0;">State of Washington Department of Ecology 15700 Dayton Avenue N, Shoreline, WA 98133</p>			WADOE Stormwater Phone: (206) 594-0000										
Section A: General Data															
Inspection Date 4/27/2022	NPDES Permit # WAR305202	County King	Receiving Waters Mill Creek	Inspector Rose Propst	Facility Type Industrial										
Discharges to: Surface Water <input checked="" type="checkbox"/> Ground Water <input type="checkbox"/>				ANNOUNCED Inspection											
Section B: Facility Data															
Name and Location of Site Inspected				Entry Time	Permit Effective Date										
Mondelēz Global, LLC 19032 62 nd Ave S Kent, WA 98032				9:30 AM	1/1/2020										
				Exit Time	Permit Expiration Date										
				10:30 AM	12/31/2024										
On-Site Representative(s): Name(s)/Title(s)/Contact number(s) or E-mail					Additional Participants:										
Betsy Boyko Manager of Customer Logistics (253) 395-3167 betsy.boyko@mdlz.com					Kenzi Smith, ERM (consultant)										
Responsible Official(s):					Sampling and Photos										
Betsy Boyko (see above for contact information)

PHOTO ADDENDUM –

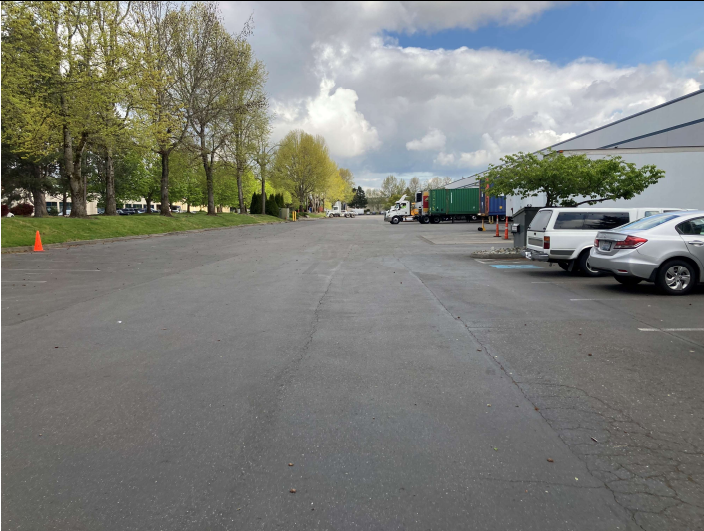
- The inspection covered the paved western (Photo #1) and southern (Photo #2) portions of the facility, and observation of the eastern portion of the facility (eastern building exterior and adjoining railroad spur [Photo #3]) from the southern easement.

PHOTO 1
DIRECTION: North
DESCRIPTION: Western drive/parking area of facility.

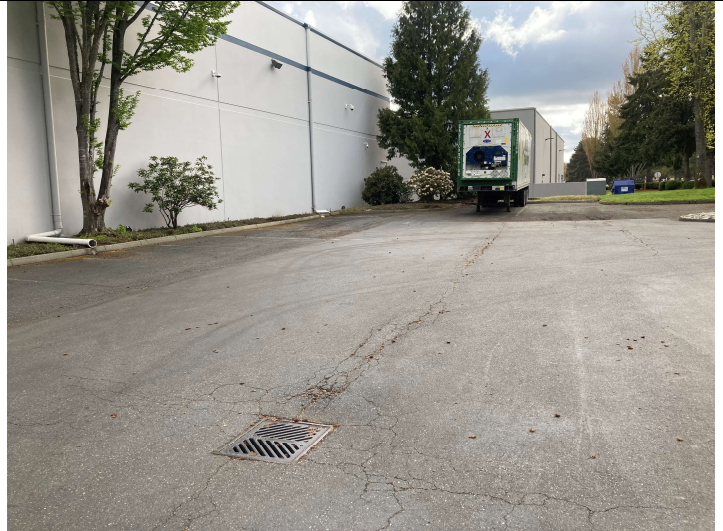
PHOTO 2
DIRECTION: East
DESCRIPTION: Southern side of facility; note roof drains on building exterior draining to pavement.

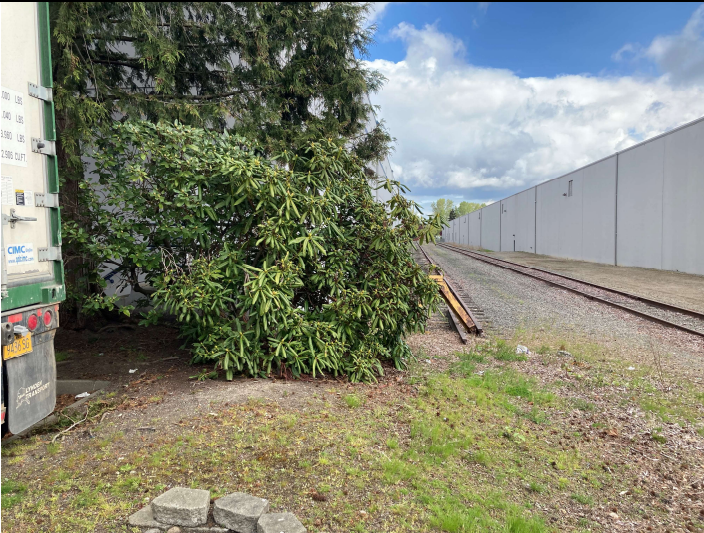
PHOTO 3
DIRECTION: North
DESCRIPTION: Eastern side of facility (vegetated and railroad spur).

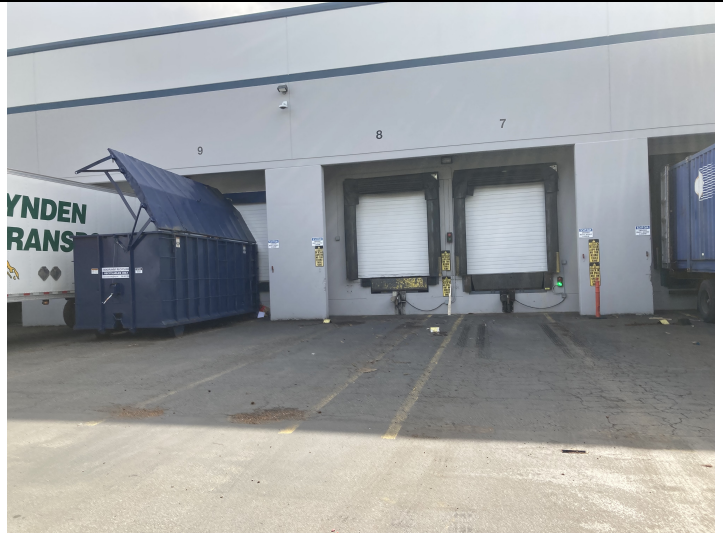
- The stormwater sample is collected from an outlet pipe within storm drain #2 in the northwestern portion of the facility. This drain collects storm water from the areas of operation (Photo #4), fueling, and washing, and catch basin #1 in the northwestern corner of the facility, then discharges to the Kent municipal separate storm sewer system ("MS4") on 62nd Ave S. Catch basins in the southwestern and southern portions of the lot collect surface flow and roof drain outflow (See Photo #2). The southern portion of the site is used for employee parking and occasional trailer storage. These drains also drain to the Kent MS4.

PHOTO 4
DIRECTION: East
DESCRIPTION: Loading docks and dumpster along western building exterior.

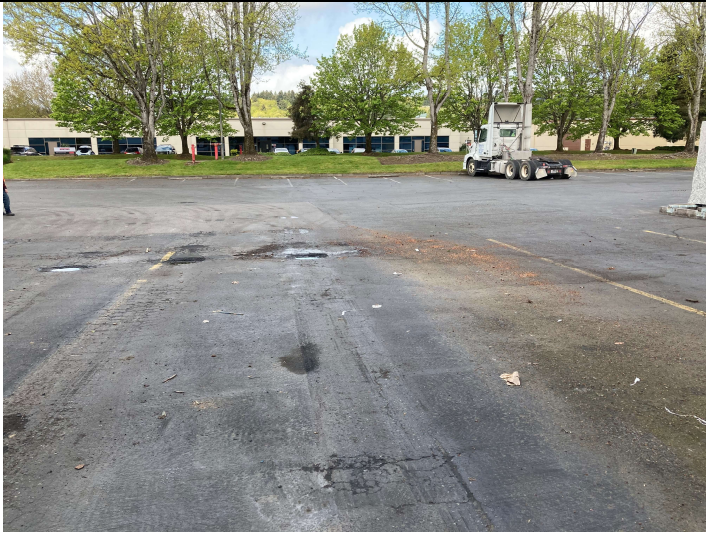
- Some debris was observed in the staging/unloading/loading area near the building exterior (Photo #5). We discussed trailer movement and sweeping schedules, as well BMPs in place such as manual sweeping/leafblowing to remove debris around staged trailers or between sweeping visits. Curbing around a landscape island had degraded and landscaping material was sloughing into the parking lot (Photo #6). This island is located along the western exterior of the building within the permitted area. We discussed repairing the berm as soon as possible to prevent soils and/or fertilizer from washing into the driveway and to the sample point.

**PHOTO 5****DIRECTION:** West**DESCRIPTION:** Debris on pavement in truck bays along western building exterior.

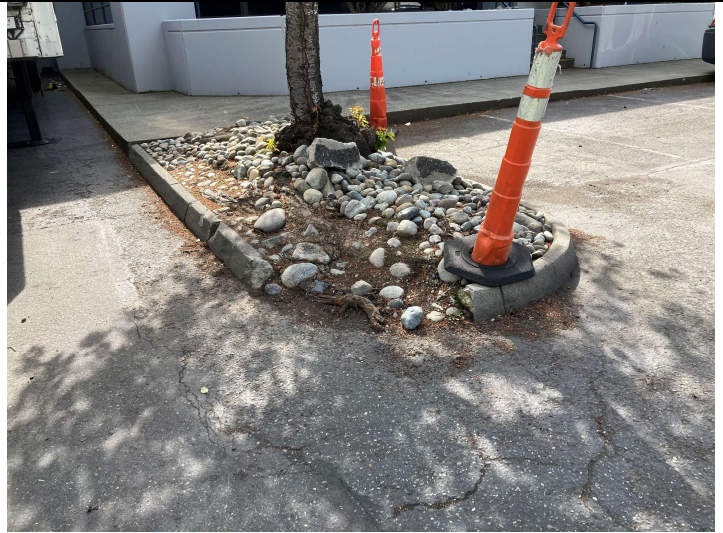
**PHOTO 6****DIRECTION:** East**DESCRIPTION:** Landscaping island with deteriorated curb.

- Repair curbing around landscaping island on western side of building exterior immediately to ensure soil or fertilizer do not mix with precipitation and enter storm drain.

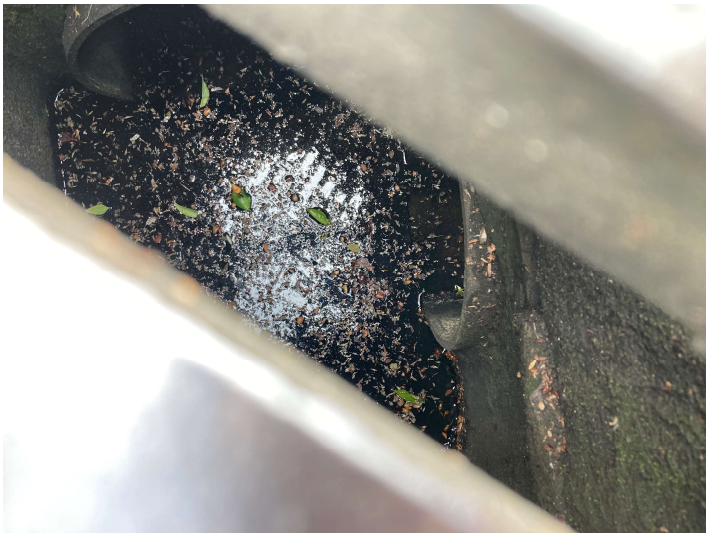
- Some floating debris was observed within catch basin vaults (Photo #7). Catch basins were not equipped with catch basin filter inserts. Mondelēz and ERM indicated that discussions were underway with the property owner/manager regarding purchasing and maintenance responsibility of the filters. Ecology urged the facility to expedite the installation of filters to reduce sediment and debris buildup in the catch basins and discussed the 2021 benchmark exceedances and corrective actions required. CBRE is reportedly responsible for catch basin cleanout, and Mondelēz contracts the parking lot sweeping. Sweeping consists of mechanical vacuum sweeping as well as leaf blowing/manual sweeping in areas that are not able to be mechanically swept. Trailers are also moved if needed. The provided BMP maintenance records indicate catchbasin cleaning was last performed 3Q21 and vacuum sweeping is performed quarterly.

**PHOTO 7****DIRECTION:** N/A**DESCRIPTION:** Representative photo of interior of catch basin vault.

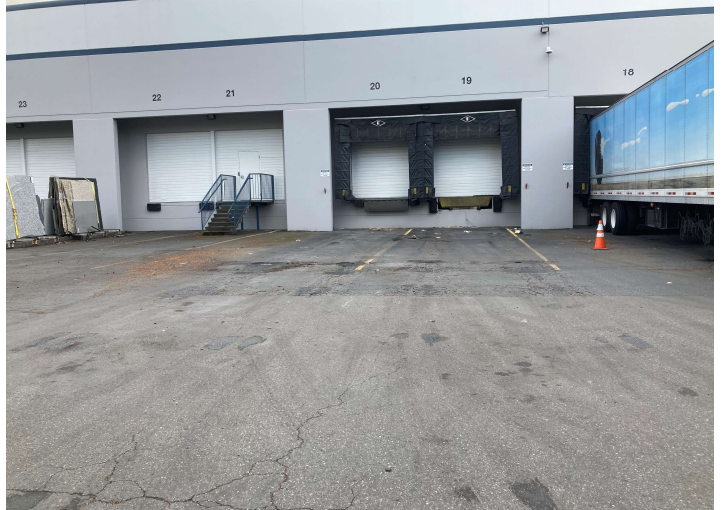
- The northern portion of the site may also receive storm water runoff from the northern-adjointing facility that shares the building with Mondelēz. During the inspection, the shared driveway contained a rack of stone or composite slabs (permitted facility boundary and staged materials shown in Photo #8). We discussed the possibility of Mondelēz talking with property manager/landlord regarding erecting a berm or other structure to prevent run-on that may come into contact with materials stored at the northern-adjointing facility. The drive appeared to have some topographic variation to help with diverting storm water, but as it was not raining at the time of inspection, the exact flow path could not be ascertained.

**PHOTO 8****DIRECTION:** East**DESCRIPTION:** Northern boundary of facility and north-adjointing business within same drive and building; permitted facility utilizes bays 1-20. Note staged materials in left side of photo.

- **In accordance with S3.B.4.b.ii.2.a**, Permittees shall use grading, berming, or curbing to prevent runoff of contaminated flows and divert run-on away from these areas.

- Use the above-mentioned mandatory structural source control BMPs to address off-site run-on as applicable.
