DEPARTMENT OF ECOLOGY State of Washington	<h2 style="text-align: center;">CONSTRUCTION STORMWATER GENERAL PERMIT</h2> <h3 style="text-align: center;">INSPECTION REPORT</h3> <p style="text-align: center;">State of Washington Department of Ecology</p>		
Section A: General Data			
Ecology Inspector(s): Joe McCord	On-Site Representative Name: Skyler Felton Title: CESCL Phone: 360-787-1202	Inspection Date and Entry/Exit Time: May 26, 2022, 11:54/1:20 Receiving waters: Groundwater	Inspection Type: Unannounced Permit webpage: https://fortress.wa.gov/ecy/paris/FacilitySummary.aspx?FacilityId=56454
Section B: Background			
<p>The Village Cooperative of South Sound project is covered under the State of Washington's Construction Stormwater General Permit (CSWGP). The CSWGP is a National Pollutant Discharge Elimination System (NPDES) and a State Waste Discharge permit for discharge of construction-related stormwater. The purpose of this inspection is to conduct a compliance inspection and to provide technical assistance as appropriate.</p> <p><u>Skyler Felton, the CESCL for CSI</u>, was present during inspection and all observations and recommendations were discussed.</p> <p>Inspection Observa

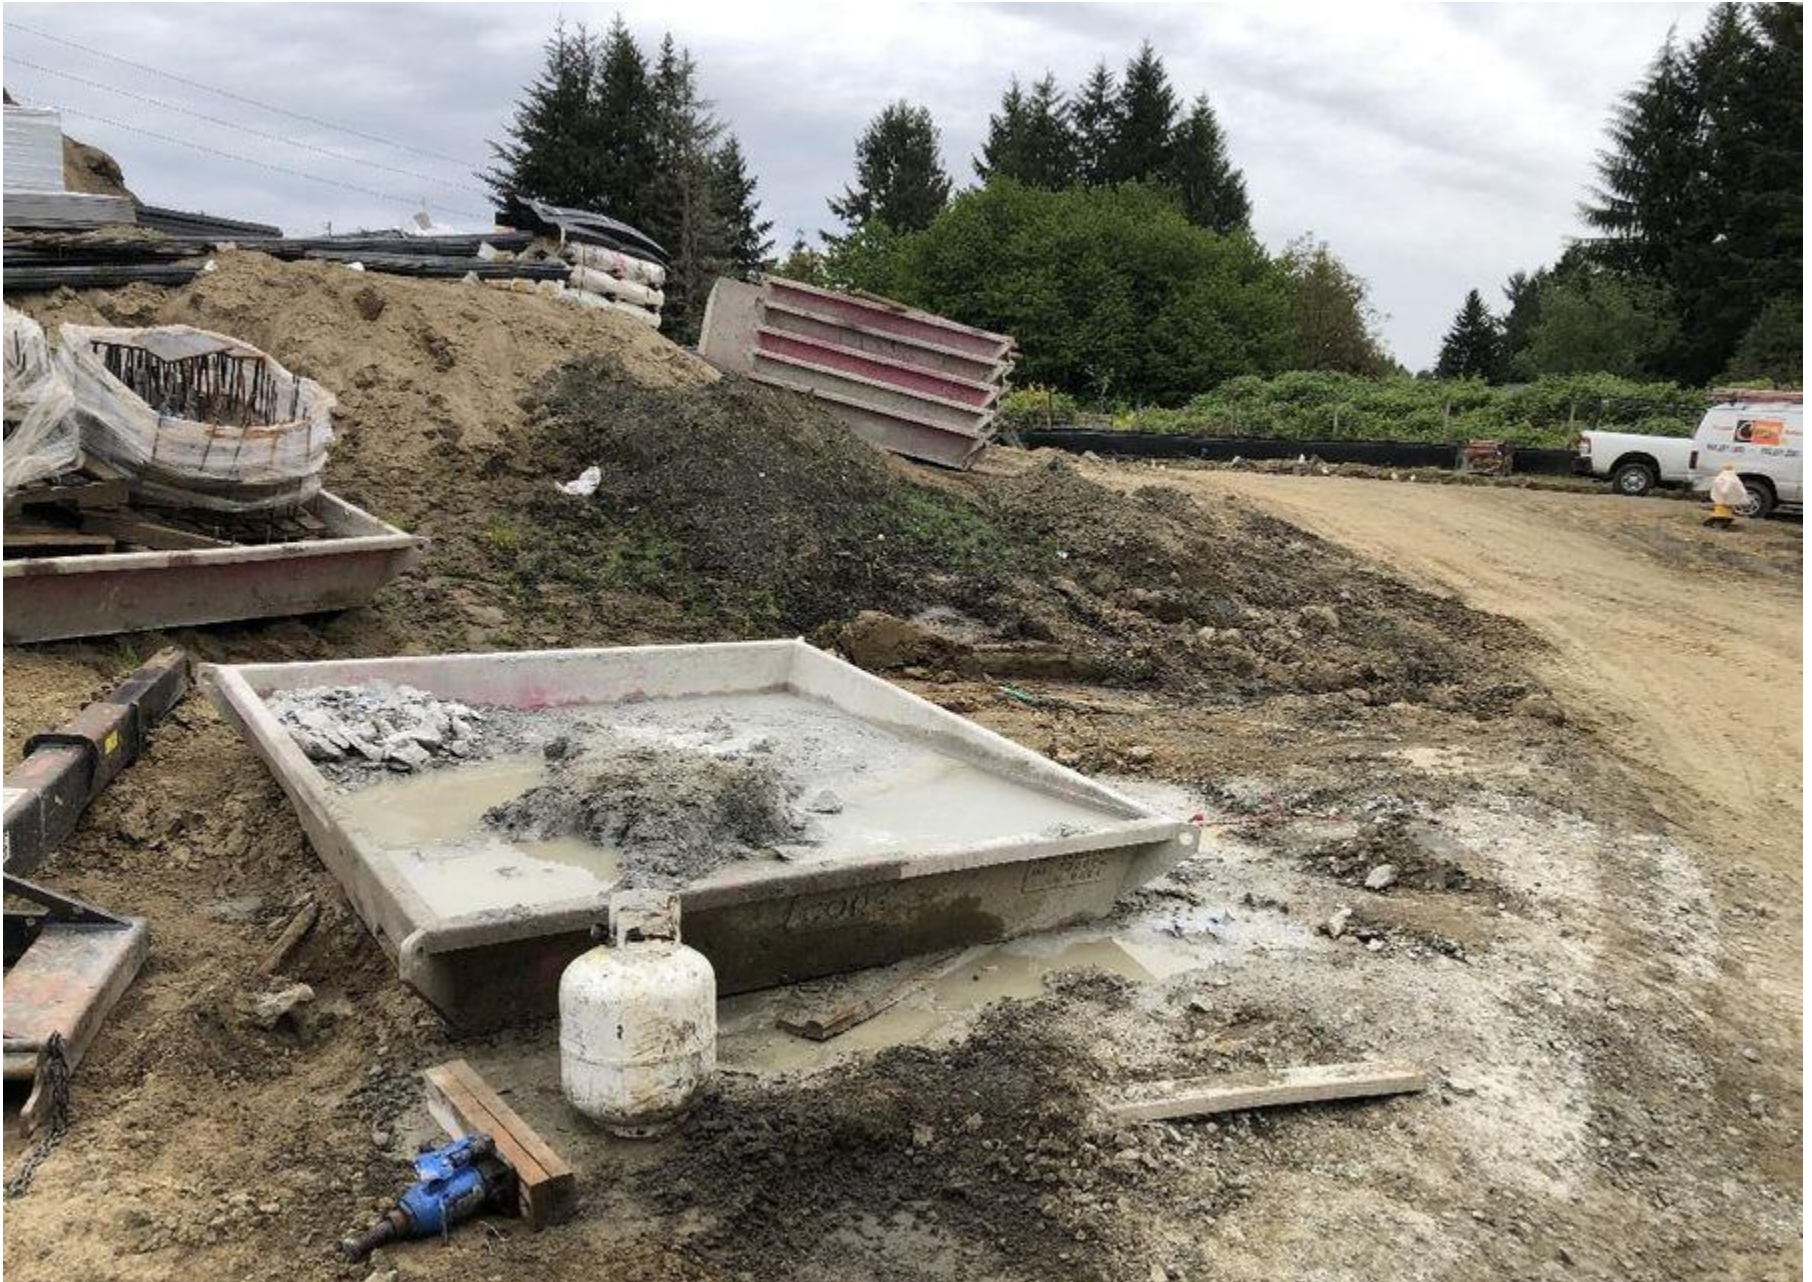
Photo 1

Photo Description: Concrete washout eco pan. Contractor has removed and replaced the eco pan for concrete washout.

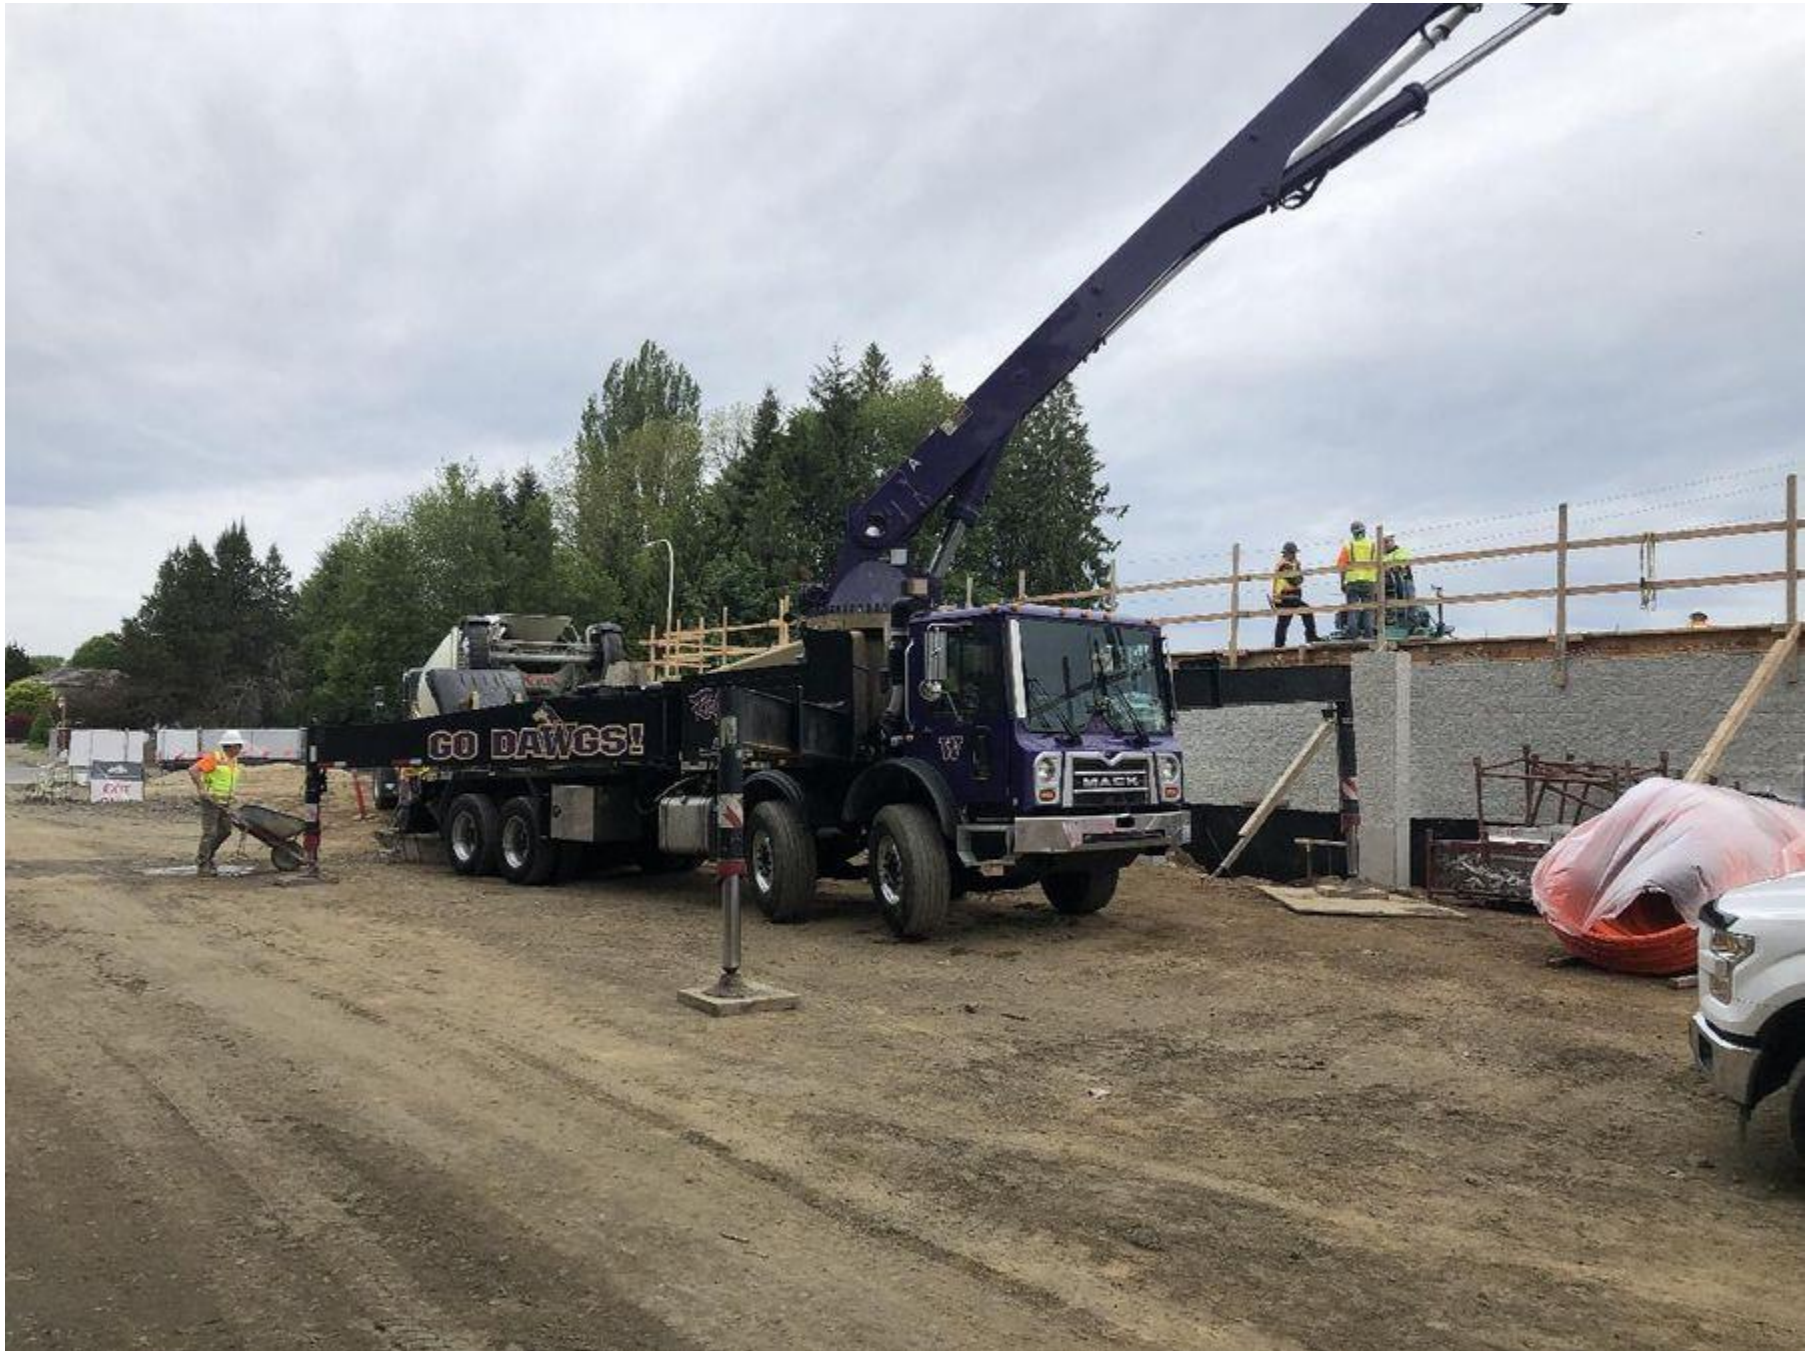
Photo 2

Photo Description: Site is active with many trades working.

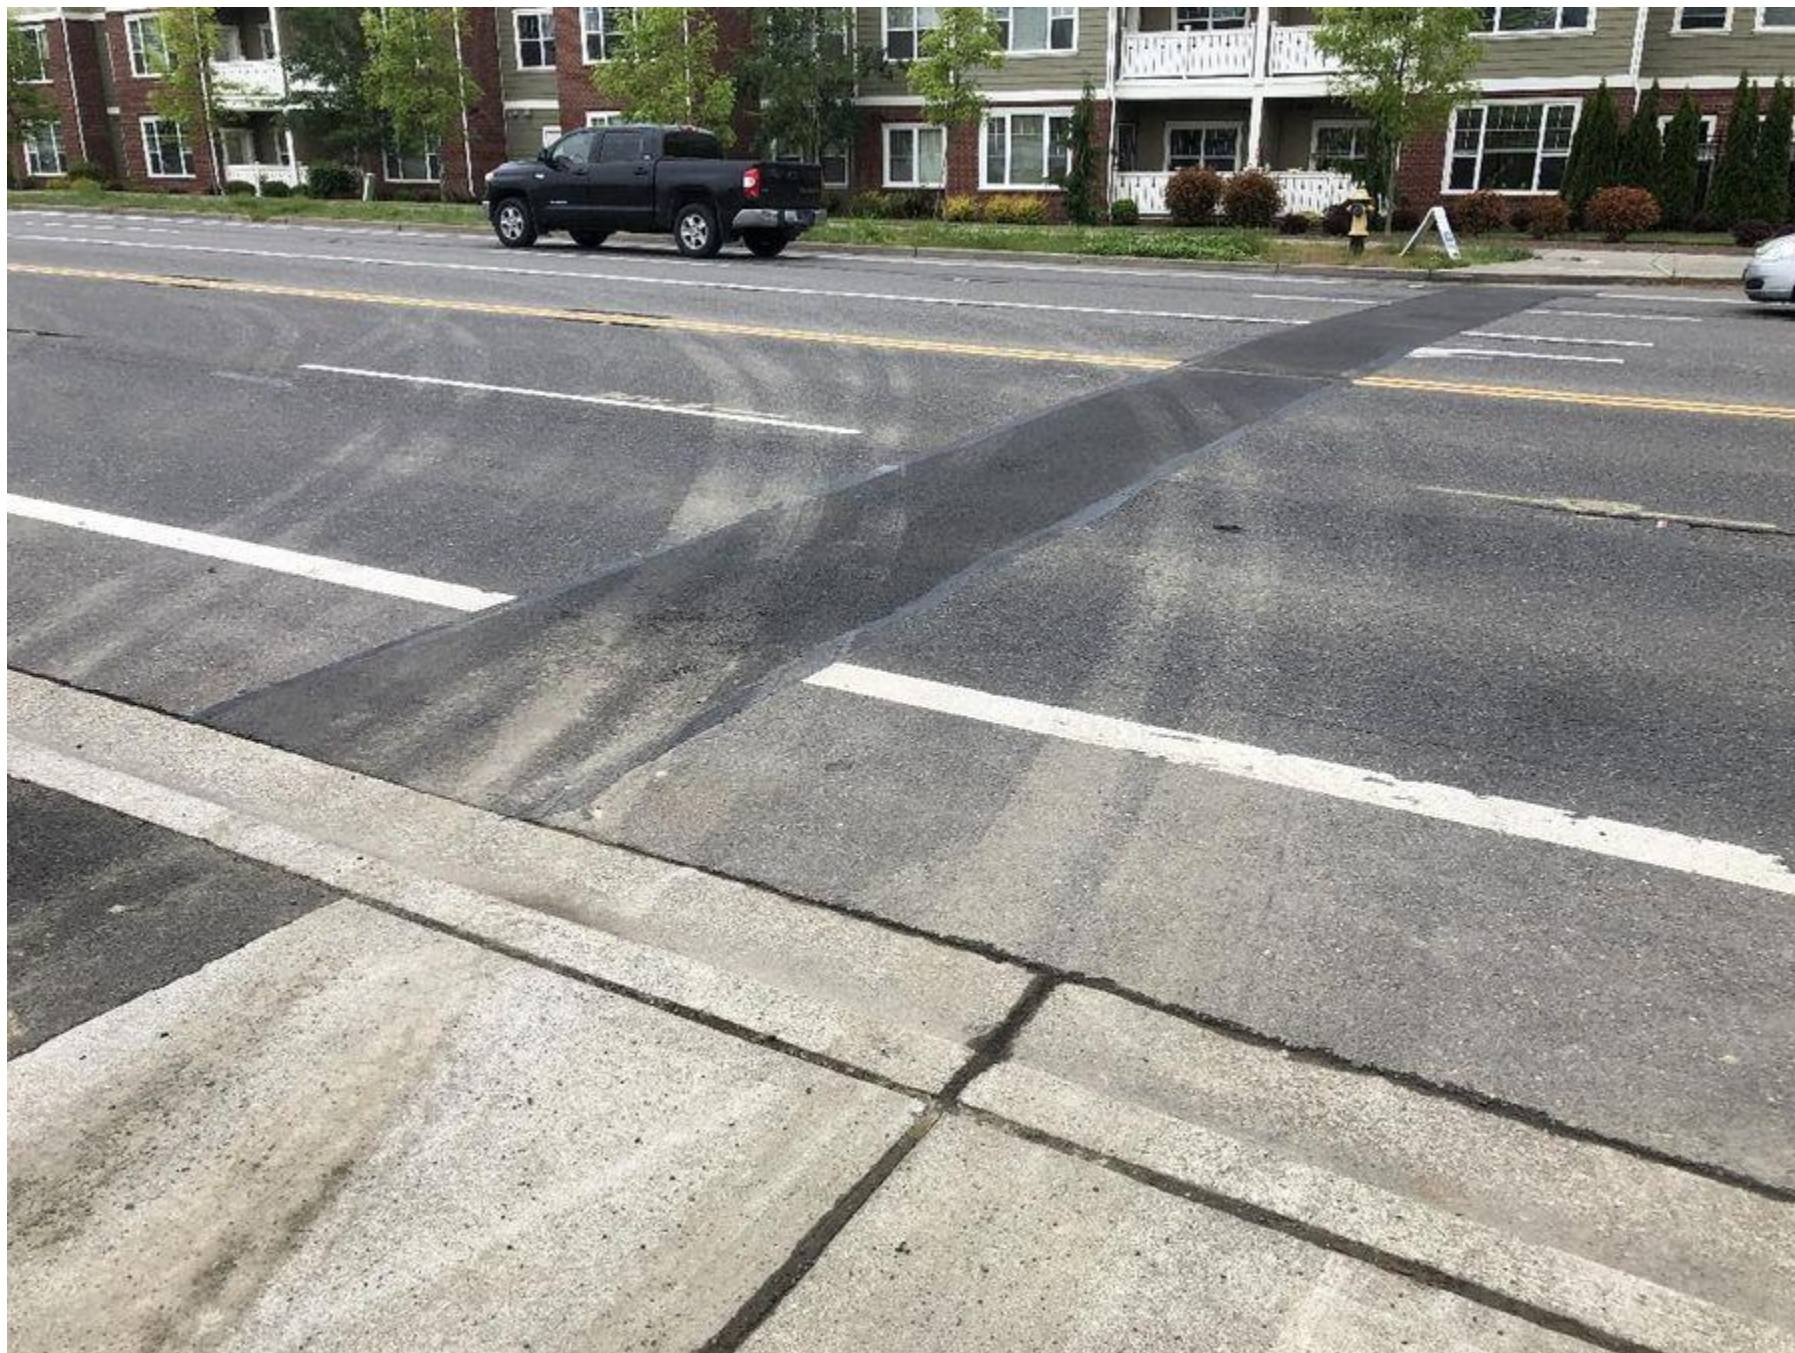
Photo 3

Photo Description: Track out seen at "entrance" of site. Contractor has now swept track out and advised personnel to use this location as entry only.

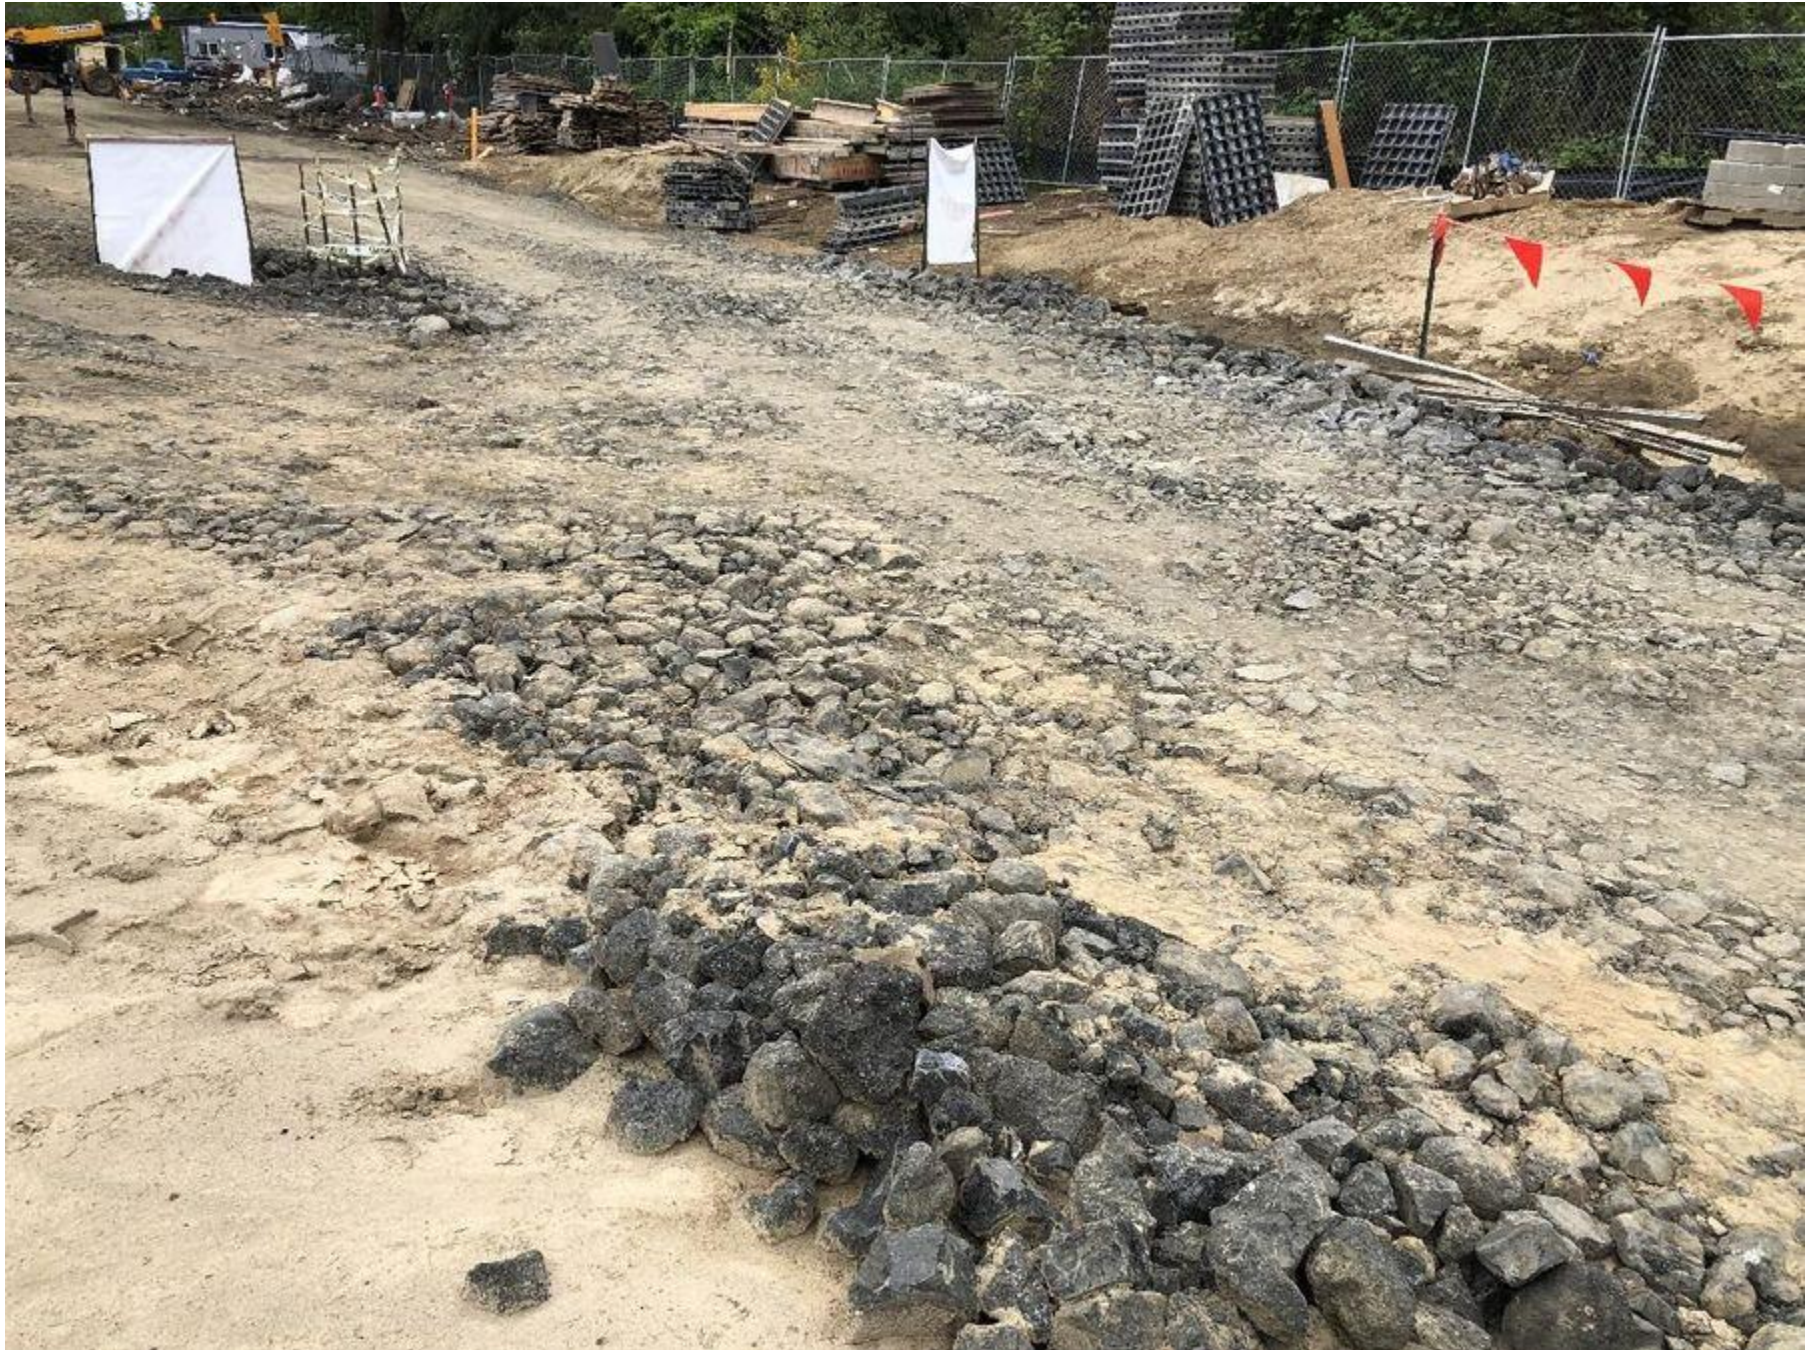
Photo 4

Photo Description: Construction entrance required maintenance, issue corrected by the site CESCL.
