# CONSTRUCTION STORMWATER COMPLIANCE INSPECTION REPORT

State of Washington Department of Ecology

Name and Location of Site Inspected: Bakerview Everett 4308 108th Street SE Everett, WA 98208	Permit webpage: <a href="https://fortress.wa.gov/ecy/paris/FacilitySummary.aspx?FacilityId=60941">https://fortress.wa.gov/ecy/paris/FacilitySummary.aspx?FacilityId=60941</a>
	On-Site Representative: Jay Pullen with PACE and Josh with Aero <a href="mailto:jayp@paceengrs.com">jayp@paceengrs.com</a>

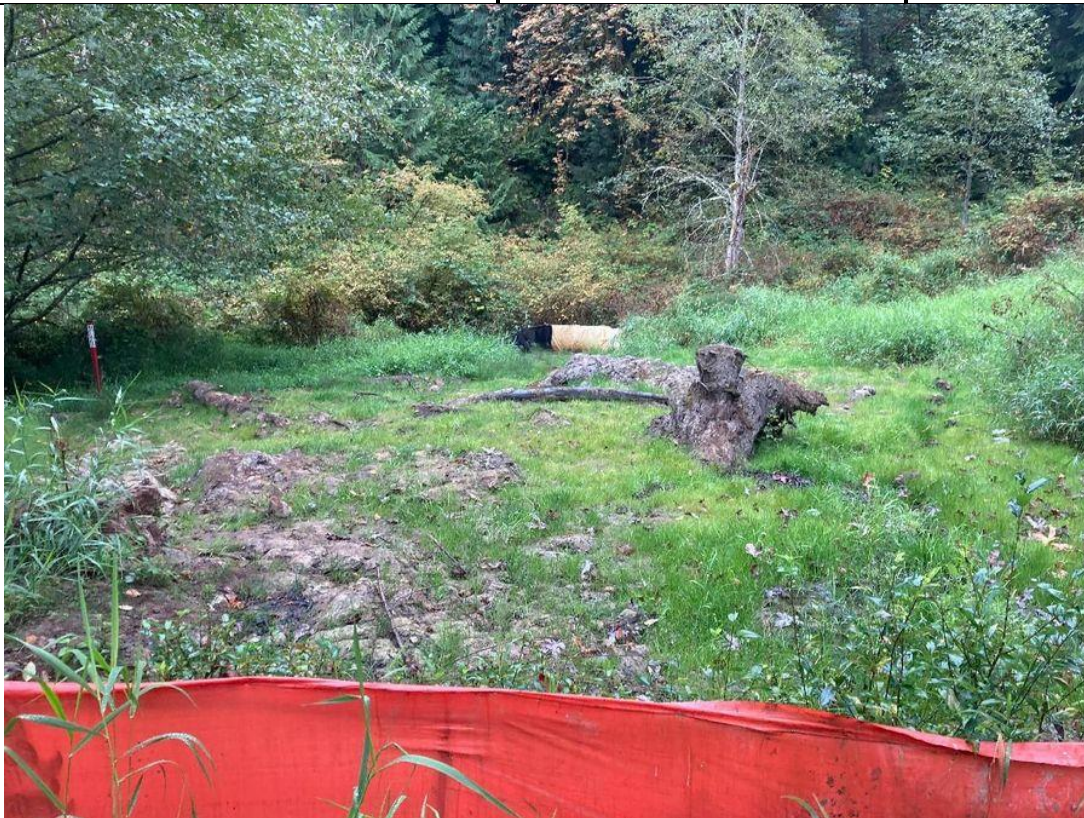
Photo 1 Description: Some spots of soil from slide last year is bare.

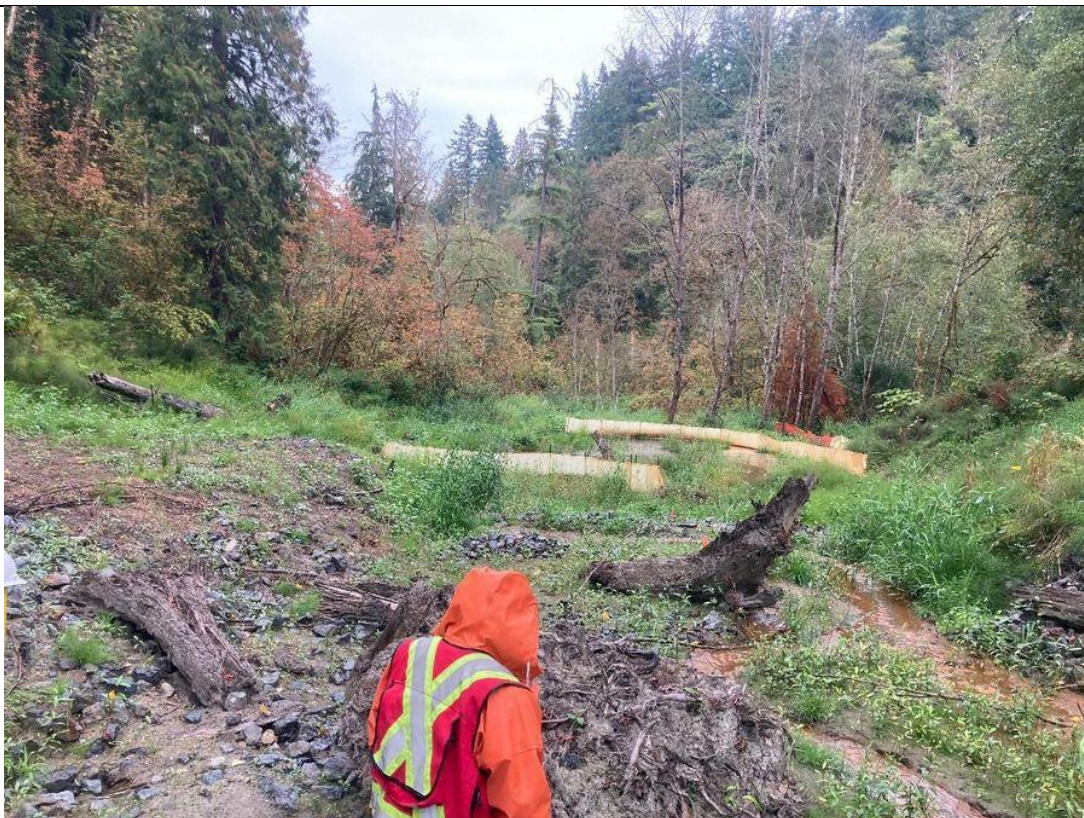
Photo 2 Description: Discussed silt fence j hook extension and straw wattle checks refreshed in this area of the slide.

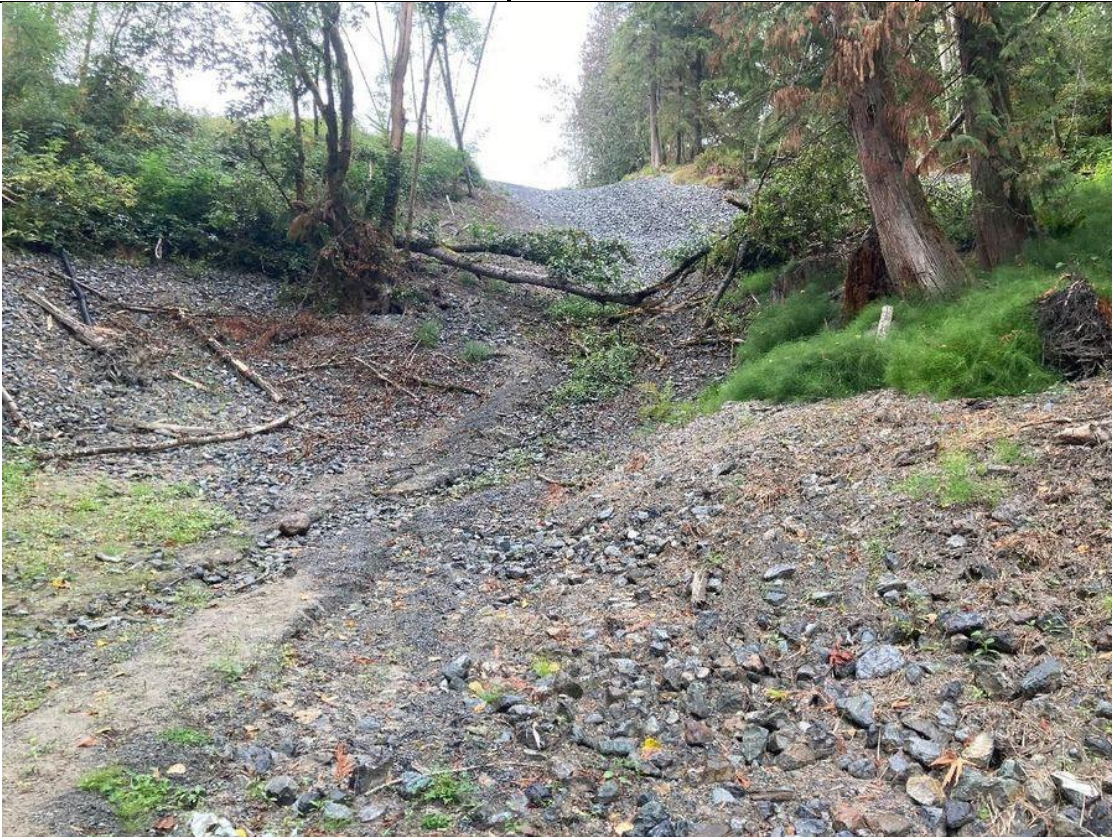
Photo 3 Description: Discussed check dams where erosion near bottom of the drain.

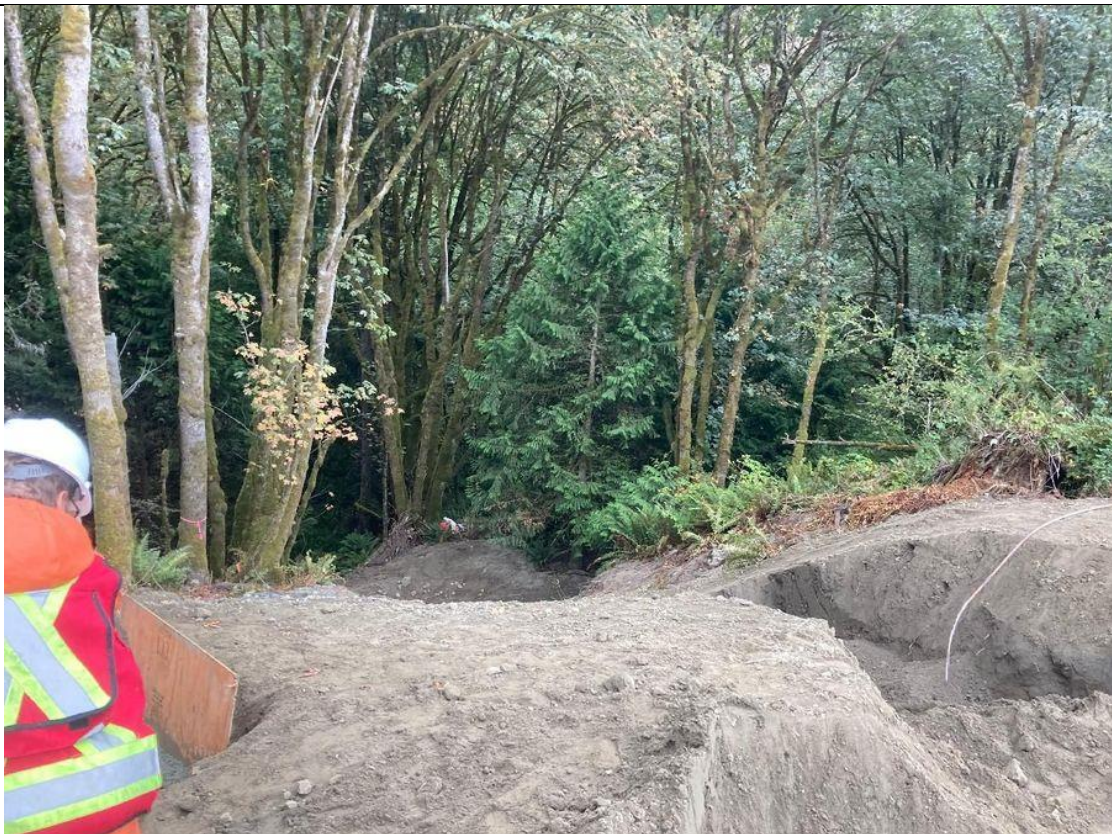
Photo 4 Description: Utility work down slope.

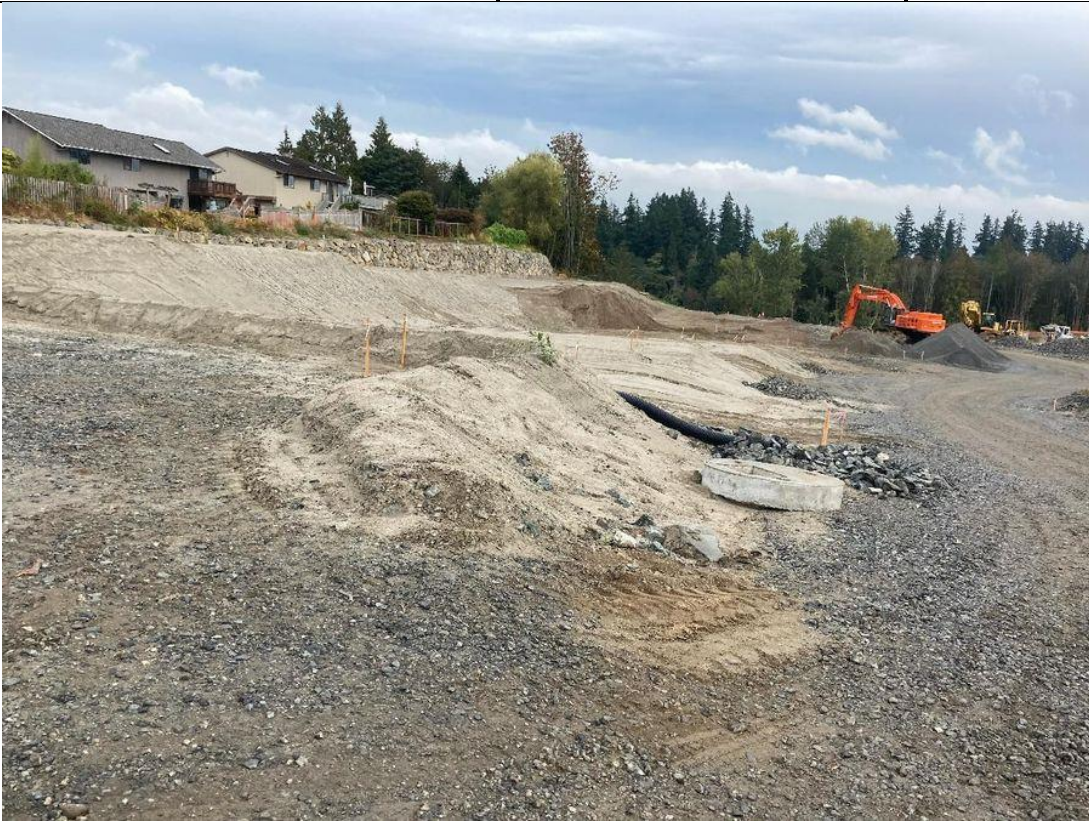
Photo 5 Description: Utility work.

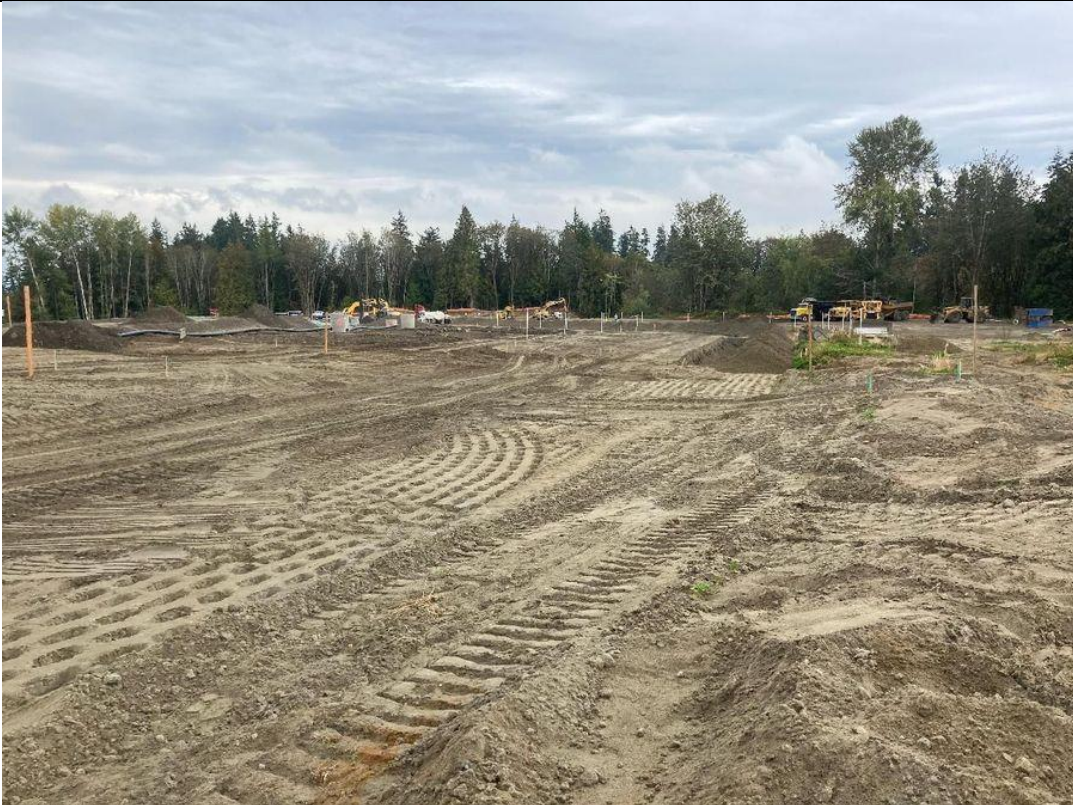
Photo 6 Description: Utility work.

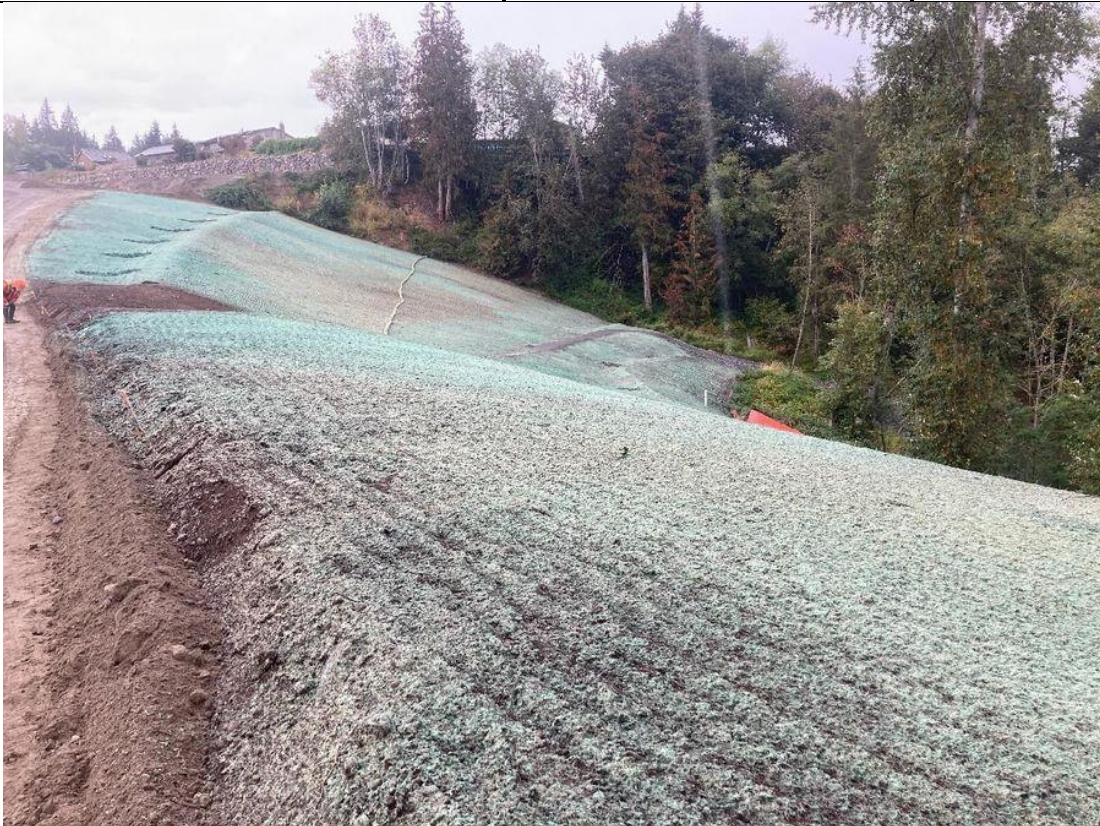
Photo 7 Description: Slope above slide was hydroseeded.

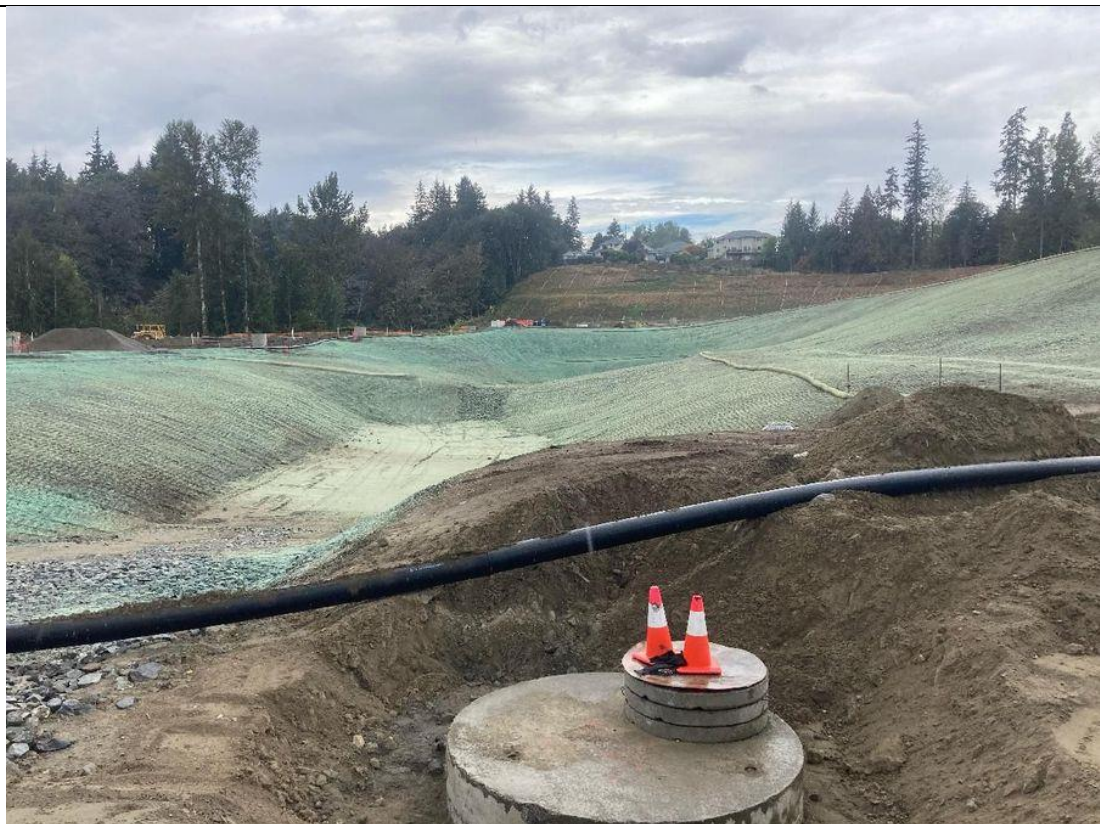
Photo 8 Description: Pond and slopes above hydroseeded.
