**STATE OF WASHINGTON**  
**DEPARTMENT OF ECOLOGY**

Re: NPDES Permit Number WAR000074

Enclosed is the report from the Department of Ecology's recent National Pollutant Discharge Elimination System (NPDES) Industrial Stormwater General Permit (ISGP) compliance inspection conducted virtually at Milgard Essence and Woodclad/ WAR000074 on October 11, 2022. Thank you for the time Lucas Samuel spent with me during my visit.

Enclosures: Industrial Stormwater Inspection Report  
Image Log

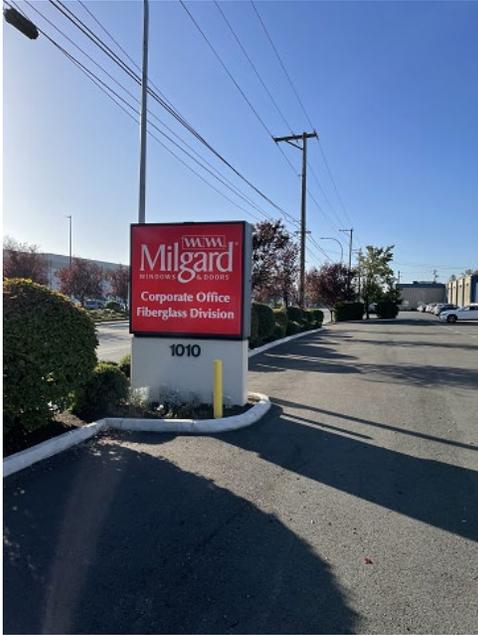
1. Signage for east facility entrance at 54th Avenue East

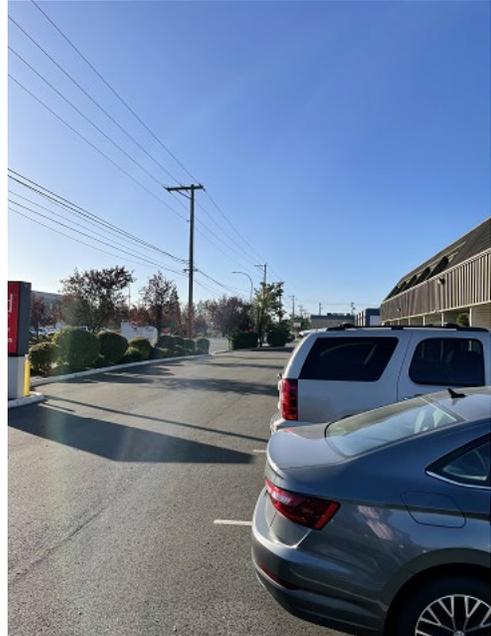
2. Administrative parking on east side of facility, facing south.

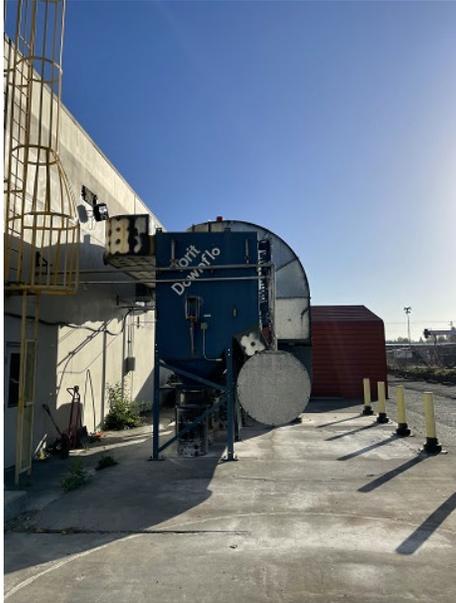
3. Cyclone dust collection system at west end of south side of 1010 building

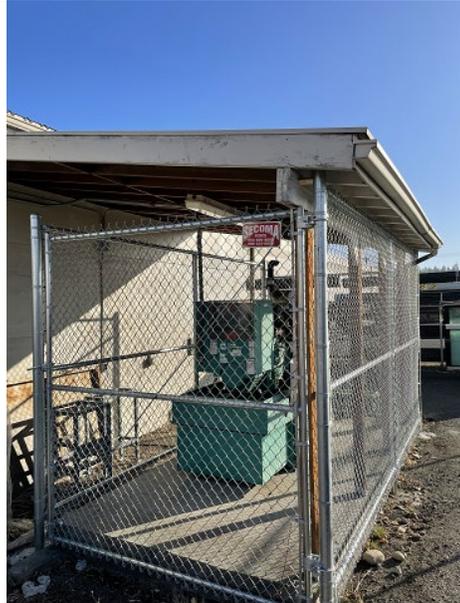
4. Generator under cover on south side of 1010 building

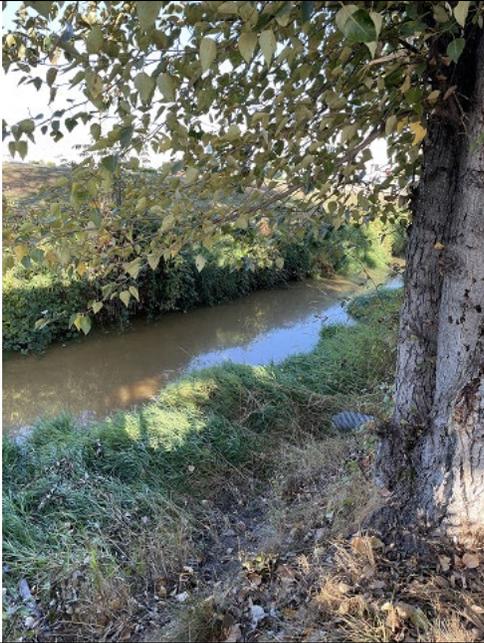
- Additional sampling for freshwater ammonia was required at outfall FG2, on the west side of the facility, because discharge from FG2 enters a segment of the Fife ditch that was impaired for freshwater ammonia (Ammonia- N) when the permit was issued.
- Discharge points on the north side of the site were described and identified as substantially identical. North discharge points are in mostly administrative parking areas in the front of the building and enter Fife's municipal stormwater system which flows to a receiving environment that was *not* impaired when the permit was issued. Additional monitoring was not required at the north outfalls.

5. Impaired receiving waterbody on west side

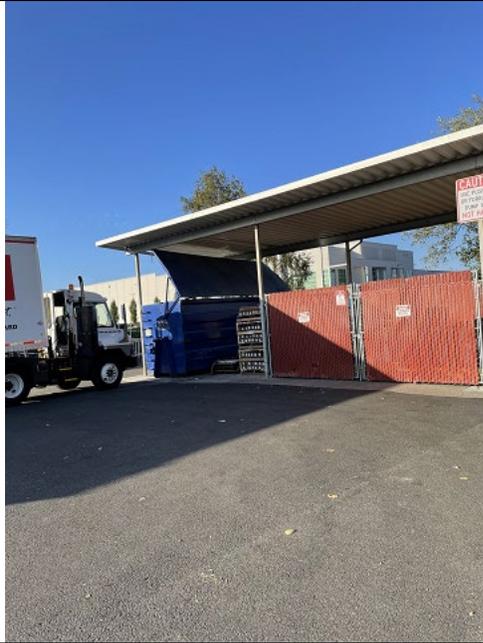
6. Lidded recycle container under roof, west side

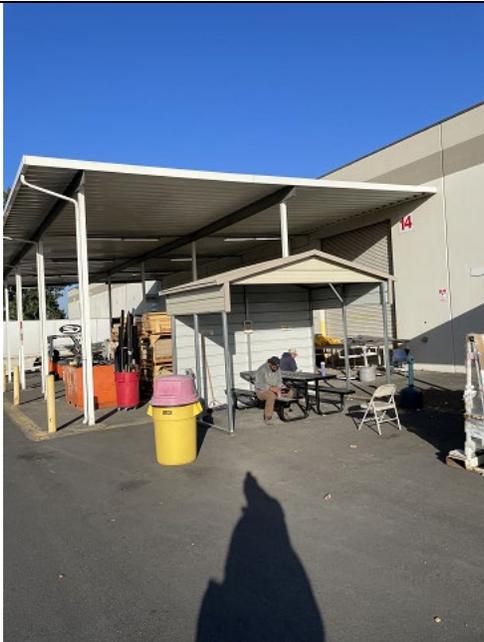
7 Covered glass recycle zone on south side of 910.

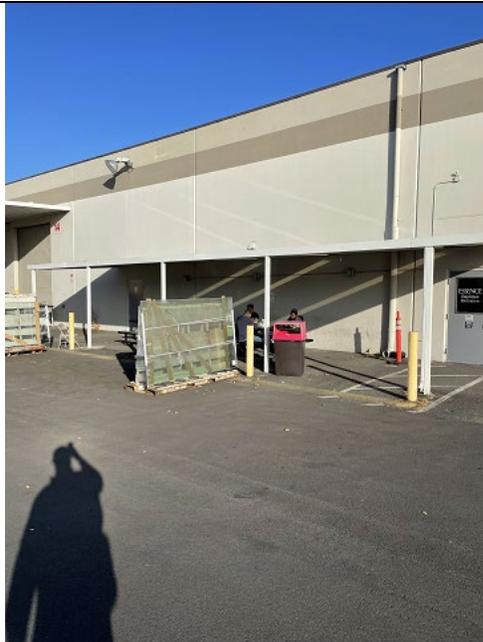
8. Glass recycle area, south side of 910

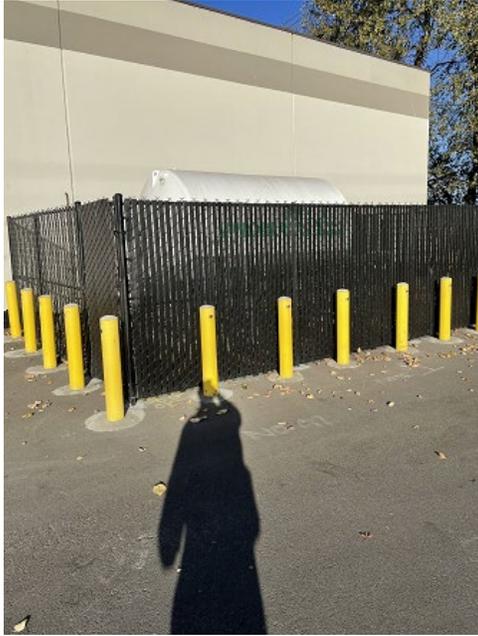
9. Liquid argon tank in area protected by bollards

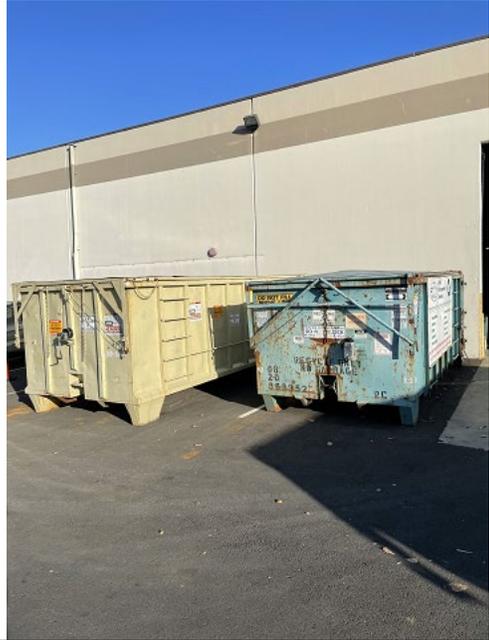
10. Waste and recycle containers

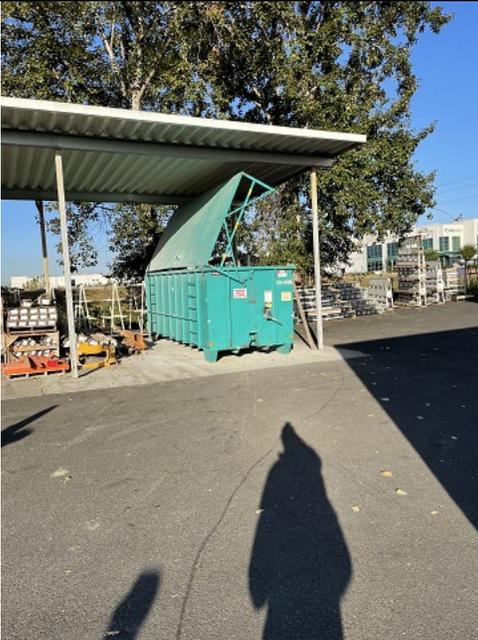
11. Recycle container and wrapped finished materials on west side of 910

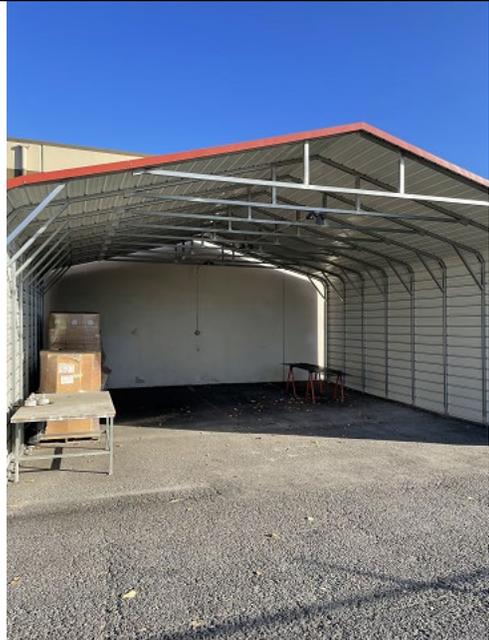
12. Covered storage
