State of Washington Department of Ecology
Northwest Regional Office
PERMIT COMPLIANCE INSPECTION REPORT

Inspection Date: 11/2/2022	NPDES Permit #: WAR 305536	County: Whatcom	Receiving Waters: Bellingham Bay	Inspector(s): Elizabeth Fint, Sylvia Graham, Mak Kaufman	Facility Type: Industrial
--------------------------------------	--------------------------------------	---------------------------	--	--	-------------------------------------

Name and Location of Facility Inspected Bellingham Shipping Terminal Port of Bellingham Alice Cords 629 Cornwall Ave. Bellingham WA 98225	Entry Time 9:25 AM	Permit Effective Date
	Exit Time 12:00 PM	Permit Expiration Date

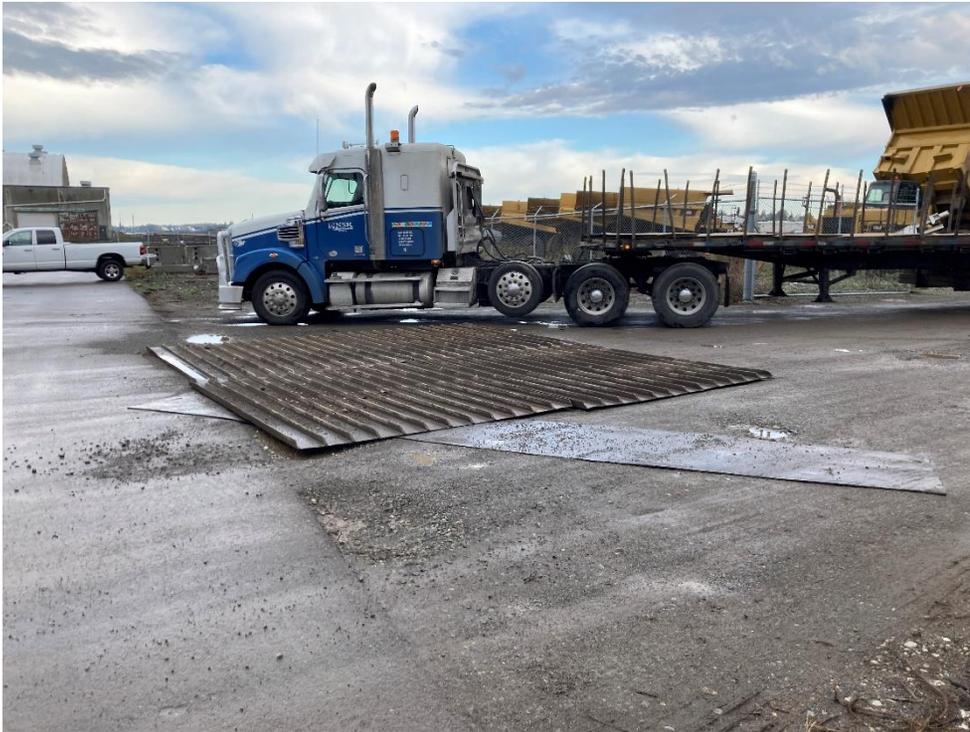
Photo 1

- The source control BMP (rumble pad ingress/egress) for vehicle and equipment track out at the access gate for ABC's stockpiles was bypassed by a truck maneuvering around the BMP. The BMP is meant to be driven over to reduce sediment and contaminant track out as vehicles move metal scrap to and from the stockpile area and moorage area.
- The Stockpile yard consisted of some gravel areas, deteriorating pavement, and sediment/mud. The yard was a large source of sediment and turbidity, and was not adequately stabilized to reduce pollutants from comingling with stormwater discharges.

- We began our inspection South near the Cornwall Ave. entrance and moved north towards ABC recycling's ingress/egress to the metal stockpiles. We watched a haul truck purposefully drive *around* the rumble pad (photo 1), contributing to the track out observed (photo 2).

Description: Flatbed truck purposely bypassing the track out BMP while exiting the stockpile yard. Bypassing the track out BMP doesn't reduce track out of sediments and other pollutants from the stockpile yard.

- **Special Condition S3.B.4.v.** requires the permittee to implement BMPs necessary to prevent the erosion of soils and other earthen materials, control off-site sedimentation, and prevent violations of water quality standards.

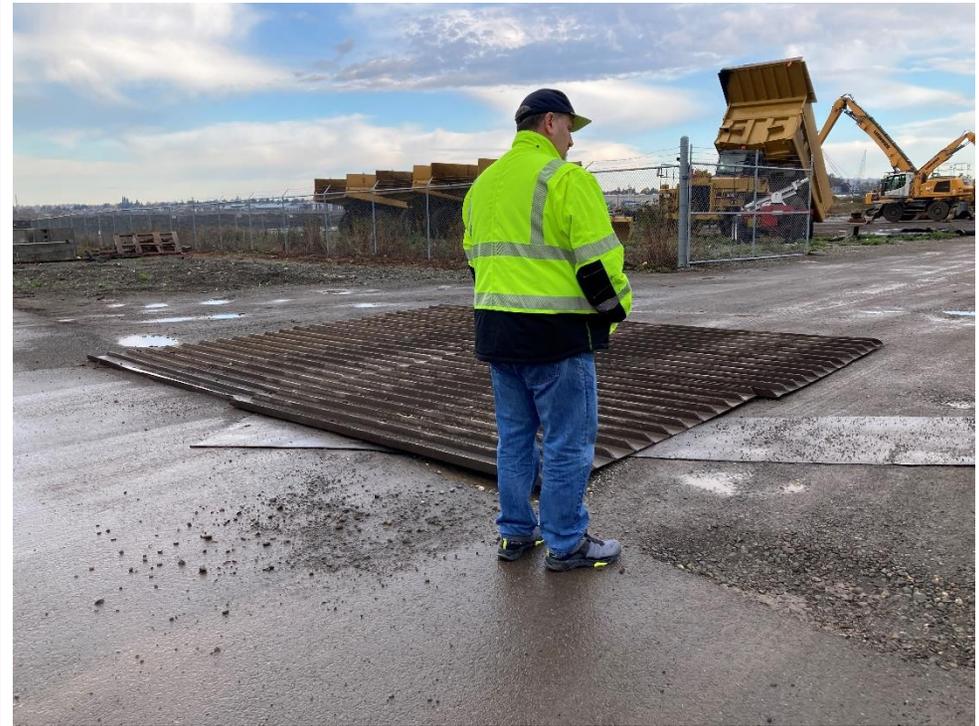
Photo 2

Description: Sediment and debris tracked out to pavement from trucks bypassing the track out BMP.

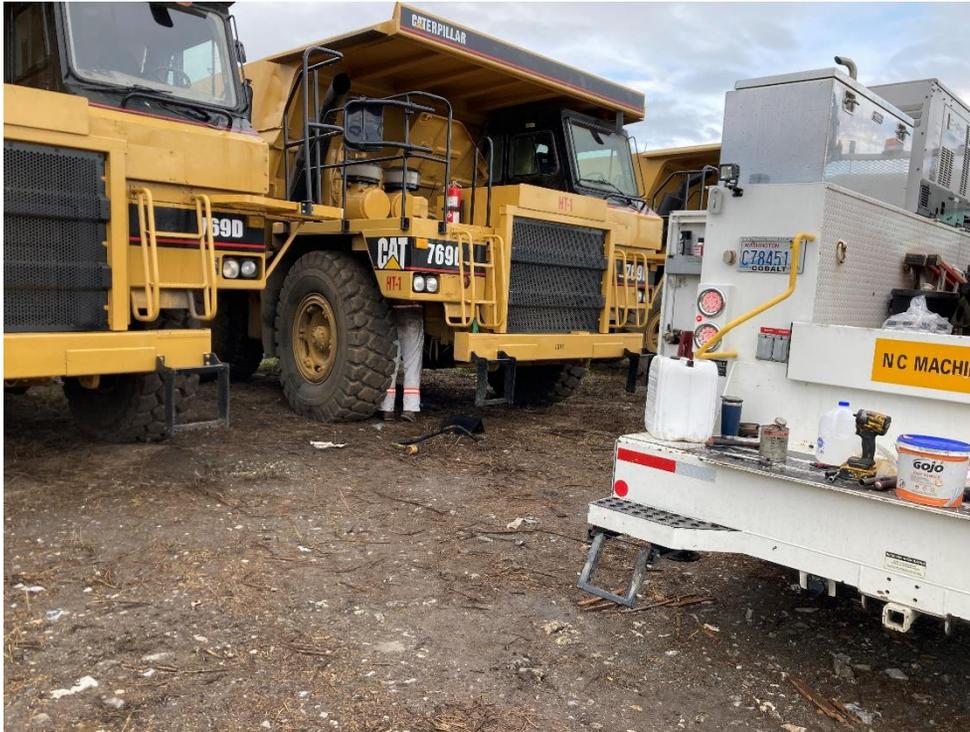
Photo 3

- Vehicle maintenance activities were being performed outdoors in ABC's stockpile yard at the time of inspection. The mechanic was fixing two vehicles with no cover or containment of parts, contaminants, or fluids.

- Near the stockpile entrance, a mobile mechanic was actively repairing two broken vehicles, without cover and exposed to stormwater (photo 3). Andy said they are installing a half dome covered space for maintenance and storage. They are also bringing two storage containers on site to store spill materials, lubricants, and other misc. items.

Description: Mechanic actively repairing two pieces of heavy equipment without cover or containment to reduce pollutants from comingling with stormwater.

- **Special Condition S3.B.4.b.i.4.g** requires the permittee to locate materials, equipment, and activities so that leaks are contained in the existing containment and diversion systems.

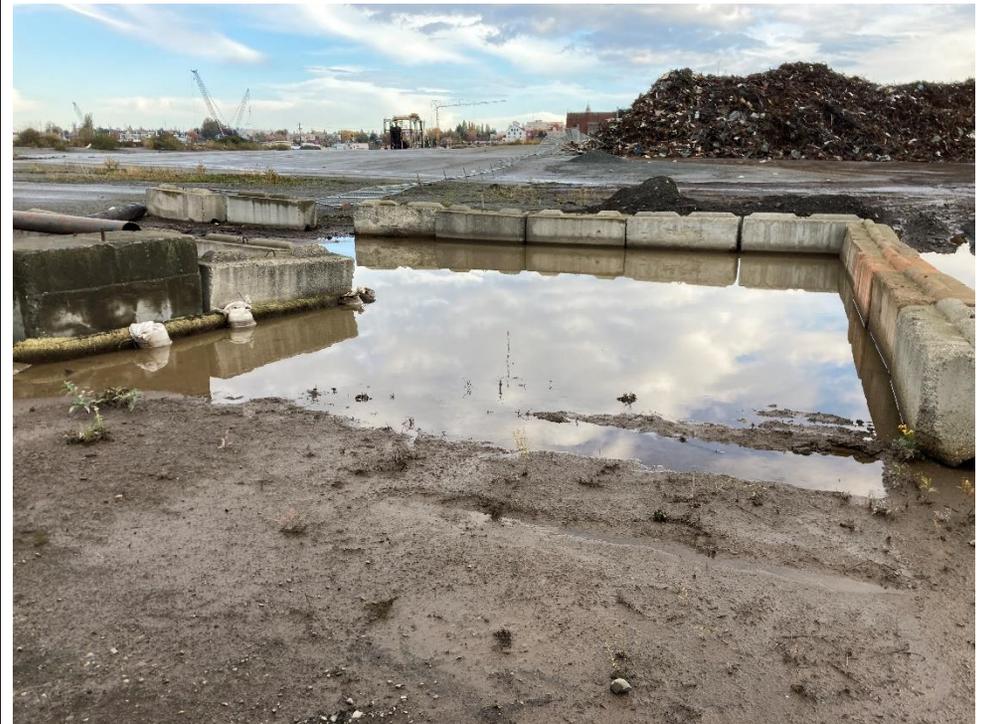
Photo 4

- The stormwater vault collects stormwater dischargers from the strip drain north of site as well as ABC Recycling's stockpile yard. At the inspection, the Port said the vault was last serviced about 6 months ago but could not provide an exact date or record of maintenance.
 - **Special Condition S3.B.4.b.i.3.b** requires the permittee to maintain ponds, tanks/vaults, catch basins, swales, filters, oil/water separators, drains, and other stormwater drainage/treatment facilities in accordance with the maintenance standards set forth in the applicable Stormwater Management Manual for Western Washington (SWMMWW).
 - **Appendix V-A: BMP Maintenance Tables from the SWMMWW** requires maintenance of stormwater vaults when accumulated sediment depth exceeds 10% of the diameter of the storage area for 1/2 length of storage vault or any point depth exceeds 15% of diameter.

- We walked parallel to the stormwater trench north of site, heading east, that intercepts stormwater from ABC's working footprint and discharges to the stormwater vault centrally located in ABC's operating yard (photo 4). From there the stormwater is eventually pumped to Port of Bellingham's aeration stabilization basin (ASB). The stabilization basin is lined to prevent infiltration to the bay, however, the ASB does have an outfall pipe to the bay as well as an emergency overflow. The port said the pipe is closed and does not currently discharge to the bay.

Description: Stormwater vault located approximately in the middle of ABC Recycling's stockpile yard. Vault was full of turbid water and sediment accumulation surrounded the vault.

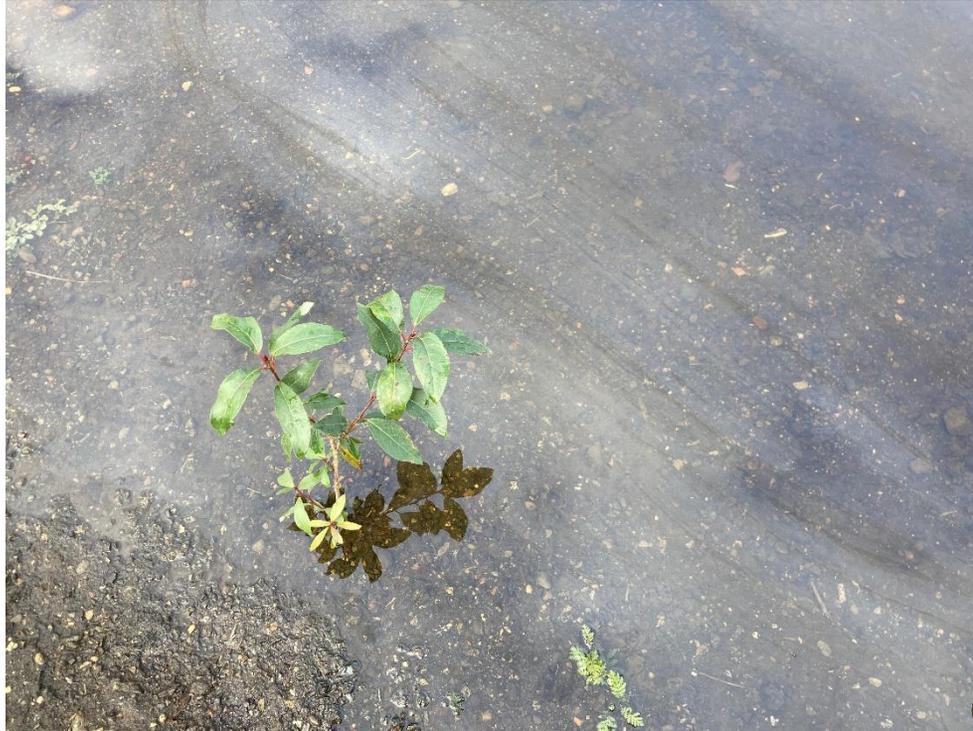
Photo 5

- We observed petroleum sheen, emulsified oil, as well as petroleum spills/leaks on the ground and in stormwater puddles throughout ABC Recycling's stockpile yard (photos 5 and 6). There were no operational, structural, or treatment BMPs in place to prevent contamination of stormwater or to treat or prevent contaminated stormwater from leaving the site. The petroleum sheen and emulsified petroleum throughout site was egregious. We did not observe any spill kits in the stockpile area. Oil sheen was also observed near the moorage area (middle wharf) at catch basin B2A. Dave was able to grab some floor dry and clean-up the spill during the inspection (photo 7).

Description: Oil sheen floating on top of a stormwater puddle in ABC Recycling's stockpile yard.

- **Special Condition S3.B.4.b.i.3.d** requires the permittee to clean-up spills and leaks *immediately* to prevent discharge of pollutants.
 - **Special Condition S3.B.4.b.i.4.g** requires the permittee to locate materials, equipment, and activities so that leaks are contained in the existing containment and diversion systems.

- **Special Condition S3.B.4.b.iii.2** requires the permittee to employ oil/water separators, booms, skimmers, or other methods to eliminate or minimize oil and grease contamination in stormwater discharges.

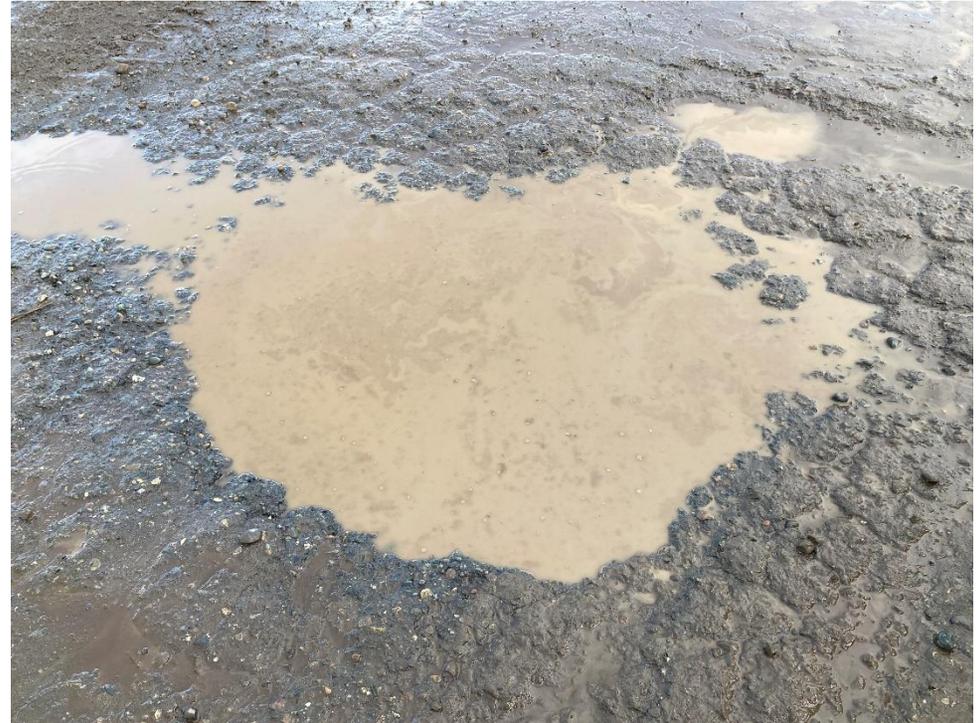
Photo 6

Description: Emulsified oil/petroleum mixed with stormwater in ABC Recycling's stockpile yard.

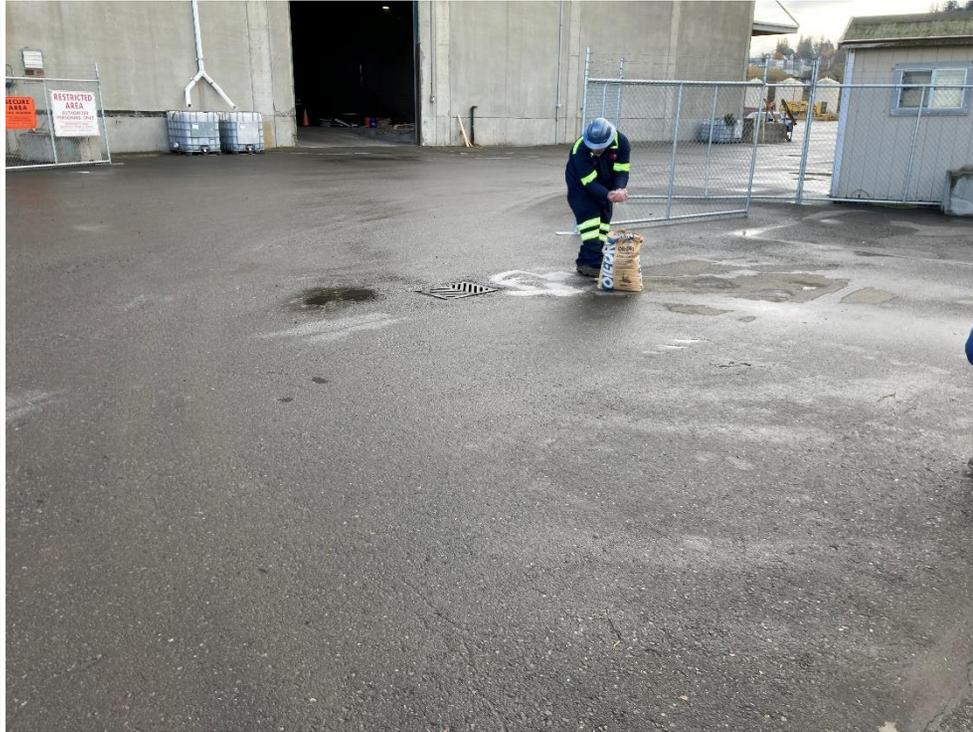
Photo 7

Description: Petroleum spill clean up at catch basin B2A.

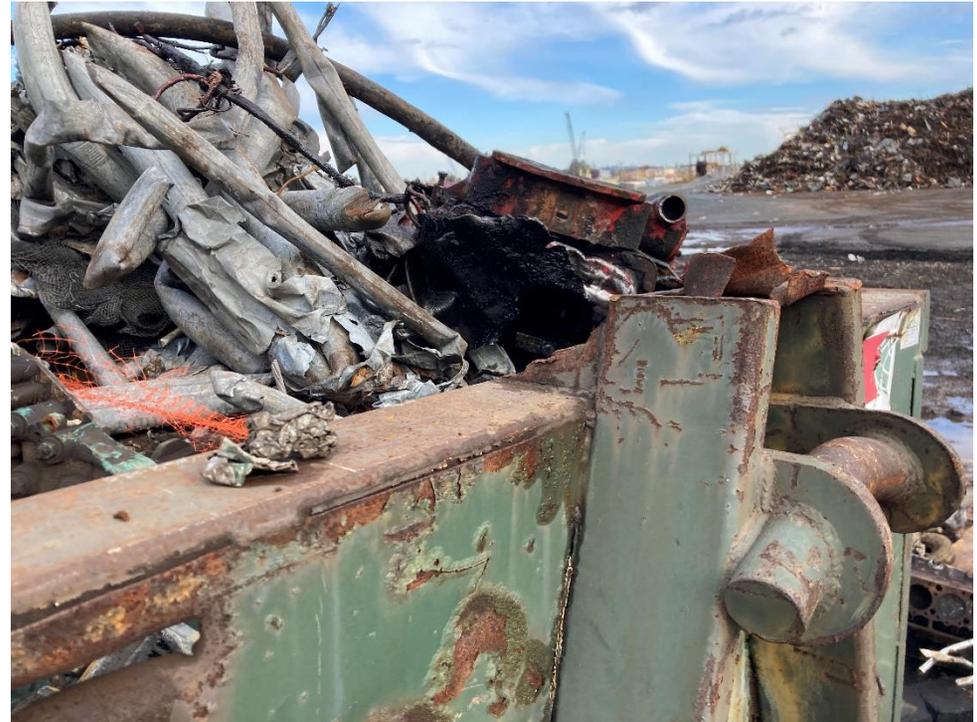
Photo 8

- ABC recycling uses dumpsters to deposit trash metal items that will not be recycled. Ecology observed at least two trash dumpsters with no lids/covers – lids/cover are required on dumpsters to prevent stormwater from comingling with the contents of the trash dumpsters to prevent contamination of stormwater.

- Andy said ABC does not sort piles on site, but if they see an item that is not allowed in the pile, they will pull it out and put it in the roll-off trash dumpsters. The roll-off trash dumpsters observed during the inspection had items that were covered in oil/grease (photo 8). The dumpsters did not have lids or covers to prevent stormwater from comingling with contaminants.

Description: Trash items removed from recycling piles – trash items have oil/grease residue exposed to stormwater – dumpsters did not have a cover or storm proof lid.

- **Special Condition S3.B.4.b.i.2.d** requires the permittee to keep all dumpsters under cover or fit with a storm resistant lid that must remain closed when not in use.

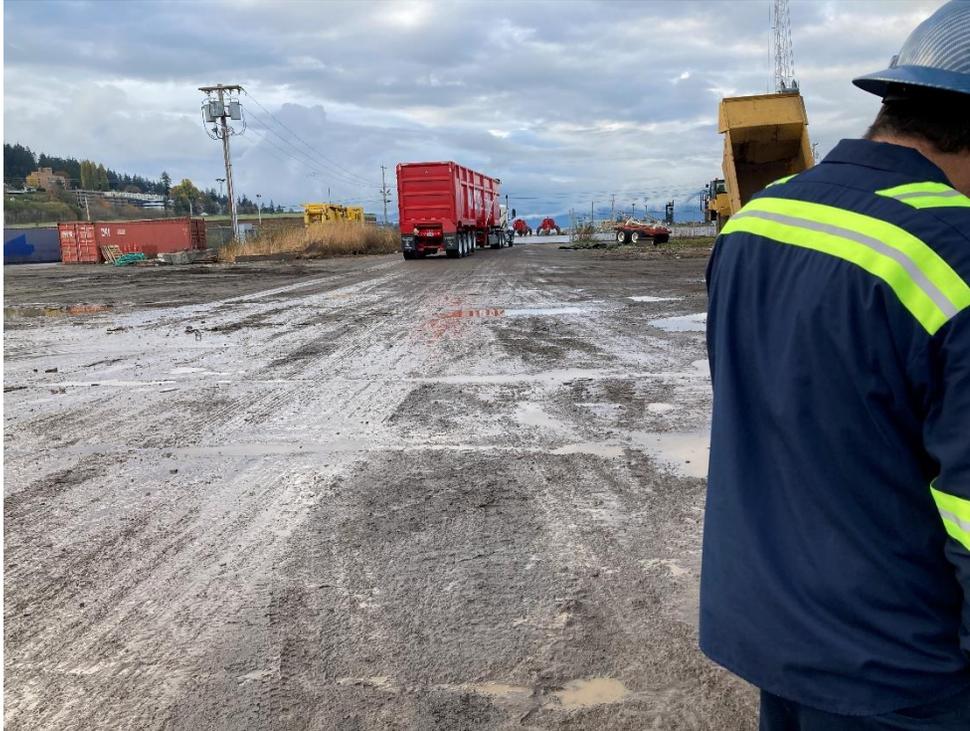
Photo 9

Description: Muddy stockpile yard that has not been stabilized to prevent pollutants from comingling with stormwater.

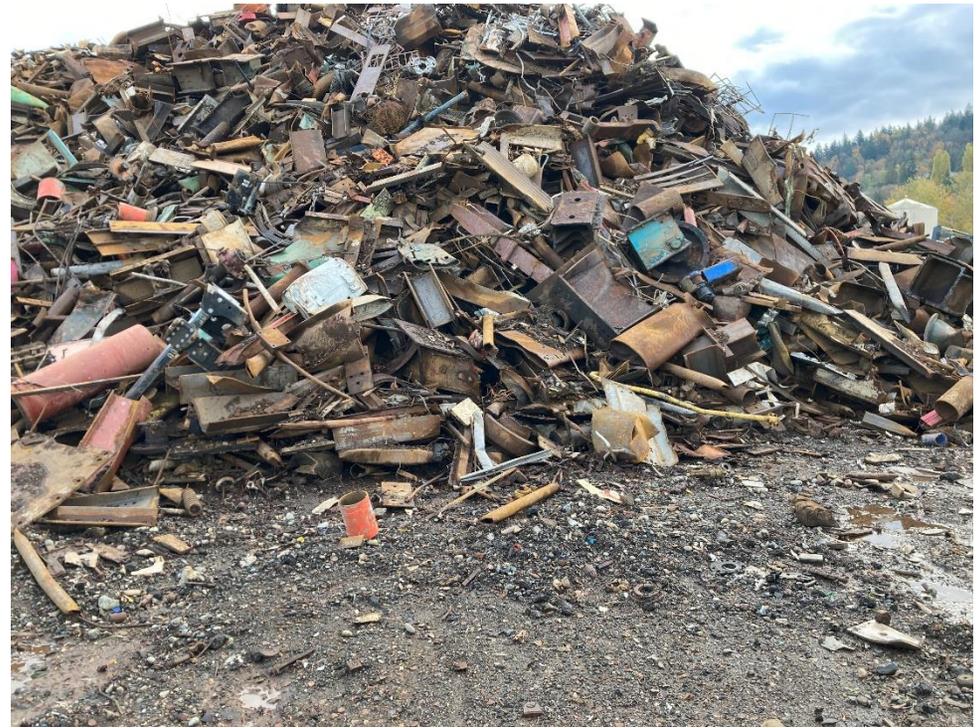
Photo 10

Description: Metal stockpile to be loaded on barges.
