State of Washington Department of Ecology  
Northwest Region Office  
**WATER QUALITY COMPLIANCE  
INSPECTION REPORT**

Name and Location of Facility Inspected PACIFIC COAST COAL COMPANY (John Henry Mine No. 1) 30500 Lake Ginder Road Black Diamond, WA 98010	Entry Time 9:56 am	Permit Effective Date March 01, 2008
	Exit Time 10:48 am	Permit Expiration Date January 11, 2013 Permit extended
Name(s) of On-Site Representative(s)/Title(s)/Phone and Fax Number(s)  Erik Wheeler, Project Manager – Wheeler Construction Co. EWheeler@wheelercc.net		Other Participants:  Jay Fennell Sand and Gravel Inspector Washington State Dept. of Ecology
Name, Address of Responsible Official/Title/Phone and Fax Number. David Morris General Manager - Pacific Coast Coal Co. P.O. Box 450 Black Diamond, WA 98010 Email: djmorris@aol.com		Cleo Neculae TMDL Lead Washington State Dept. of Ecology
Phone Number 206.321.5984 Fax Contacted? <input checked="" type="checkbox"/> Yes <input type="checkbox"/> No		Samples Taken? Yes <input type="checkbox"/> No <input checked="" type="checkbox"/> Photos Taken? <input checked="" type="checkbox"/> <input type="checkbox"/>

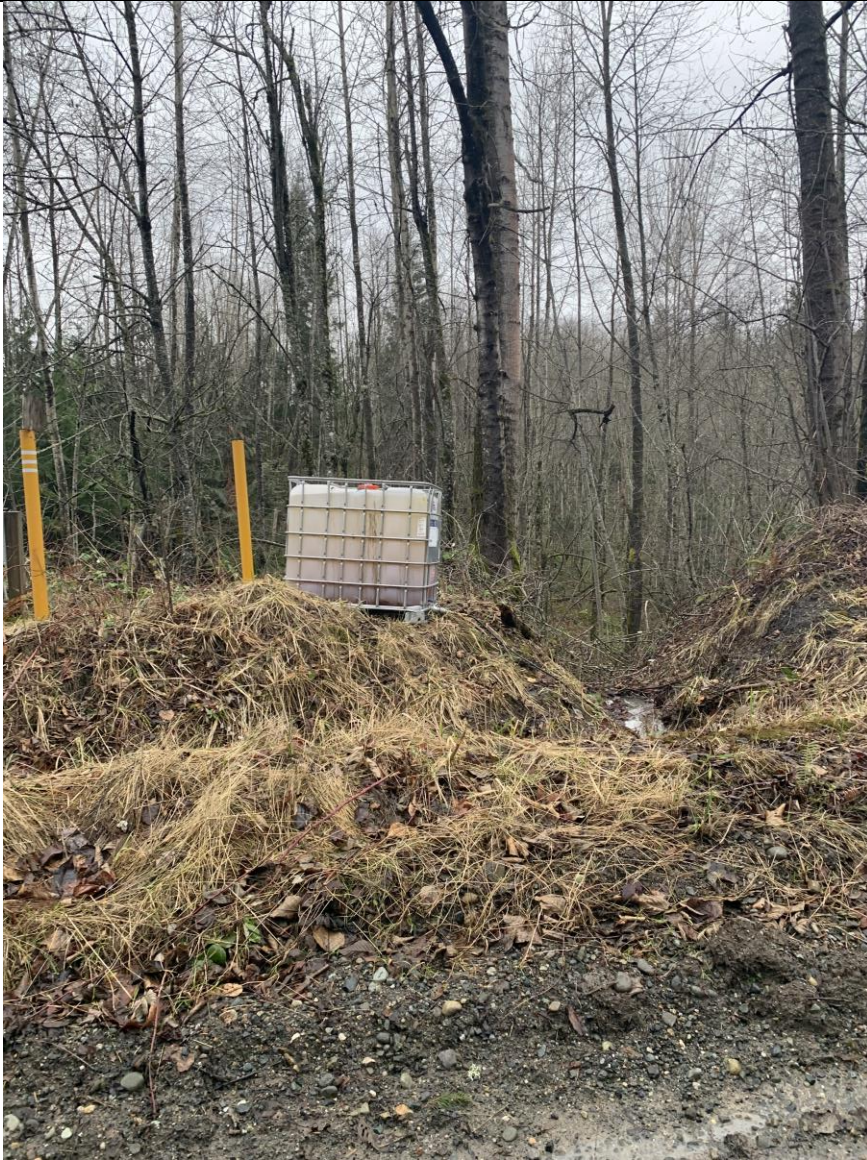
**Photo 1 [IMG\_3619, taken by J. Fennell on Jan. 12, 2023]**

When asked about Pond 1 dewatering when considering additional influent from the spoil pile impoundments, E. Wheeler stated that the mine recently constructed a roughly 20-foot high dike, to prevent discharges from Pond 1 into the neighboring Mud Lake (photo 1).

Following the conference with E. Wheeler, Ecology staff traveled to the south side of the mine via Green River Gorge Road to observe the newly constructed dike separating Pond 1 from Mud Lake. As E. Wheeler described, the dike provides substantial capacity to Pond 1 and there did not appear to be any visible seepage through the dike to Mud Lake.

A concern raised through observing the dike were whether the installation of the dike required additional permitting through the Office of Surface Mining & Reclamation, the local jurisdictional authorities, or engineering review through Ecology's Dam Safety Program. Confirmation of the design review and permitting requirements will be documented outside of this report.

**Description:** View looking northwest from the south side of Pond 1 at the John Henry Mine. Earthen dike constructed to prevent discharges from Pond 1 into Mud Lake. Dike also provided haul access to south side of Pond 1 for continued back filling and reclamation.
