<h2 style="text-align: center;">STORMWATER COMPLIANCE INSPECTION REPORT</h2> <p style="text-align: center;">State of Washington Department of Ecology 15700 Dayton Avenue N, Shoreline, WA 98133</p>			WADOE Stormwater Phone: (206) 594-0000						
Section A: General Data											
Inspection Date 3/2/2023	NPDES Permit # WAR301508	County King	Receiving Waters Duwamish via SPU Stormwater	Inspectors Jessica Kasmari David Adler	Facility Type Industrial						
Discharges to: Surface Water <input checked="" type="checkbox"/> Ground Water <input type="checkbox"/>				ANNOUNCED Inspection							
Section B: Facility Data											
Name and Location of Site Inspected Plymouth Poultry 4500 7 th Avenue S. Seattle, WA 98108				Entry Time 9:15 am	Permit Effective Date 01/01/2020						
				Exit Time 11:45 am	Permit Expiration Date 12/31/2024						
On-Site Representative(s): Name(s)/Title(s)/Contact number(s) or E-mail Wes Himes Compliance and Purchasing Manager				Additional Participants:							
Mailing Address of Responsible Official(s): Wes Himes 4500 7 th Avenue S. Seattle, WA 98108 Phone: 206-310-2749				Weather: Overcast 40 degrees							
				Sampling and Photos

PHOTO ADDENDUM – PLYMOUTH POULTR

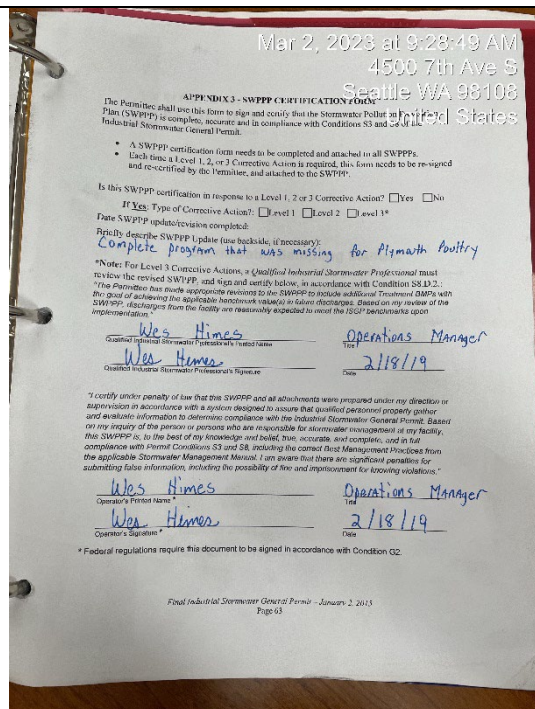
PHOTO 1

- SWPPP: is out of date and should be updated to account for the changes. For example, no more fueling of trucks, no longer washing trucks on-site, the shop maintenance area is moving off-site. In addition, update the contact information and remove any unnecessary BMPs and add any necessary new BMPs.

DESCRIPTION: Most recent update of the SWPPP

- In accordance with **S3.A.3.a.ii**, the Permittee shall modify the SWPPP to correct the deficiencies identified in writing from Ecology within 30 days of notice.

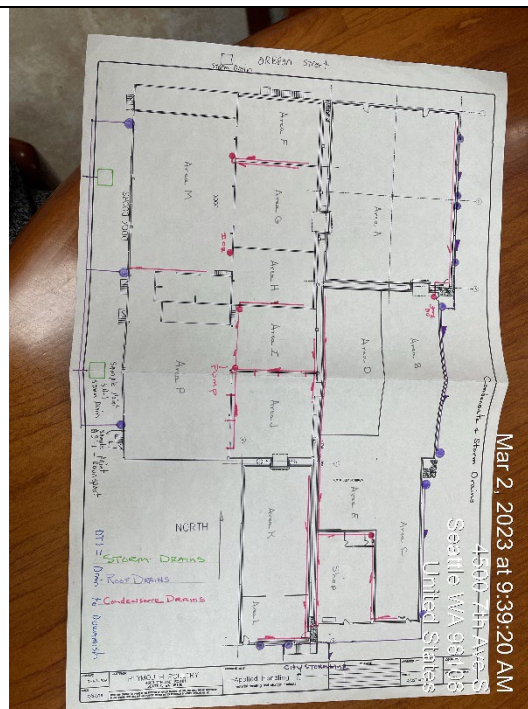
PHOTO 2

- Older version of the permit: An older version of the permit was available; Ecology indicated the current version is required to be available.
- Site map and aerial photo: it was not clear from the site map, how stormwater travels. While catch basins, downspouts and sampling locations were included. It is lacking the flow direction and the discharge points. While it was unclear during the time of the inspection. After the inspection, J. Kasmari utilized the SPU GIS data base and the downspouts located along Airport Way S, drain into the stormwater system on Airport Ways S. the downspouts along Snoqualmie St drain into the stormwater system along Snoqualmie St and the downspouts and catch basins located along 7th Ave, discharge into the stormwater system along 7th Ave, which eventually drains into the Duwamish River.

DESCRIPTION: Site Map

- In accordance with **S3.B.1**, the following items needed to be added to the facility map: The Seattle Public Utility website illustrates the stormwater and sewer connections around the property and indicates the flow direction of stormwater: Utilize the following website [DSO Water & Sewer Map \(seattle.gov\)](https://www.seattle.gov/util/DSO-Water-Sewer-Map) and the permit criteria below to create a new map.

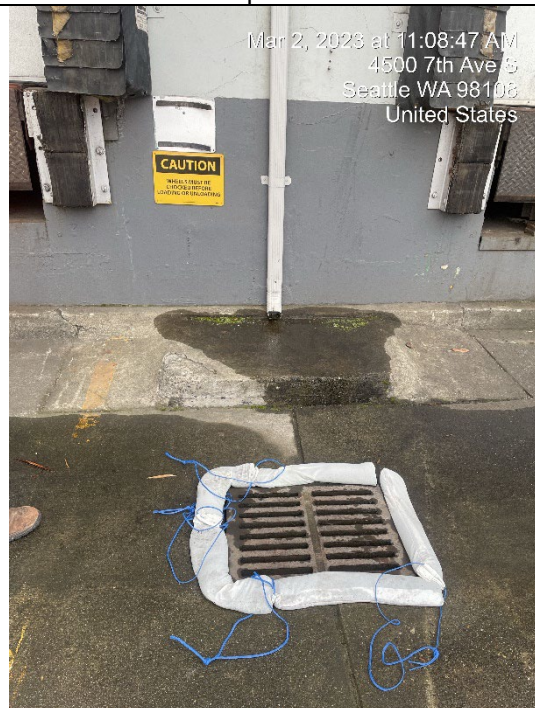
PHOTO 3

DESCRIPTION: SAMPLE LOCATION SD-1

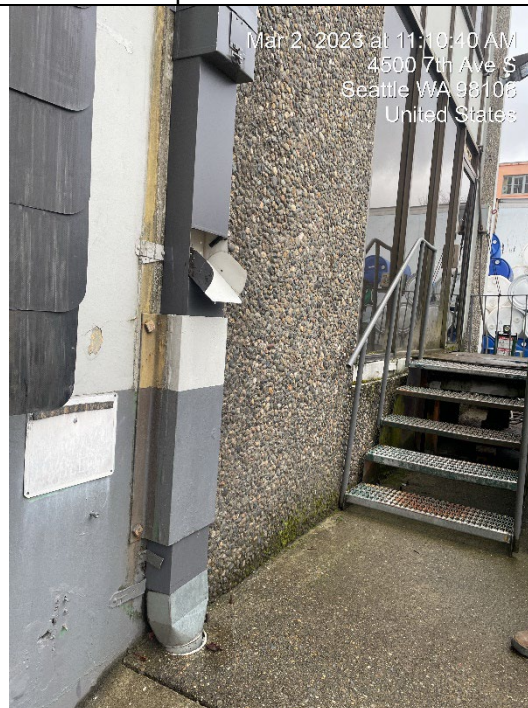
PHOTO 4

DESCRIPTION: SAMPLE LOCATION DS-1

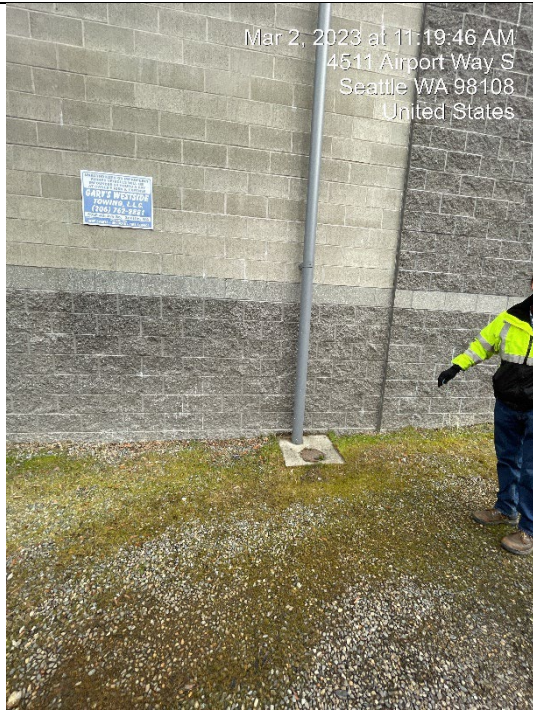
- All downspouts leading from the roof go directing into the subsurface. After the inspection, J. Kasmari reviewed Seattle Public Utility website and it appears the downspouts enter into SPU stormwater conveyances. The downspouts for the overhang on the truck bay, discharge to the paved surface and into the catch basins.

**PHOTO 5****LOCATION:** Snoqualmie Street**DESCRIPTION:** Downspout leading directly into subsurface

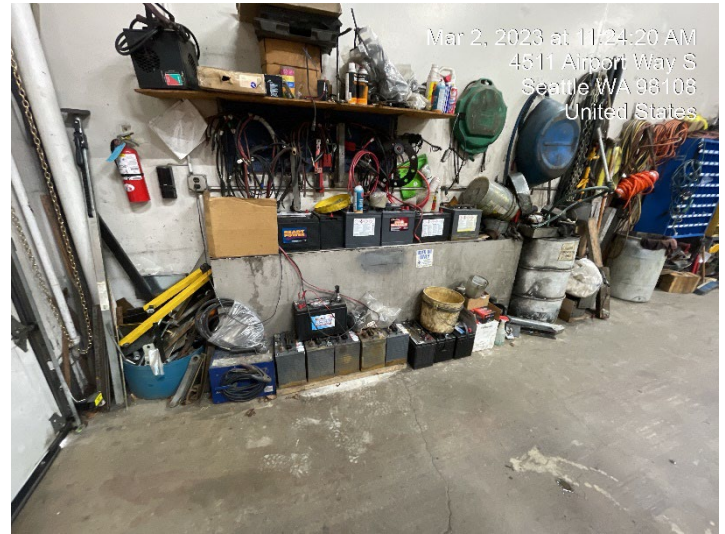
- Inside the shop was an above ground storage tank near the garage door. It was unknown if used motor oil was in the tank or not. Mr. Himes indicated they no longer used the tank, and it will be pumped out this week. There is an oil/water separator in the shop and all drains lead to the oil water separator.

**PHOTO 6****LOCATION:** GARAGE/SHOP**DESCRIPTION:** Used Motor oil tank near garage door

- 1.) Provide documentation the used motor oil tank is empty, and batteries were removed, per Mr. Himes suggestion of removing the batteries and emptying to tank.
- 2.) Provide documentation of the removal of the underground storage tank
- 3.) After speaking to Wes Himes on 4/3/23, Ecology recommends the following: Mr. Himes confirmed the downspouts are 20-30 years old and galvanized. We recommend replacing the downspouts. If zinc levels are still high after the downspout replacement. Ecology recommends sampling 3 other downspouts with a total of 4 downspouts. One sample for each roof.
