<h1 style="text-align: center;">STORMWATER COMPLIANCE INSPECTION REPORT</h1> <p style="text-align: center;">State of Washington Department of Ecology 1250 W Alder St, Union Gap, WA 98903</p>					WADOE Stormwater Compliance Inspection Form Last updated (6/19)	
						Phone: (509) 575-2434 Cell: (509) 480-1277 <a href="mailto:kdol461@ecy.wa.gov">kdol461@ecy.wa.gov</a>	
<b>Section A: General Data</b>							
<b>Inspection Date</b>	<b>NPDES Permit #</b>	<b>County</b>	<b>Receiving Waters</b>	<b>Inspector</b>	<b>Facility Type</b>		
5/12/2023	None	Yakima	Yakima River	Kevin Dolan	Industrial		
Discharges to: Ground				<b><u>ANNOUNCED</u></b> Inspection			
<b>Section B: Facility Data</b>							
<b>Name and Location of Site Inspected</b> Farwest Fabricators 7537 POSTMA RD Moxee, WA				Entry Time 11:06am			
				Exit Time 11:36am			
				GPS Lat: Long:			
				Entrance: <b>46.562899, -120.399286</b>			
				Discharge: 46.562712, -120.399188

5/12/23

Farwest Fabricators

7537 Postma Rd.

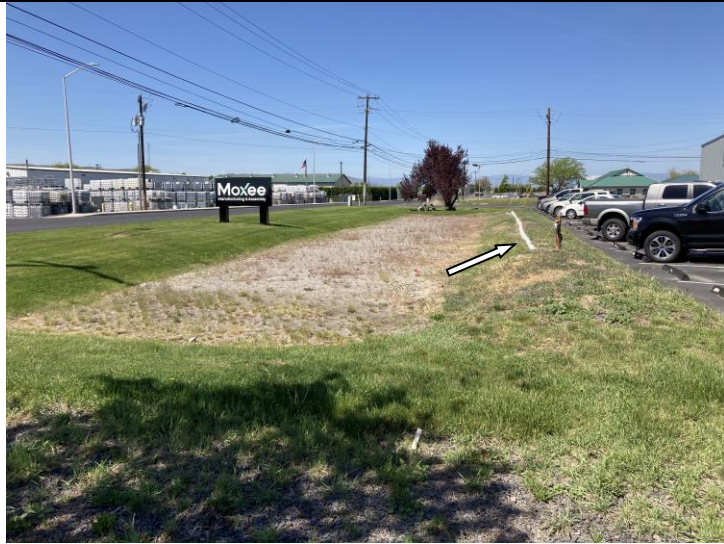
FIGURE 1: INFILTRATION SWALE TO SOUTH HAS PUMP AND AN EXPOSED PERFORATED PIPE.

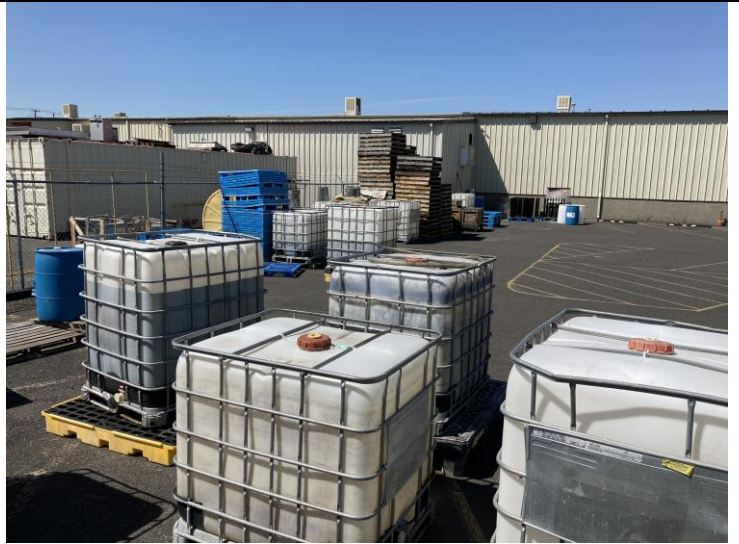
FIGURE 2: WASTE WATER IBCs OUTSIDE ON CONTAINMENT

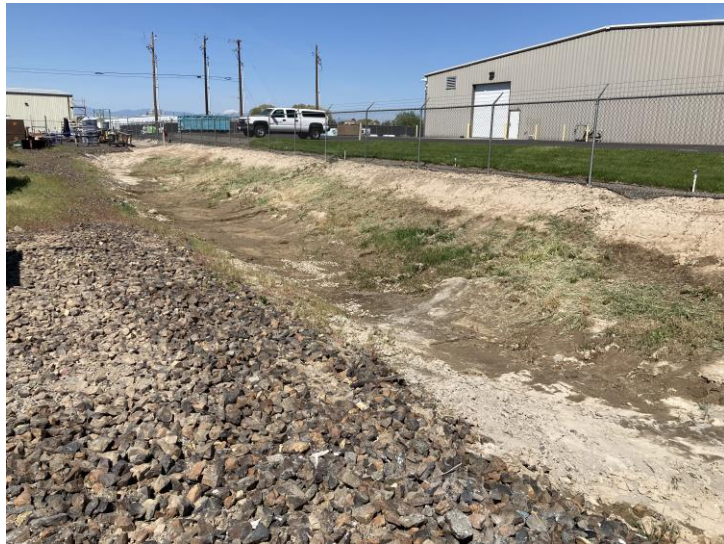
FIGURE 3: NORTHERN SWALE

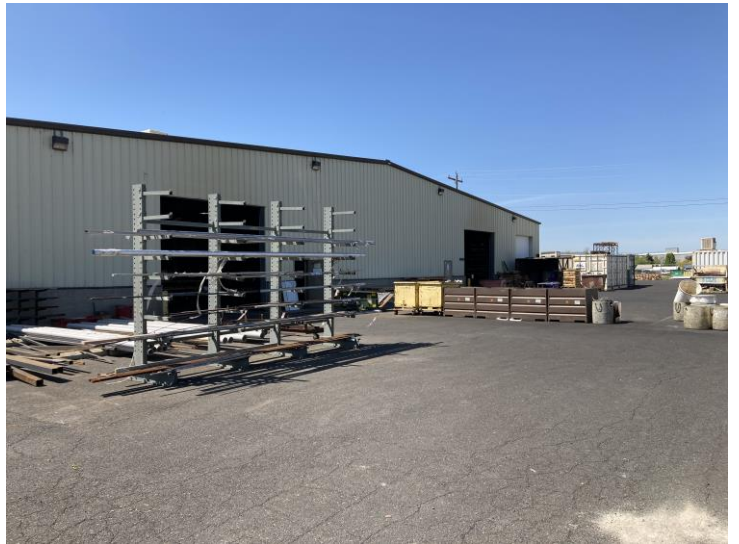
FIGURE 4: NORTHERN LOT DRAINS TO SWALE IN FIGURE 3.

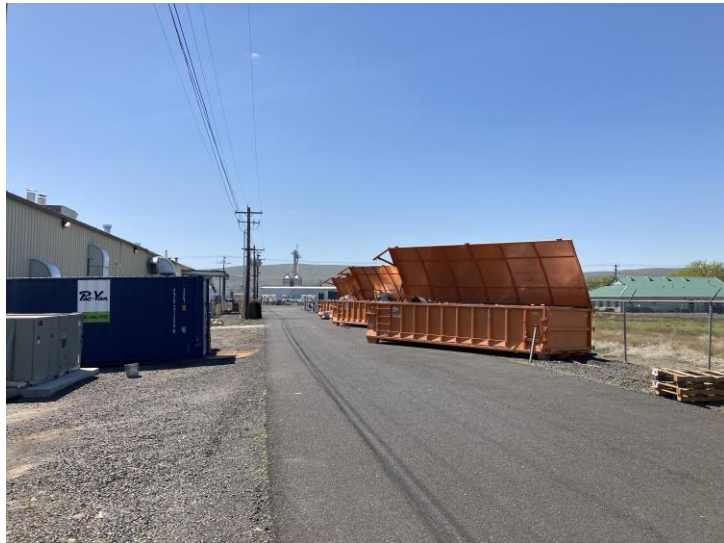
Figure 5: West side of business has waste metal bins.
