State of Washington Department of Ecology  
Northwest Regional Office  
**STORMWATER COMPLIANCE INSPECTION  
REPORT**

Inspection Date January 4, 2023	NPDES Permit # <b>WA0032166</b>	County Island	Receiving Waters Homes Harbor via upland infiltration pond
Discharges to: Surface Water <input checked="" type="checkbox"/> Ground Water <input type="checkbox"/>		Weather at time of inspection: Sunny, mid 50°F

Name and Location of Facility Inspected ICE FLOE LLC DBA Nichols Brothers 5400 S Cameron Road, Freeland, WA 98249	Entry Time 9:50 am	Permit Effective Date 07/01/2021
	Exit Time 11:00 am	Permit Expiration Date 06/30/2026 Permit extended for 5yrs in 2021.

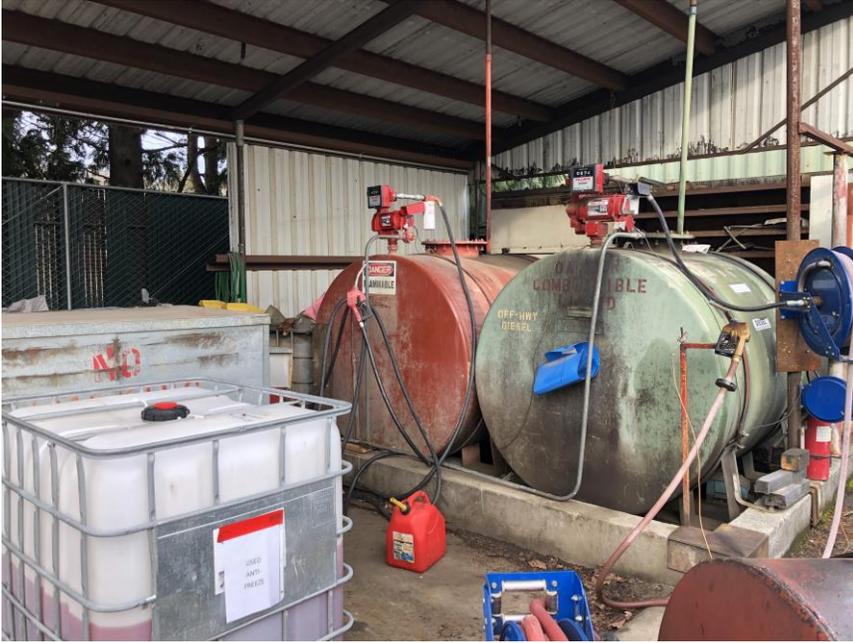
Photo 1.

1. Fuel container on the ground without secondary containment see photo 1.

Description: Storage area. Fuel tank on the ground without secondary containment.

Recommendation: Move the fuel container to an area with secondary containment. (Permit Special Condition S11.D and H)

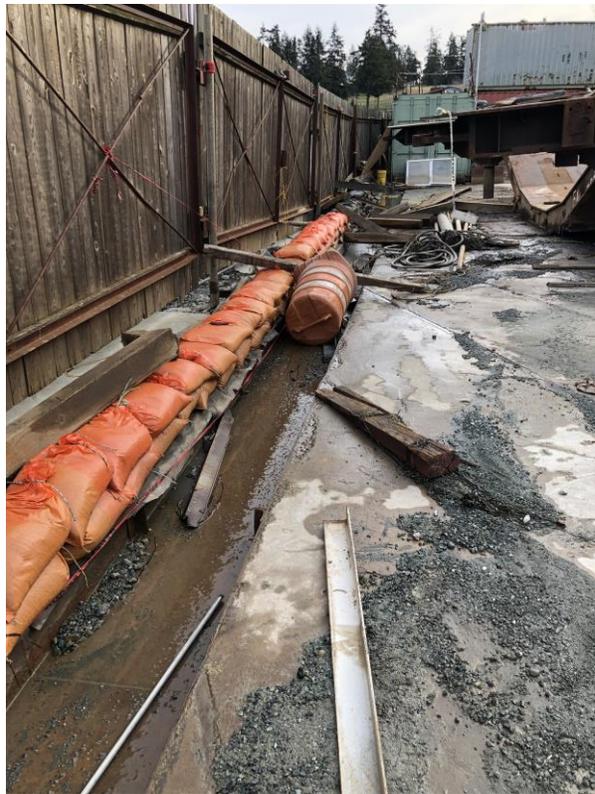
Photo 4.

2. Scrap metals and loose gravel on the ground see photo 4.

Description: Ditch and sandbags on northeast corner of the property. Scrap metals on the ground. Standing water in the ditch as well as gravel on the pavement.

Recommendation: The yard must be cleaned on a regular basis to minimize the possibility that stormwater runoff will carry sandblasting grit or other debris into the treatment system. (Permit Special Condition S11.E)

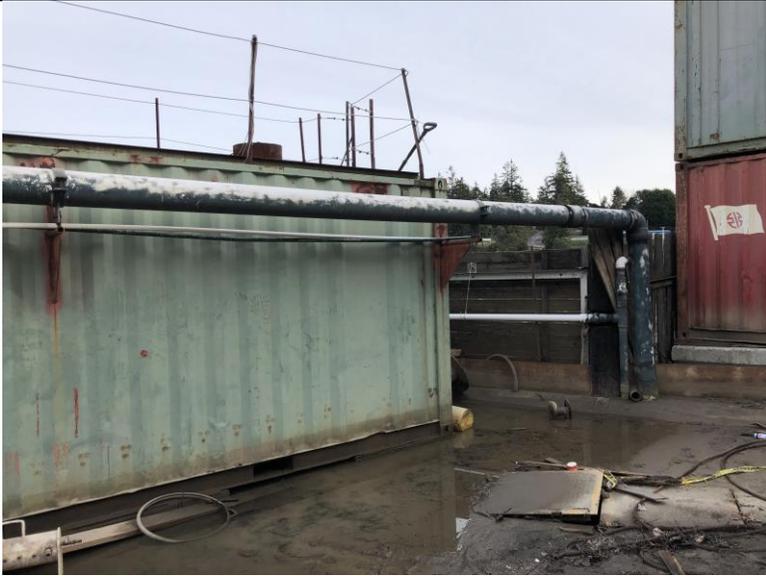
Photo 5.

We then walked to the northwest of the property where the two pumps are located. The north end has a small ditch, which is parallel to the Shoreview Ave. It collects surface stormwater runoff from the fabrication area. The hatch of the pumps is submerged in surface water, and is half opened.

3. Standing water next to the detention tank see photo 5.

Description: Water detention tank. Standing water on the ground with half-opened hatch.

Recommendation: Drain the standing water and investigate where the water come from. Remove solids from the hatch and close the hatch door when it's not used. General housekeeping BMPs should be applied. (Permit Special Condition S11.F)

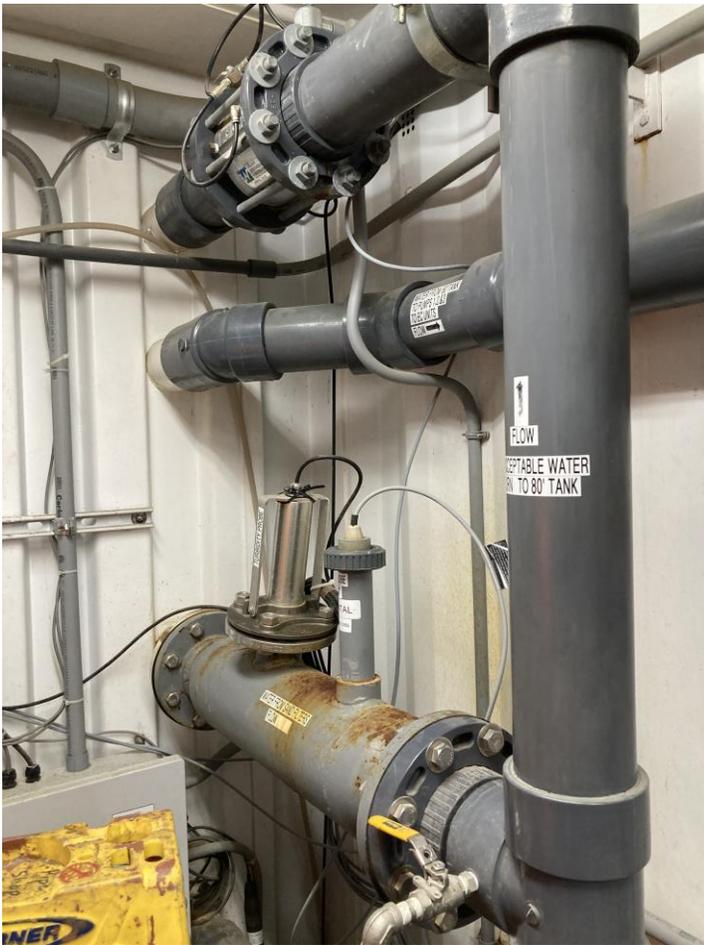
Photo 6.

Description: Pipes configuration inside the EC treatment system operation room. Pipe has rust over it.
