STORMWATER COMPLIANCE INSPECTION REPORT

WADOE Stormwater Compliance Inspection Form

Inspection Date 6/22/2023	Permit # WAR001526	County King	Receiving Waters Elliot Bay	Inspector(s) Luis Buen Abad	Facility Type Industrial
Discharges to: Surface Water <input checked="" type="checkbox"/> Ground Water <input type="checkbox"/>

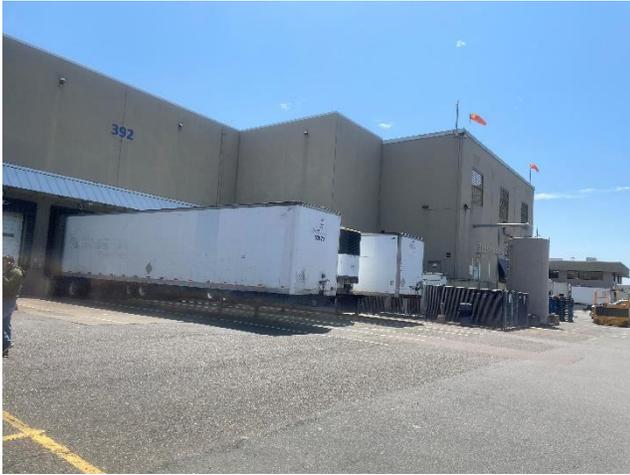
PHOTO 1 LOAD AND UNLOAD AREA

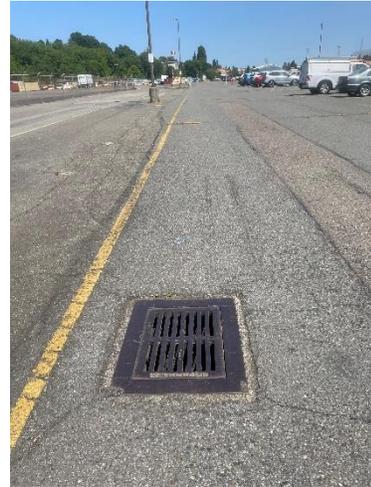
PHOTO 2 ACCESS ROAD, WEST OF THE BUILDING OF THE FACILITY.
STORMWATER CONVEYANCE SYSTEM DRAINS TO THE SOUTH.

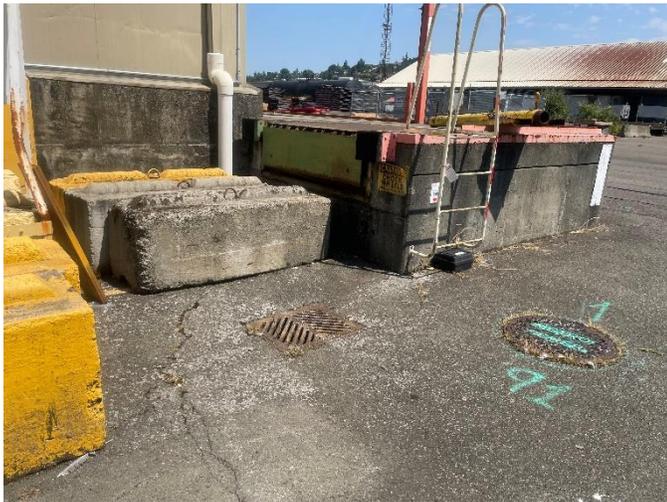
PHOTO 3 CAB IN THE SOUTHEAST CORNER OF THE BUILDING.

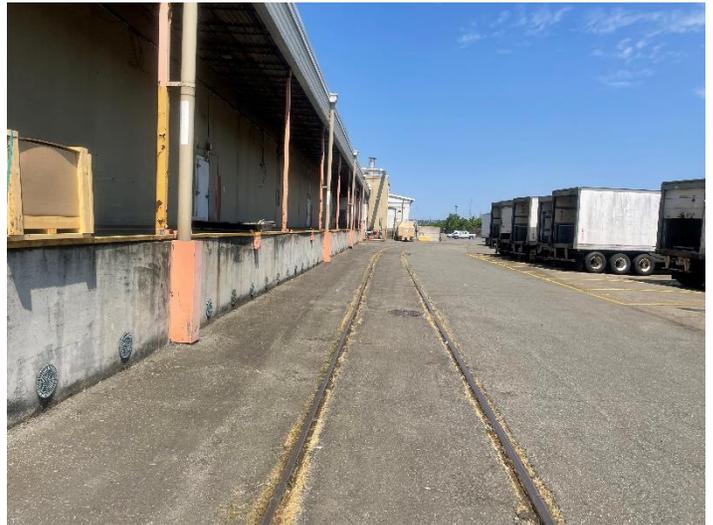
PHOTO 4 LOAD AND UNLOAD AREA IN THE EAST SIDE OF THE
FACILITY

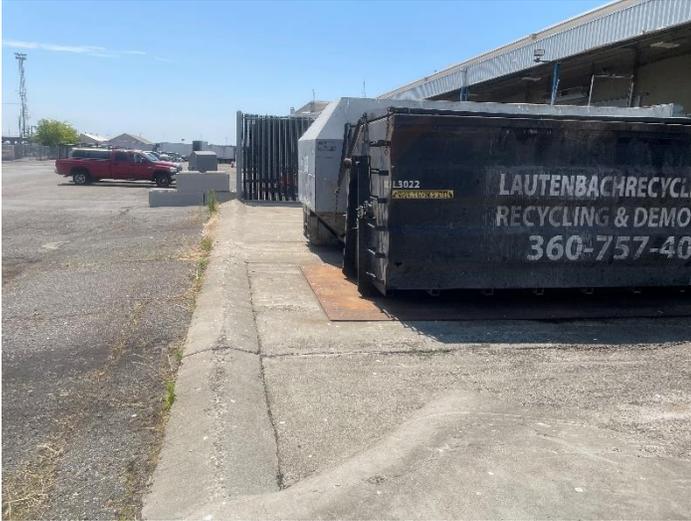
PHOTO 1 EAST SIDE OF THE FACILITY LOOKING SOUTH. OBSERVE BERM IN THE LEFT SIDE OF THE FRAME

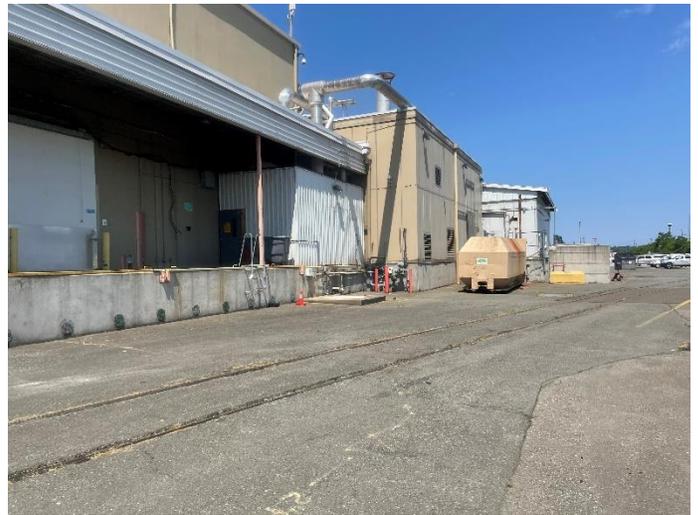
PHOTO 2 EASTSIDE OF THE FACILITY LOOKING NORTH. DUMPERS WITH COVERS.

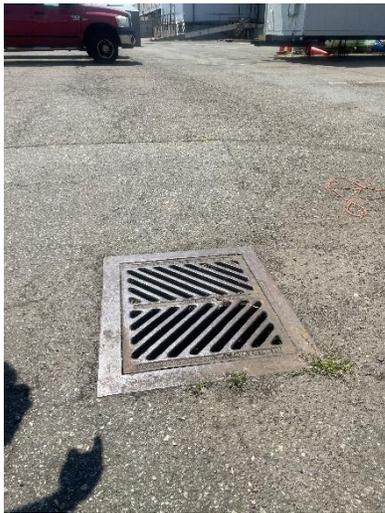
PHOTO 3 CB NEAR THE LOAD AND UNLOAD DOCK

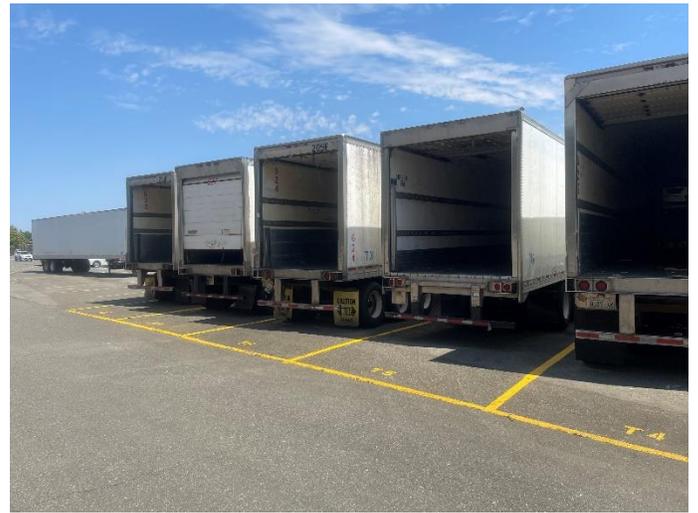
PHOTO 4 TRUCK PARKING AREA
