PHOTO ADDENDUM – CSR MARINE SOUTH

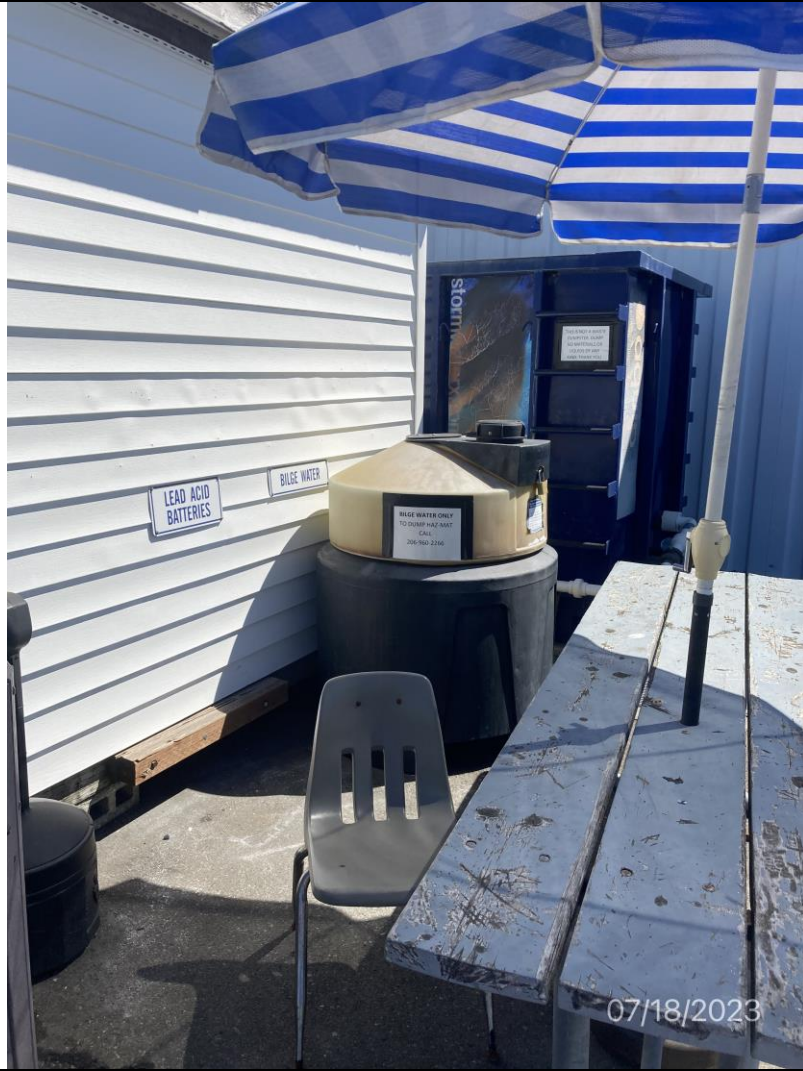
001

Description: Photo showing double walled waste oil container and Stormwater Rx units

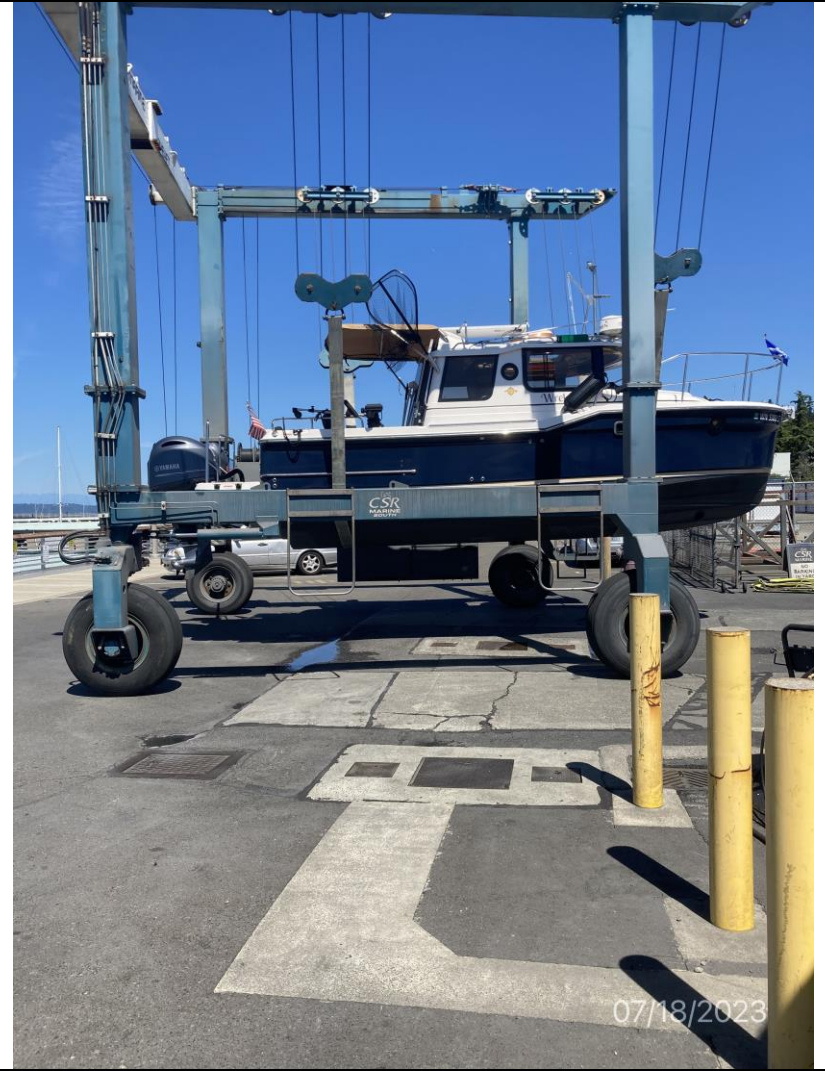
002

Description: Photo showing wash pad with vessel on lift recently washed and waiting to be moved.

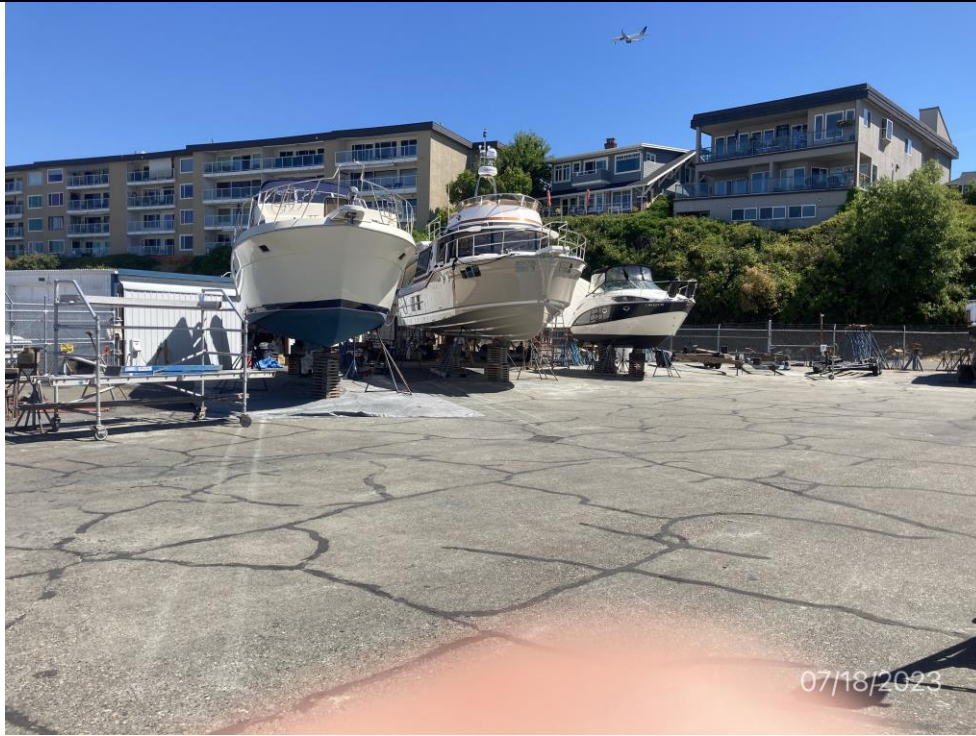
003

Description: Photo showing north side of facility with vessels on blocking and tarps under vessels where work is being conducted.

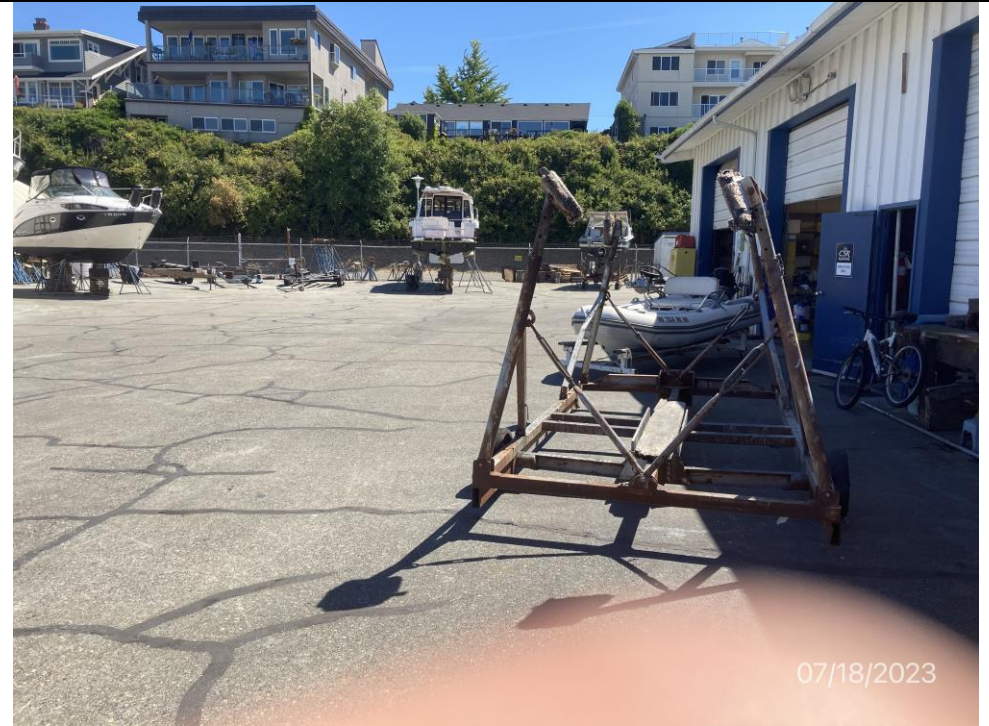
004

Description: Photo showing north side of facility main building.

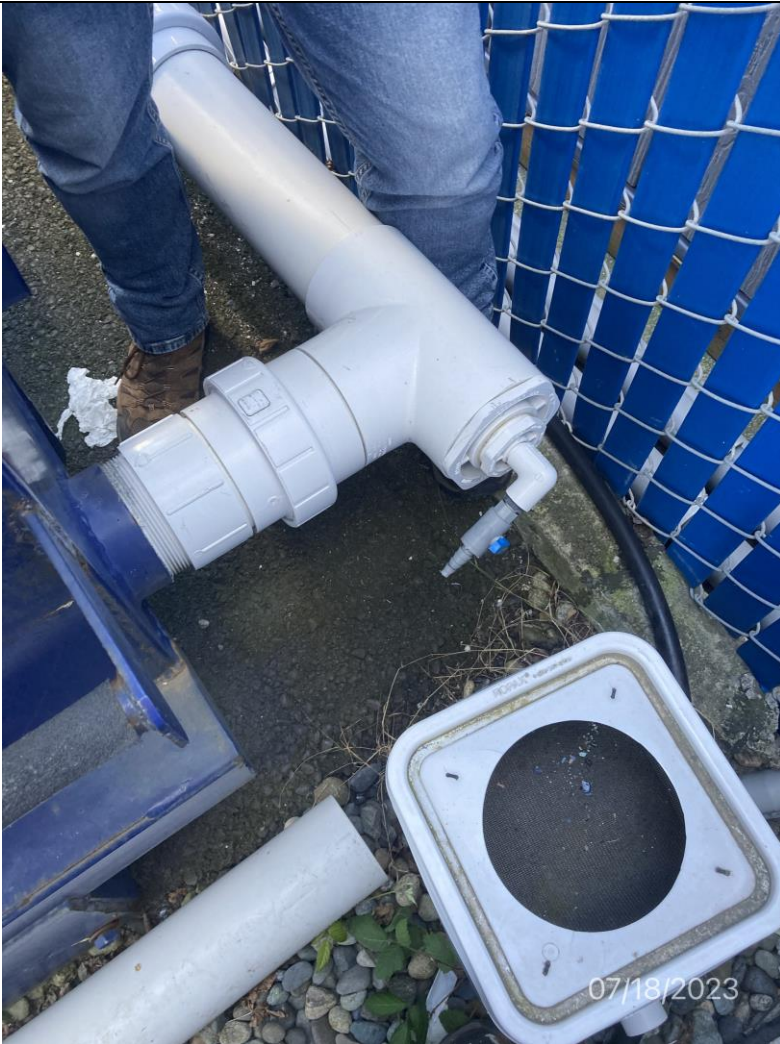
005
Description: Photo showing Stormwater-Rx current sample location which does not collect overflows.

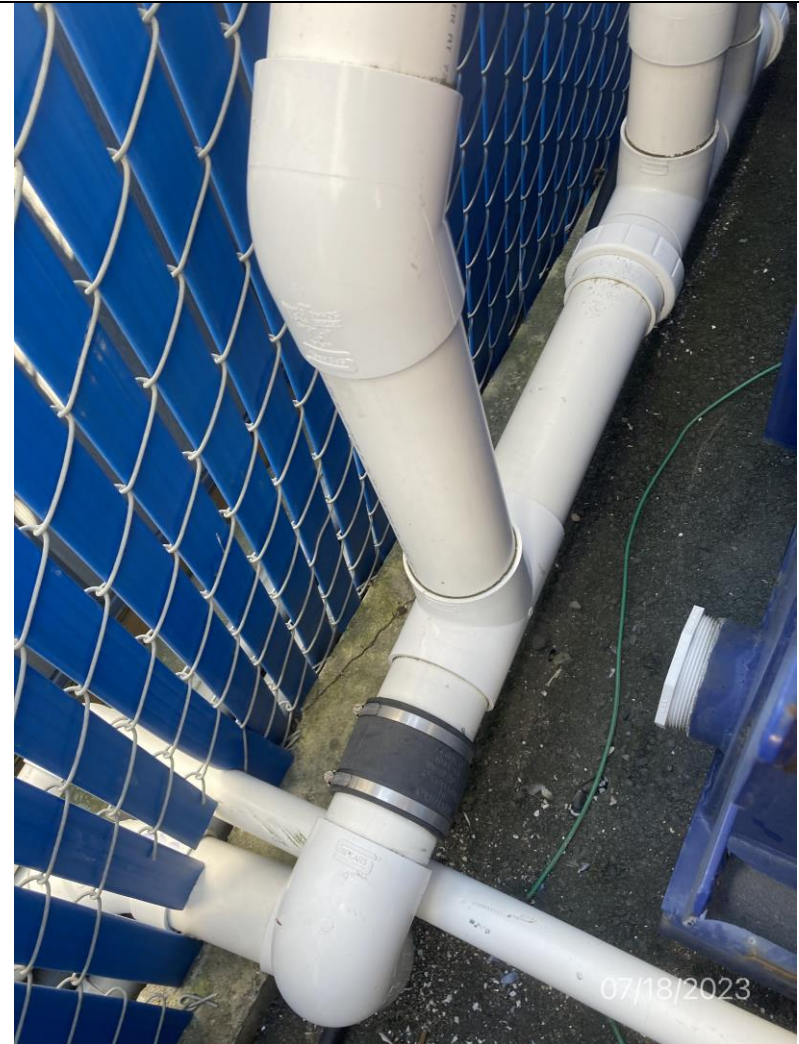
006
Description: Photo showing Stormwater-Rx piping after overflow connection where new sample port needs to be installed for permit compliant sampling.

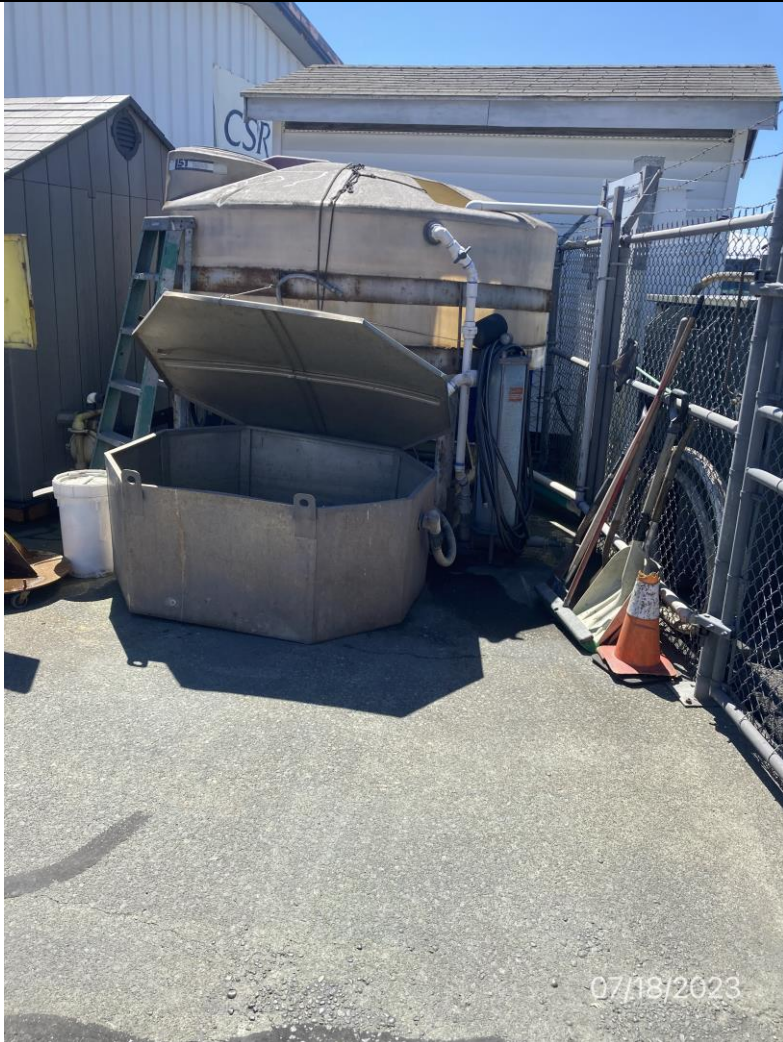
007
Description: Photo showing above ground wash water tanks.

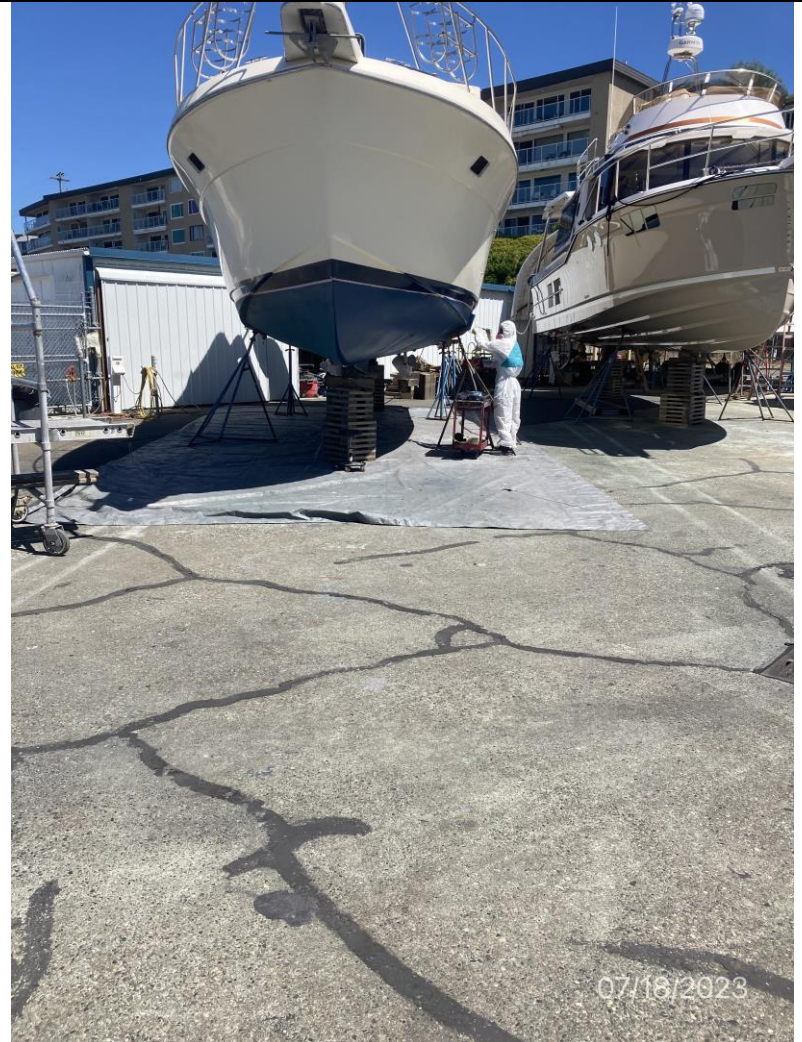
008
Description: Photo showing vessel being painted via roller with tarp underneath.

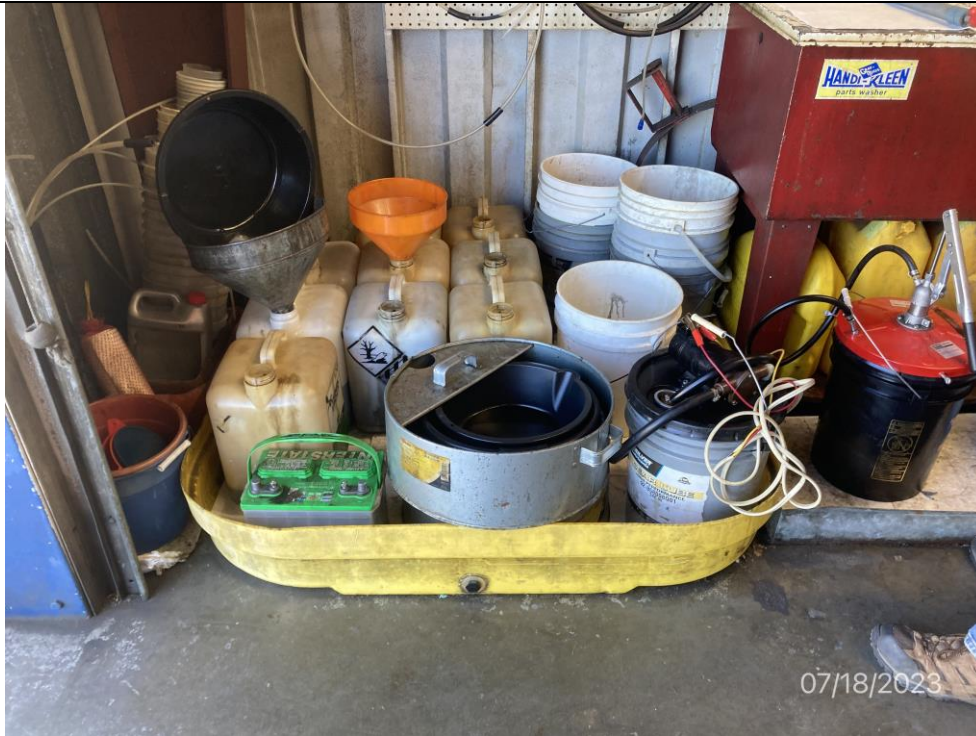
009

Description: Photo showing secondary containment inside the shop building.

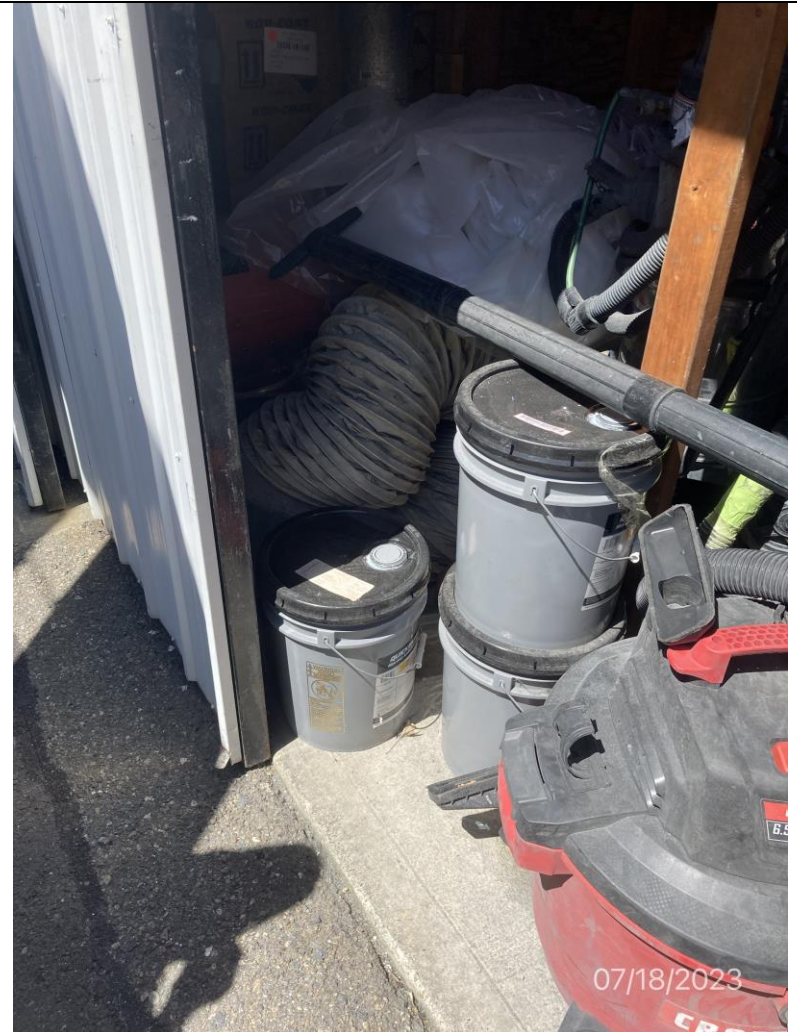
010

Description: Photo showing storage shed to the north with liquid chemicals stored without secondary containment.

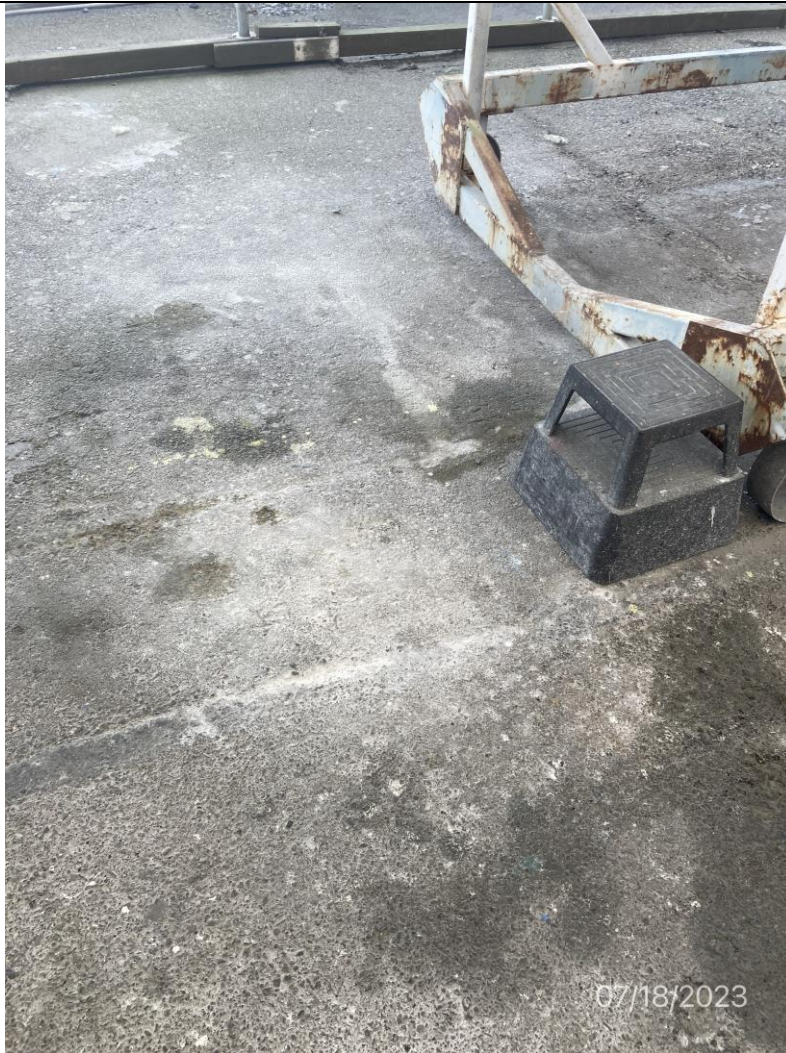
011
Description: Photo showing sanding dust on ground inside temporary tent structure due to not using tarping during vessel maintenance activities involving sanding of the exterior.

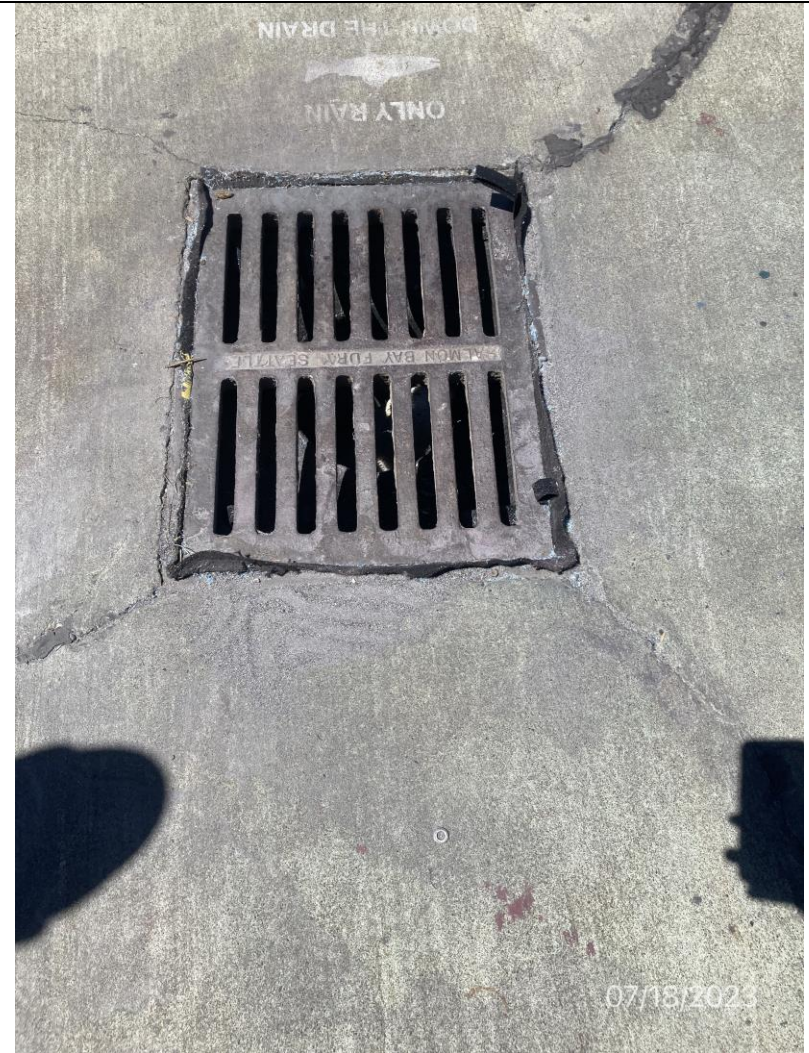
012
Description: Photo showing catch basin with insert. Large amounts of fine debris around this catch basin that is on the east side of the main building.

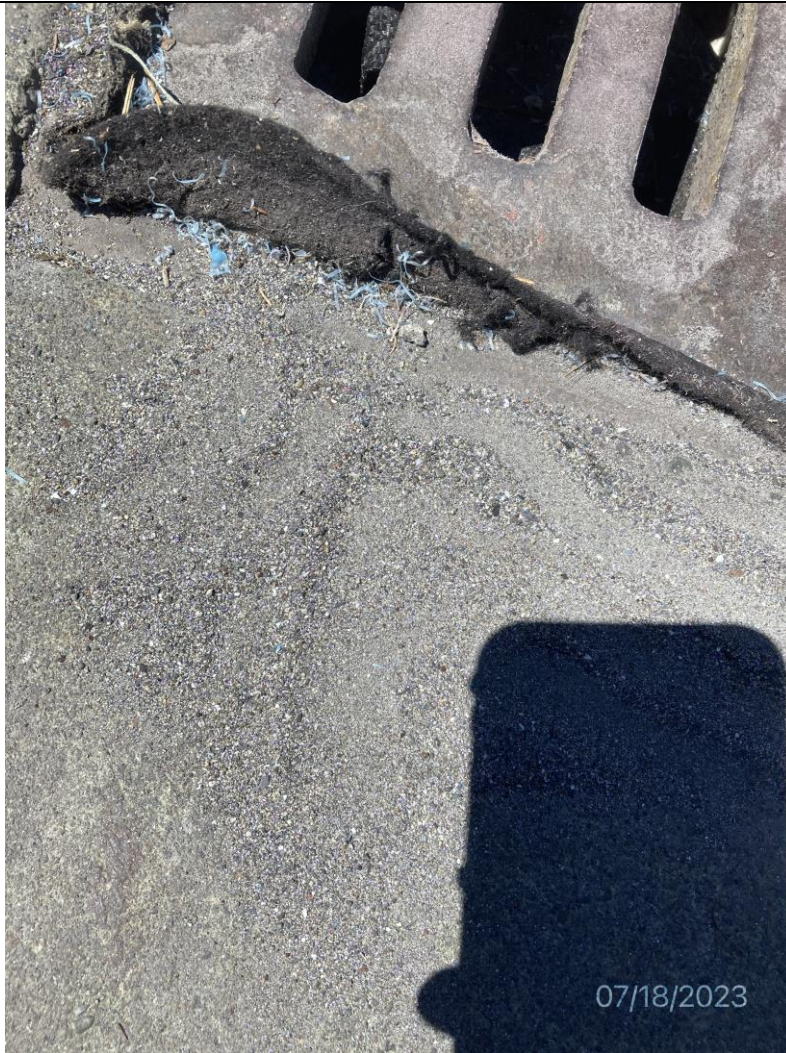
013
Description: Photo showing close up of catch basin in photo 012

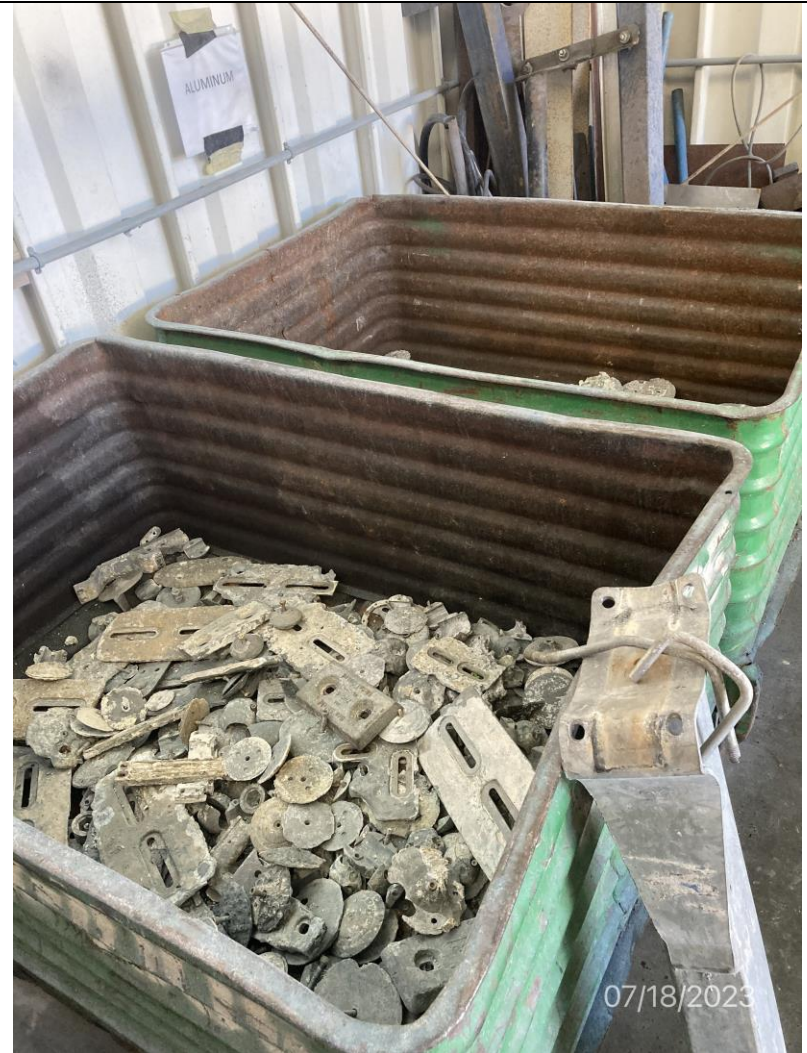
014
Description: Photo showing zinc and aluminum storage containers that are inside a metal storage building.

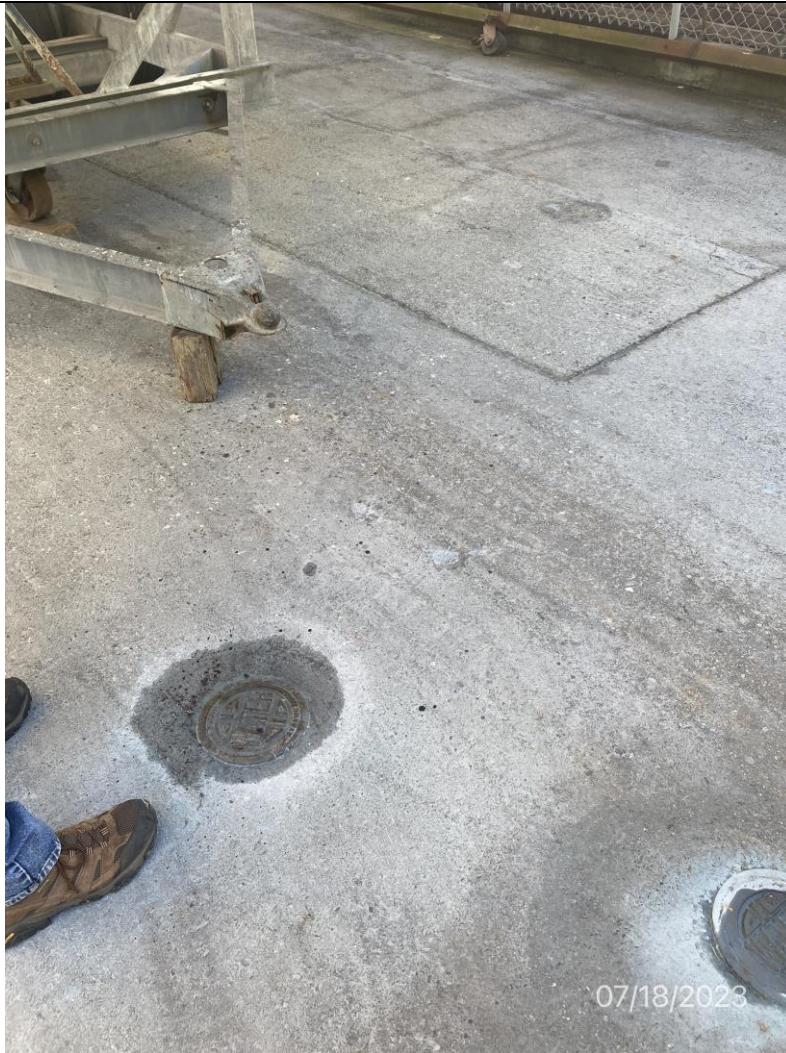
015

Description: Photo showing sanding dust from exterior maintenance of vessels on the ground inside a temporary tent structure due to not using tarps.

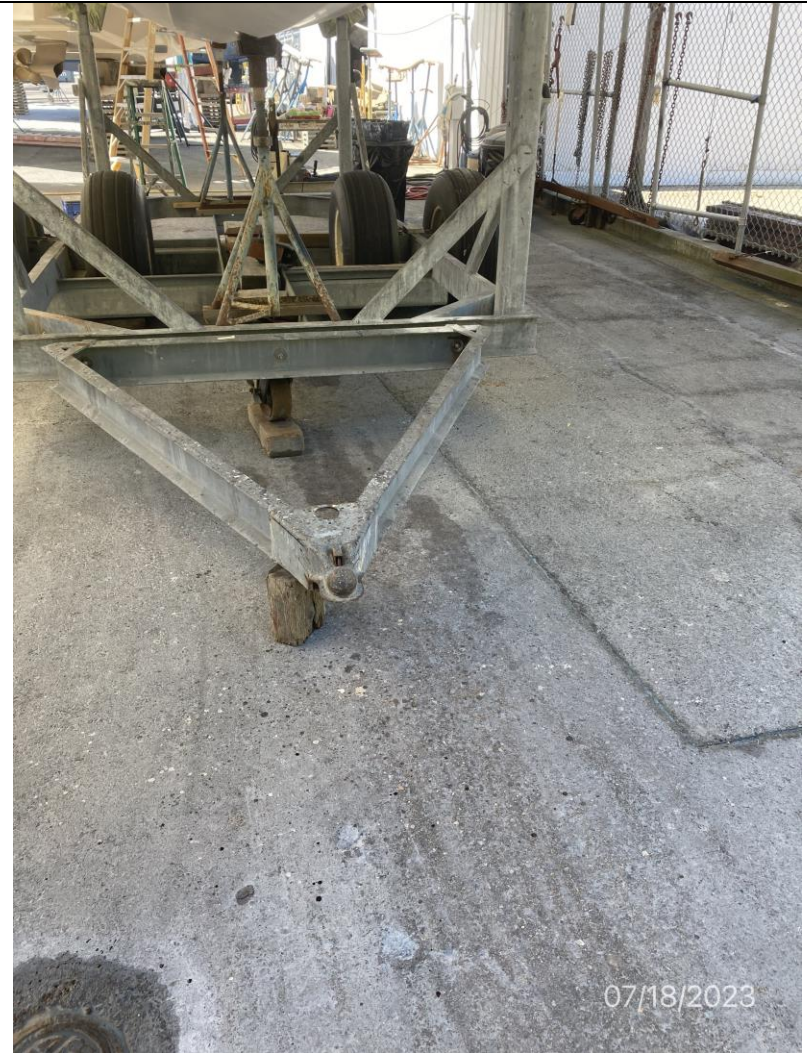
016

Description: Photo showing sanding dust from exterior maintenance of vessels on the ground inside a temporary tent structure due to not using tarps.
