STATE OF WASHINGTON  
**DEPARTMENT OF ECOLOGY**

Re: Inspection of Paneltech Permit No. ST0006202

## Waste Discharge Compliance Inspection Report

Name and Location of Facility Inspected  Paneltech International, LLC 2999 John Stevens Way Hoquiam, WA 98550	County Grays Harbor	Entry Time 9:56
	Inspection Date <u>06/07/2023</u>	Exit Time 11:40
Name(s) of On-Site Representative(s)  Raeanne Wolfley  Max Bailey Imran Khan	Title(s)  Environment, Health, and Safety Manager Supervisor Plant Superintendent	Phone Number(s)  (360) 538-1480
Name, Address of Responsible Official  Dave Wentworth 2999 John Stevens Way Hoquiam, WA 98550	Phone  (360) 538-1480  Title  General Manager	Contacted  <input checked="" type="checkbox"/> Yes <input type="checkbox"/> No

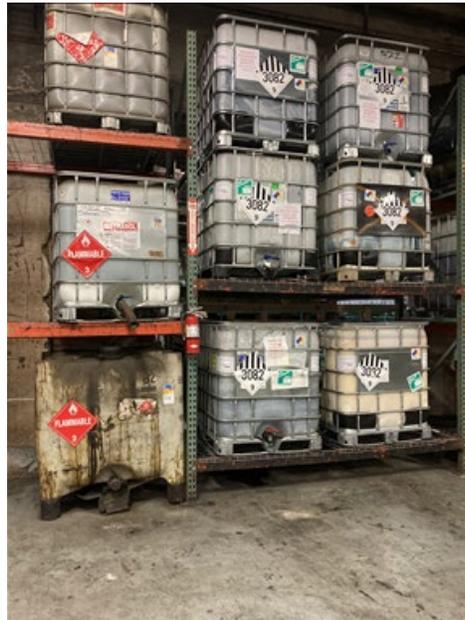
After we walked through the main production area (Photos 1 to 7), we went to the chemical storage area. We observed chemical crates stacked on top of each other (Photo 8). There is a bay door that leads to the train tracks in the chemical storage area that is no longer in use (Photo 9). Imran explained that they used to be a large quantity hazardous waste producer and produced hazardous waste from 14,000 to 29,000 gallons per year. However, they do not produce any hazardous waste as they recycle spills and have increased training of employees which allows more effective handling of the chemicals. Will asked how they clean the chemical storage tanks and Imran explained they use methanol to clean chemical tanks and then that waste is recycled back into the plant for use. Raeanne stated that one of the planned upgrades for the facility is changing the formaldehyde storage to a PUA (glue) tank with a capacity of 45,000 gallons.

**Photo 8.** Chemical storage

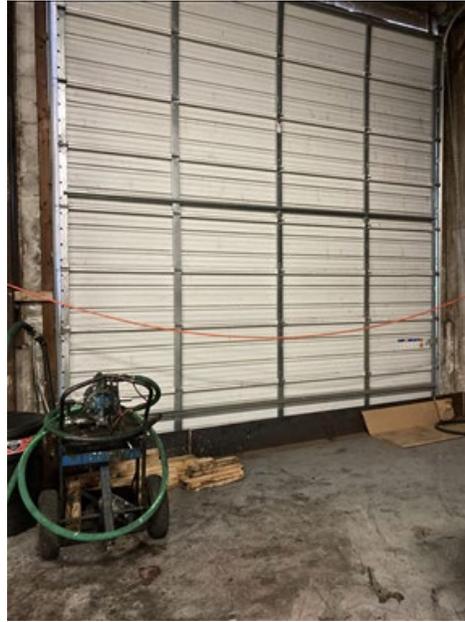
**Photo 9.** Bay door that leads to train rail. Not in use

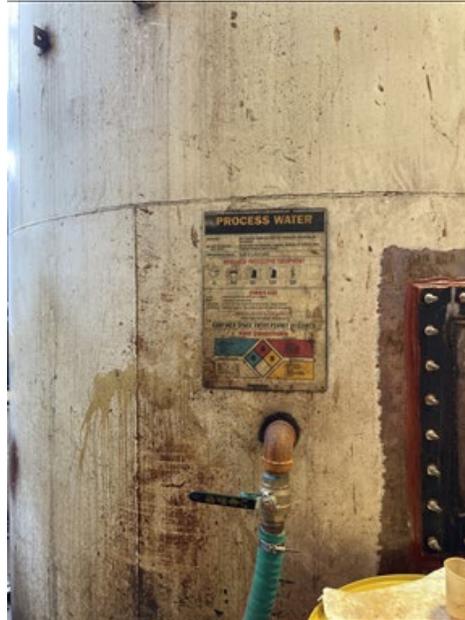
I asked to see the process water tank which is located on the outside of the facility (Photo 11). I noticed a potential leak about 18 inches above where the process water pipe meets the tank (Photo 13). The potentially leaking pipe needs to be evaluated and addressed. Will and I also observed leak in the pipe that leads to the phenol tank (Photo 33 and Video 1). Imran stated that this is clean condensate and does not contain phenol fumes. He further hypothesized that the dripping water could be from external condensation on the pipe. This leak needs to be investigated and resolved.

**Photo 11.** Process water tank. Valve to open when taking sample

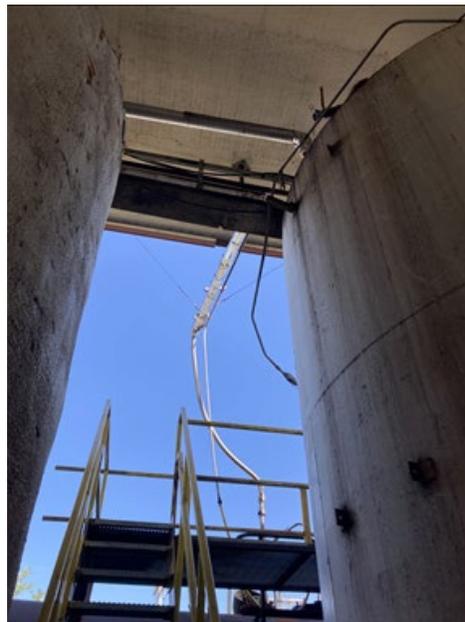
**Photo 12.** Stairs leading up to top of process water tank. What board going across phenol and process water tank. Used for a bridge?

- *Inspect Eyewashes Regularly* – All eyewash stations need to be routinely checked for operation and records of these checks maintained at each station.
- *Employ alternative access to the top of the process water and phenol tanks* – The ladder leading up to process water tank and board going from process water tank to phenol tank pose a health and safety risk. An alternative method of accessing the top of these tanks is recommended.
- *Repair Sink/Eyewash station (Photo 17)* – The leaking sink/eyewash station needs to be repaired.
- *Electrical cords running through puddles of water (Photos 15, 16 and 32)* – As general safety concern the electrical cords that are running through puddles of water in the sump pump area need to be properly routed so as not to pose an electrical hazard.

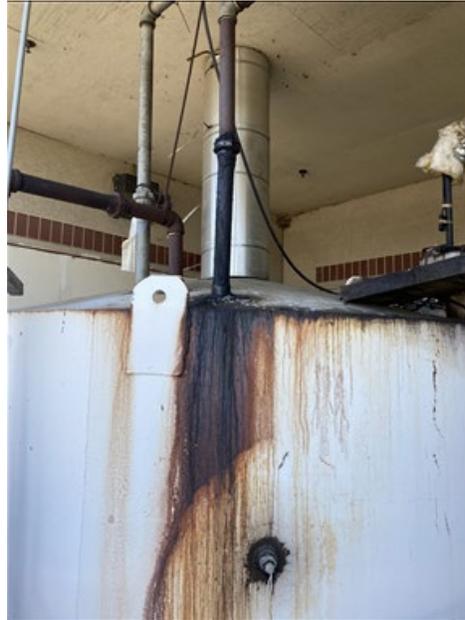
**Photo 13.** Pipe leading into the process water showing signs of leaking

- *Address leaking pipe (Photo 33, Video 1)* – The pipe along the back wall that was dripping needs to be repaired.
- *Address residue on process water tank pipe (Photo 13)* – The brown residue collecting around and dripping down the pipe leading into the top of the process water tank indicates a current or past leak. This issue needs to be evaluated and addressed.

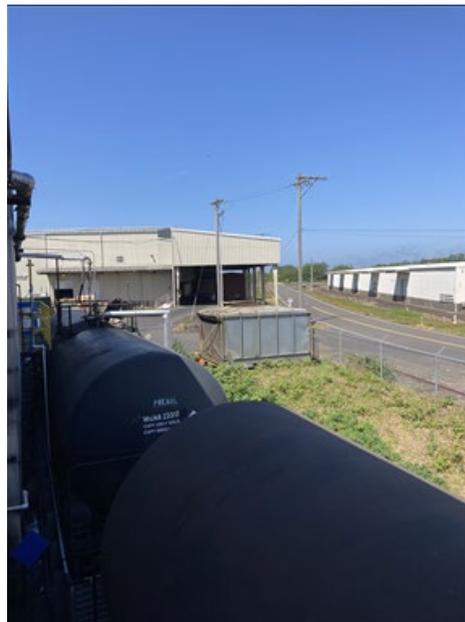
We left this area and continued to the phenol storage tanks. The phenol is stored in rail cars. They have a permanent rail car in secondary containment that they rent (Photo 14). The second rail car is outside secondary containment and is switched out when they receive a phenol shipment. Because it is not covered, the rail car in secondary containment collects rainwater. The rainwater is pumped out of the secondary containment to the nearby storm drain. Raeanne stated that if there is any concern there might be phenol in the captured rainwater, they test it before they discharge to the storm drain. Imran stated that it is obvious there is phenol contamination by smell and sheen. If there is contamination, the rainwater is pumped out and sent to the process water tank. We observed that the hose used to pump the rainwater from phenol rail car secondary containment was discharging, to a drain labeled "sewer" (Photo 31). Additionally, the manhole cover on the drain was open and blackberry vines were growing into the tank (Photo 31).

**Photo 14.** Rail cars holding phenol (foreground). Rented rail car in back, transfer rail car in front. Rectangular metal apparatus for cooling water (background).

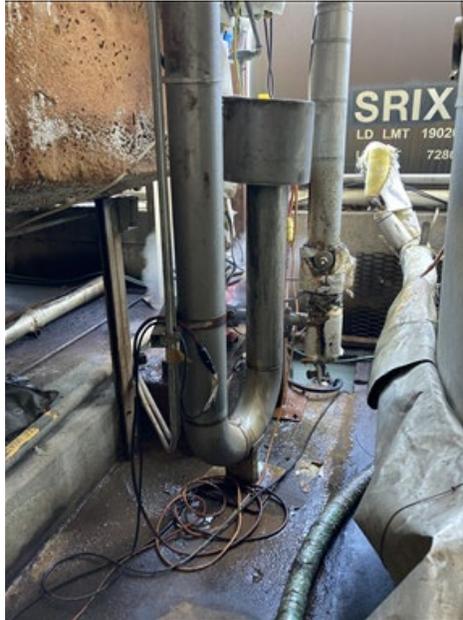
On the tour into the area where they take the process water sample, we noticed a leaking sink, which is also an eye wash station (Photo 17). There were puddles of water on the floor below the sink and the two sumps were full to about 2-3 inches from the top of the catchment indicating clogged sumps (Photos 15, 17, and 24). The leaking sink and clogged sump pumps need to be addressed. There were also extension cords going through the puddles which pose a health and safety risk (Photos 15 and 16).

**Photo 15.** Electrical cords in puddles of water

- *Clogged sump pumps (Photos 15, 17, and 24)* –The sump pumps appear to be clogged and are near full capacity indicating the pumps may not be working properly or they are clogged. They need to be cleared, drained, and properly maintained. How does Paneltech maintain their sump pumps?

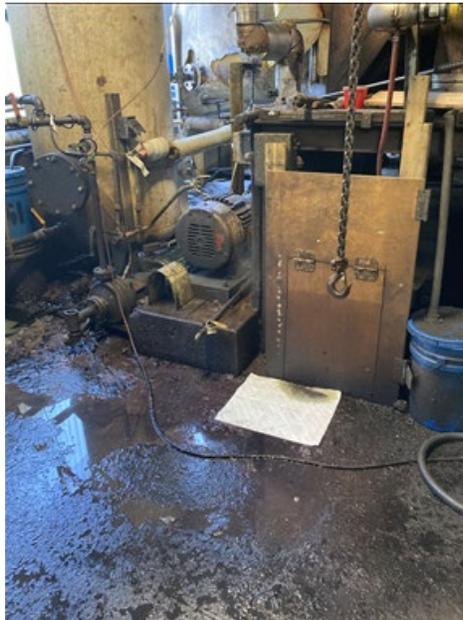
**Photo 16.** Electrical cords running through puddles of water

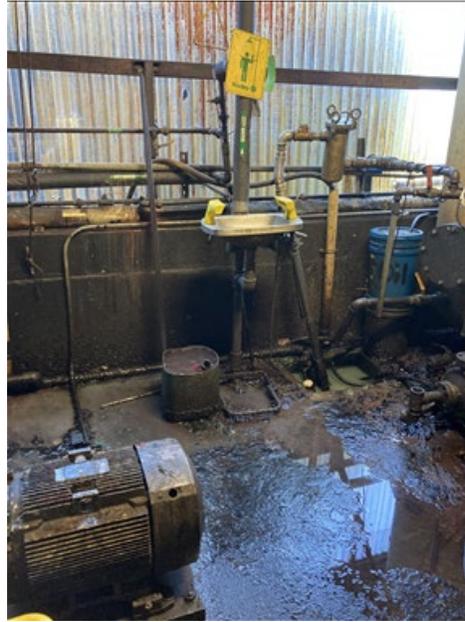
**Photo 17.** Sump pump in left corner potentially clogged. Sink/eyewash station leaking, not being checked and maintained for operation.

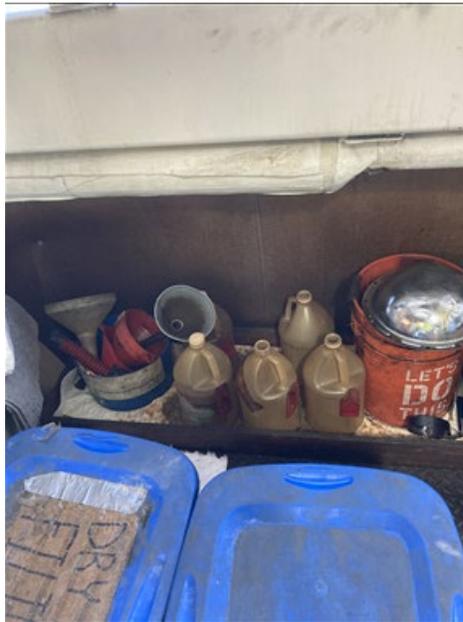
**Photo 20.** Chemical storage secondary containment. Containers without lids.

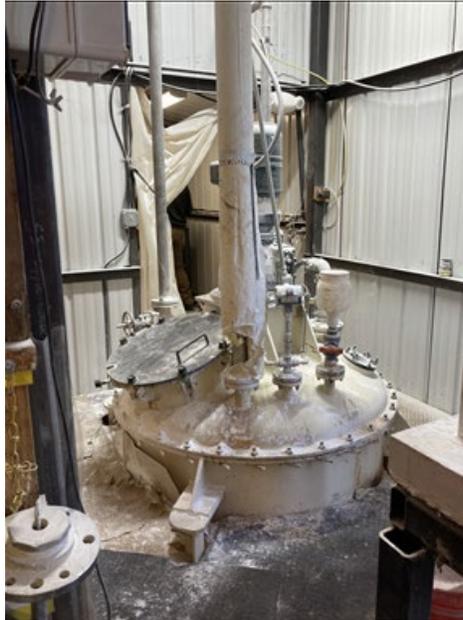
Imran took us upstairs and we observed the melamine storage. Melamine powder is a plasticizer, polymer that reacts with formaldehyde and is alkaline resistant. Imran explained that while the shelf life for melamine is 14 days, they have a way to keep the melamine so that it lasts 50 days. There was melamine spillage around the storage tank (Photo 21). Imran stated that melamine is not hazardous, and they use a vacuum to clean up the spills which they recycle back into the tank. Imran stated that they are working on upgrading the melamine kettle to minimize mess and automate dose. Imran said that right now it is manual and a messier process.

**Photo 21.** Melamine storage kettle showing some spill

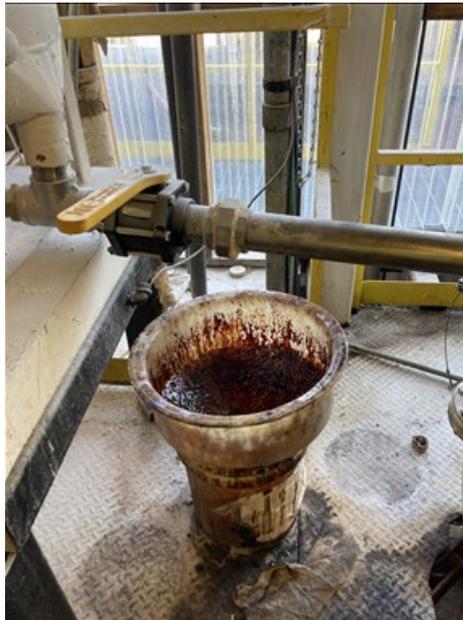
**Photo 22.** Catch for when samples are taken to test glue. Proper secondary containment?

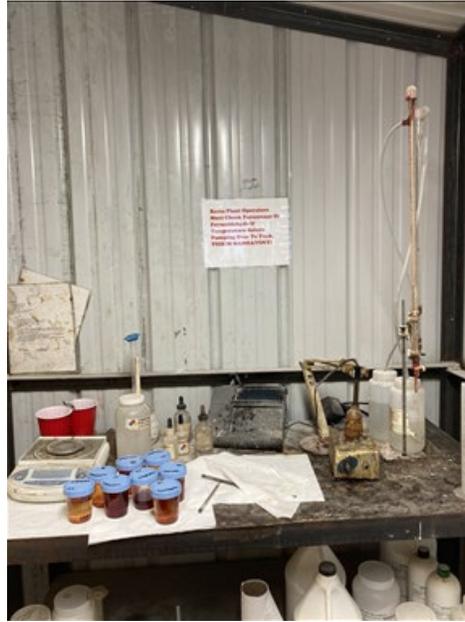
Imran showed us their chemical testing area. The station had some glue residue on the instruments and other items (Photo 23). I sked what pH meter they use to test the process water. Imran stated that they use the pH meter on the

bench (Photo 23). They use the same meter to measure the pH of their product and calibrate it regularly. I did not see a lab book that might be a record for pH calibration. I did not ask them to provide this at the time of the inspection.

**Photo 23.** Sample testing area. pH meter used for testing in house pH samples as well as effluent samples for compliance with permit

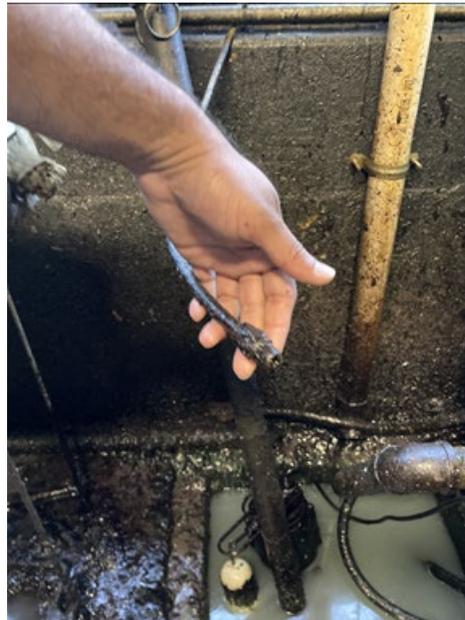
**Photo 24.** Sample collection port. Clogged sump pump

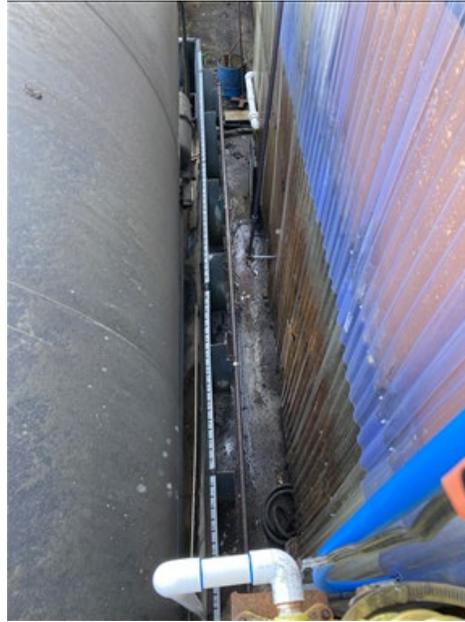
**Photo 25.** Outdoor area between phenol tank and facility wall. Signs of water from pipe leaking above

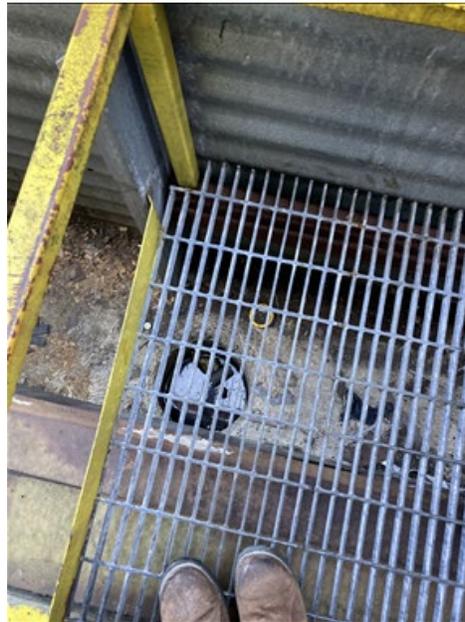
**Photo 26.** Drain in cement outside of the secondary containment for the phenol rail car. Facility representatives did not know the purpose.

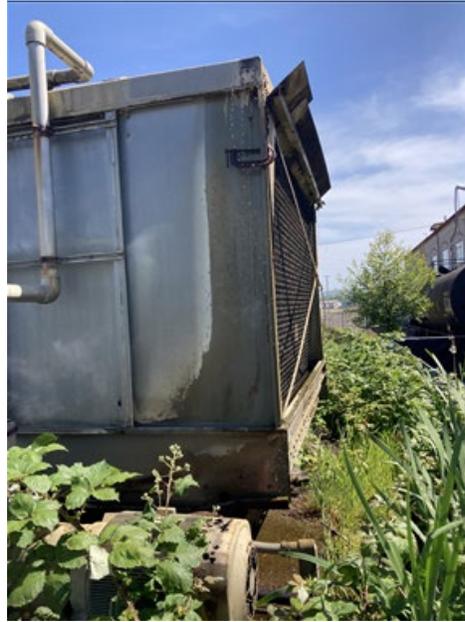
They also use city water in a closed loop system for cooling water (Photo 27).

We walked to the recirculating cooling water system that was near the phenol rail cars. Raeanne stated that they test recirculating cooling water once per quarter. There was a recirculating cooling water leaking from the apparatus, and Raeanne said it was potable water from the city (Photo 27). She further clarified that the recirculating cooling water is not part of the process water system.

**Photo 27.** Recycled cooling water. Potable from POTW, apparatus was leaking from corners

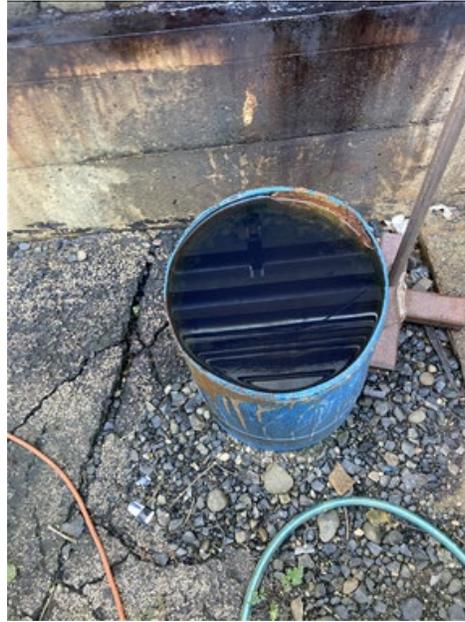
**Photo 29.** Bucket full of water showing other constituents adhered to the sides

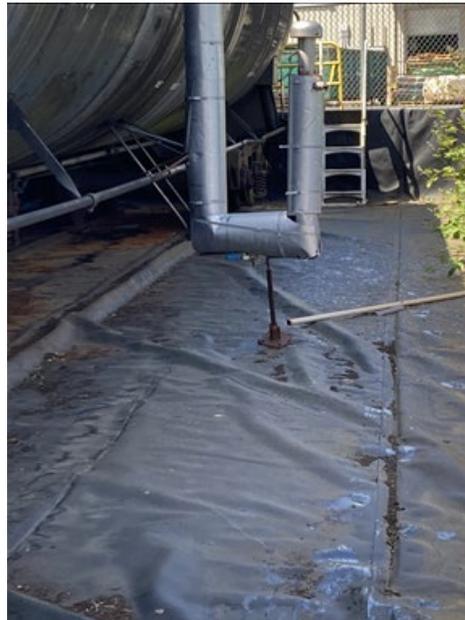
As we headed around to the other side of the rail cars, we noticed a support that was being used to hold up a pipe coming off the permanent phenol storage rail car (30). The support was skewed at an angle. Will suggested that the support be secured.

**Photo 30.** Support for metal piping coming off rail car is askew, potential for failure.

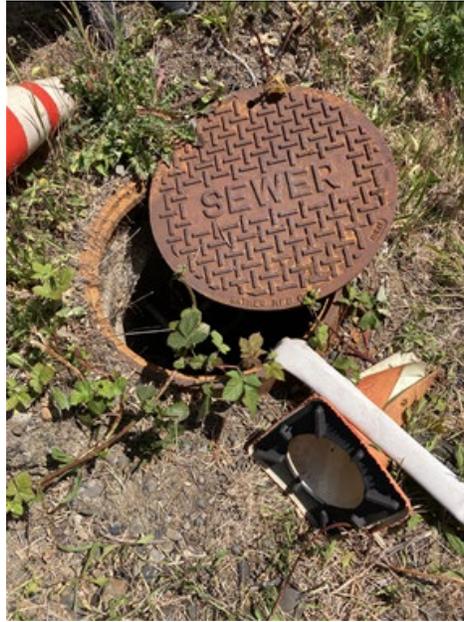
**Photo 31.** Open sewer/stormwater grate. Blackberry vines growing into sewer grate.

- *Disposal of stormwater from phenol storage rail car (Photo 31)* – The current method raises some concerns. Please check your industrial stormwater general permit (ISGP No.WAR010088) to confirm that this is an appropriate method for discharge. When not in use, the manhole should remain closed. Additionally, how is Paneltech recording that there is not phenol in the discharge? Please refer to your ISGP to insure you are correctly monitoring the stormwater discharge. Does Paneltech have records of laboratory tests when they suspected phenol is in the stormwater? Adonia McKinzi, your ISGP manager, will follow up with an inspection.

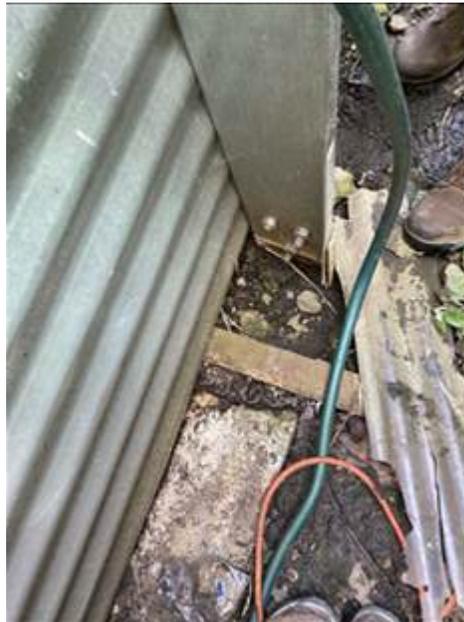
While walking around the secondary containment, we noticed that the ground under the front of the rail car was wet and soggy. We asked if this might be a possible leak from secondary containment of rented rail car, however Raeanne stated that the water was probably from a leaking pipe. The City of Hoquiam was out recently trying to take care of it. There was water seeping from under the secondary containment just beneath a puddle of standing water that was inside the secondary containment (Photo 32). I recommended that they double check that the secondary containment was not leaking as well.

**Photo 32.** Water seeping from underneath phenol rail car secondary containment

- *Ensure the phenol rail car secondary containment is not leaking (Photo 32)* –Paneltech hypothesized that the soggy water underneath the secondary containment was possibly from a leaking pipe belonging to the City of Hoquiam. Ecology recommends that they test to make sure the secondary containment is not leaking.

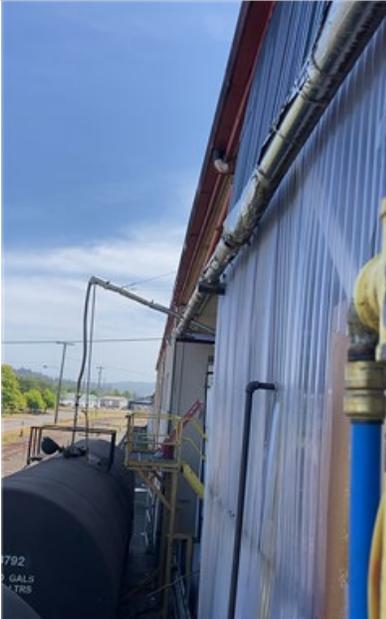
<a href="#">Ctrl+Click HERE to view full size image</a>	
<b>Photo 33.</b> Leaking pipe at back of building
