State of Washington Department of Ecology  
Northwest Regional Office  
**WATER COMPLIANCE INSPECTION REPORT**

Name and Location of Facility Inspected (For industrial users discharging to POTW, also include POTW name and NPDES permit number) Marine Fluid Systems 801 NW 42 <sup>nd</sup> St, Seattle WA 98107	Entry Time/Date 9:55 AM 07/26/2023	Permit Effective Date 04/01/2018
	Exit Time / Date 10:55 AM 07/26/2023	Permit Expiration Date 03/31/2023
Name(s) of On-Site Representative(s)/Title(s)/Phone and Fax Number(s)  Gregory Bostwick, General Manger & Owner Marine Fluid Systems 801 NW 42 <sup>nd</sup> St   Seattle, WA 98107  Phone Number 206-706-0858	Other Facility Data

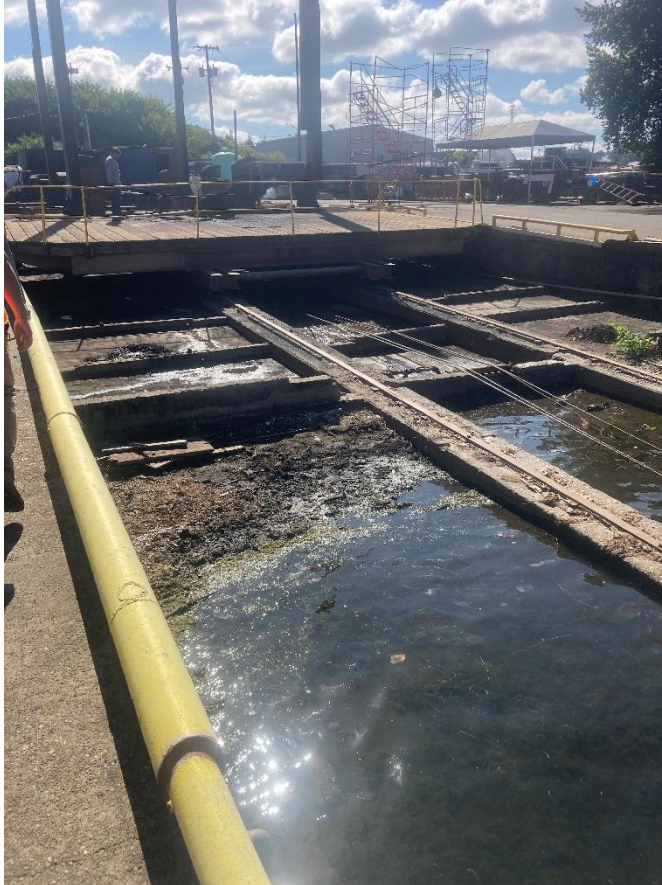
Photo 1

- After that, we walked over to the Marine Railway (photo 1). The basic functions of the marine railway are the repair of ships and the cleaning and painting of ships' bottom, propellers, rudders, and the external parts below the waterline. CB #1 is located inside the marine railway. It collects runoff from paint blasting and other working surface, and it flows to the water treatment building before it discharges to King County Sewer line. We then walked inside the water treatment building (photo 12 and 13), where process wastewater is being treated by a series of treatment train, which consists of settling tank, sand filter, media filter, and the carbon filter (photo 10, 11, 12 and 13). We also found pipes (photo 14) underneath the concrete pad of the marine railway. Greg did not know what those pipes are nor the direction they flow to.

Description: An overview of the Marine Way, where ships come in for repair and painting.

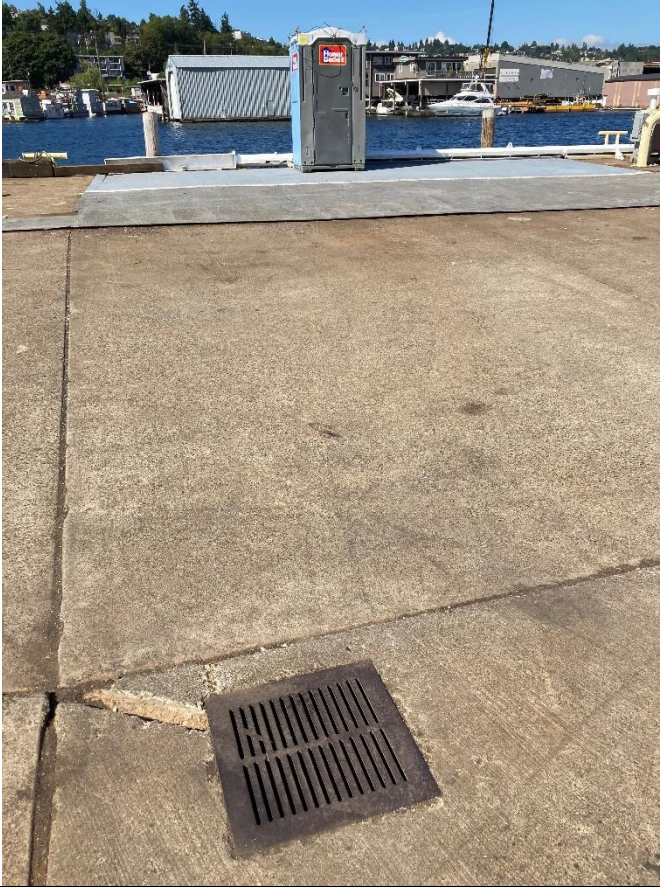
Photo 2

Description: Catch basin #3. It collects stormwater runoff of the working surface, and it's routed to catch basin #1 and the treatment building.

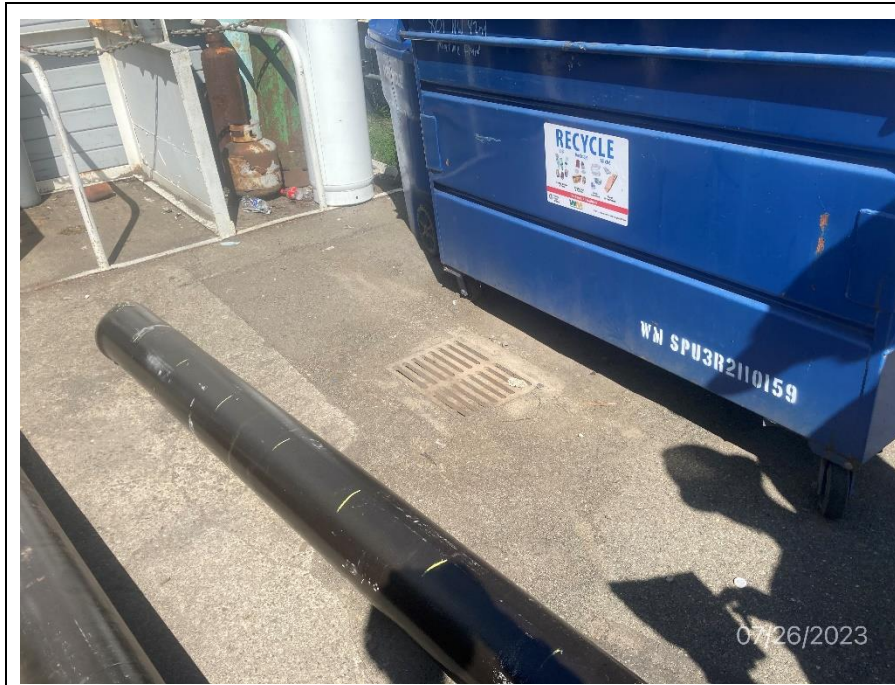
Photo 3

- The inspection ended at the main entrance of the shipyard. There is an unidentified catch basin next to the recycle bin and the power building. (Photo 2 and 4) We found that there is a pipe going out to catch basin #2 (photo 3), which eventually drains to city stormwater conveyance system.

Description: Catch basin #2 that drains to city storm sewer line.

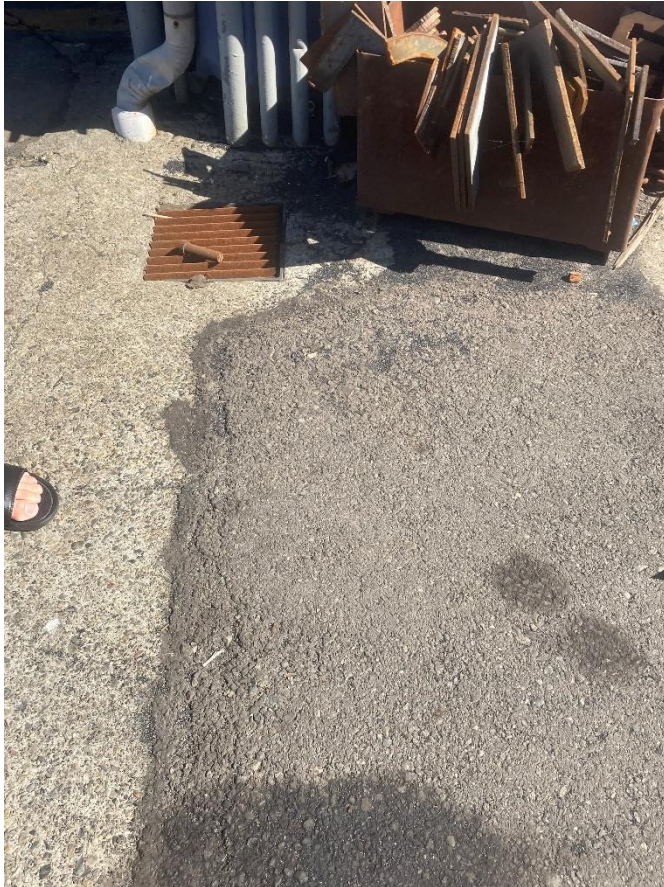
Photo 4

Description: Unidentified catch basin next to the power building.

3. Facility needs to update the existing drainage map or the site map to include the unidentified catch basin (photo 4) during the inspection on July 26. Provide Ecology with the updated map within 30 days of receiving this report.

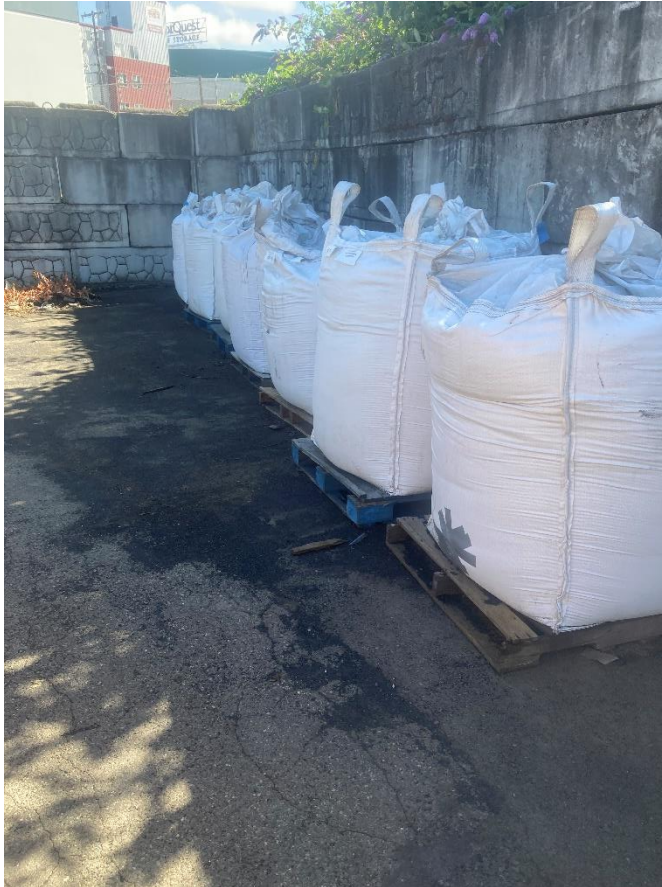
Photo 6

- We then walked towards east side of the property, where the blast shed, and paint shed are located. Inside the paint shed, there were paint containers on the ground without any secondary containment (photo 7). Next to the paint shed, we saw several sacks of grits sitting by the ecology blocks (photo 6). We then began walk of the non-working surface area at the south end of the property. We noticed grits on the ground (photo 9). Gregory explained that they were carried over from the working surface by vehicles travelling between the non-working surface and the working surface. Evan Dobrowski explained that these spilled grits need to be vacuumed and cleaned up, otherwise surface runoff will carry them over and flow straight into the Lake Washington Ship Canal via the stormwater infrastructure that does not flow to the King County Sanitary Sewer System. We then walked over to the very south end of property, which is owned by Trident Seafood next door. This portion of the property is leased to Marine Fluid Systems. We discussed potential stormwater runoff from this non-working surface area because of the slope towards Lake Washington Ship Canal (photo 5).

Description: Unused grit storage area. There were grits laying on the ground. Not sure if they are used or not.

2. Facility needs to clean and vacuum all spent grits either daily or after each sandblasting event, and make sure no spent grits are on the non-working surface per permit S10.B.6. Provide photo documentation of cleaned up sand grit from various locations on the facility within 30 days of receiving this report.

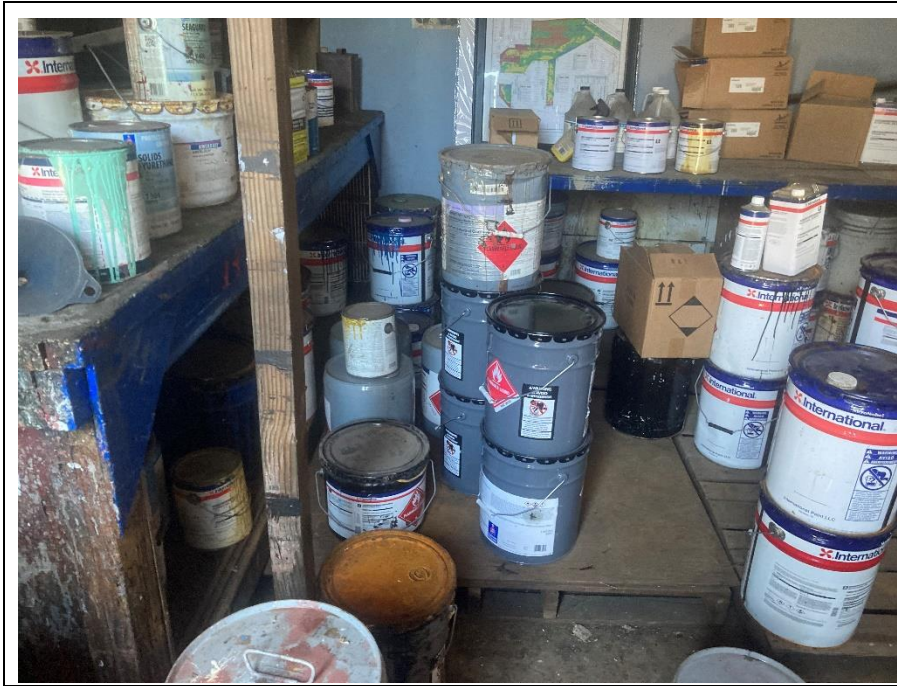
Photo 7

Description: Paint storage inside the Paint Shed.

1. Facility needs to maintain secondary containment for all liquid chemicals throughout the facility per permit S10.F.4. Provide photo documentation of cleaned up and reorganized paint and fuel storage areas within 30 days of receiving this report.

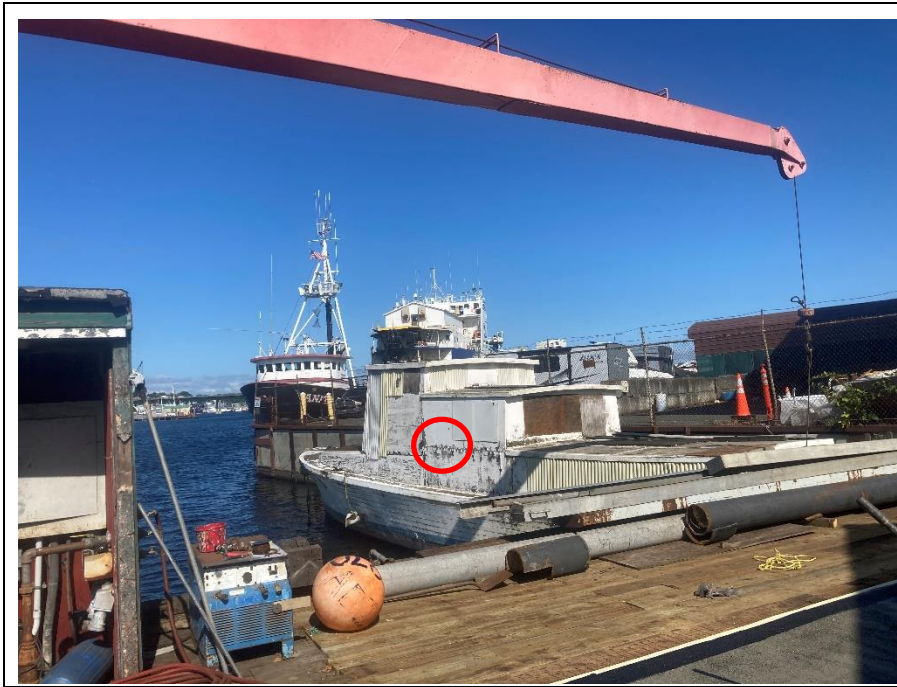
Photo 8

Description: Overview of north dock. There is an abandoned ship, see red circle, next to the dock.

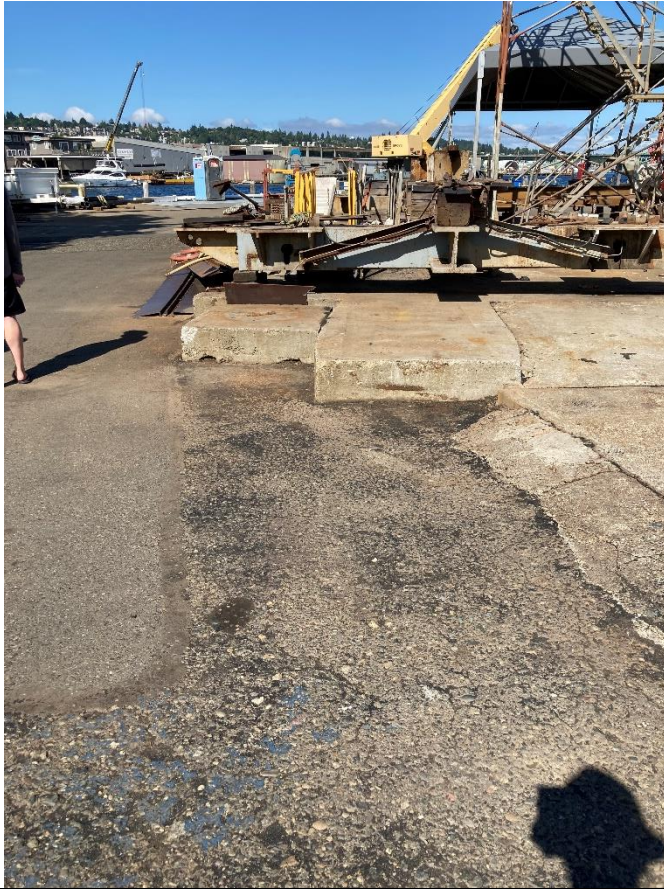
Photo 9

Description: Spent grits over the non-working surface in the northwest part of the property.

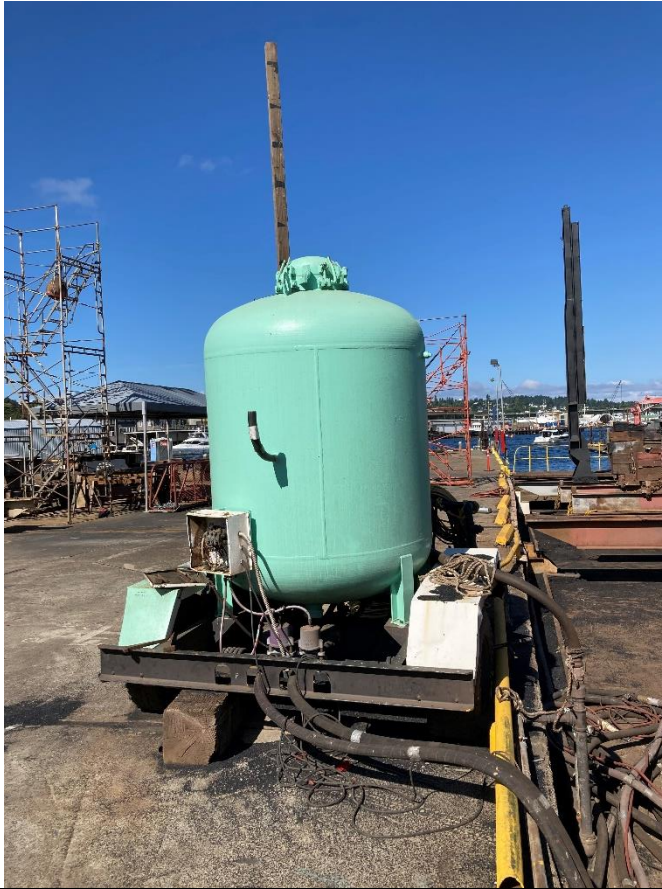
Photo 10

Description: A picture of the Media Filter before treated water goes to King County sewer line. There are spent grits on the ground.

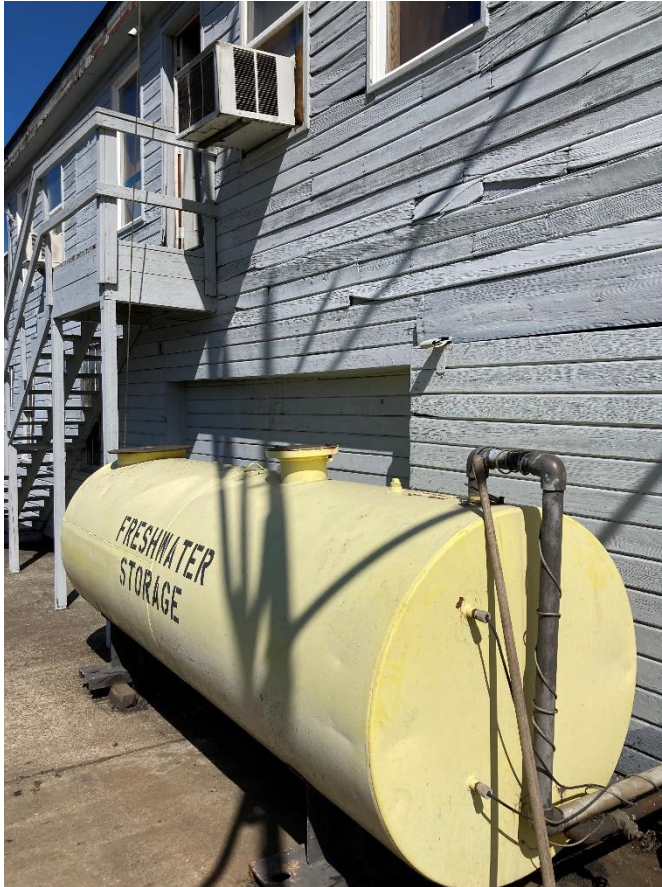
Photo 11

Description: Outside the water treatment building. A picture of the fresh water storage tank.

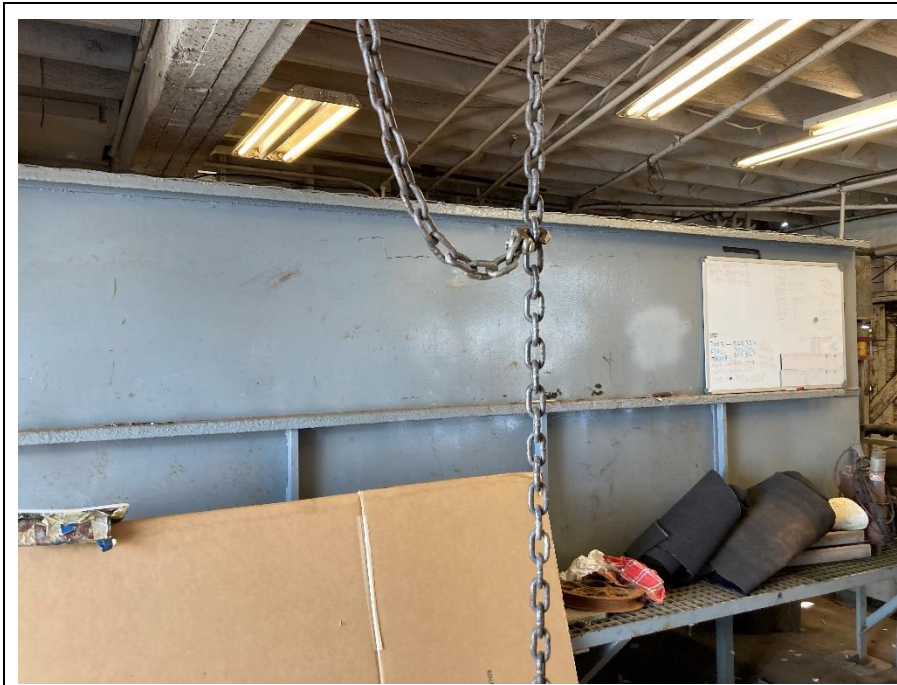
Photo 12

Description: Inside the treatment building, a side view of the 4-Chamber Settling Tank.

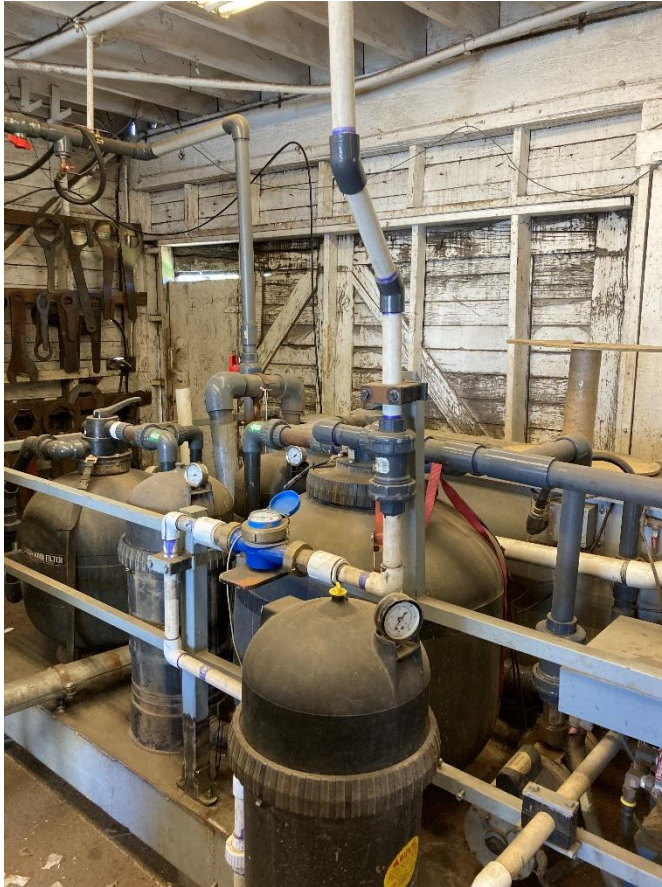
Photo 13

Description: Inside the water treatment building. Camera pointing at the sand filters and the media filter.

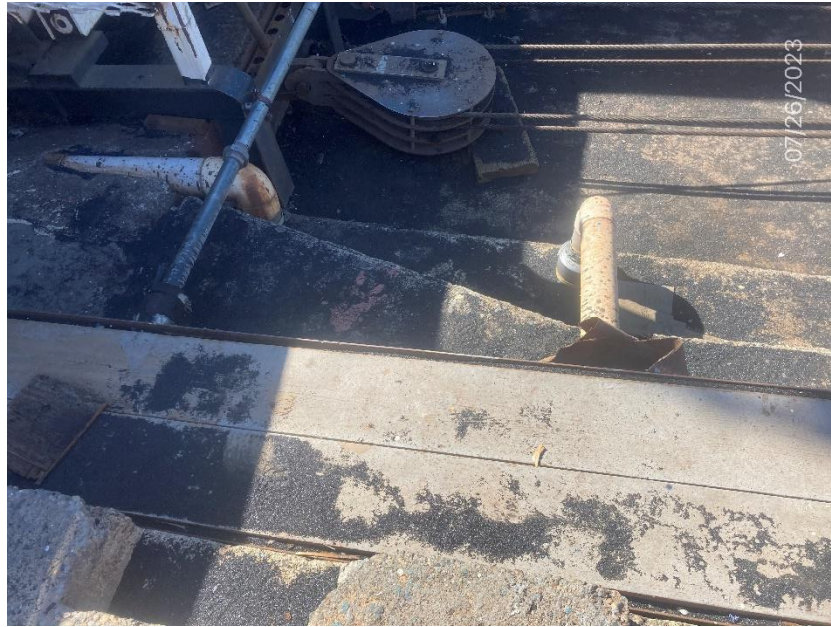
Photo 14

Description: Unidentified pipe inside the marine railway. There are spent grits on the railway.

4. Facility needs to identify pipes (photo 14) that goes into the marine railway and under the concrete along the paint shed side of the property.
5. Facility needs to contact the building owner and find out the pipe outlets from the marine railway (photo 14), which Gregory said it's connected to the parking lot of the office building.
