STORMWATER COMPLIANCE INSPECTION REPORT			WADOE Stormwater										
		State of Washington Department of Ecology P.O. Box 330316, Shoreline, WA 98133-9716			Phone: (206) 594-0000										
Section A: General Data															
Inspection Date 9/8/2023	CNE # CNE126912	County Snohomish	Receiving Waters Unknown ditch	Inspector Cody Ennis	Facility Type Industrial										
Discharges to: Surface Water <input checked="" type="checkbox"/> Ground Water <input type="checkbox"/>				Unannounced Inspection											
Section B: Facility Data															
Name and Location of Site Inspected				Entry Time	Permit Effective Date										
Ocean Beauty Seafoods 14651 172 nd Dr SE Monroe, WA 98272				10:45am	N/A										
				Exit Time	Permit Expiration Date										
				11:30am	N/A										
On-Site Representative(s): Name(s)/Title(s)/Contact number(s) or E-mail				Additional Participants:											
Zach Kunz Zach.kunz@oceanbeauty.com				Rose Propst (ECY)											
Mailing Address of Responsible Official(s):				Weather: Sunny											
14651 172 nd Dr SE, Monroe WA 98272

**Photo Addendum – Ocean Beauty Seafoods
all photos taken on 8/16/2023**

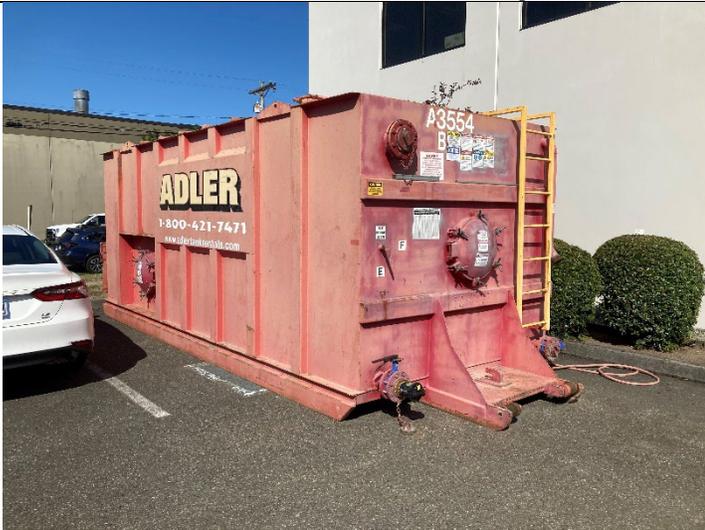
Photo 001
Direction: West
Description: A wastewater treatment tank located on the south side of the building.
Photo by Rose Propst

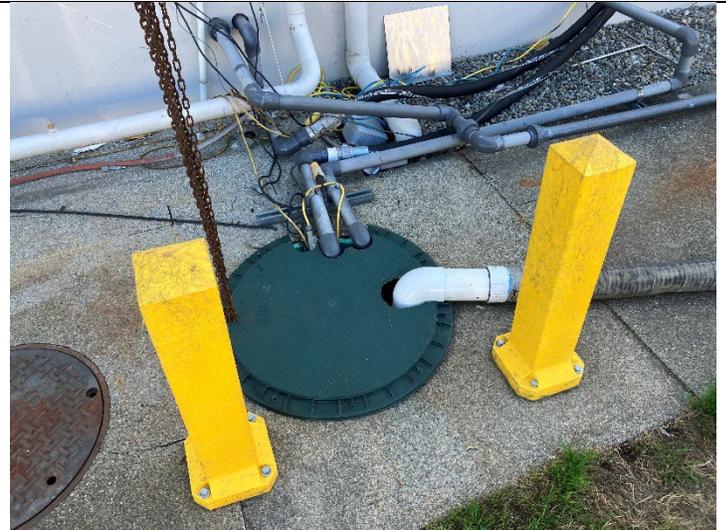
Photo 002
Direction: East
Description: The wastewater treatment tank is piped into the sewer inlet.
Photo by Cody Ennis

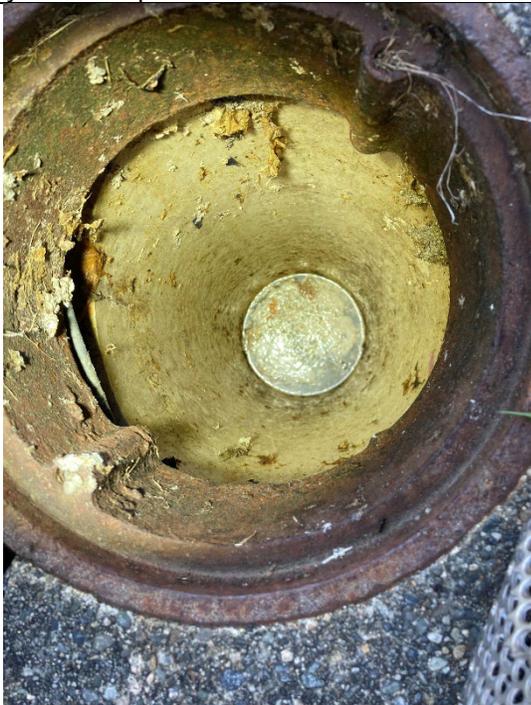
Photo 003
Direction: N/A
Description: An open-top pipe near the sewer inlet. Liquid with an unknown substance is on the surface.
Photo by Rose Propst

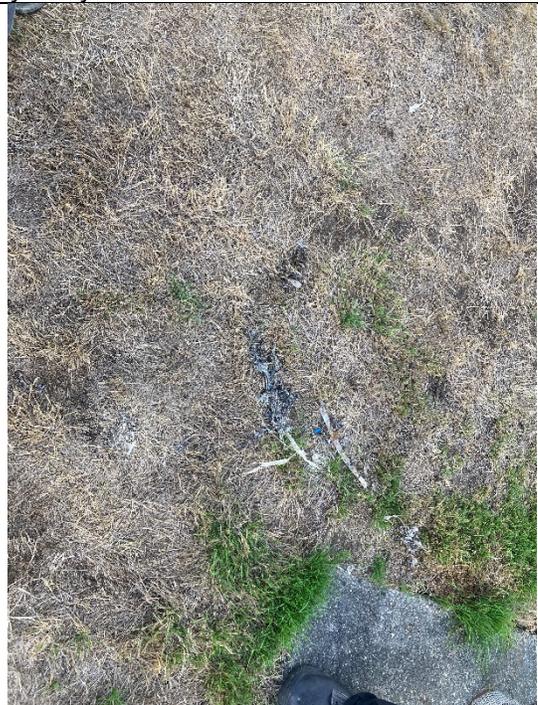
Photo 004
Direction: N/A
Description: Some debris left over from cleaning operations of the sewer inlet.
Photo by Rose Propst

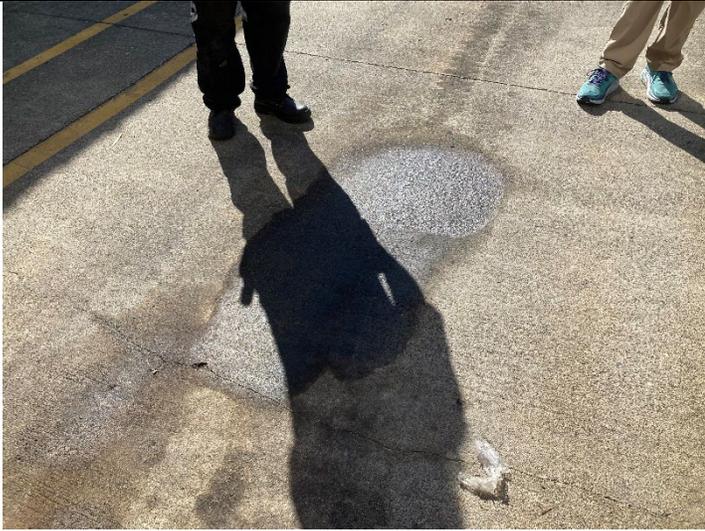
Photo 005
Direction: South
Description: A large oily stain on the loading dock pavement.
Photo by Rose Propst

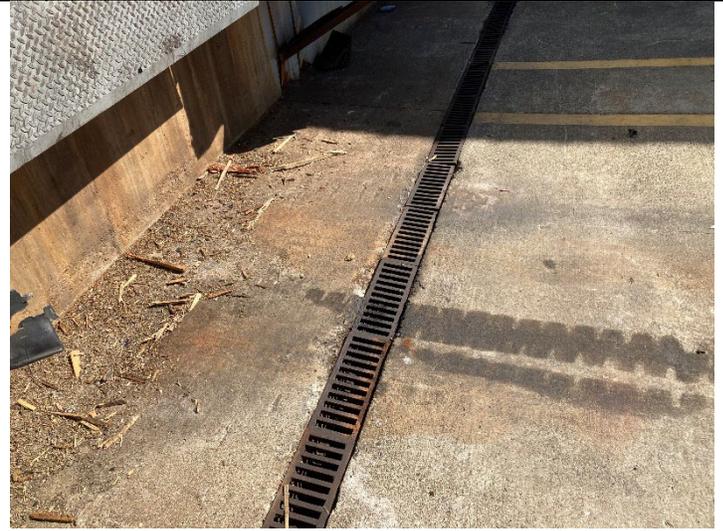
Photo 006
Direction: East
Description: A trench drain at the lowest point in the loading dock. Flows from west to east.
Photo by Rose Propst

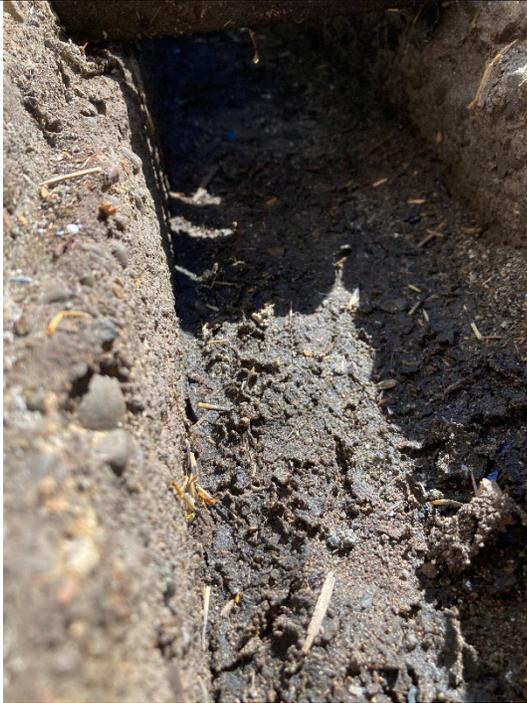
Photo 007
Direction: East
Description: A closeup of material buildup in the trench drain.
Photo by Rose Propst

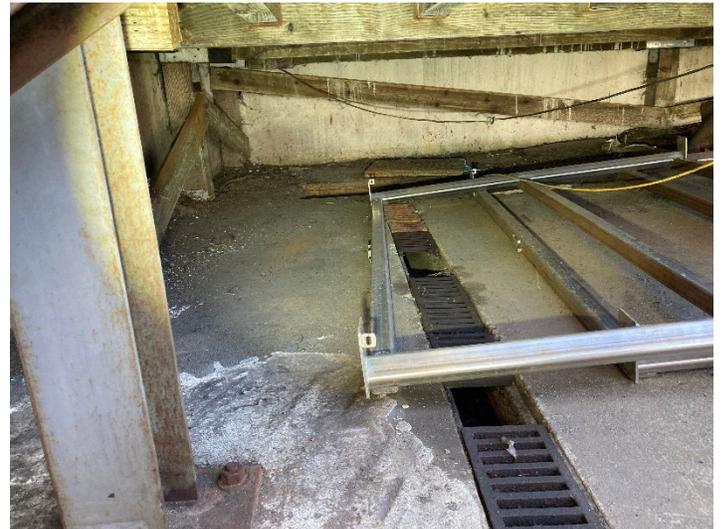
Photo 008
Direction: East
Description: A sump on the east most side of the trench drain. Sump is stated to be pumped into the catch basin further south in the parking lot.
Photo by Rose Propst

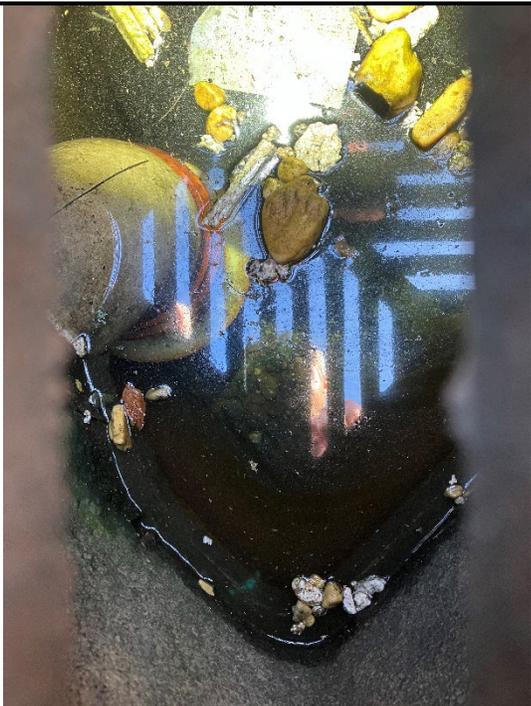
Photo 009
Direction: N/A
Description: Inside the catch basin that the sump is pumped into. Debris and floating material can be seen.
Photo by Cody Ennis

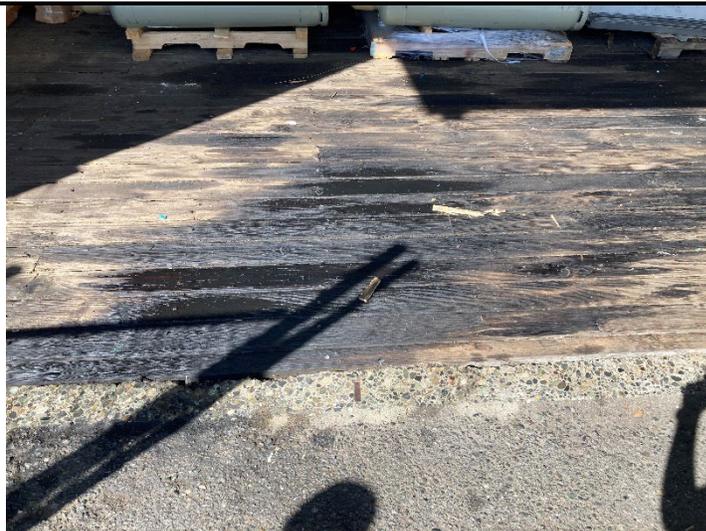
Photo 010
Direction: West
Description: Oily stains on the wooden floor of the storage container. Container is located above the loading dock sump.
Photo by Rose Propst

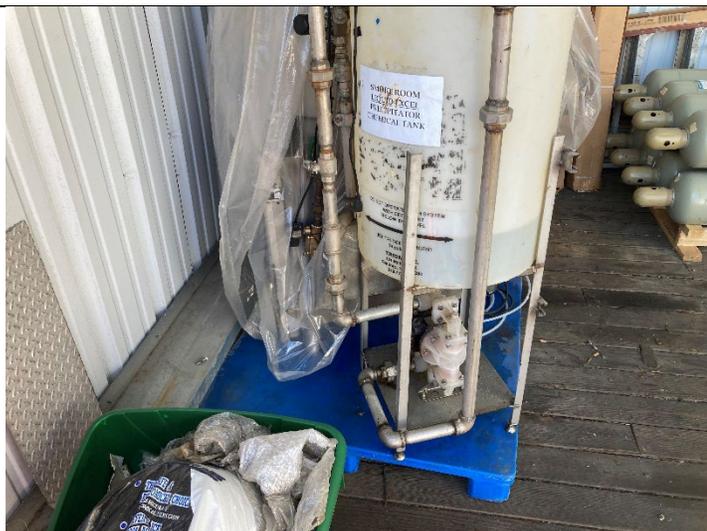
Photo 011
Direction: West
Description: A polymer tank, filled with liquid chemical, stored in the storage container.
Photo by Rose Propst

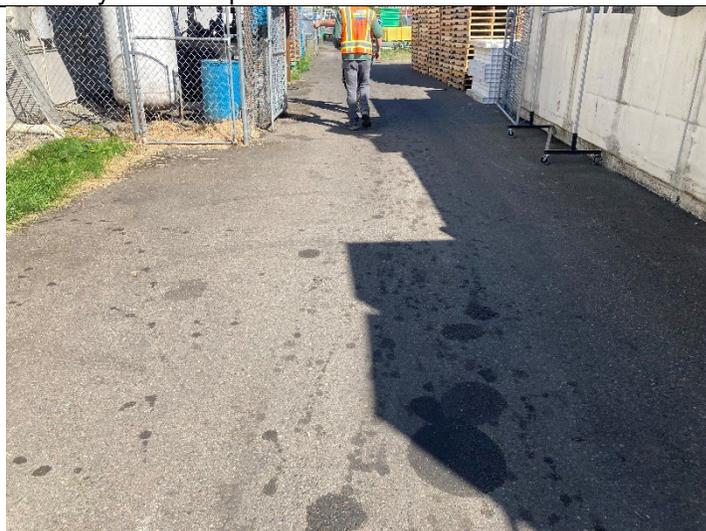
Photo 012
Direction: North
Description: Oily stains present on the pavement, east of the building.
Photo by Rose Propst

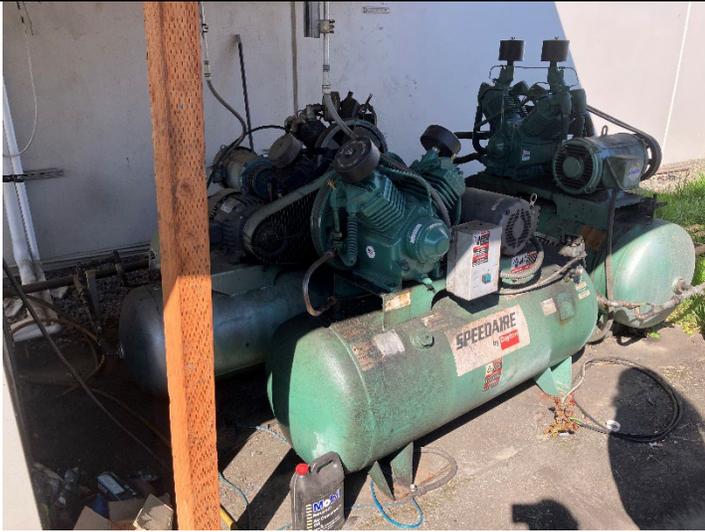
Photo 013
Direction: West
Description: Three air compressors on a concrete pad and covered by a permanent structure.
Photo by Cody Ennis

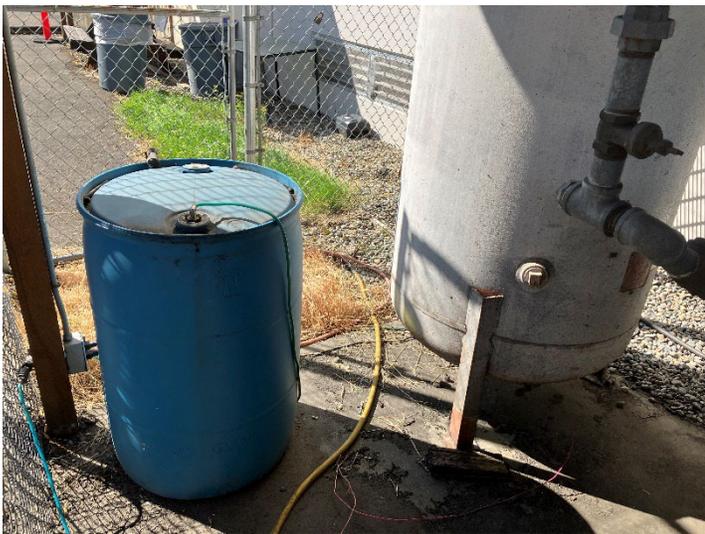
received a new compressor unit. In this covered area, a blue drum, with unknown contents, stood next to a tank, not in secondary containment [photo 015].

Photo 015
Direction: Southwest
Description: Blue drum containing an unknown liquid. The blue hose leads into the air compressors.
Photo by Cody Ennis

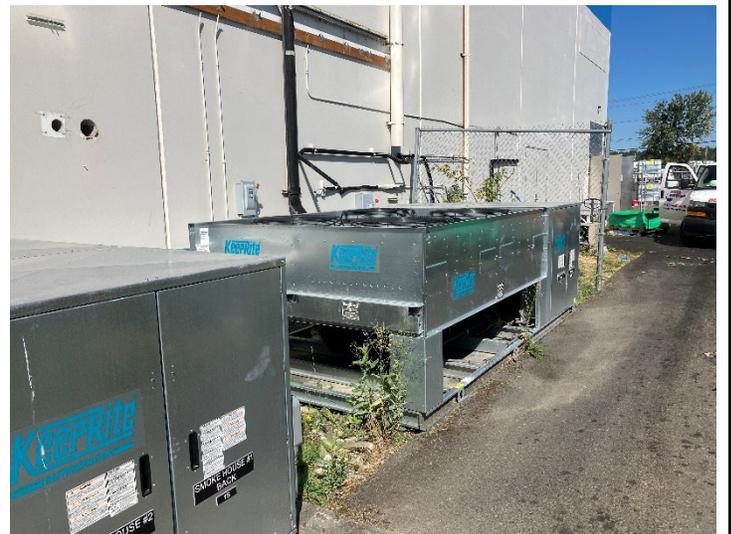
Two condenser units stood along the northeastern side of the building, north of the compressors [photo 016]. We observed several stacks of wooden pallets staged directly east of the condensers [photo 017] Fish off-cuts laid on the ground on the drive up the east side of the building [photo 018]. Zach stated that to maintain food safe conditions, the third-party that purchases the off-cuts must handle and load them outside of the building. In this same area, a plumber truck was parked and in the process of cleaning the floor drains inside the building and scrap metals lay on pallets [photo 019]. Zach explained that the water from the drain cleaning was going to their wastewater stream.

Photo 016
Direction: Northwest
Description: Two condensing units for internal refrigeration systems on the east side of the building.
Photo by Cody Ennis

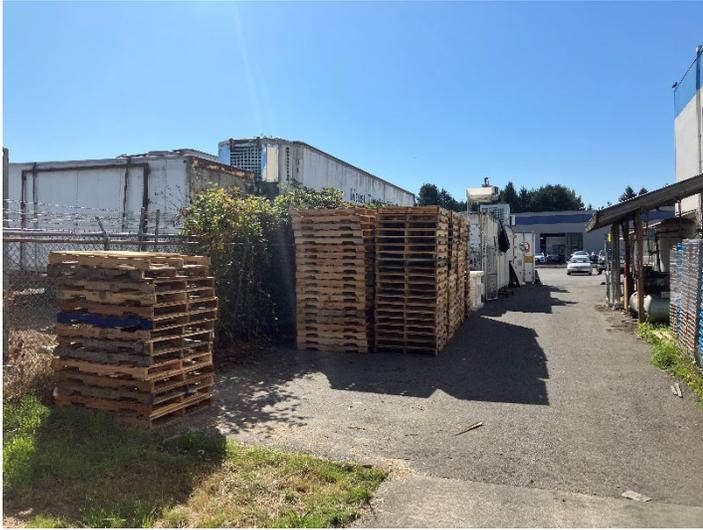
Photo 017
 Direction: South
 Description: Stacks of pallets present by the condensers and compressors.
 Photo by Cody Ennis

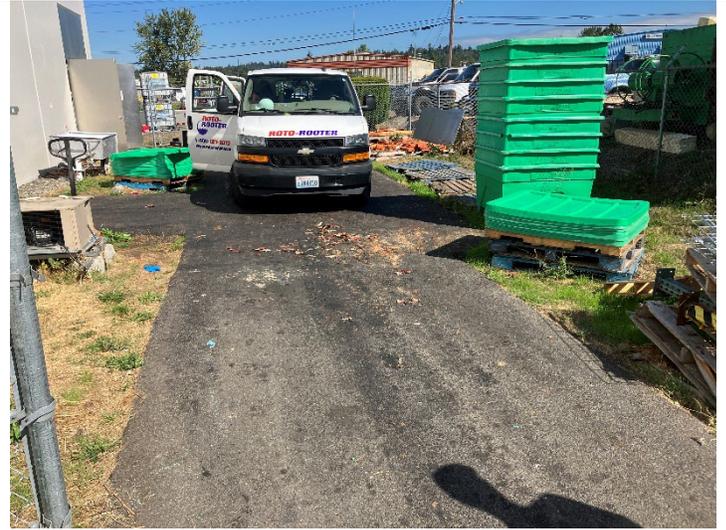
Photo 018
 Direction: North
 Description: Fish off cuts laying on the ground. Green totes used to carry the offcuts are present.
 Photo by Cody Ennis

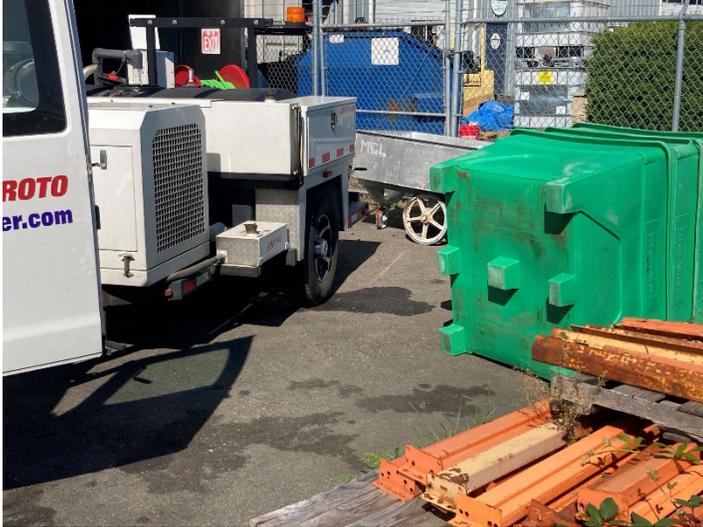
Photo 019
 Direction: Northwest
 Description: A stack of scrap metal is present along with more green totes. A plumber is performing maintenance to the building's internal floor drain system.
 Photo by Rose Propst

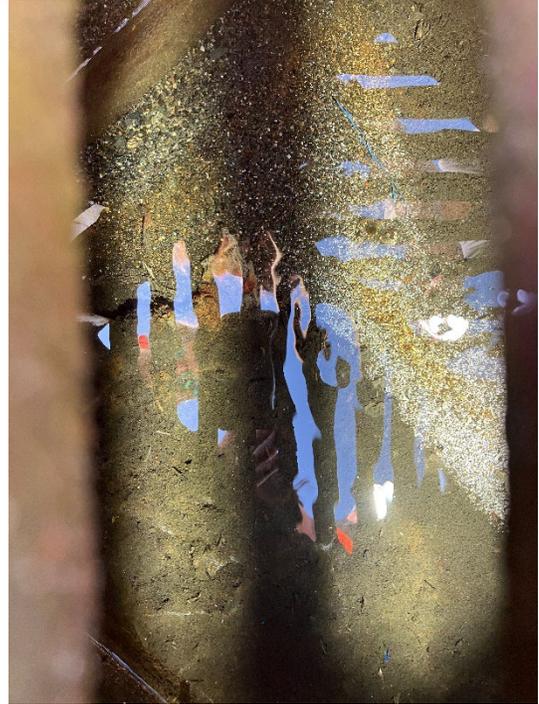
We then moved back to the parking lot, to the catch basin located near the southeast corner of the property. This catch basin had active flow, despite the lack of rain. Zach stated that they use sprinklers on the roof to keep the refrigeration units' condensers cool. This water then flows through the roof's downspouts and into the storm drains [photo 020]. This storm drain flows into the first observed storm drain noted in Photo 009.

1. Discharges of pollutants to water: Water used to cool the condensers on the roof is considered process water. Discharge of process water to stormwater is considered an illicit discharge.

Photo 020
 Direction: N/A
 Description: The inside of the catch basin on the south east side of the parking lot. The ripples in the reflection are caused by water flowing from the roof condenser sprinkler system.
 Photo by Cody Ennis

- b. Chapter 90.48.080 Revised Code of Washington (RCW) prohibits the discharge of polluting matter into waters of the state.
 - c. Required corrective action: Ocean Beauty Seafoods must stop discharging process water into stormwater.
