# STORMWATER COMPLIANCE INSPECTION REPORT

WADOE Stormwater  
Compliance Inspection Form

<b>Name and Location of Construction Site Inspected</b> Cathcart Crossing 14806 Highway 9 SE Snohomish WA 98290		<b>Entry Time</b> 11:00 AM	<b>Exit Time</b> 12:30 PM
<b>Site Contact</b> Steve Garka Land Development Project Manager D.R. Horton   Pacific Ridge Series 17921 Bothell-Everett Hwy., Suite 100, Bothell, WA 98012 o: 425 438-8444 m: 425-393-4349 <a href="mailto:SJGarka@pacificridgehomes.com">SJGarka@pacificridgehomes.com</a>		<b>Additional Participants:</b> Jeff T <a href="mailto:jefft@tayexinc.com">jefft@tayexinc.com</a>	
<b>Responsible Official(s):</b> Tom Allen Division VP of Construction D.R. Horton   Pacific Ridge Series 17921 Bothell-Everett Hwy., Suite 100, Bothell, WA 98012 m: 425 219-2658 <a href="mailto:tallen1@pacificridgehomes.com">tallen1@pacificridgehomes.com</a> Phone: (425) 438-8444		<div>Yes No</div> <div>Samples Taken? <input type="checkbox"/> <input checked="" type="checkbox"/></div> <div>Photos Taken? <input checked="" type="checkbox"/> <input type="checkbox"/></div>

Water Quality Name: Cathcart Crossing

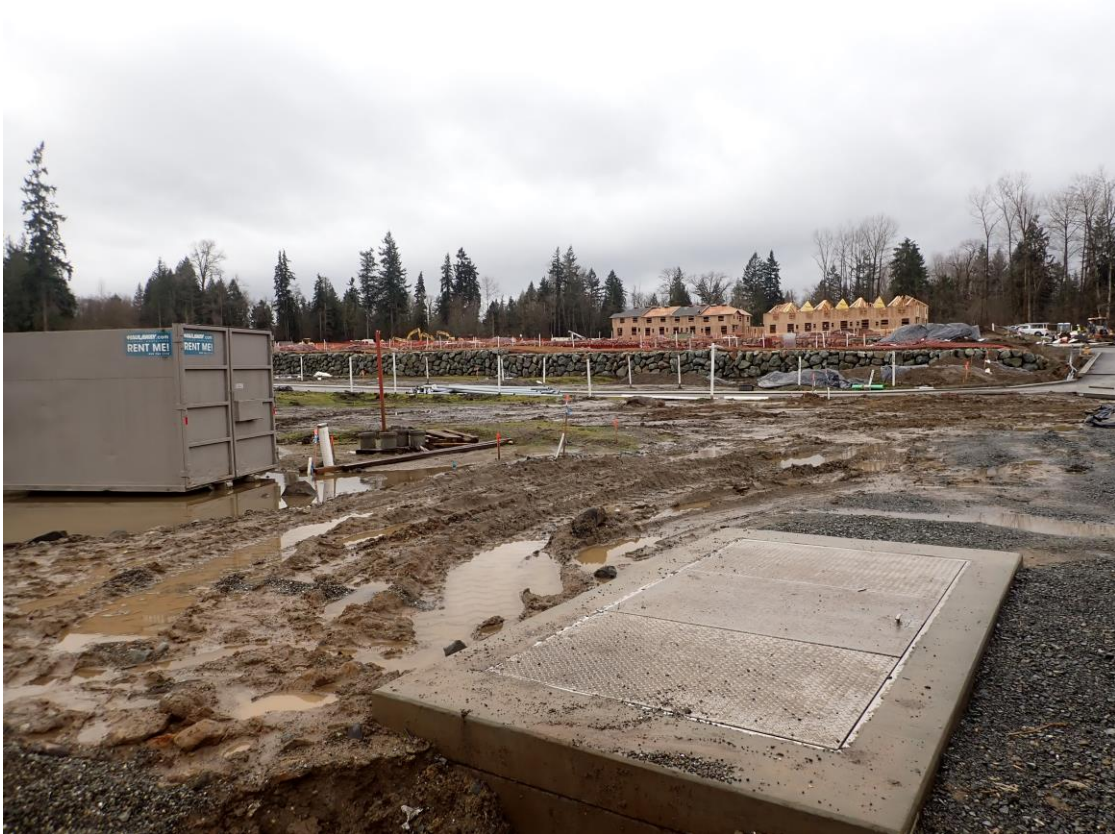
Figure 1 Description: Lower portion of the job site. Facing West. The vertical work started in the west side. I am standing on top of one of the stormwater vaults.

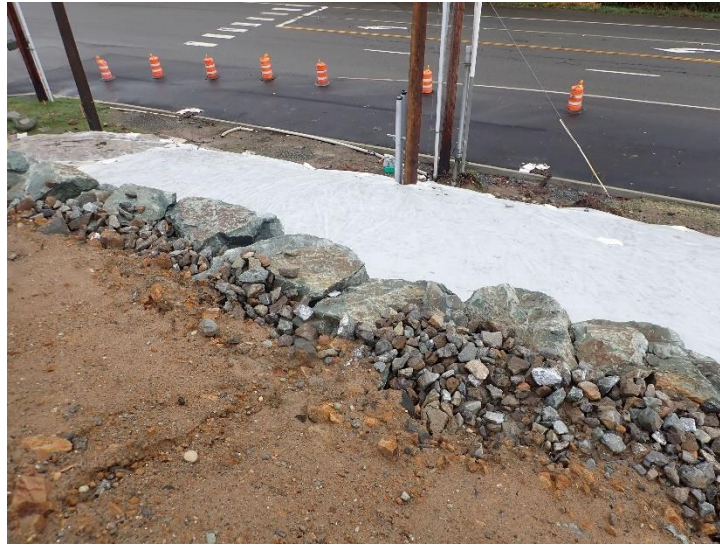
I observed areas of exposed soils, including the roads. During a rain event this sediment would be picked up by the stormwater stream and conveyed to the vault. This sediment would increase the turbidity of a potential discharge from the vault during heavy rain events. The event on December 6<sup>th</sup>, 2023 highlights the need to maintain appropriate source control.

Figure 5 Description: Exposed soils

**Action:** Update and implement the SWPPP in accordance with permit requirements.

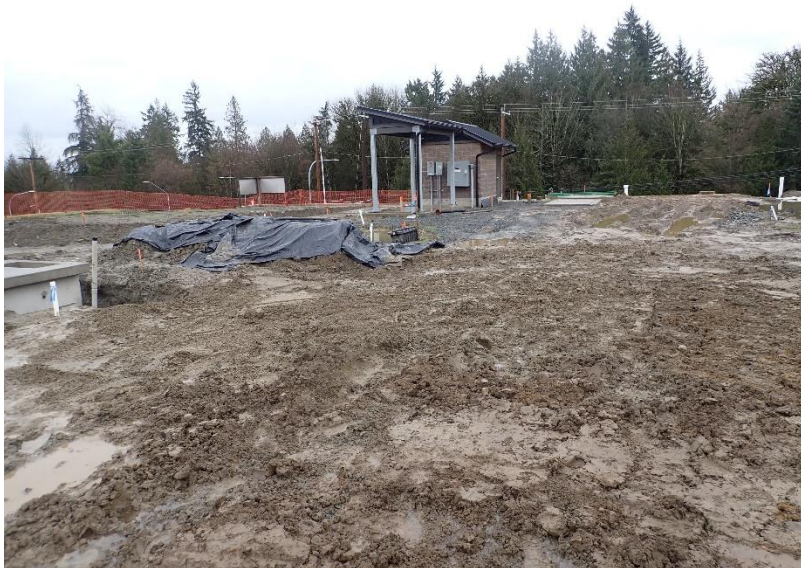
Figure 6 Description: Exposed soils

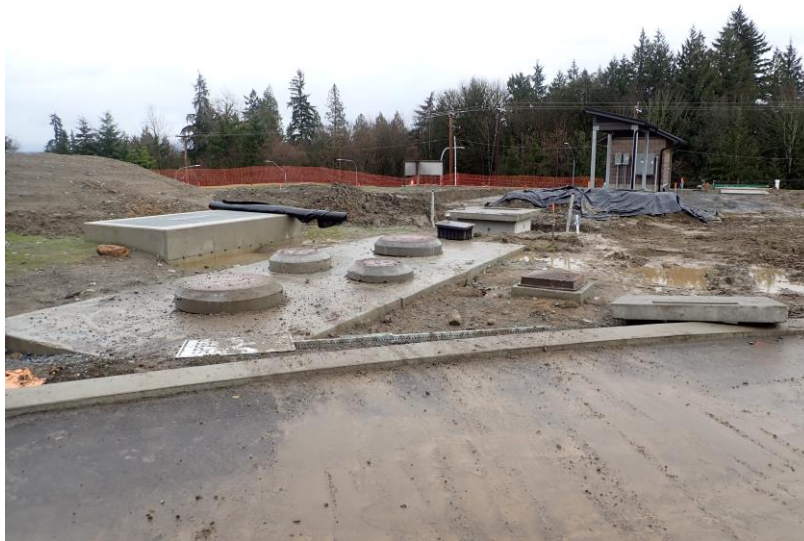
Extensive areas of track-out on the street. Some areas will transport sediment to the vaults. In the access areas, the sediment may leave the job site. See photo log.

Figure: 8 Description: sidewalks in place. Soil on the road. BMPs covering the slopes on left side of the frame.

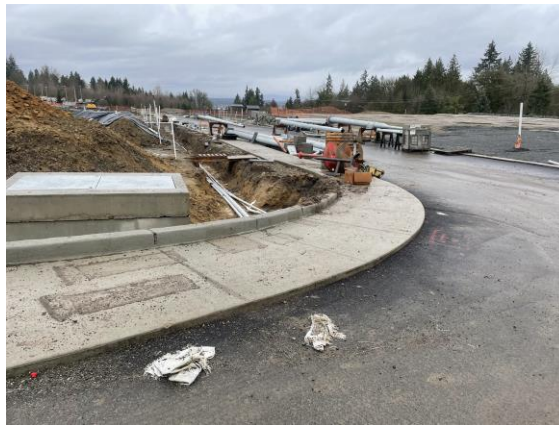
Figure: 10 Description: road with track out

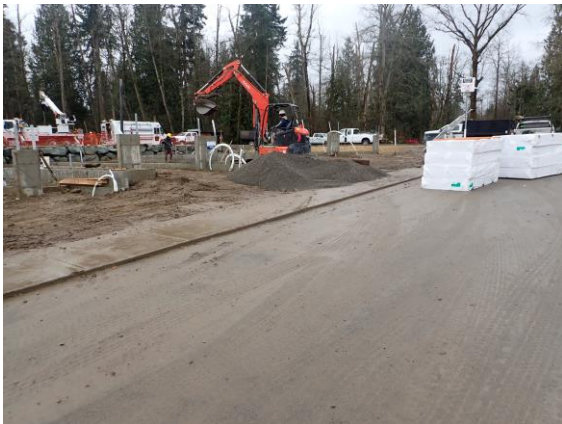
Figure: 14 Description: road with visible track out

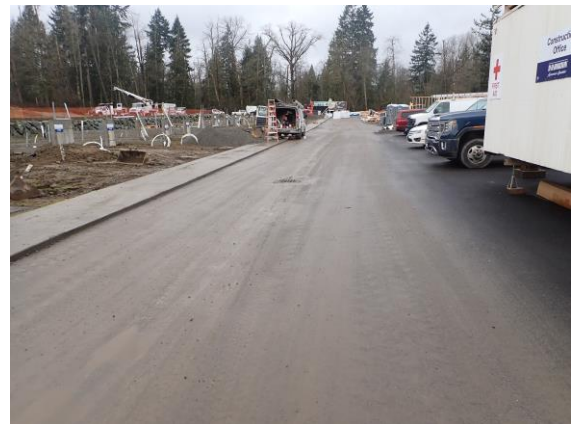
Figure: 15 Description: BMPs covering soils. Track out on road

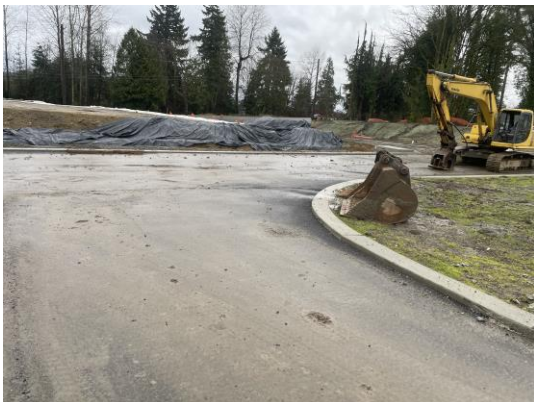
Figure: 16 Description: road with track out
