# Permit Compliance Inspection Report

Facility Name & Address: Monson Bulk Crush Facility  
63615 E Jacobs Rd, Benton City, WA 99320

Permit Type: State Waste Discharge IP Only Permit Number: ST0009266

Date of Inspection: 4/10/2024

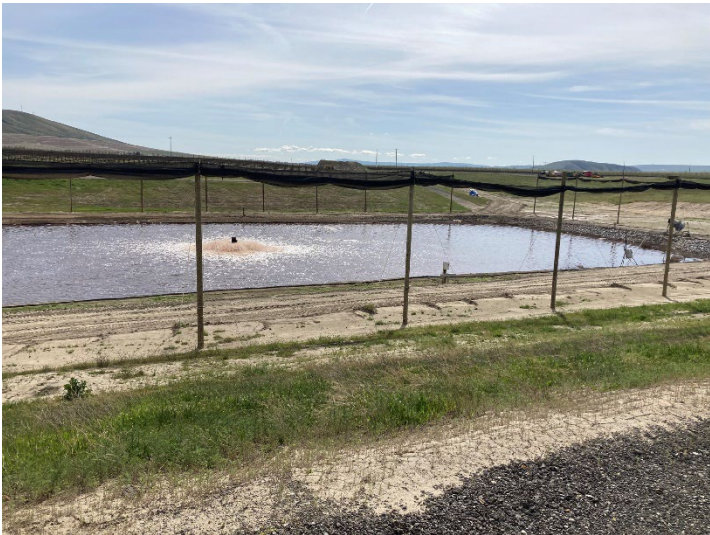
First, we walked down to the lagoons. The nets are rolled up because they were ripped from the wind and needed to be fixed. The aerators were operating in both the North and South lagoons. Christian explained the South lagoon was the original lagoon on site and it is 6 feet and the North lagoon is 11.5 feet in depth. The facility has a Shark brand evaporator that blows a mist of process wastewater into the air back over the lagoon to increase evaporation, which is only used when the wind blows North. In the past, the facility has had issues with winery wastewater being blown onto their vineyard if the wind changes directions. The wastewater first goes into the South lagoon and cascades into the North lagoon. Christian said in June Nalco Water Service will take a reading for deposits and sediment. I asked Matt if there were requirements for the removal of solids from the lagoon in the permit. Matt said they would list those requirements in their Operations and Maintenance (O&M) manual. Christian said Nalco also does monitoring for sodium annually.

**Photo 1 [IMG\_0372]**  
**Description: *South Lagoon***

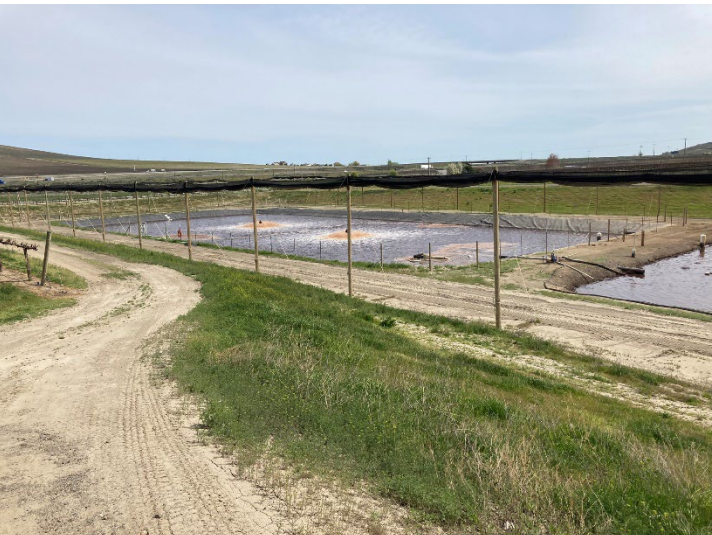
**Photo 2 [IMG\_0373]**  
**Description: *North Lagoon***

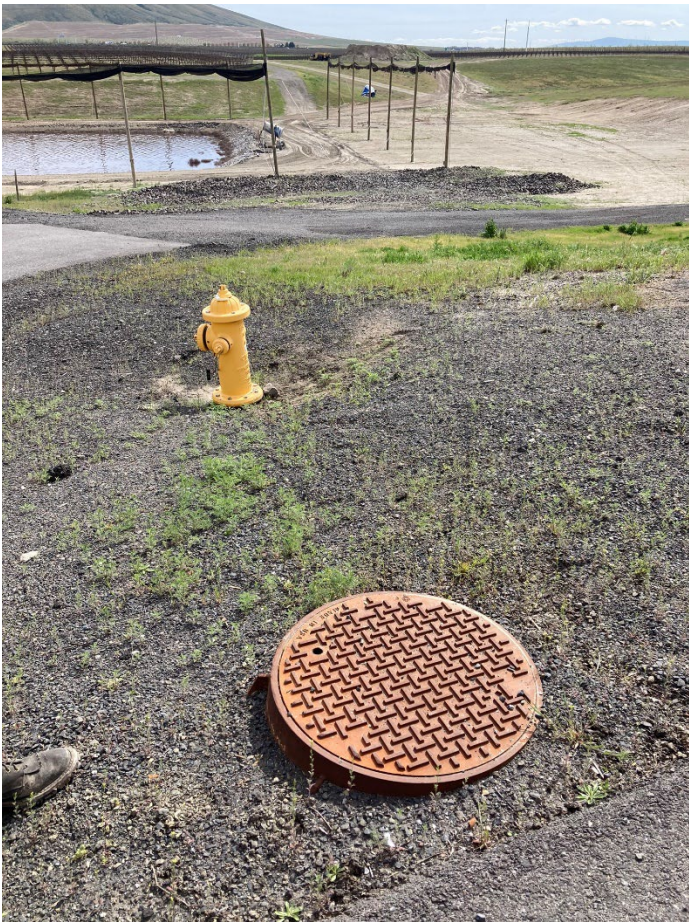
We walked by the culvert that goes to a stormwater basin and Christian showed us where the valve is for the wastewater going to the lagoons. The stormwater basin is located south of their building. We discussed the options they are considering to improve the management of their wastewater which include, engineering a larger double-lined lagoon, water reuse with treatment for irrigation, or creating an evaporative basin made of concrete. There are two engineering firms currently working on those plans, Nalco and JUB engineering. Matt told Christian we could schedule a meeting with the facility and the engineering firms if they have questions or discuss plans further.

**Photo 3 [IMG\_0374]**  
**Description: *Valve for lagoons and culvert below constructed for stormwater management***

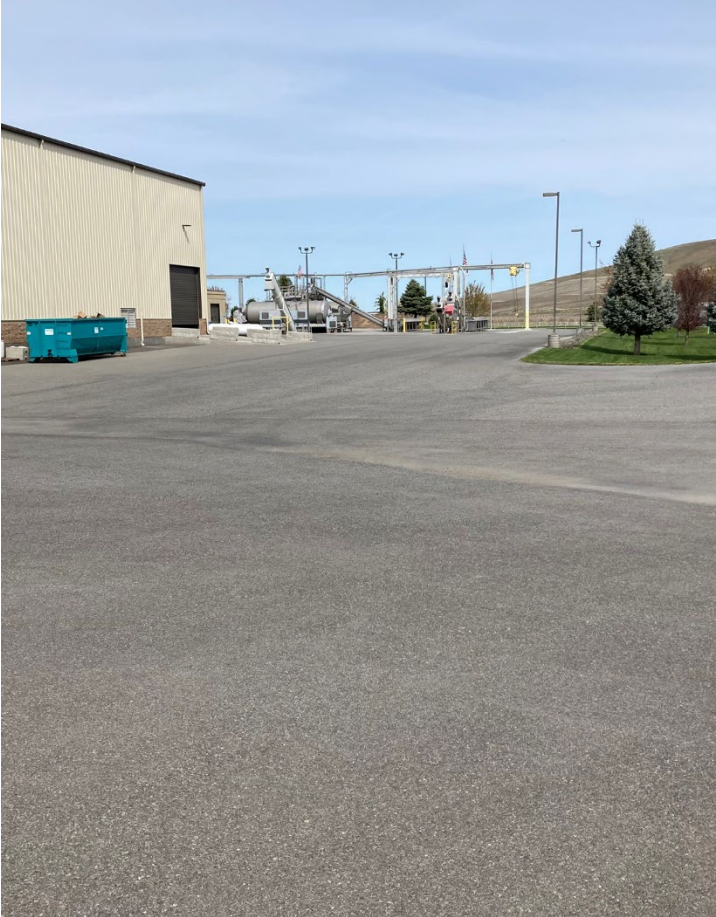
**Photo 4 [IMG\_0375]**  
**Description: *Crush pad***

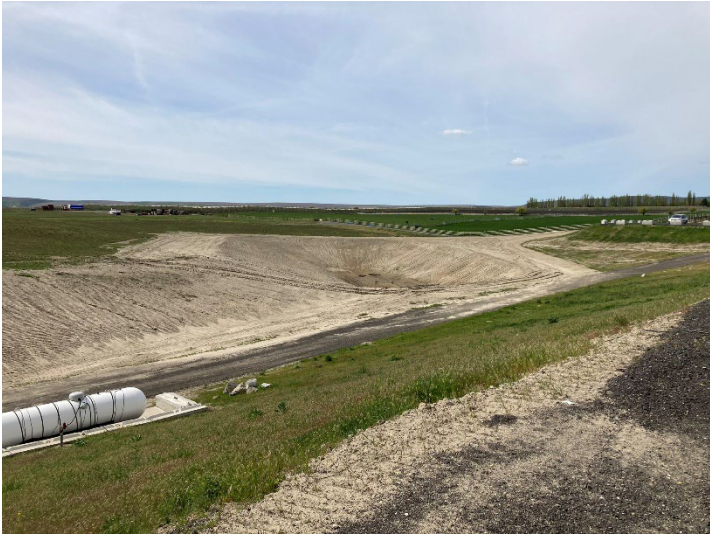
**Photo 5 [IMG\_0376]**  
**Description:** *Stormwater basin*

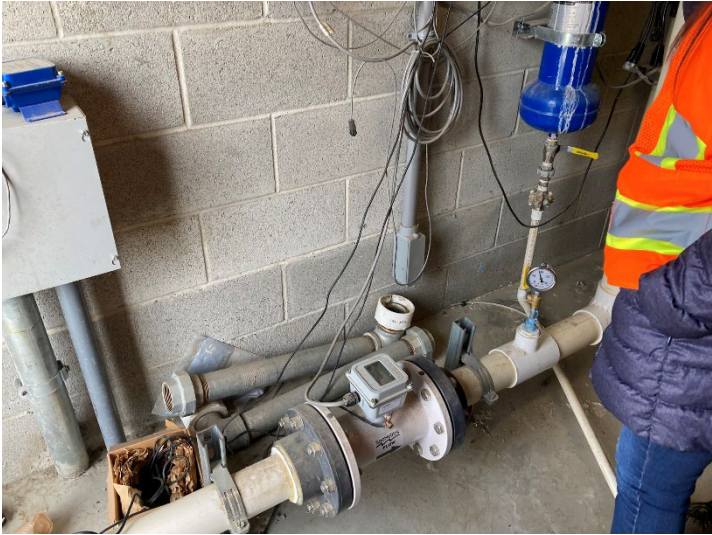
Christian took us to the pump house to see the new flow meter. Christian said they will need another well because they need more water pressure. Regarding the wells, Matt said he anticipates that groundwater monitoring wells would not need to be installed with writing the new permit.

**Photo 6 [IMG\_0377]**  
**Description:** *Pump house with new flow meter*

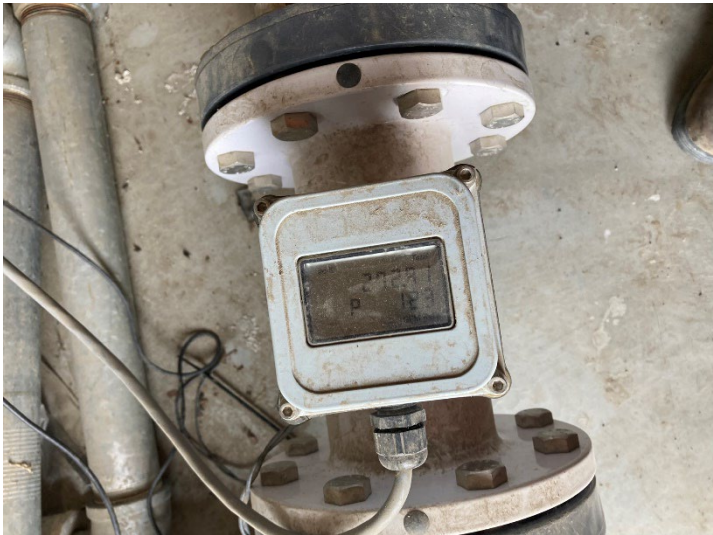
We discussed that the facility installed a new flow meter in their well pump house and Christian told me on a phone call several weeks ago that they would be installing a flow meter on the influent to their lagoon. The facility has had several flow effluent violations on its Discharge Monitoring Reports (DMRs) through the years. The new flow meter should help to reduce these violations. Since last year, many DMRs have been submitted late because of issues with their flow meter. I told Christian the importance of submitting DMRs on time, even if not all data is available. Comments should be provided explaining missing information and communicating those issues to me when DMRs are submitted. Permittees can go back into DMRs and update missing information and any violations associated with missing information will be removed.

**Photo 7 [IMG\_0378]**  
**Description:** *Flow meter*

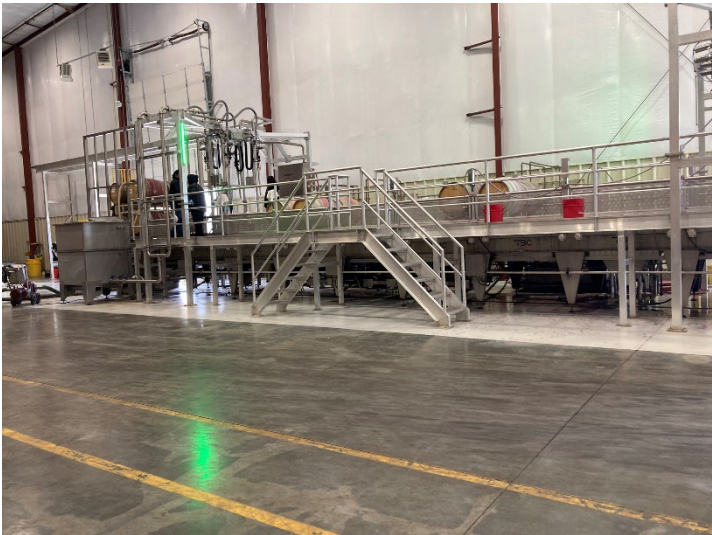
To finish the tour, Christian showed us the new barrel-washing system. The system goes through three washing stations, the second washes are recycled. This system uses  $\frac{1}{4}$  the water used in general barrel washing systems. The lees recovered from the washing system are taken up and used at their distillery to make brandy. Christian also mentioned they are getting a new tank washing system that will use  $\frac{1}{2}$  water than with previous washing methods.

**Photo 8 [IMG\_0379]**  
**Description:** *Barrel washing system*
