Permit Compliance Inspection Report

Water Quality Program

Facility Name & Address: Seattle Yachts Service (North Yard)
2417 T Ave
Anacortes, WA 98221

Date(s) of Inspection: 4/18/2024

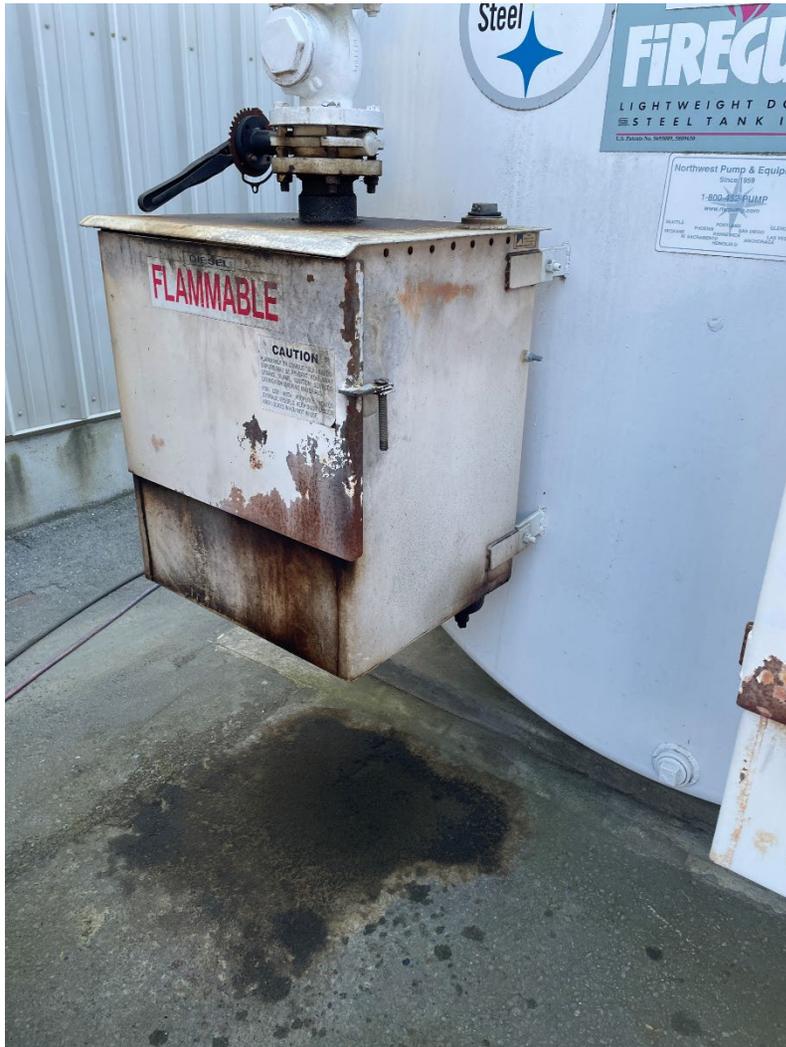
Photo 1 [IMG_0275]

D. Habenicht escorted me through the site. I observed two above ground storage tanks, one for diesel and one for gasoline, located at the west side of the building. The tanks are surrounded by a locked fence, which D. Habenicht unlocked for us to go inside. I observed dark stains under a valve for one of the tanks, indicating past spills or leaks (Photo 1). This area lacked a spill kit; D. Habenicht said he would place one there. We also discussed keeping a drip pan in this area for use during fuel transfers to catch spills or leaks.

Description: Dark stains on the concrete below a valve on the fuel tank at the west side of the site, indicating past leaks or spills.

Locate spill kits within 25 feet of the diesel and gasoline tanks, as well as all stationary fueling stations, fuel transfer stations, mobile fueling units, and used oil storage/transfer stations. See Condition S8.B.3.f.ii.3 for minimum contents of spill kits for these areas.

Use drip pans or equivalent containment measures during all petroleum transfer operations.

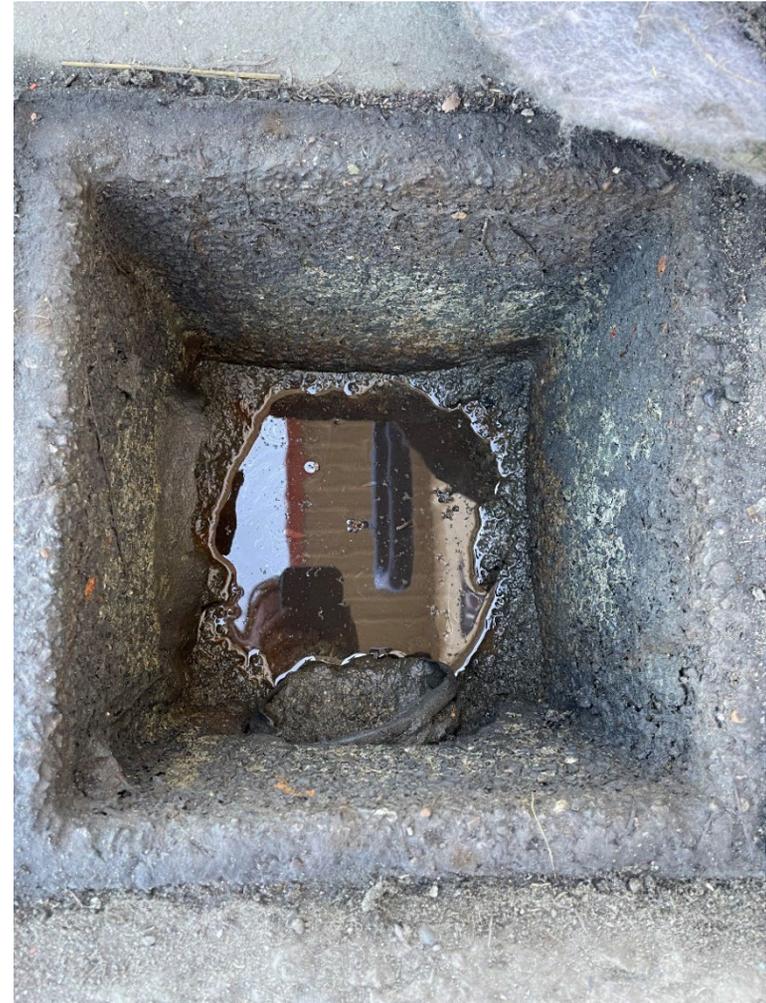
Photo 2 [IMG_0276]

We looked in five of six catch basins on site. All were clean and free of sediment, except a small one at the northwest corner of the building. This small catch basin did not have a sump below the outlet and sediment was accumulated at the bottom and into the outlet (Photo 2). We did not look at a second small catch basin at the center of the north side of the building because of water ponded all around it. D. Habenicht said he thinks the outlet pipe is collapsed and blocking drainage. He is working to address this. This catch basin was missing from the site map.

Description: View inside the small catch basin at the northwest corner of the building. Sediment was accumulated at the bottom of the basin and into the outlet.

- Repair the damage to the conveyance system along the north side of the building which led to the ponded water in that area.
- Clean out sediment from the two small catch basins on the north side of the building.

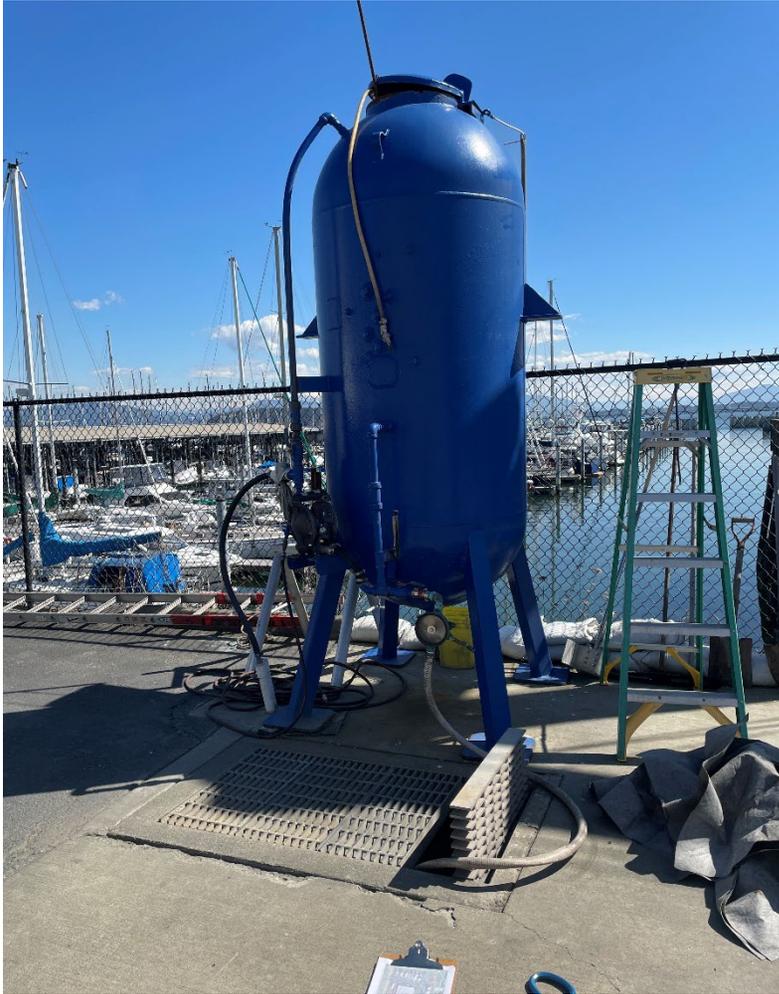
Photo 3 [IMG_0282]

Greg Moses, SYS staff, met us at the wash pad and described the wastewater treatment system as follows: The wash pad drains into a trench drain on the pad, which drains north to a single-chamber vault. G. Moses said the vault can hold the volume of wastewater from approximately one boat wash. After each wash, a pump in the vault is turned on to pump wastewater into the above-ground flocculation tank (Photos 3-4). The flocculation tank will become near full after a few washes, at which point G. Moses adds flocculant to the tank from a port at the top of the tank. He turns on air circulation to mix the flocculant for approximately 8 hours or overnight. Then he turns off the air and lets the flocculated material settle to the bottom of the tank for 24 hours or more. After that time, a valve is opened to discharge treated water from near the middle of the tank to an underground connection to a sewer line and manhole just northwest of the tank. The settled solids are emptied from the bottom of the tank into a perforated plastic bin lined with thick filter fabric. This plastic bin is placed back on the wash pad to drain remaining water, which flows back into the treatment system. The solids are disposed of with Safety Kleen. G. Moses said he collects the wastewater sample from the top of the flocculation tank; however, that does not represent the water discharging from the treatment tank. The sample must be collected where it discharges from their system.

Description: Flocculation tank for treating pressure wash wastewater, located at the east side of the site. Wastewater from the wash pad (out of the photo to the right) flows to the vault in the foreground and then is pumped into the flocculation tank. Photo faces east.

- 1) Update the sampling location for pressure wash wastewater. SYS currently collects the wastewater sample from the top of the flocculation tank; however, this may not represent the water quality of the water leaving the tank from the outlet. SYS must designate a location to collect a representative sample. Starting in June 2024, begin sampling wastewater from a more representative location, such as the sanitary sewer manhole located northwest of the wastewater treatment system, or a sample port installed between that manhole and the flocculation tank outlet. Update your SWPPP and site map accordingly.
- 2) Vacuum out the sewer manhole to identify and map the related connections.
- 3) The facility must have a method to plug the vault outlet during pressure washing activities. Install a valve or other system that allows staff to easily switch between a closed and open vault.

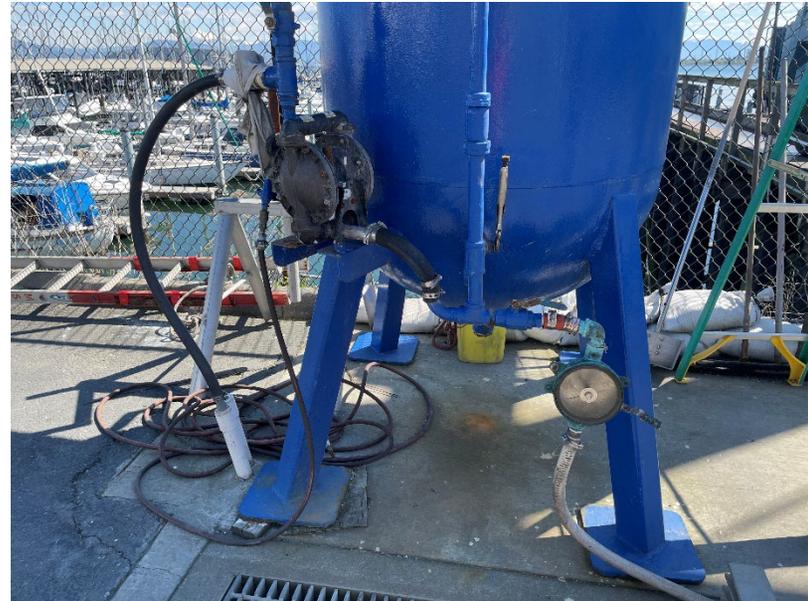
Photo 4 [IMG_0283]

Description: Closer view of the wastewater treatment system. The pipe on the right brings untreated water from the vault into the flocculation tank. The black pipe on the left brings treated water from the tank to an underground connection to the sewer line.

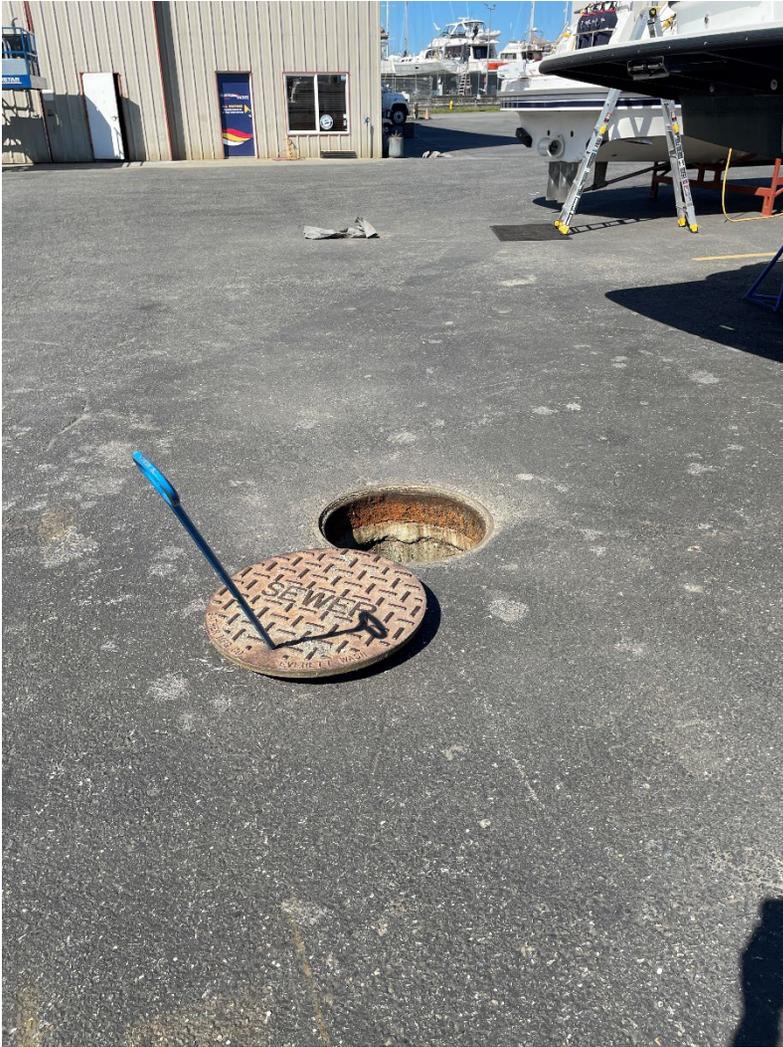
Photo 5 [IMG_0277]

We looked inside the sewer manhole northwest of the flocculation tank (Photos 5-6). The water inside had a floating layer of light brown material. I observed two inlets coming into the manhole from the southeast, likely one of which comes from the vault. We observed a T-baffle outlet to the northwest, which had a flexible plastic pipe going into it. The other end of the flexible pipe was under water in the manhole and we could not see where it connected; it did not connect to the two inlets from the southeast. This manhole should be vacuumed out to investigate all the connections to and from the manhole.

Description: Sewer manhole to which the treated wastewater from the flocculation tank flows. Manhole is northwest of the flocculation tank. Photo faces west.

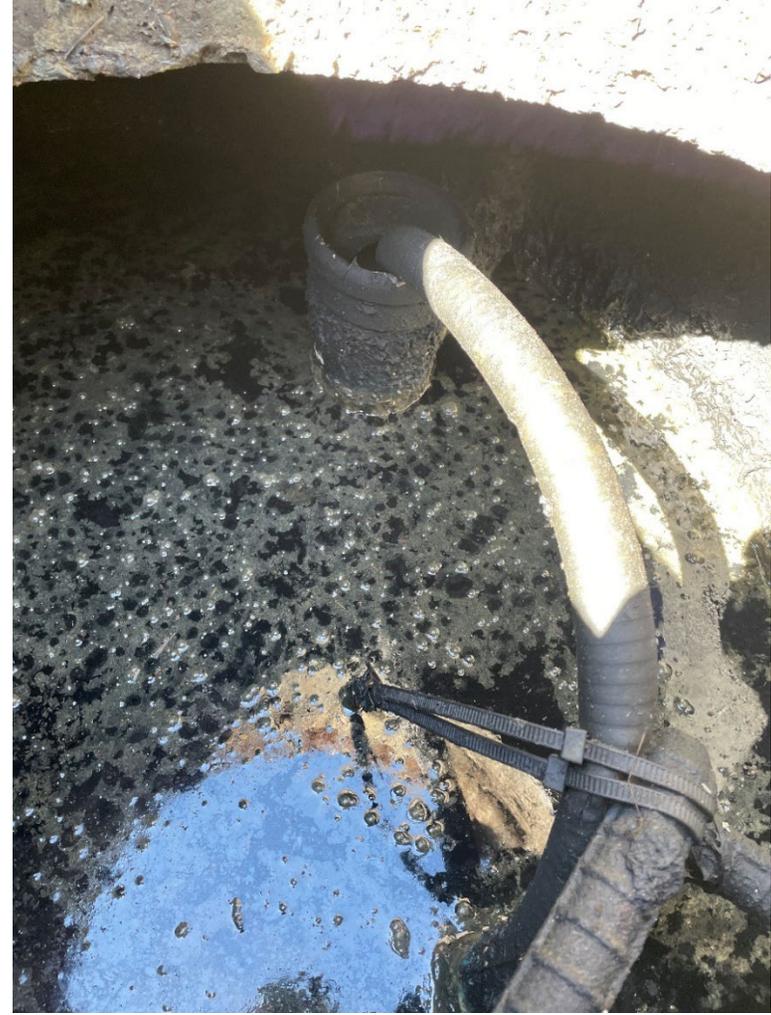
Photo 6 [IMG_0278]

Description: View inside sewer manhole shown in Photo 5. The water inside had a floating layer of light brown material. The underwater connection of the flexible piping was unknown.

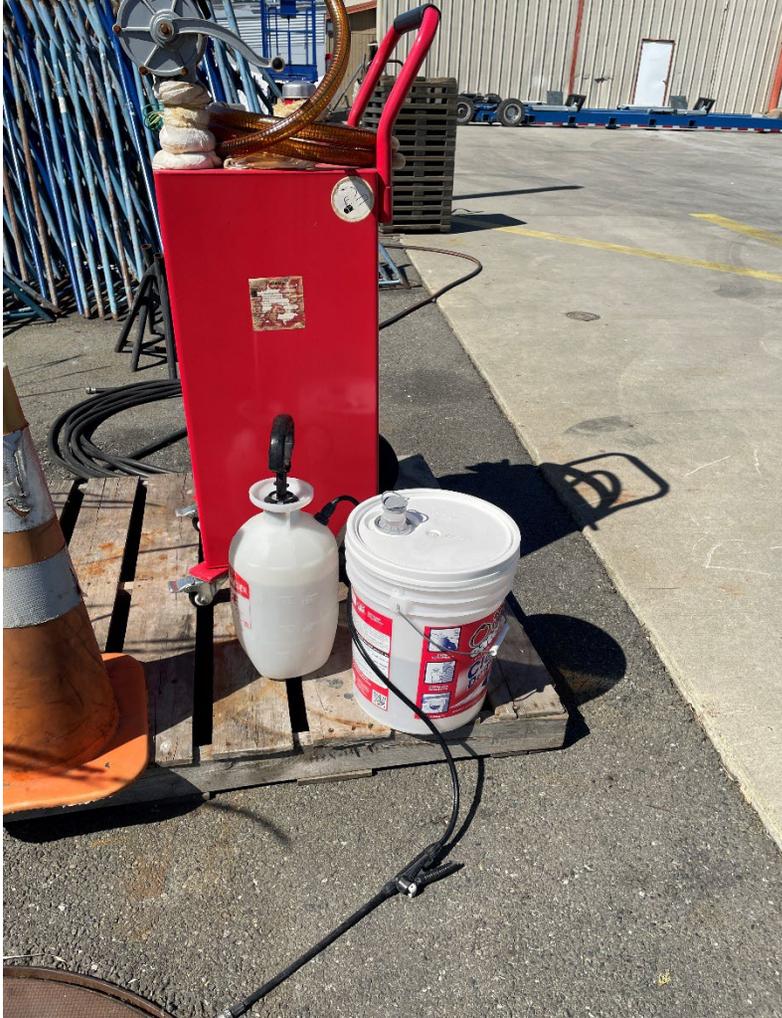
Photo 7 [IMG_0285]

- A 5-gallon bucket of degreaser and a spray applicator sitting outside without cover or secondary containment (Photo 7). Degreaser should not be sprayed on outdoor surfaces where the residue will runoff with stormwater. Use dry absorbents to clean up spills and leaks.
- Three fuel canisters outside without cover or secondary containment (Photo 8). Two of the three canisters were full.
- An enclosed materials storage shed, which held IBC totes of used oil and coolant, and drums and smaller containers of other chemicals (Photos 9-10). Most drums were placed over secondary containment pads, and some of the smaller containers were empty. The IBC totes did not have secondary containment.

Description: A 5-gallon bucket of degreaser and spray applicator sitting outside without cover or secondary containment at the south side of the site. Photo faces west.

Store all hazardous substances, petroleum/oil liquids, and other chemical solid or liquid materials that have potential to contaminate stormwater on an impervious surface that is surrounded with a containment berm or dike that is capable of containing 10% of the total enclosed container volume or 110% of the volume contained in the largest container, whichever is greater, or use double-walled tanks. Prevent precipitation from accumulating in containment areas by using a roof or equivalent structure or include a plan on how it will manage and dispose of accumulated water if a containment area cover is not practical.

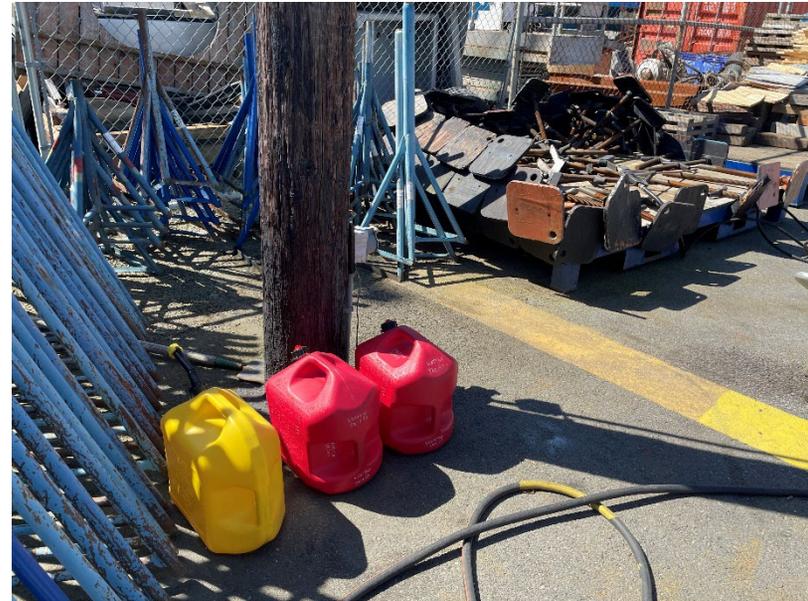
Photo 8 [IMG_0286]

Description: Three fuel canisters placed outside without cover or secondary containment, located at the south side of the site. Two of the three canisters were full. Photo faces south.

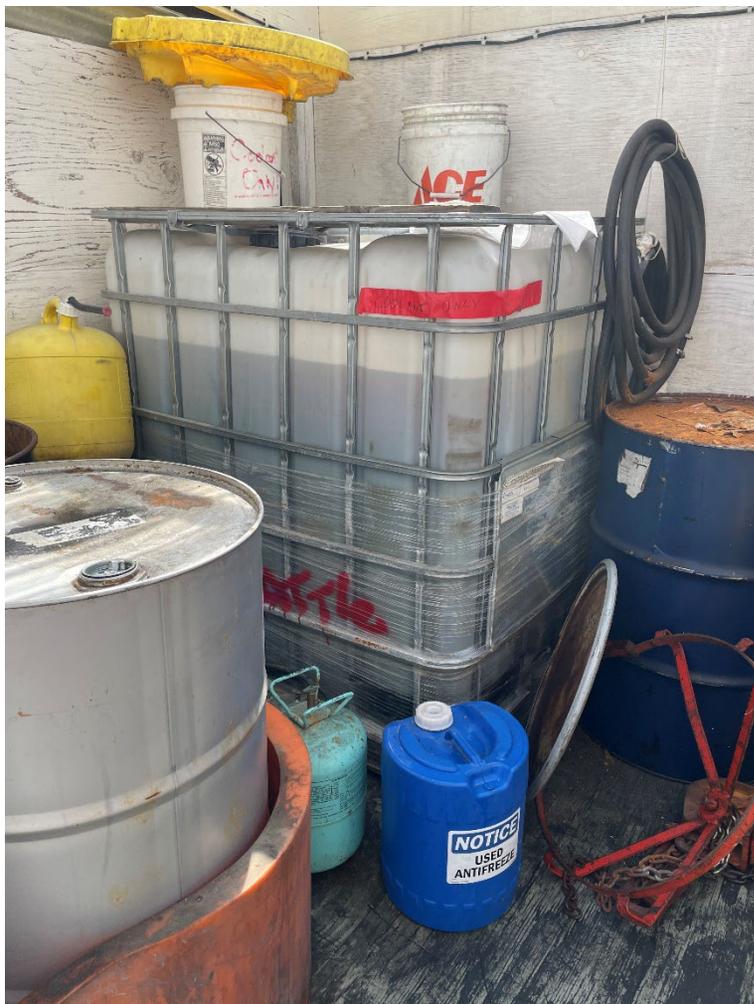
Photo 9 [IMG_0287]

Description: View inside left side of storage shed at south side of the site. The IBC tote was labeled “coolant” and was lacking secondary containment. Most of the smaller containers were empty.

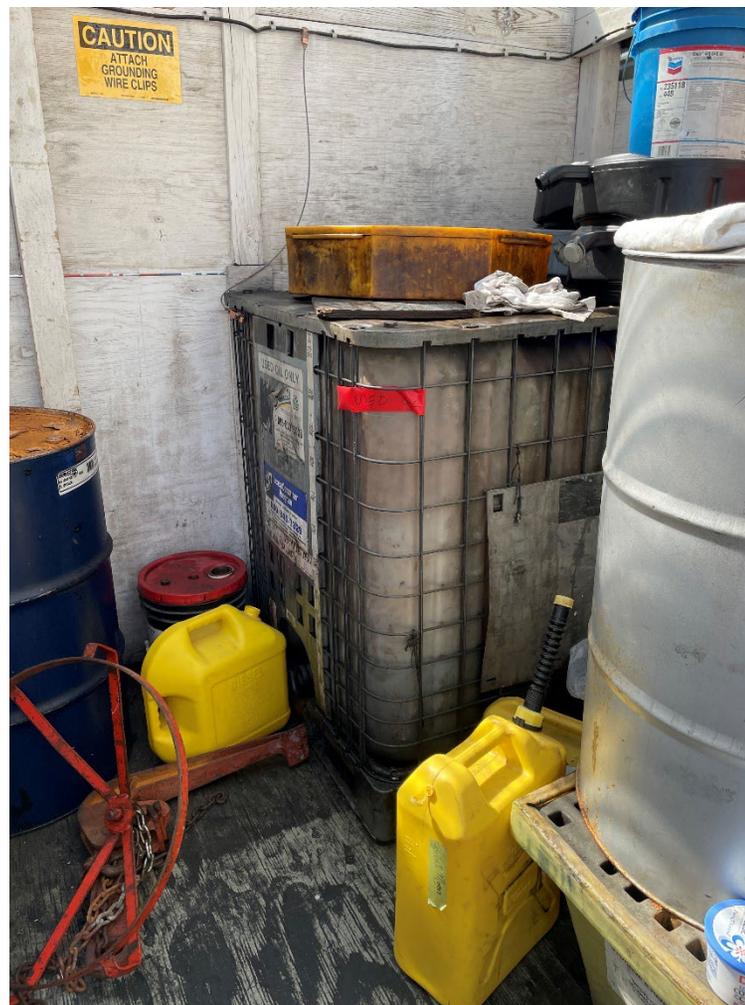
Photo 10 [IMG_0288]

Description: View inside right side of storage shed shown in Photo 9. The IBC tote was labeled “used oil” and was lacking secondary containment. Most of the smaller containers were empty.
