STATE OF WASHINGTON
DEPARTMENT OF ECOLOGY

Re: NPDES Permit Number WAR000074

Enclosed is the report from the Department of Ecology's (Ecology) recent National Pollutant Discharge Elimination System (NPDES) Industrial Stormwater General Permit (ISGP) compliance inspection conducted virtually at Milgard Essence / WAR000074 on May 23, 2024. Thank you for the time, Lucas Samuel spent with me during my visit.

Water Compliance Inspection Report

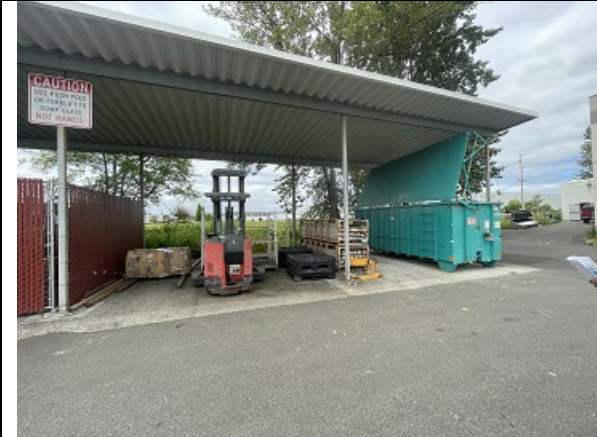
1. Receiving dumpsters and equipment under cover

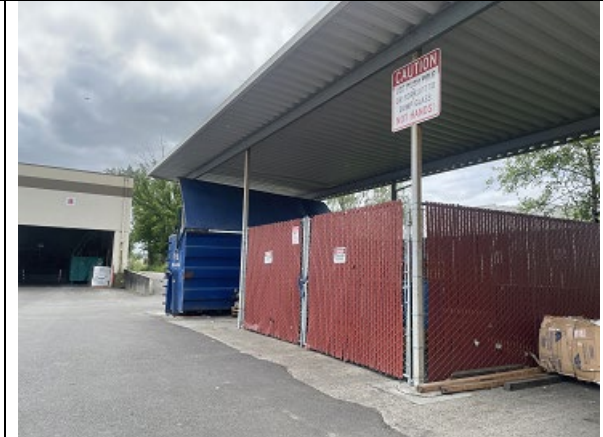
2. Structure provides (redundant) cover for waste receptacles

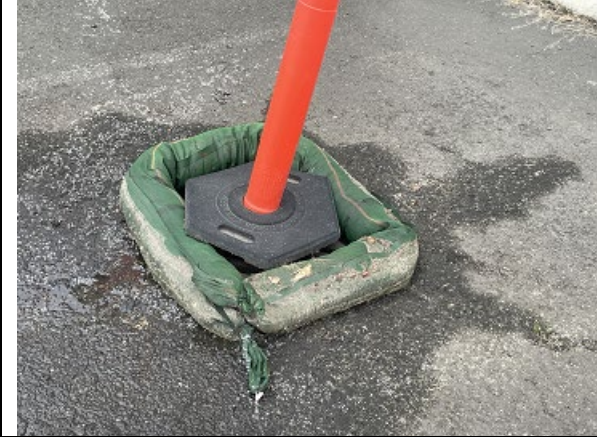
- Additional sampling for freshwater ammonia was required at outfall FG2, on the west side of the facility, because discharge from FG2 enters a segment of the Fife ditch that was impaired for freshwater ammonia (Ammonia- N) when the permit was issued.
- Discharge points on the north side of the site were described and identified as substantially identical. North discharge points are in mostly administrative parking areas in the front of the building and enter Fife's municipal stormwater system which flows to a receiving environment that was *not* impaired when the permit was issued. Additional monitoring was not required at the north outfalls.

3. Monitoring point FG2, west side of facility

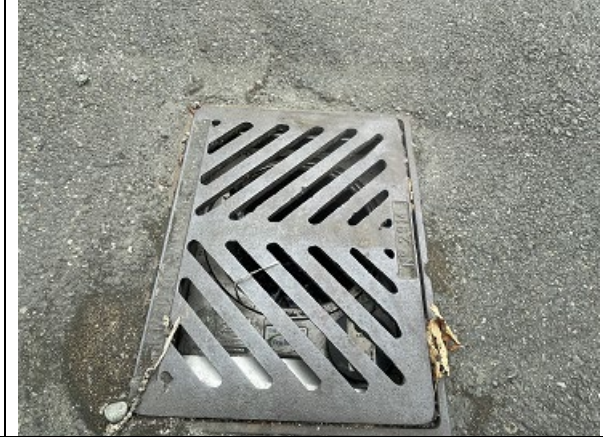
4. Zinc treatment inserts in catch basin 4

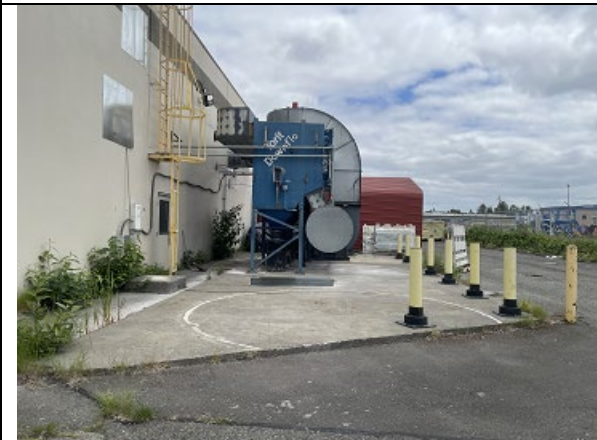
5. Dust collection system

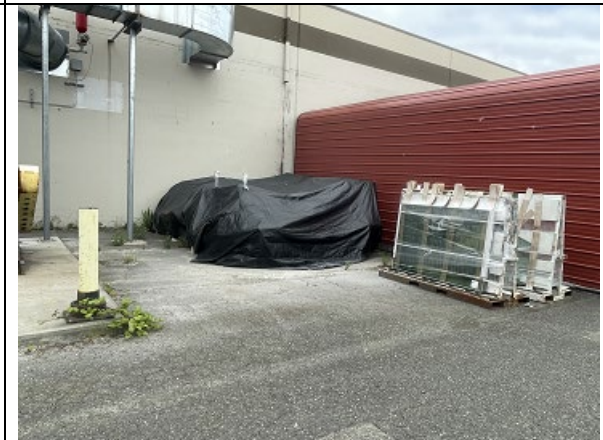
6. Tarped equipment and protected storage
