Permit Compliance Inspection Report

Water Quality Program

Facility Name & Address: Milne Fruit Products Prosser
804 Bennett Ave
Prosser, WA 99350

Date of Inspection: 6/18/2024

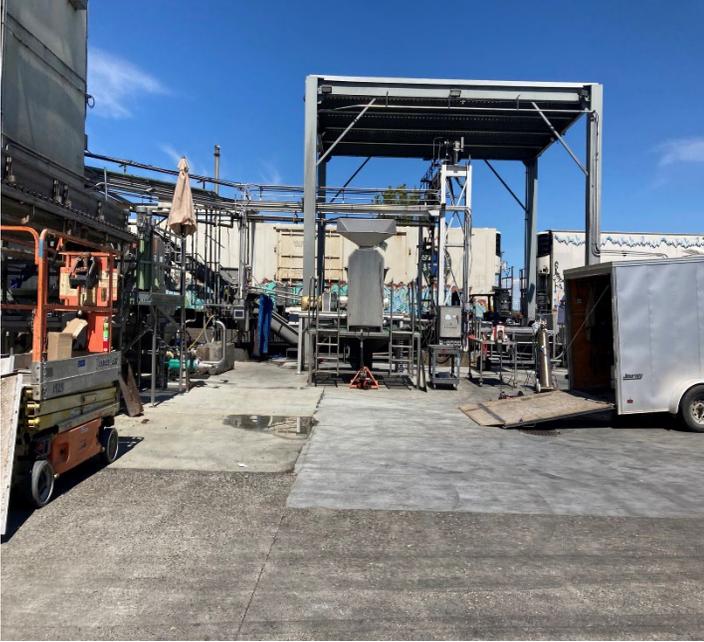
Photo 1 [IMG_0494]

Description: Fruit receiving area

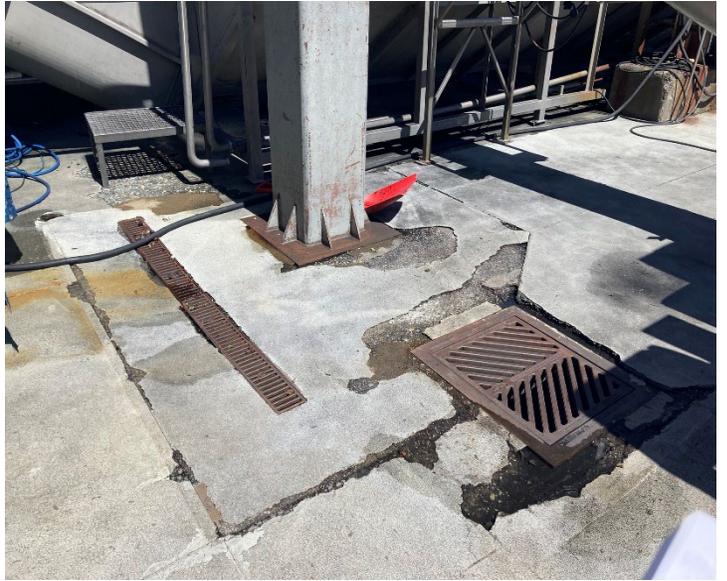
Photo 2 [IMG_0495]

Bruce walked us outside to the receiving area where all the fruit comes into the plant. All drains outside go to the wastewater pit before treatment then discharge to the POTW. Stormwater in the processing area outside also goes to the wastewater pit before being discharged to the POTW.

Description: Drains in fruit receiving area – go to wastewater pit

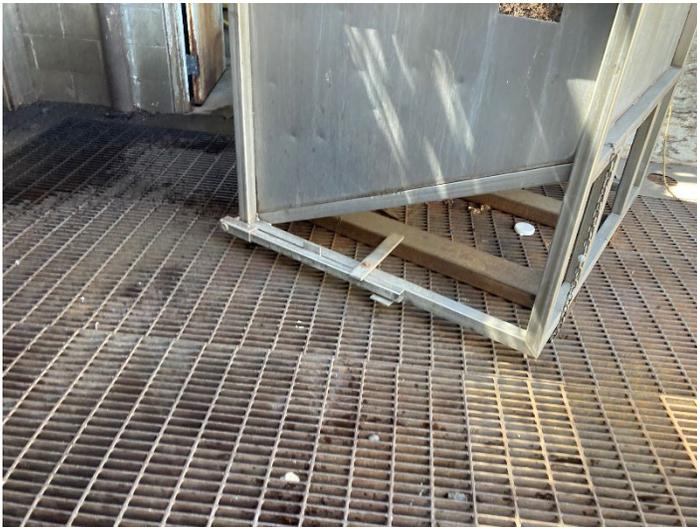
Photo 3 [IMG_0496]

Description: Wastewater pit with screened solids bin above

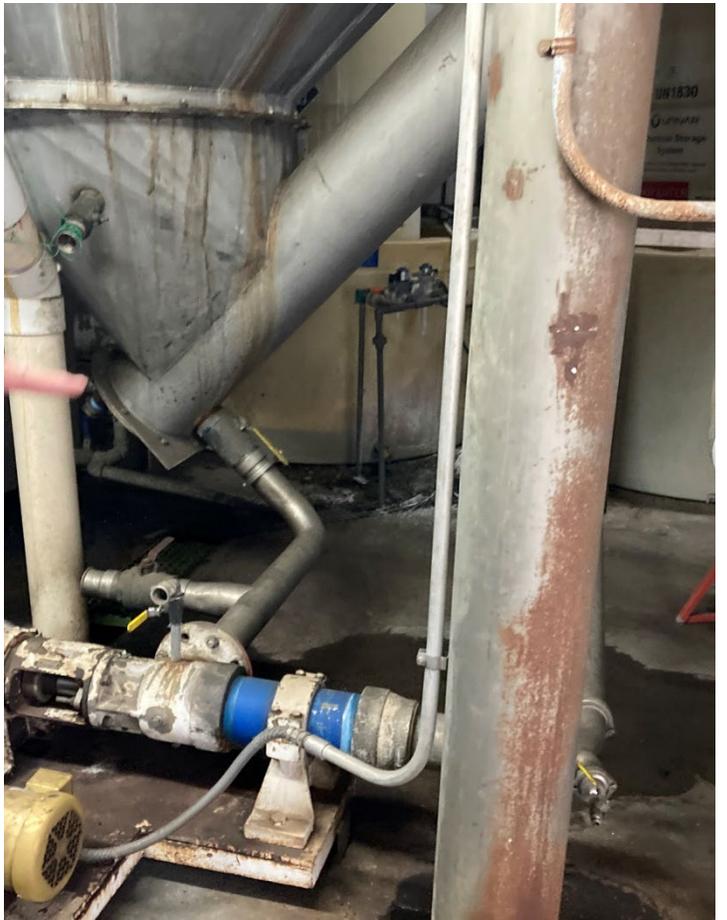
Photo 4 [IMG_0497]

All wastewater from the facility goes to the wastewater pit. The wastewater goes through a screen before treatment. The wastewater then goes through the clarifier and then adjusted for pH as necessary. If the wastewater is not within limits for pH the wastewater goes back to the pit for further treatment. Bruce said the polymer system they have is no longer functional due to several power outages the facility has experienced recently. The flow meter next to the clarifier is currently not functional. The control panel for the facility is in this room with the clarifier.

Description: Clarifier

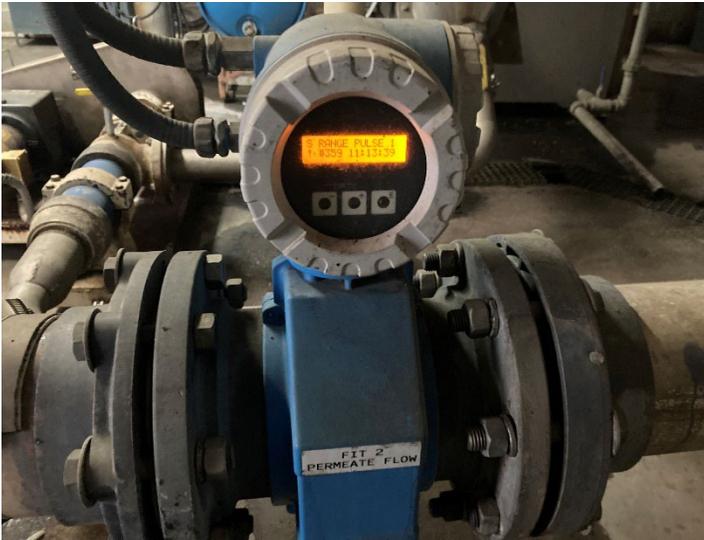
Photo 5 [IMG_0498]
Description: Flow meter next to clarifier – not functional

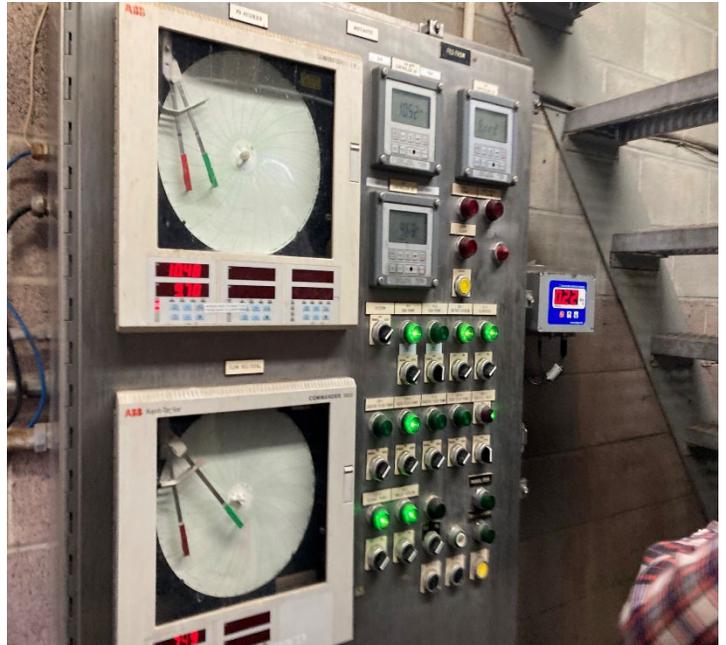
Photo 6 [IMG_0499]
Description: Facility Control panel

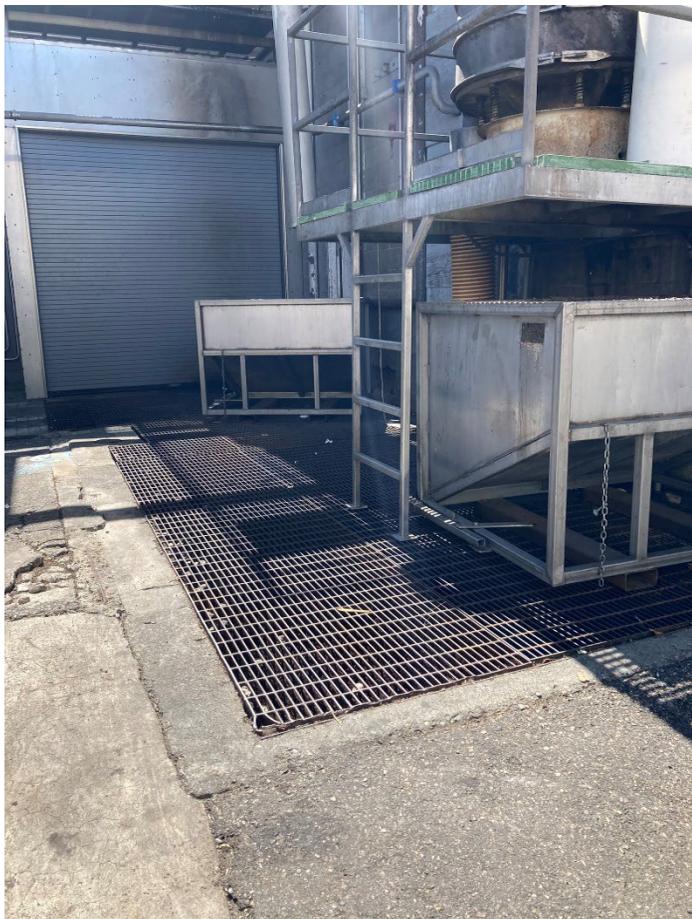
Photo 7 [IMG_0500]
Description: Wastewater pit and solids bin from screening

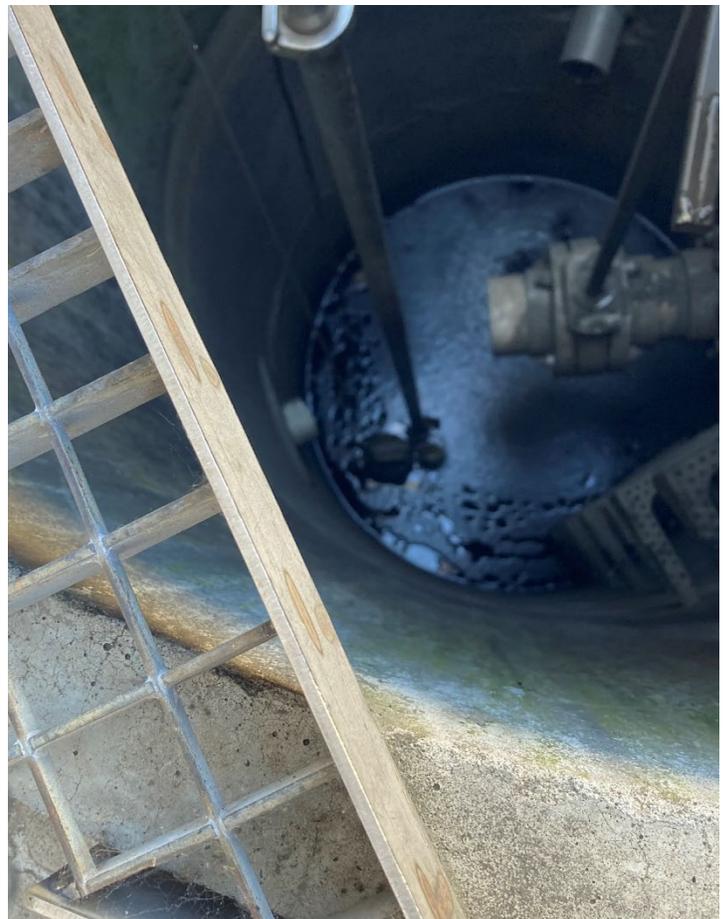
Photo 8 [IMG_0501]
Description: Lift station
