Permit Compliance Inspection Report  
Water Quality Program  
Central Region Office

Facility Name and Address: Piepel Premium Storage  
524 S Columbia Street  
Wenatchee, WA 98801

Permit Number: WAG435289

Inspection Date and Time: October 14, 2024, 10:20 AM to 11:30 AM

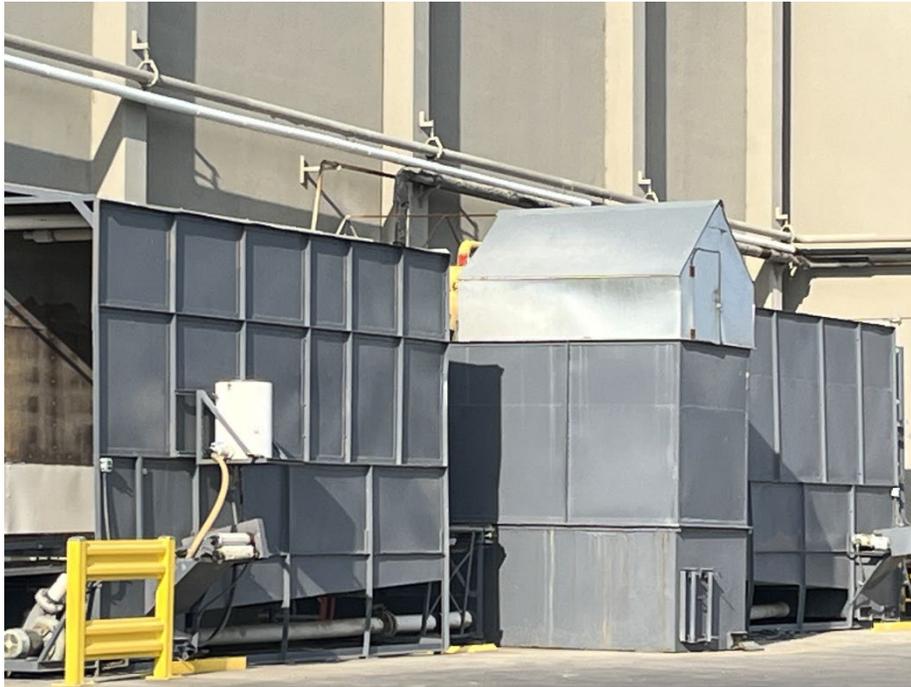
**Photo 1**  
**Description: Outdoor cherry hydrocooler not in use at time of the inspection.**

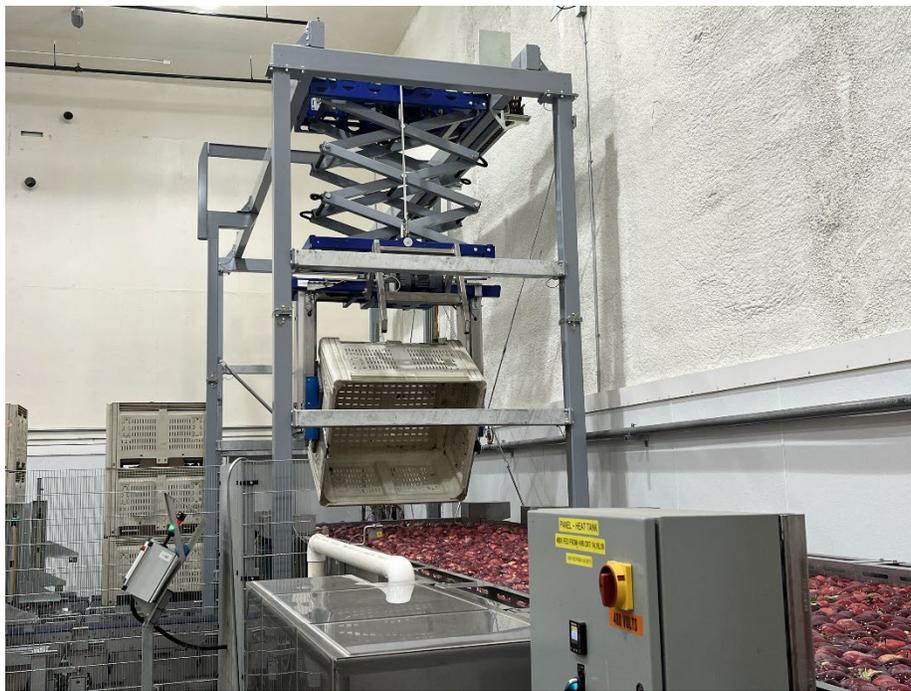
**Photo 2**  
**Description: Apple dump and tank float with red apples in the float.**

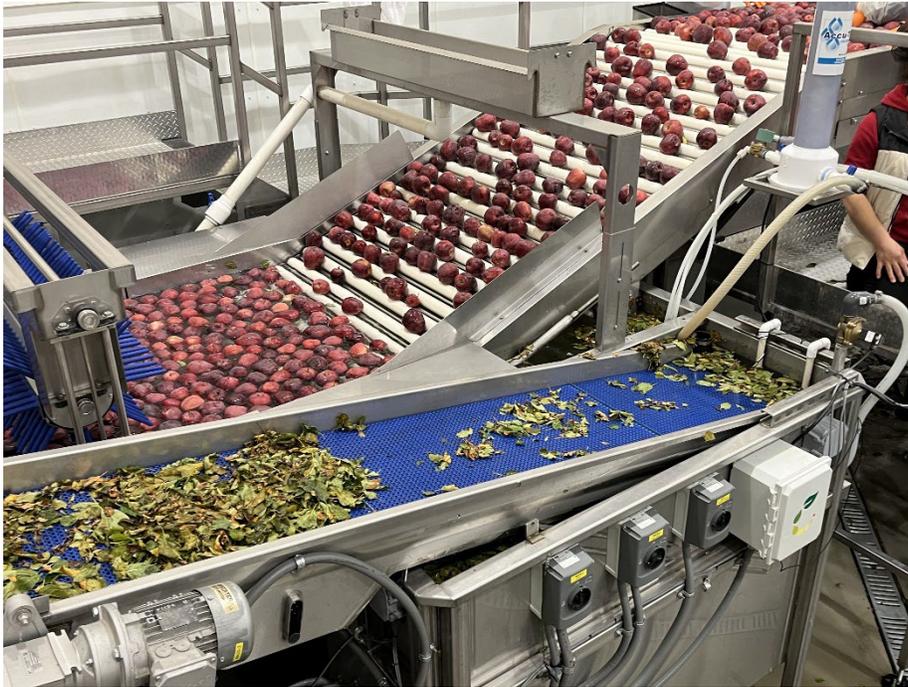
**Photo 3**

**Description: Screening at an apple pack line to remove leaves and stems.**

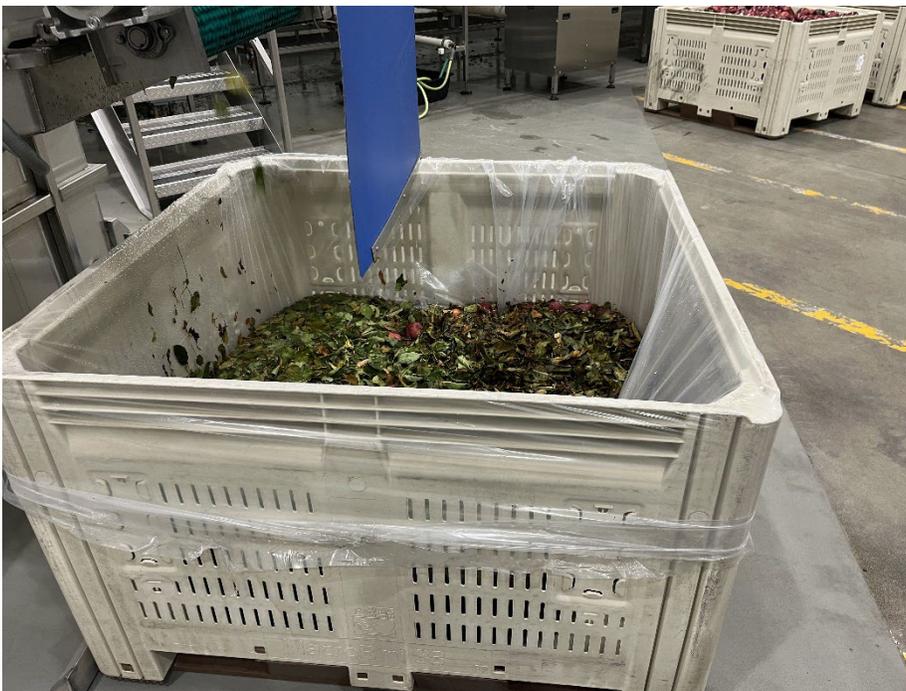
**Photo 4**

**Description: Screenings and rot apples collected for garbage.**

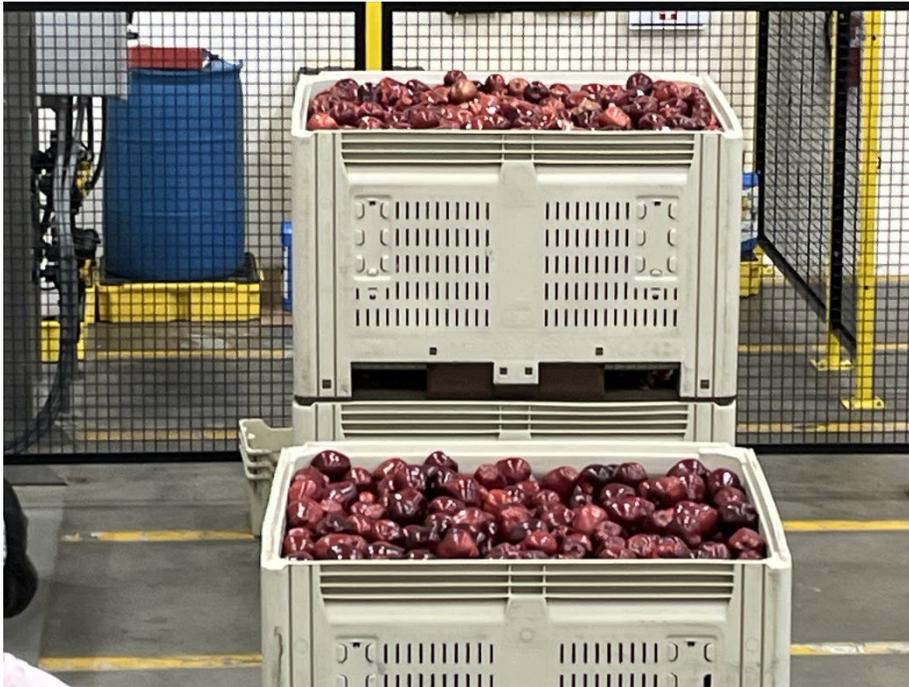
**Photo 5**  
**Description: Apples in bins and chemical cage with secondary containment pallets.**

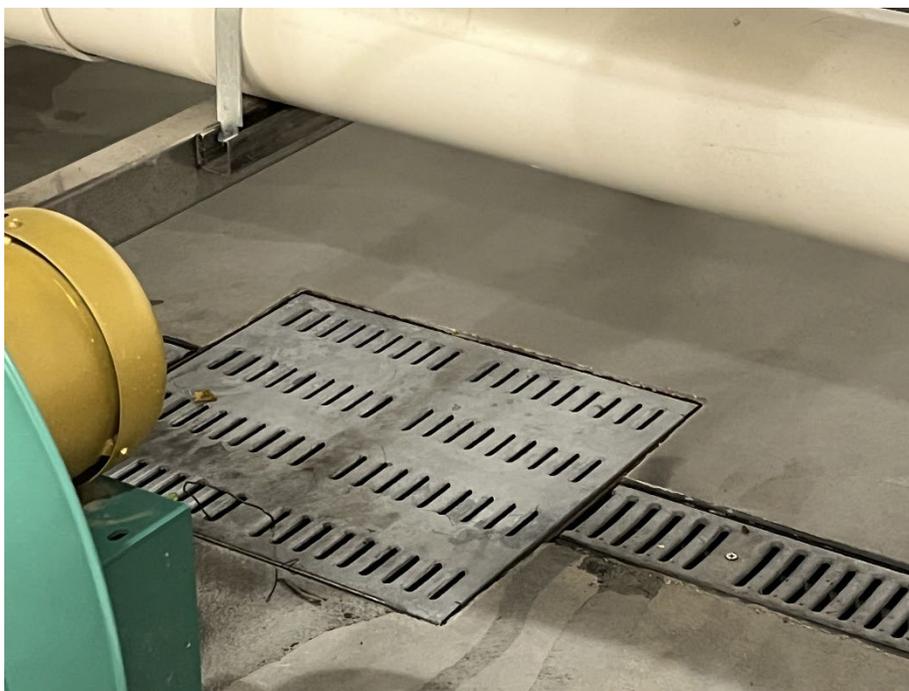
**Photo 6**  
**Description: Drain with sump pit to go to POTW.**

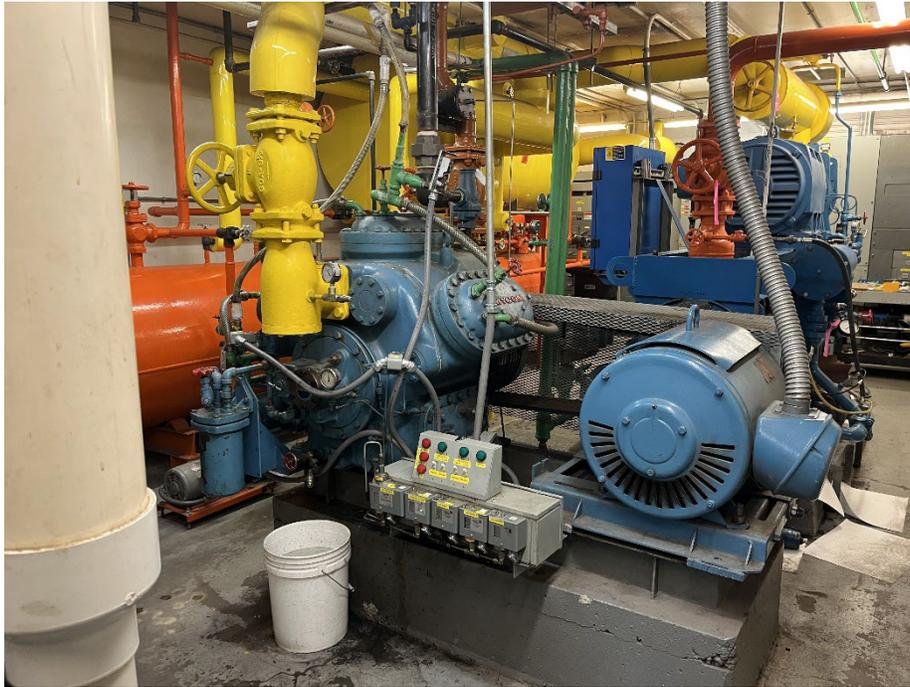
**Photo 7**  
Description: clean engine room for long term apples storage.

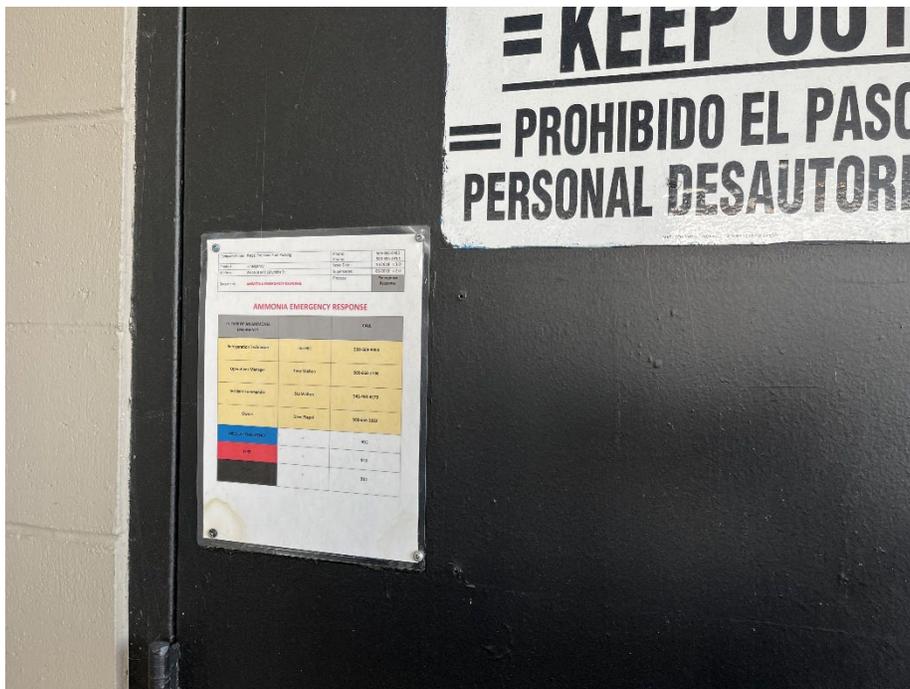
**Photo 8**  
Description: Engine room door with names and contact numbers for any after hour emergencies.

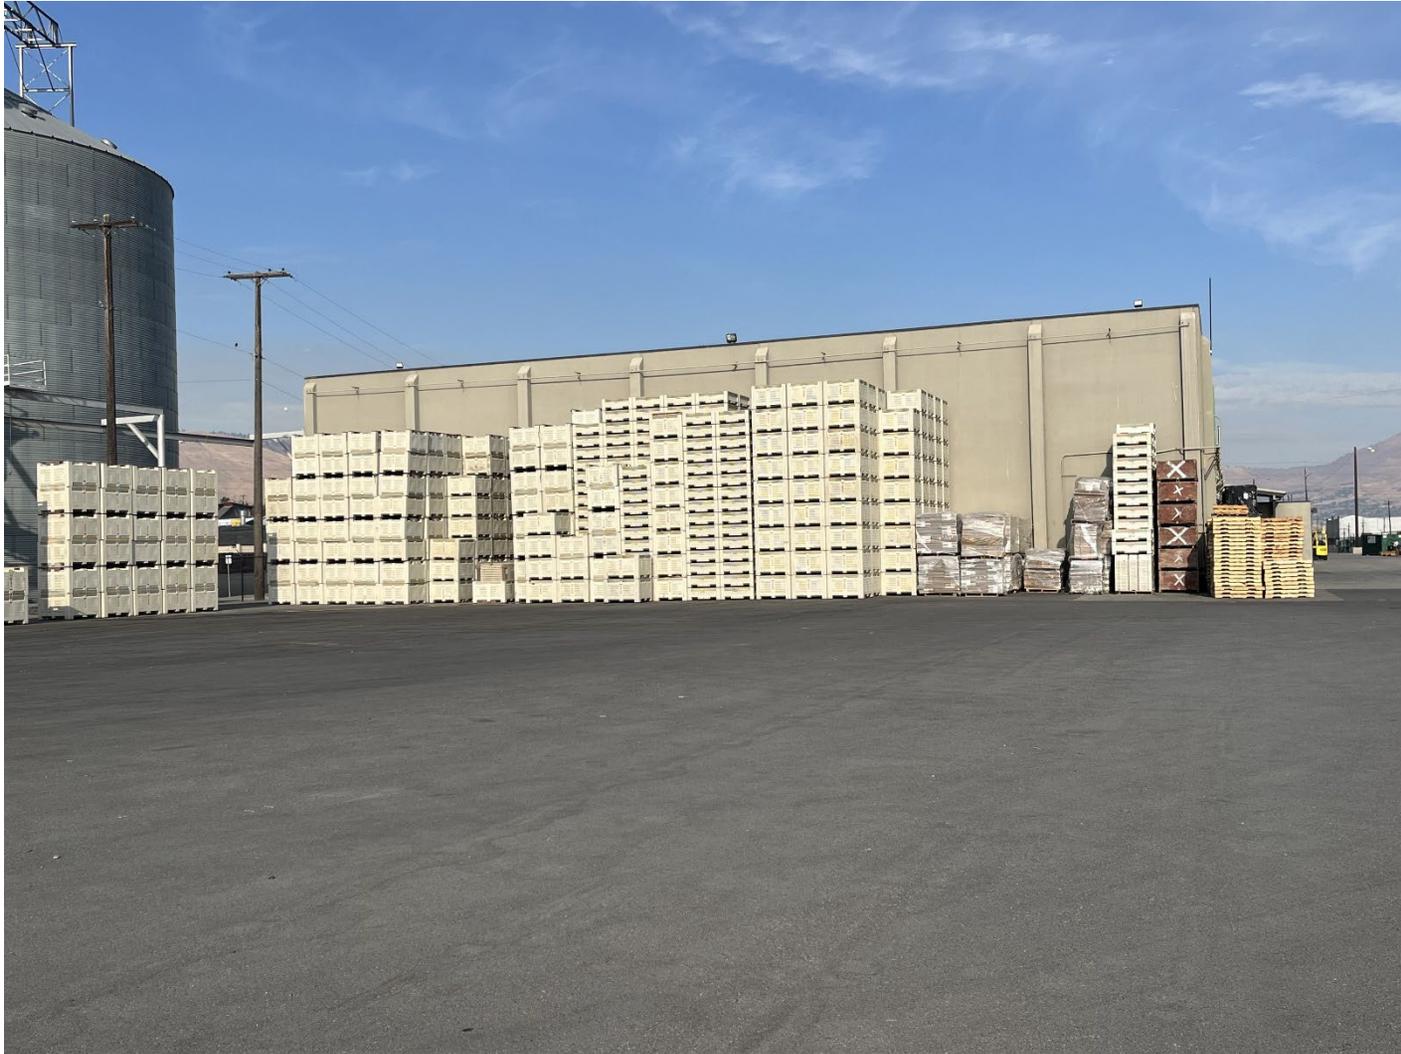
**Photo 9**

Stormwater runoff is to the City of Wenatchee system and there is no real exposure of concern at this facility.

**Description: Very clean outdoor facility showing limited exposure for stormwater contamination.**
