Permit Compliance Inspection Report

Water Quality Program

Facility Name & Address: Old Mill Site Port Gamble
Rainier Ave
Port Gamble, WA 98364

Date of Inspection: November 14, 2024

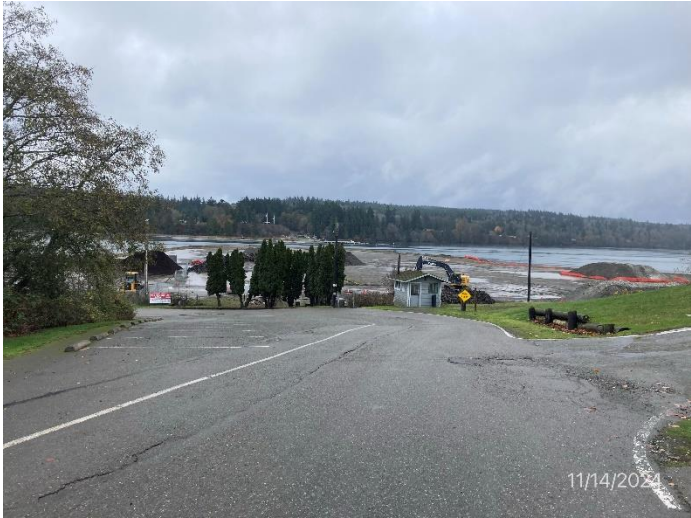
Photo 1 [IMG_2330]

Description: *Photo showing view of site from View Dr NE*

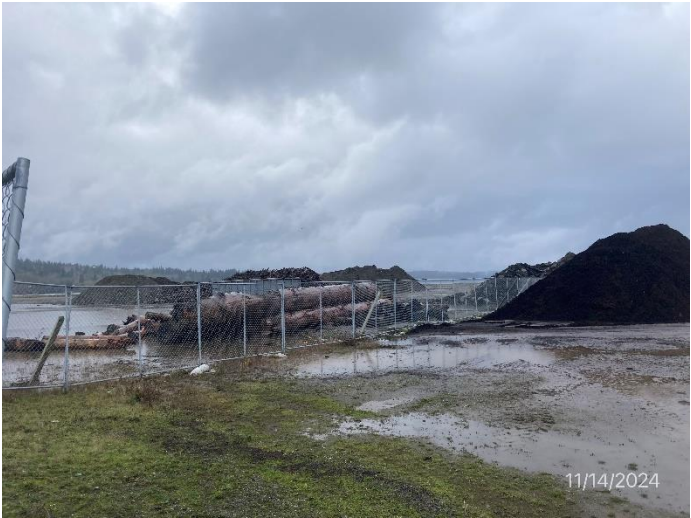
Photo 2 [IMG_2331]

- **Violation:** In accordance with **permit condition S3.B.4.b.i.2.d**, The Permittee shall...keep all dumpster under cover or fit with a storm resistant lid that must remain closed when not in use. (Tarps are not considered storm resistant.)
 - In the case of Old Mill Site Port Gamble, the facility had several locations where dumpsters without lids or lids that were not closed and not in use were documented. Within 30 days of receipt of this inspection report, review permit condition S3.B.4.b.i.2.d and begin maintaining dumpsters with storm resistant lids that are closed when not in use.

Description: *Photo showing gate around contaminated site area, dumpster with wood debris, uncovered stockpiles, and large ponding areas.*

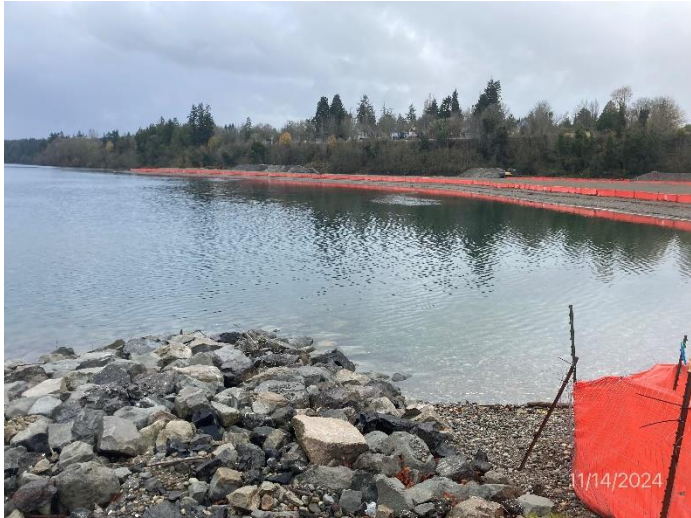
Photo 3 [IMG_2332]

Description: *Photo showing silt fencing near high tide mark based on wrack height.*

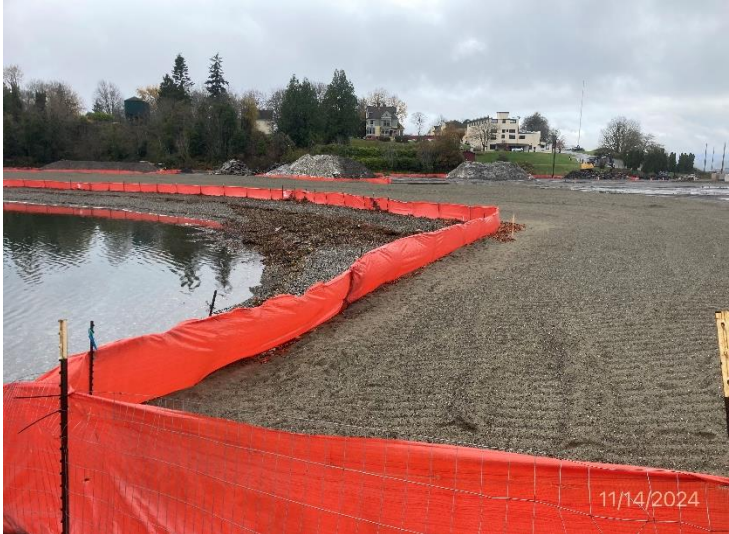
Photo 4 [IMG_2333]

Description: *Photo showing silt fencing near high tide mark based on wrack height.*

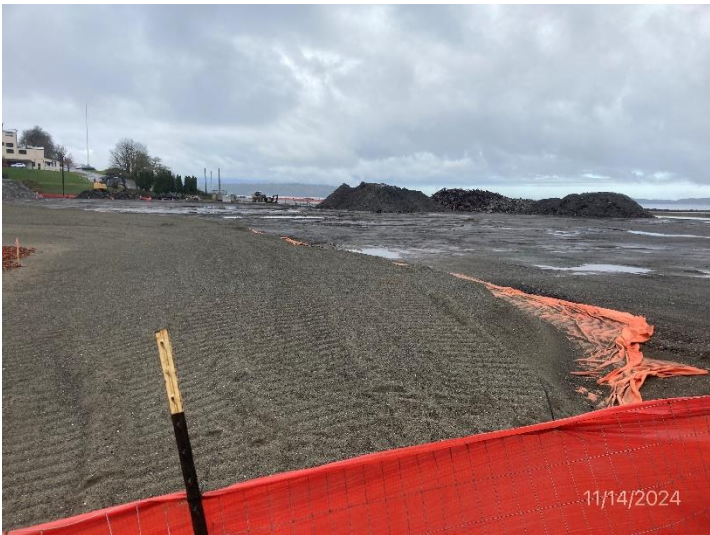
Photo 5 [IMG_2334]

Description: *Photo showing silt fencing, bare soils, and uncovered stock piles.*

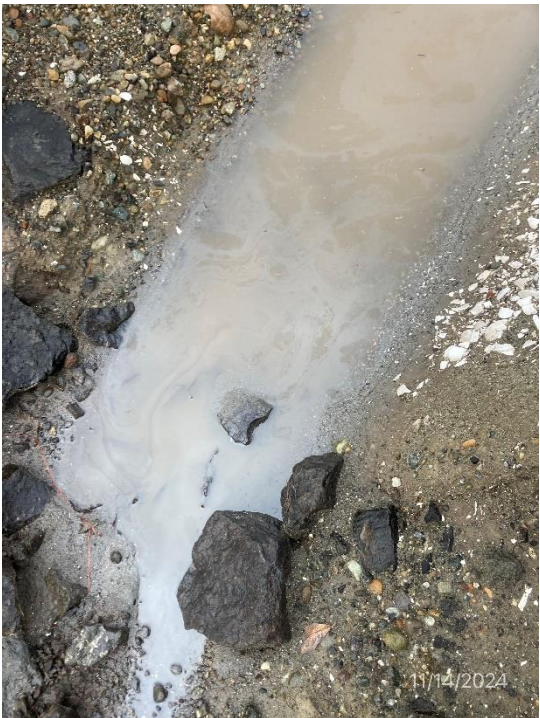
Photo 6 [IMG_2335]

Description: *Photo showing water flowing with a sheen present towards the pipe shown in photo 7.*

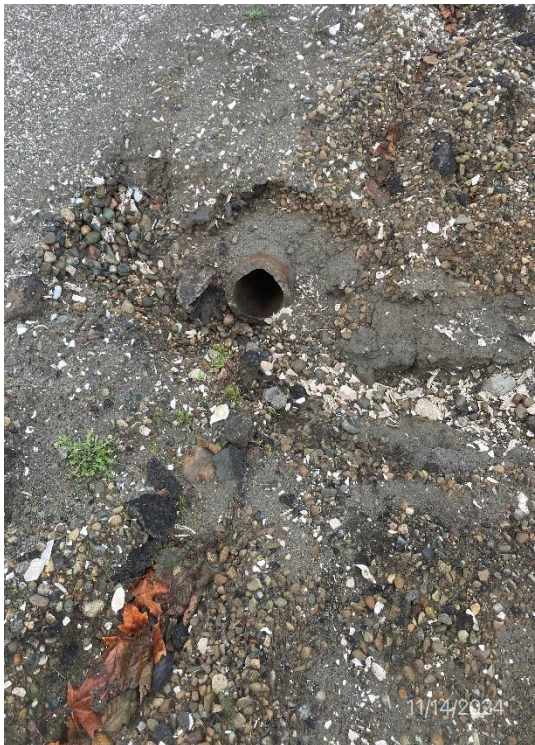
Photo 7 [IMG_2336]

During the site walk we found one roughly 6-inch concrete pipe in the ground at the edge of the beach regraded sand with roughly one-foot deep rilling present, the rilling stopped at the pipe. The pipe was not full of water or silt. I explained this indicates stormwater flowed down that pipe and discharged and that would be a location that needs to be sampled. Around this pipe was a ditch directing water to pool above the pipe. Further along the site walk we came to a concrete slab covering a stormwater structure. I was able to hear water flowing into the structure and again explained this is also a location that should be sampled. I then asked who the CESCL for the CSWGP project was; Stephanie explained that would be Seton construction and we found two Seton staff onsite one was an excavator operator, and one was the site assigned CESCL.

Description: *Photo showing roughly 6-inch concrete or tile pipe with rilling/erosion present stopping at the pipe. Rilling roughly one foot deep.*

- In the case of Old Mill Site Port Gamble, the facility has documented no discharge for many quarters and has no less than two distinct discharge points that were found during the inspection. These locations need to be added to the site map and sampling needs to begin immediately. Within 30 days of receipt of this inspection report, submit a sample point update form to Ecology adding these two locations as sample points and immediately begin sampling at these locations a minimum of once per quarter when discharges occur or more frequently if operations fall under the CSWGP.

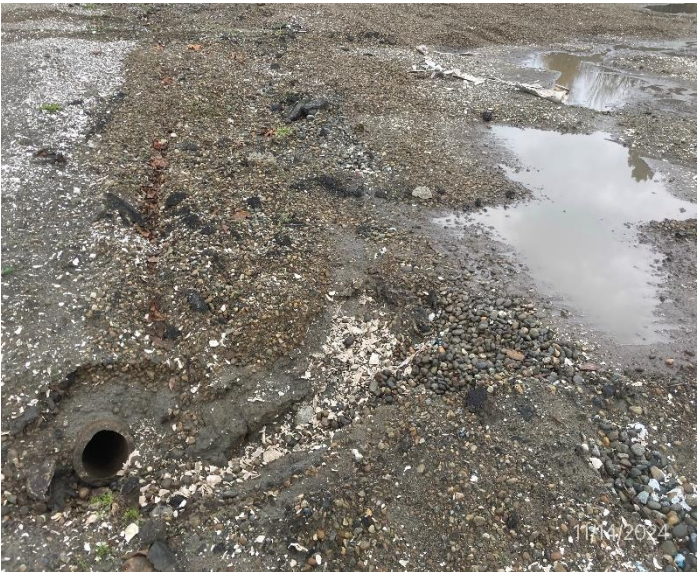
Photo 8 [IMG_2337]

Description: *Photo showing roughly 6-inch concrete or tile pipe with rilling/erosion present stopping at the pipe. Rilling roughly one foot deep.*

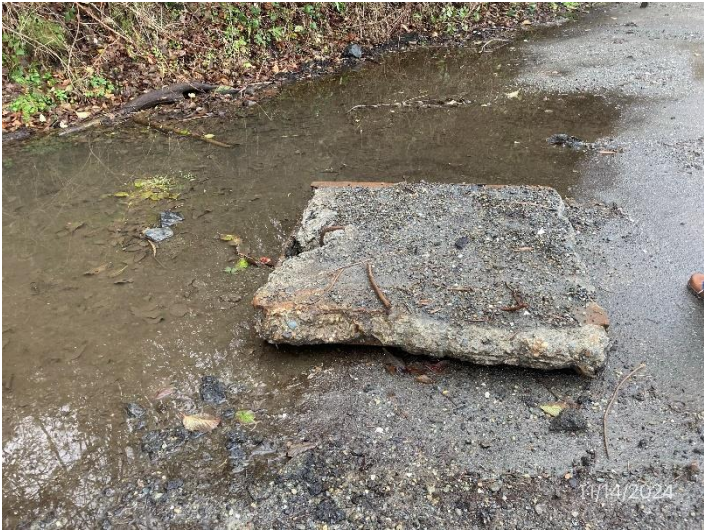
Photo 9 [IMG_2338]

The CESCL for the site explained he was unaware of both discharge locations and the excavator operator explained he was unaware of the pipe at the beach line but was aware of the concrete slab as he placed it

over the stormwater structure a week prior to avoid someone potentially falling in. I asked if he had documented the structure on the site map, in the Stormwater pollution prevention plan (SWPPP), and if the discharge locations had been sampled. The two Seton staff explained that the discharge locations were not documented and explained they believed everything infiltrated. I asked what documentation is present to indicate these two stormwater conveyance locations go to an infiltration location and do not discharge and the explanation that was provided was the regrading of the beach and that I would need to talk to Anchor QEA as they would know best. I asked if pipes were found during the regrading and if those pipes were properly decommissioned and was told the project was too large to focus on any infrastructure that was found, and it was assumed anything in the ground was just old fill material. After discussing this issue in depth, I explained that I expected to see sample results of the stormwater that flowed into these stormwater conveyance structures in the data monitoring reports submitted to Ecology. After this we continued to walk the site and found an area where a mobile fuel tank was setup. A spills kit was present, but drip pans were not present in the area. We continued walking toward the area where the excavator operator was working near the entrance to the sites gated area. In this area there was a wheel wash setup however, I was told the wheel wash was not being used for trucks that day as they were staying on the quarry spalls. The quarry spill entrance was in good condition but did not appear to be installed per the BMP manual with filter fabric below as mud was coming up through some areas of the quarry spalls. Outside of the fenced perimeter but inside the silt fence perimeter was a large asphalt area where the job shack was. In this location there are at least two catch basins covered with cones and had some rubber placed over the catch basin cover. At the first catch basin I could hear water flowing into the catch basin and I explained the rubber will not stop water once it is over the outlet because it is not a watertight plug. This catch basin or the outfall needs to be sampled and monitored closely to verify when discharges are occurring. After this site visit, I referred the site to the CSWGP manager Charles Hackel with Ecology. I explained to Stephanie that the ISGP could not be terminated until the refuse/debris piles were removed. During the site walk I also requested the site SWPPP for the ISGP. Stephanie explained she does not have it and does not know where it is but she can find it and send to me. I requested that it get sent via e-mail and as of the writing of the inspection report I have not received the SWPPP.

Description: *Photo showing concrete slab covering a stormwater conveyance structure.*

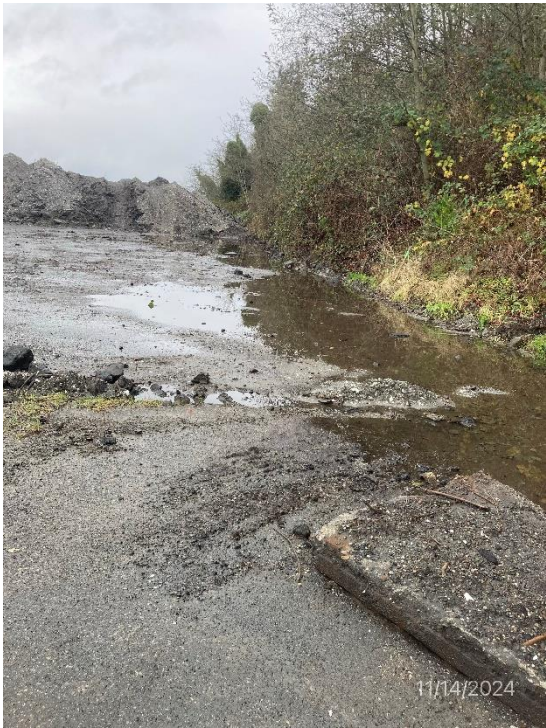
Photo 10 [IMG_2339]

Description: *Photo showing ponding water that is flowing into the stormwater conveyance structure covered by the concrete slab in photo.*

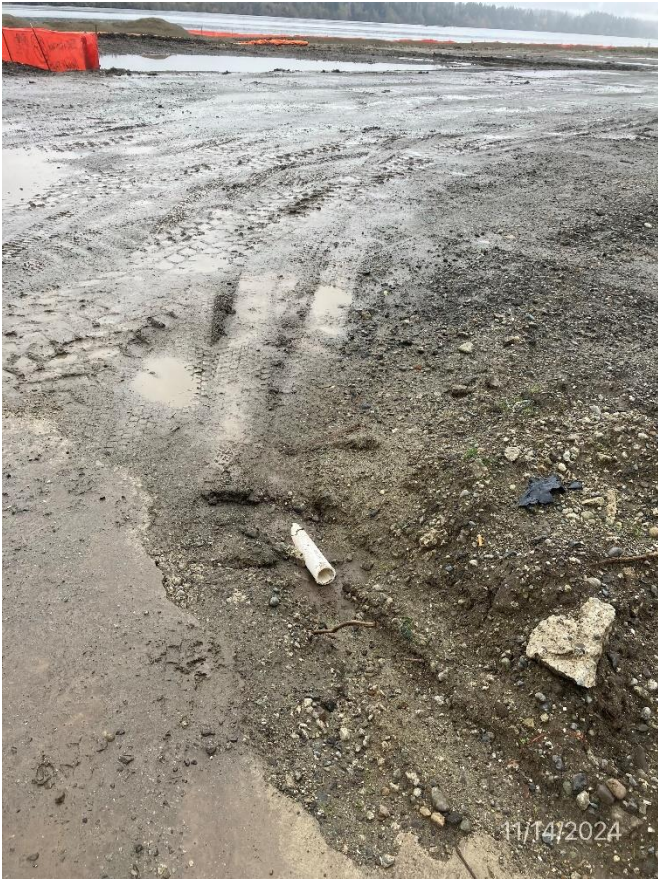
Photo 11 [IMG_2340]

Description: *Photo showing white pipe to convey water from one side of roadway towards the other side of roadway closer to the beach.*

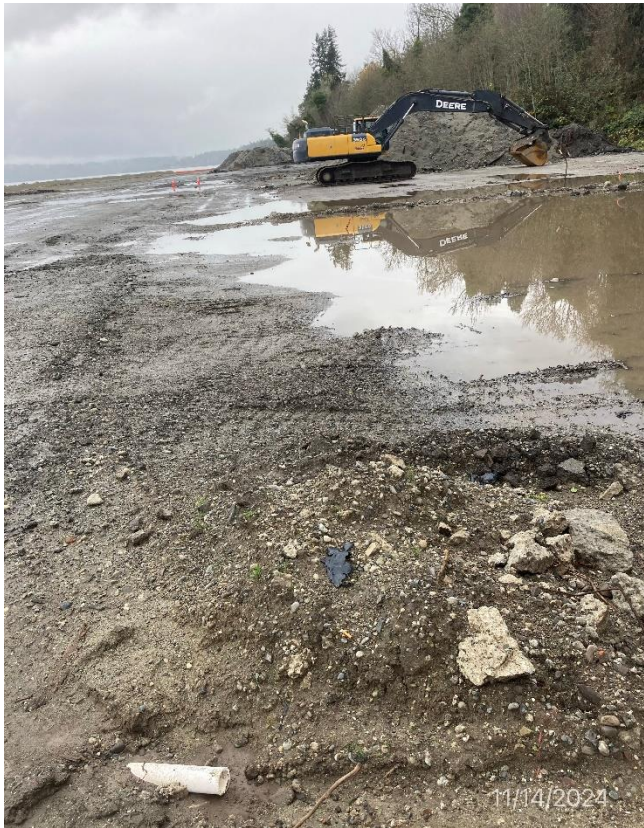
Photo 12 [IMG_2341]

Description: *Photo showing parked excavator, bare soils, and ponding water.*

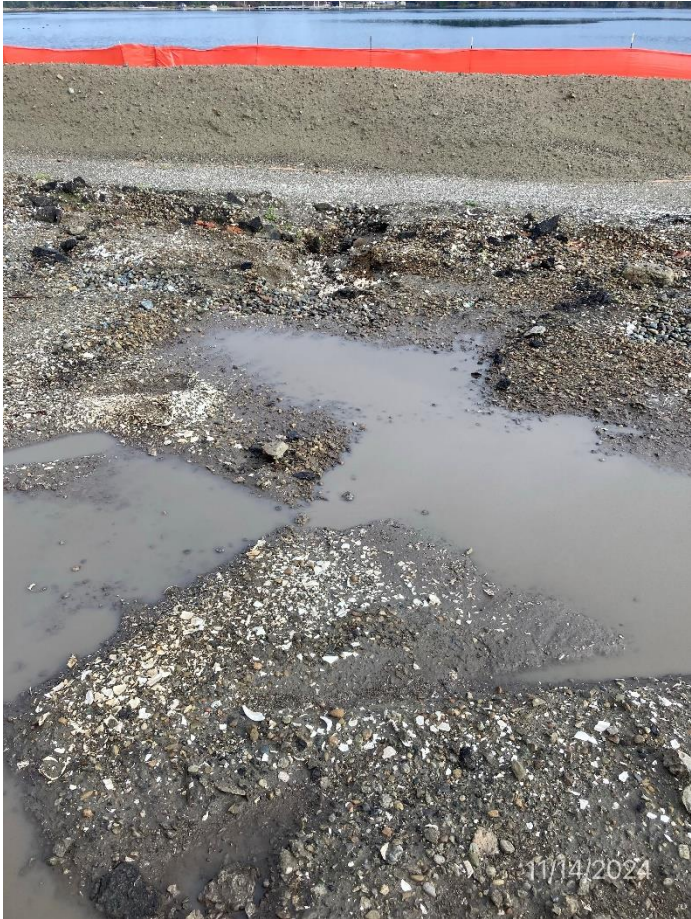
Photo 13 [IMG_2342]

Description: Photo showing ponding water near the 6-inch pipe shown in photo 7 and silt fencing/beach sand adjacent to the pipe.

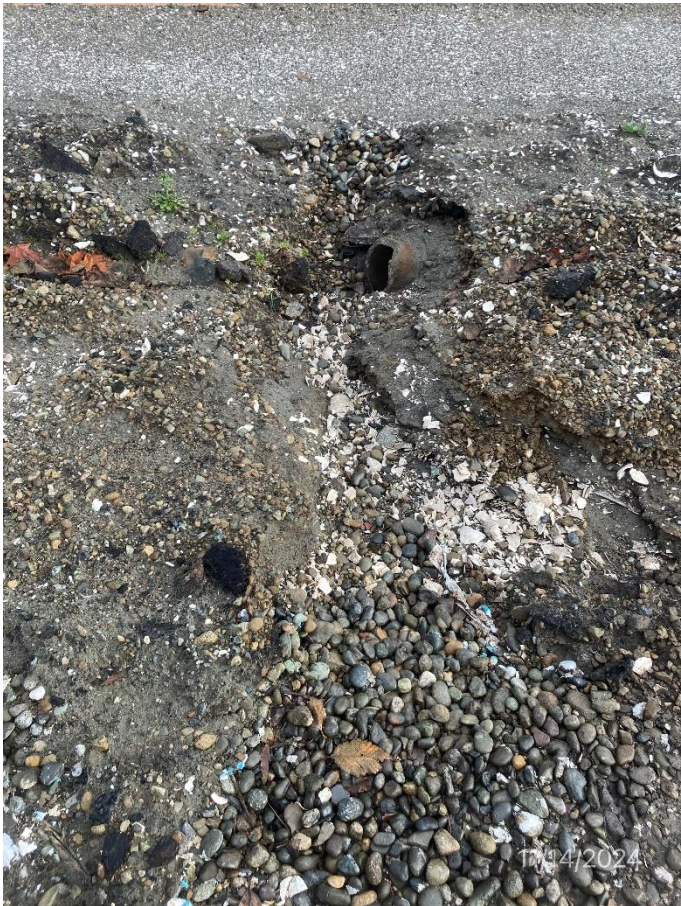
Photo 14 [IMG_2343]

Description: Photo showing the 6-inch pipe and rilling/erosion shown in photo 7 and beach sand adjacent to the pipe.

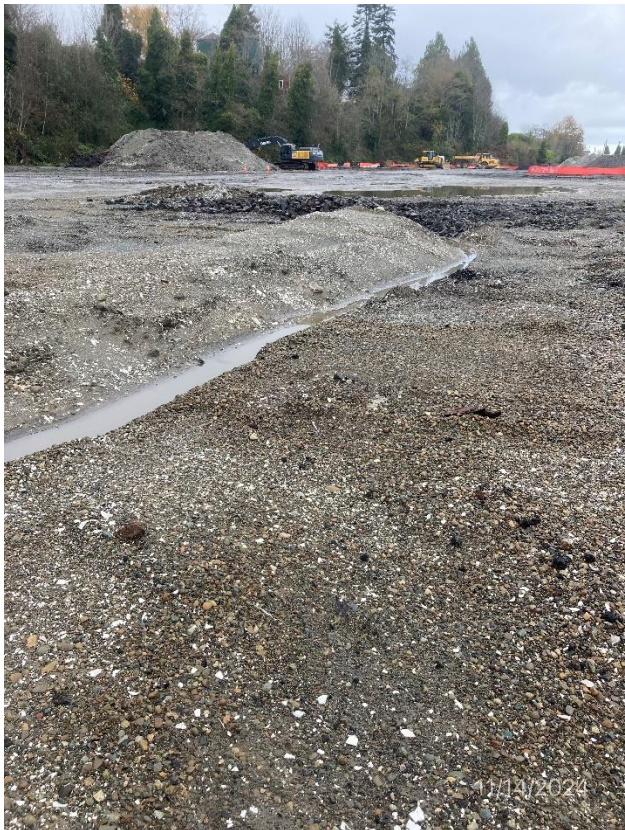
Photo 15 [IMG_2344]

Description: Photo showing ditch dug directing flow toward the pipe shown in photo 7.

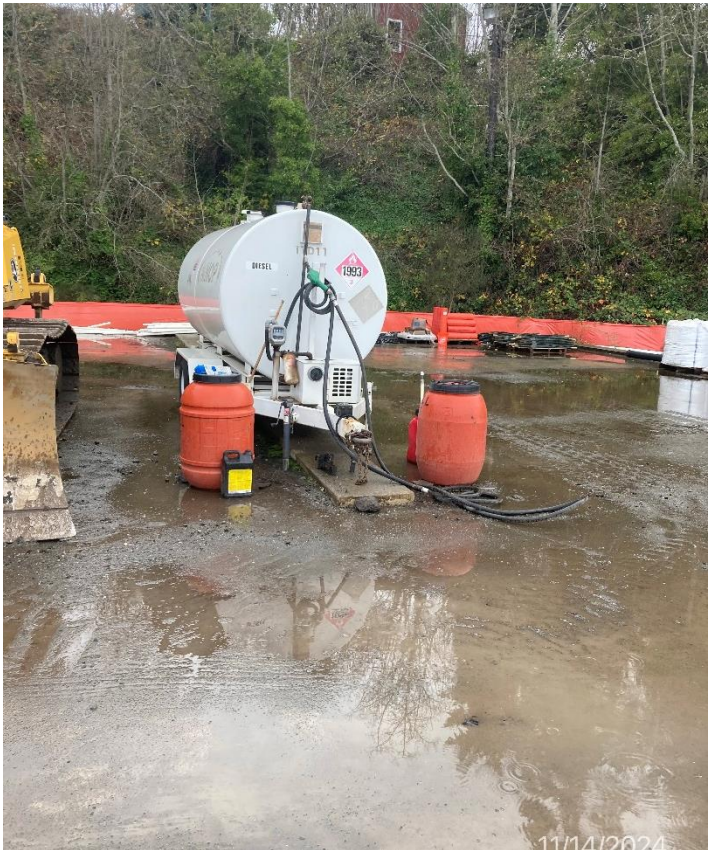
Photo 16 [IMG_2345]

Description: Photo showing mobile fuel trailer with spill kits present.

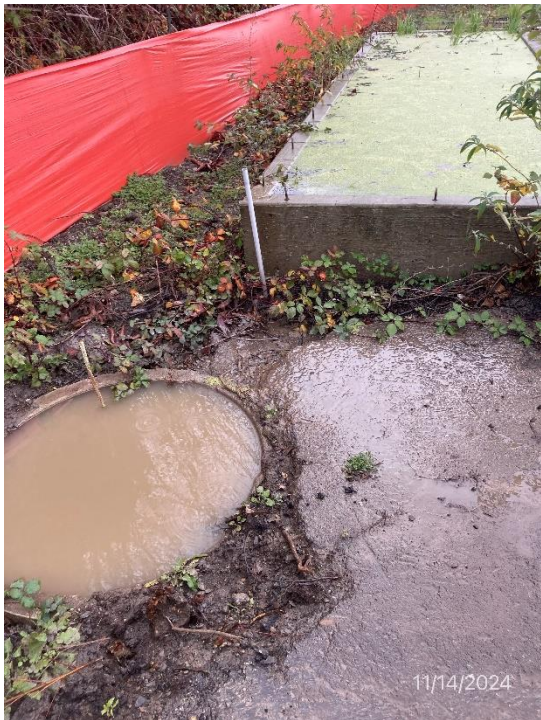
Photo 17 [IMG_2346]

Description: Photo showing concrete infrastructure filled with stormwater no information on depth available.

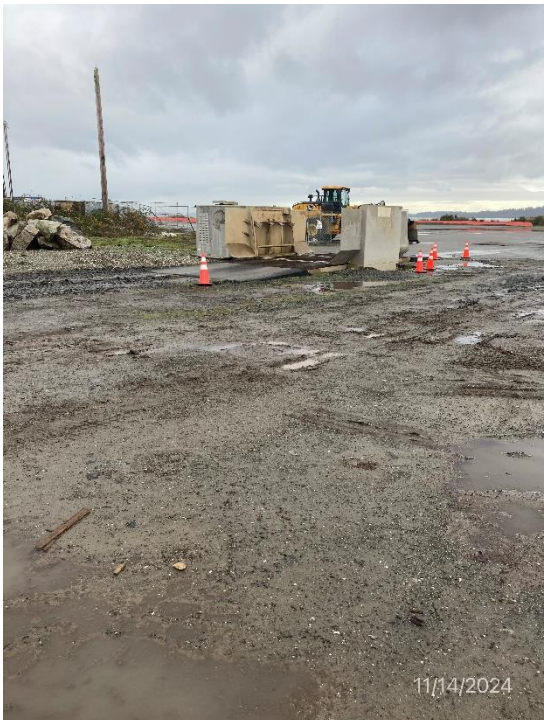
Photo 18 [IMG_2347]

Description: Photo showing entrance/exit of contaminated zone of construction site. Wheel wash present but not on at the time.

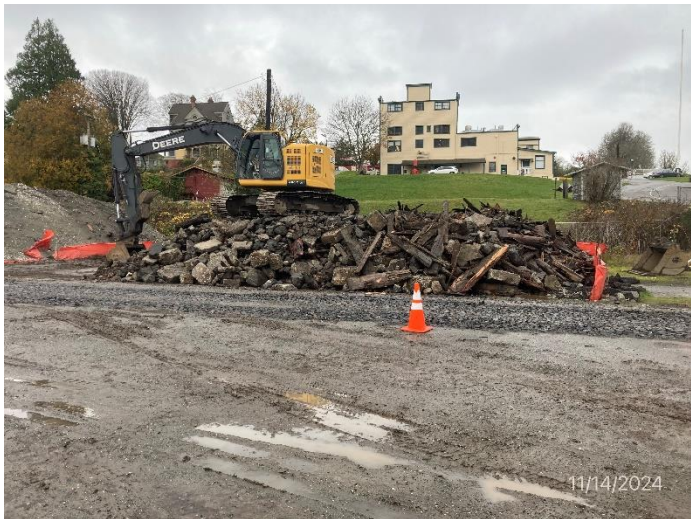
Photo 19 [IMG_2348]

Description: Photo showing concrete and wood debris pile with excavator staged for loading operations.

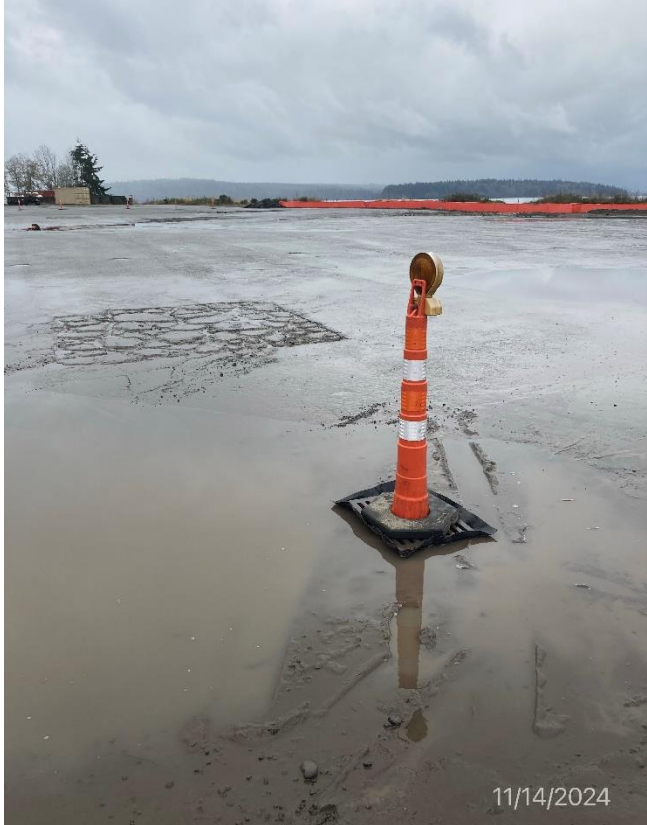
Photo 20 [IMG_2349]

Description: Photo showing traffic cone over catch basin with rubber pad over catch basin. Heard stormwater flowing into this catch basin at time of visit.

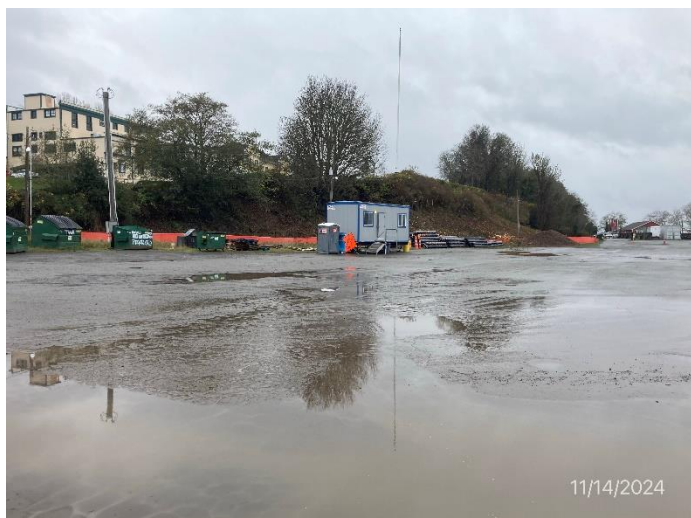
Photo 21 [IMG_2350]

Description: *Photo showing area around catch basin shown in photo 20. Job shack and staging of materials present.*
