<h1 style="text-align: center;">STORMWATER COMPLIANCE INSPECTION REPORT</h1> <p style="text-align: center;">State of Washington Department of Ecology 4601 N Monroe St, Spokane, WA 99205</p>					WADOE Stormwater Compliance Inspection Form										
						Phone: (509) 601-2124 suman.paudel@ecy.wa.gov										
Section A: General Data																
Inspection Date	NPDES Permit #	County	Receiving Waters	Inspector	Facility Type											
10/23/2024		Grant	Columbia River	Suman Paudel	Industrial											
Discharges to: Ground				ANNOUNCED Inspection												
Section B: Facility Data																
Name and Location of Site Inspected Group 14 Technologies, Inc. (BAM-2) 13431 Wheeler Road NE, Moses Lake WA 98837				Entry Time 12:05 pm												
				Exit Time 01:42 pm												
				GPS	Lat:	Long:										
				Entrance:	47.12730	-119.20450										
				Discharge:	47.12832	-119.21211										
On-Site Representative(s): Name(s)/Title(s)/Contact number(s) or E-mail				Additional Participants:												
Paul Stenhouse, (206) 385-0385 x 351, Environmental Manager, pstenhouse@group14.technology Nick Anderson, (206) 385-0385, Environmental Specialist, nianderson@group14.technology

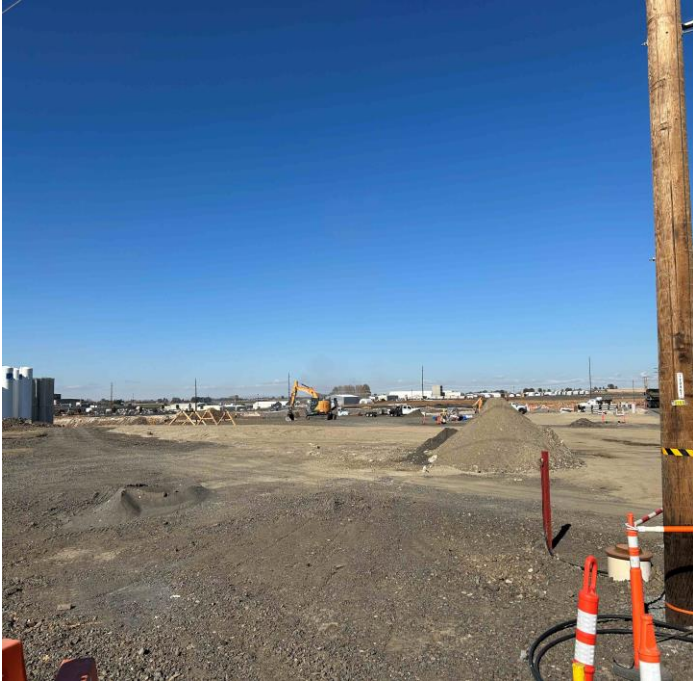
As we moved towards Modules 1 and 2, located to the west, I observed several inlets. Upon inquiry, Nick and Paul confirmed that these were stormwater catch basins directing runoff to the stormwater infiltration pond at the far western side of the facility. While walking west, I also noticed several ongoing construction activities, including the creation of a parking lot that will also feature stormwater catch basins.

Figure 1: Construction of a parking lot on the northeast

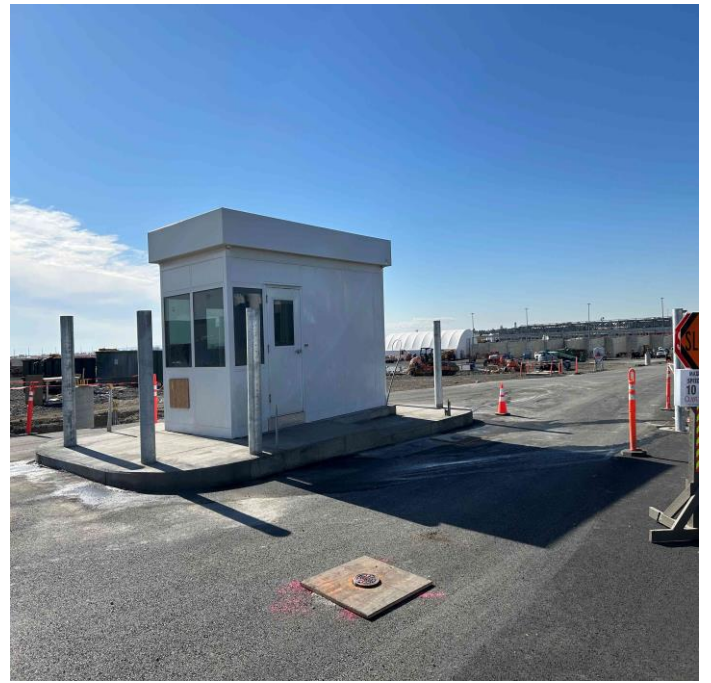
Figure 2: The stormwater inlet/catch basin, located at the entrance on the east side.

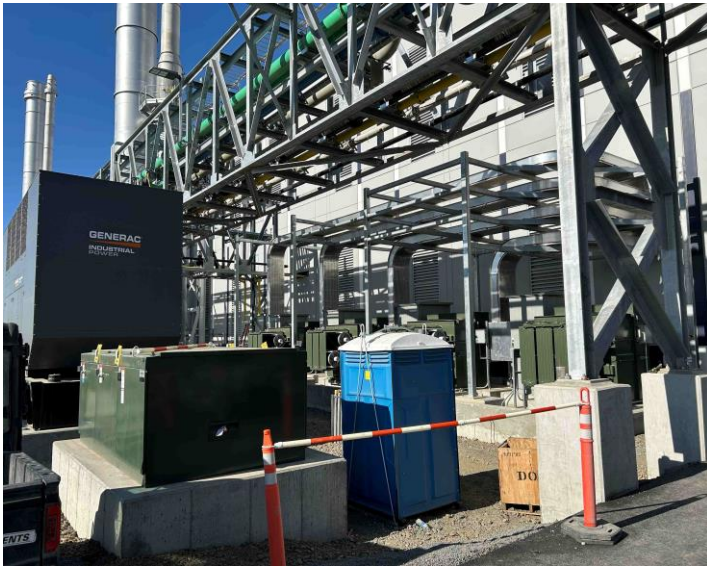
I saw a large building on my right, which the representatives identified as Module 1, with Module 2 situated immediately to the west. Additionally, I noticed generators and transformers with secondary containment close to the modules. When I inquired about the vacant space between the stormwater infiltration pond and Module 2, they explained that it is designated for the construction of Module 3 in the future. Although the stormwater infiltration pond was still unfinished, the stormwater outlets leading to it were visible. According to the representatives, Modules 4, 5, and 6 are planned for the southern side of the existing modules.

Figure 3: Generators and transformers on the right with secondary containment

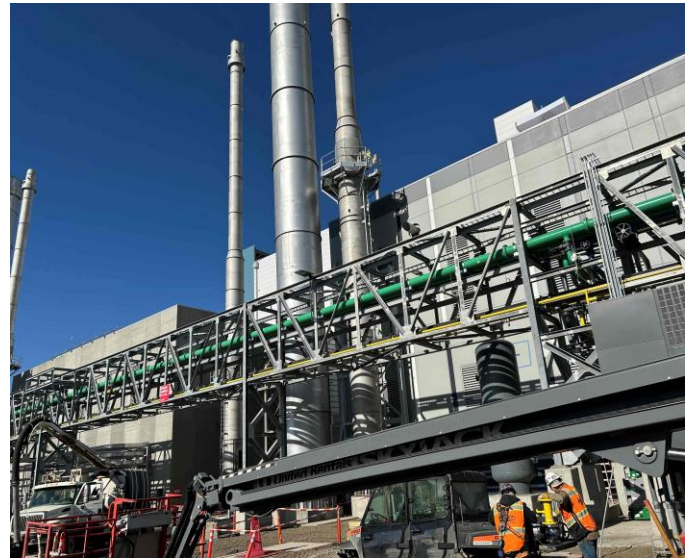
Figure 4: Module 1 and Module 2 (left)

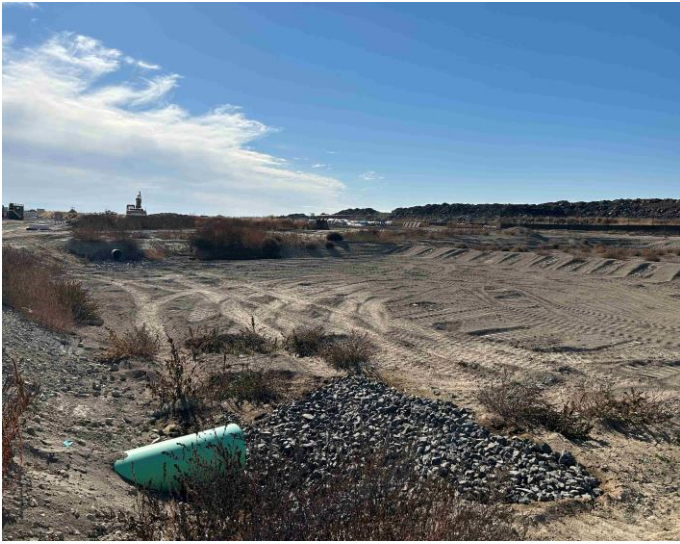
Figure 5: Stormwater infiltration pond with an outlet

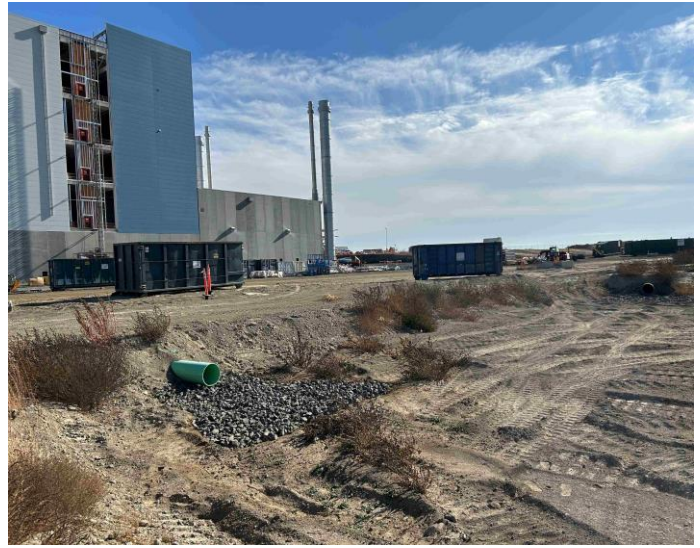
Figure 6: Stormwater infiltration pond with module 2 on the backdrop

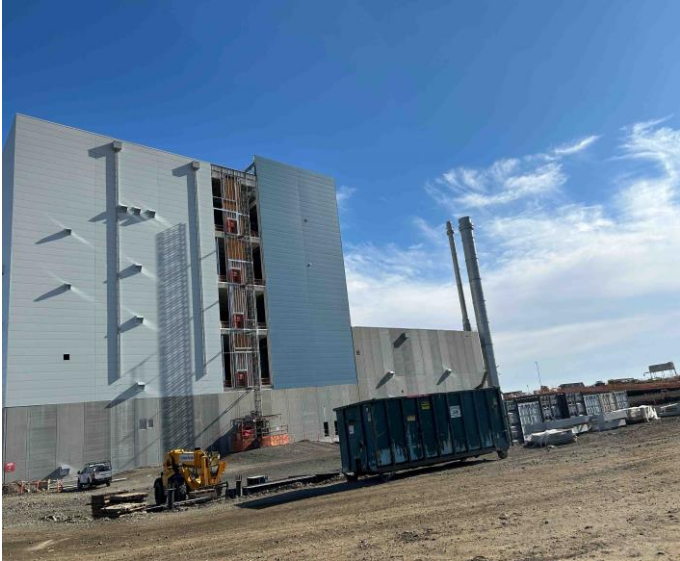
Figure 7: Vacant lot for the construction of the module 3
Situating next to Module 2

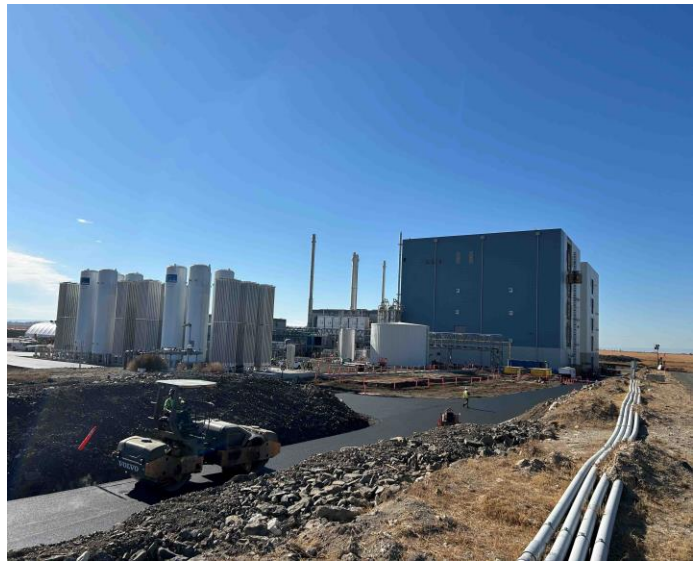
Figure 8: Construction of roads within the property with
Nitrogen plant on left and module 1 on right
