## **Level II Source Control Report- Copper**

### **Seattle Yachts- North Yard- BYGP#: WAG994608**

For 3 Benchmark Exceedances in 2024

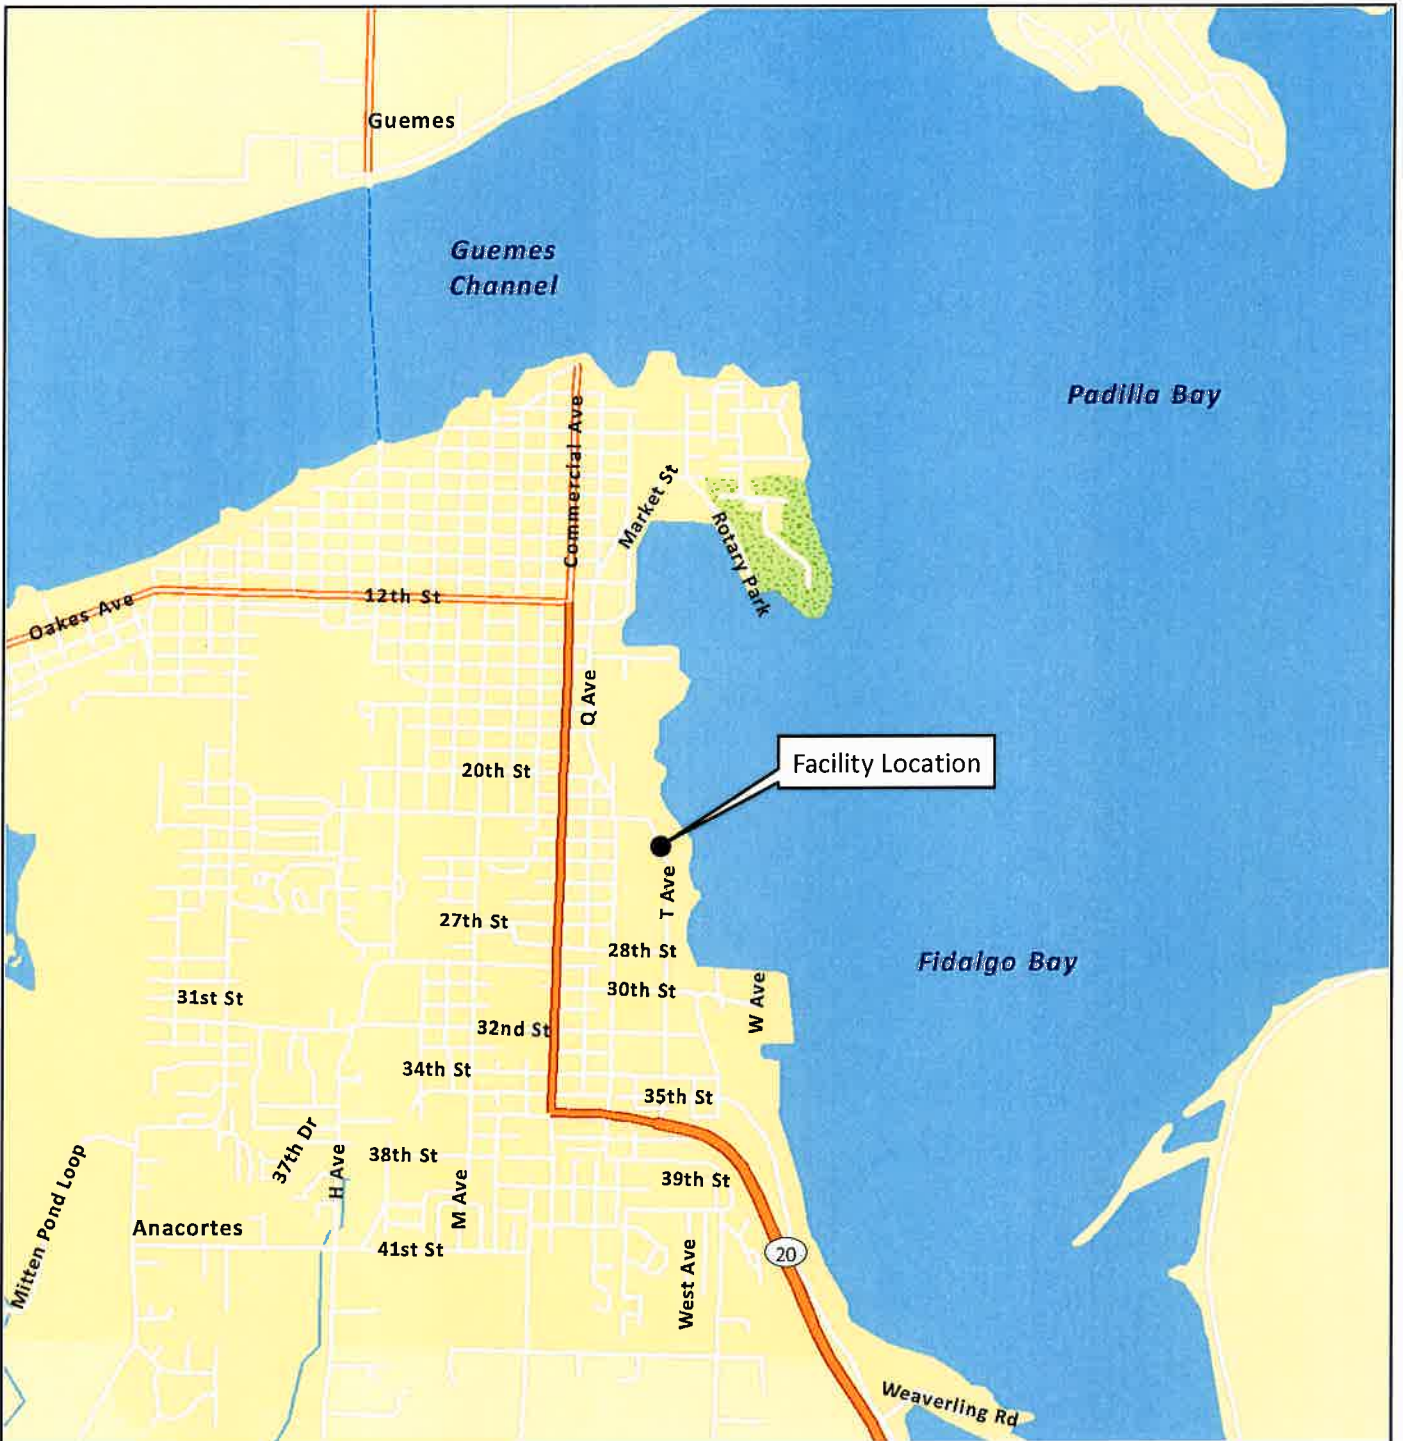
Figure 2. Stormwater Drainage in Boat Maintenance and Repair Area

The boat maintenance and repair area is located at 2417 T Ave, Anacortes (see attached Figure 2) and consists of asphalt and concrete paved surfaces and the facility's main building with an area of approximately 0.78 acres, including the wash pad area. Most of the stormwater runoff from the boat maintenance and repair area drains into catch basins that connect into one discharge conveyance pipe that leaves the facility to eventually discharge into surface waters. The stormwater collected from the boat maintenance and repair area is sampled as part of the facility's monitoring program at a catch basin on the east side of the facility (sampling point SW-1) before leaving Seattle Yachts property.

The boat pressure wash area is located just east of the facility's main building and consists of a concrete paved drainage area with dimensions of approximately 83 ft by 51 ft (4,300 ft<sup>2</sup> or 0.10 acres; Figure 2). When vessel washing is occurring, the pressure wash area drains east to a trench drain located on the east side of the boat pressure wash area. Water collected in the trench drain is pumped to the pressure wash wastewater tank for pretreatment prior to discharge to the sanitary sewer. Outside of the wash pad area, the ground is sloped so that clean stormwater drains to separate storm drain catch basins.
