Level II Source Control Report- Copper

Seattle Yachts- North Yard- BYGP#: WAG994608

For 3 Benchmark Exceedances in 2024

Report Date: November 12, 2024

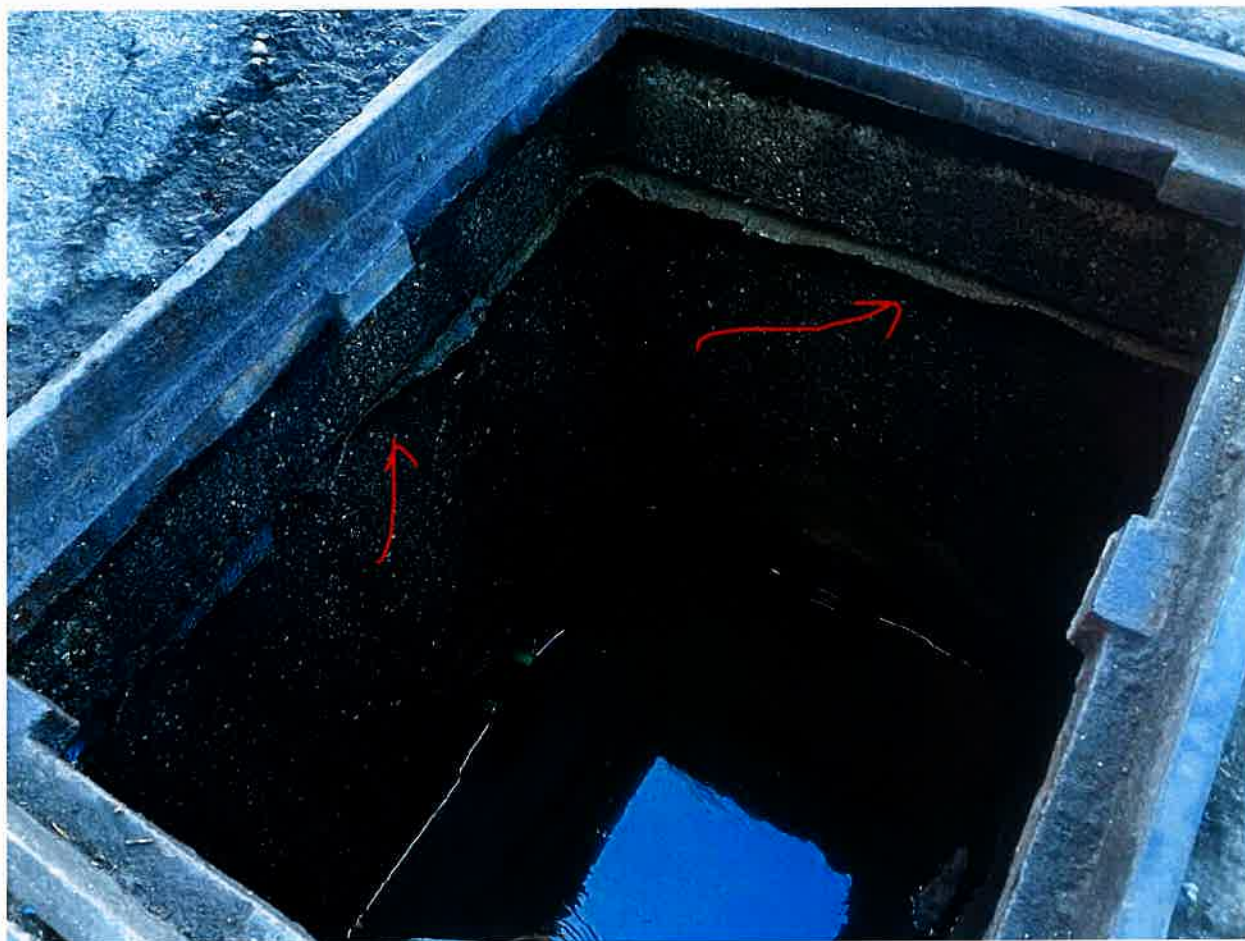
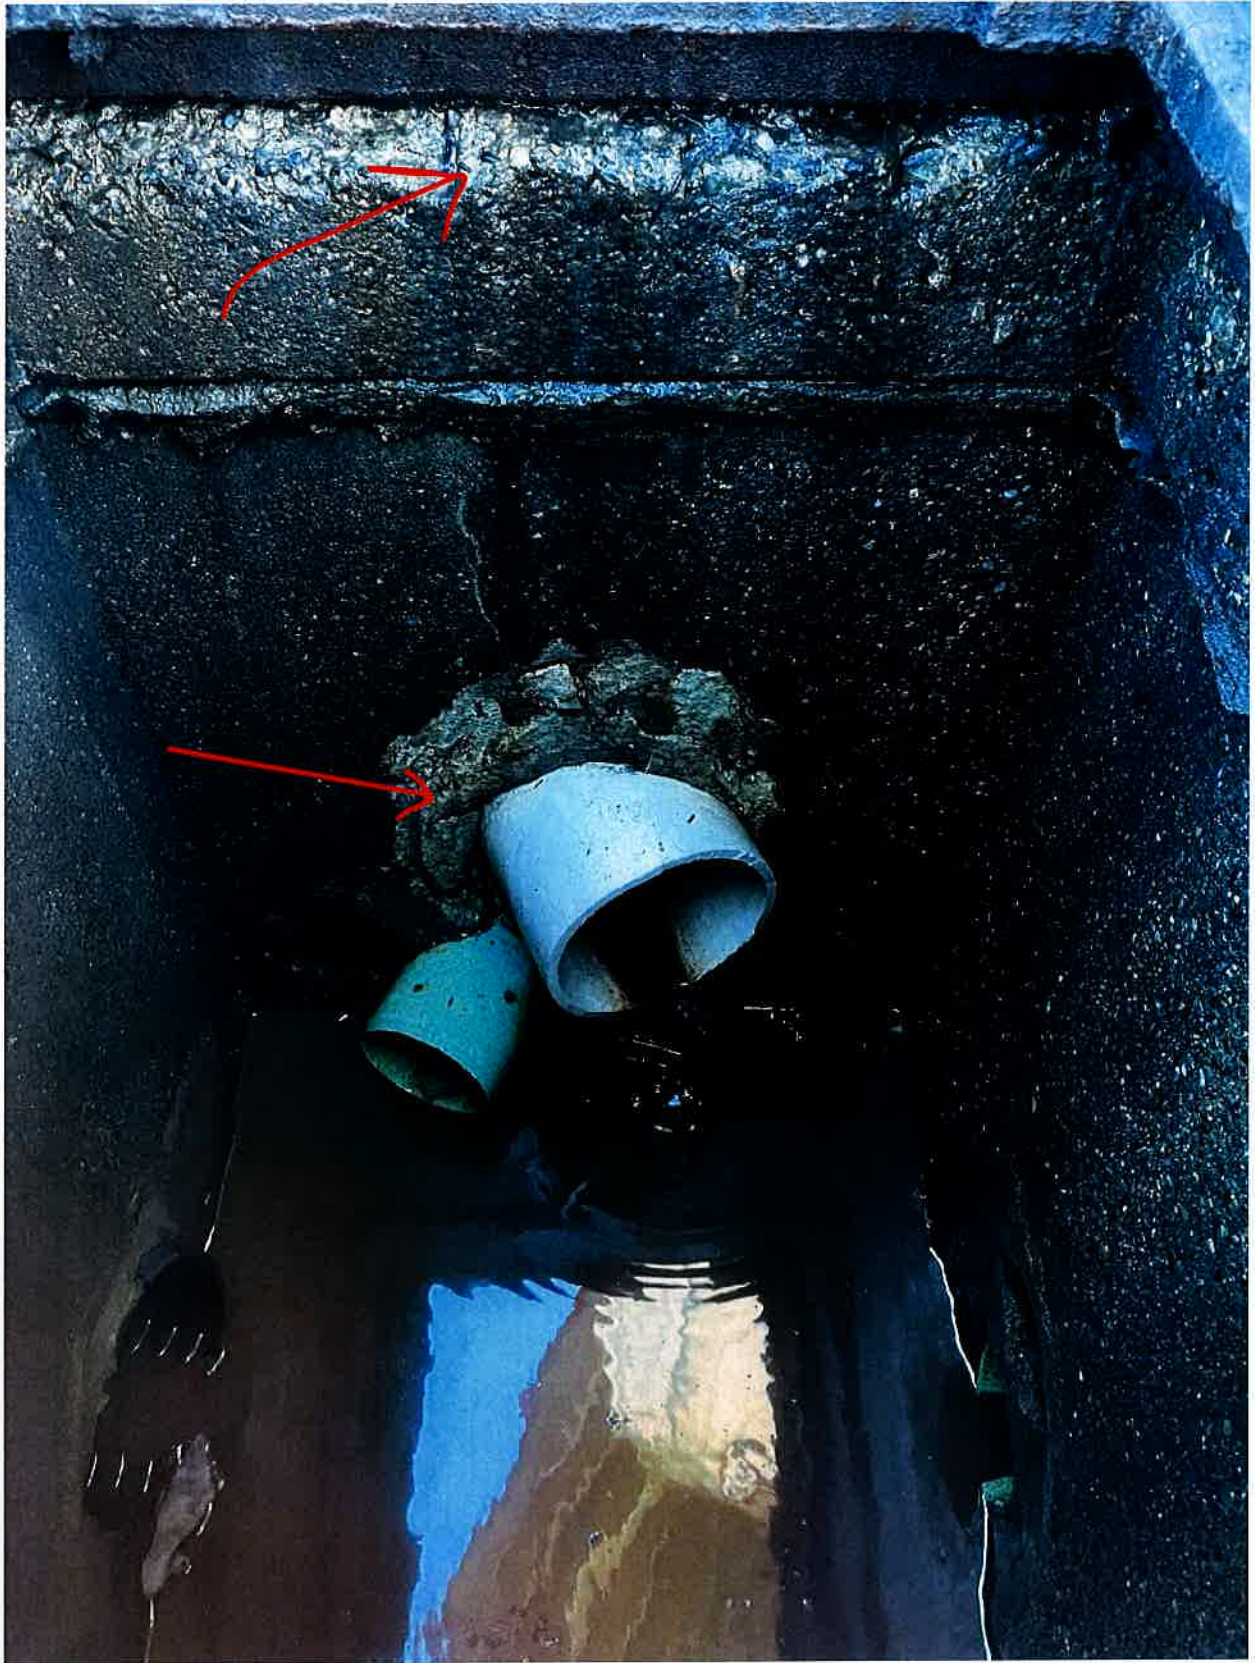
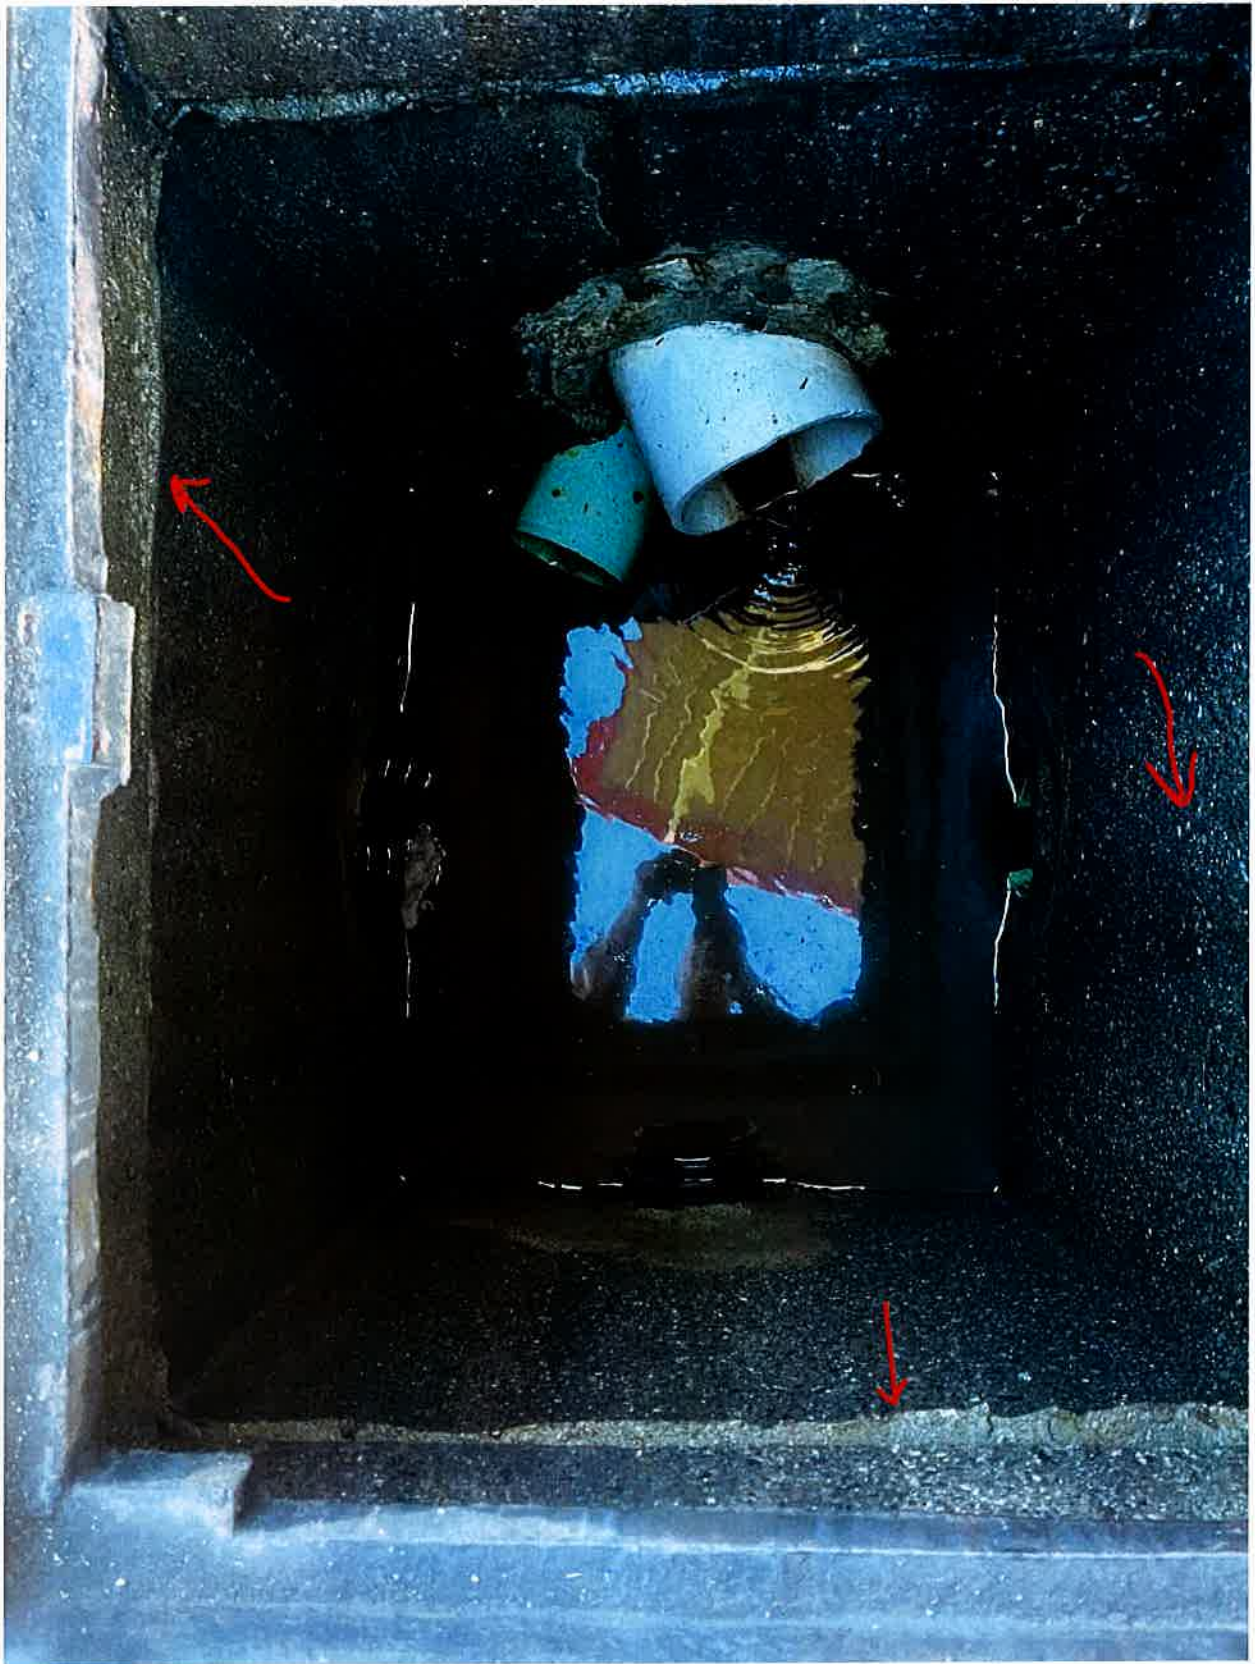
Figure 3.

While still in the summer dry season (September), and with a **dry** boatyard, we noticed ground water seeping into the storm drain vaults thru the vault seams and also thru cracks in the grouting around the drain pipes entering/exiting the vaults. We noticed **greenish-tinged stains** in these damp areas where the water was seeping into the vaults- evidence of the presence of copper in the

groundwater. This groundwater is very likely contributing to the presence of copper in our storm water samples. When weather becomes dry enough to adequately dry the interior surfaces of the vaults, we will seal the interior surfaces of the vaults with **Cem-Kote- Flexible Cementitious Waterproofing** and re-grout pipes with **Blue Line Speed Crete Grouting** to stop the intrusion of the groundwater into the storm drain vaults.

North Yard Storm Drain Vault Photos- Evidence of copper from groundwater under paved yard surface leaching into vault through poorly sealed seams and pipe grouting. Notice green-tinged stains on concrete below seams and around cracked pipe grouting.
