**STATE OF WASHINGTON
DEPARTMENT OF ECOLOGY**

Re: September 2024 Announced Non-Sampling Water Quality Compliance Inspection Report

Permit Compliance Inspection Report

Facility Name and Address: Weyerhaeuser NR Company
1701, 2901, & 3539 Industrial Way
Longview, WA 98632

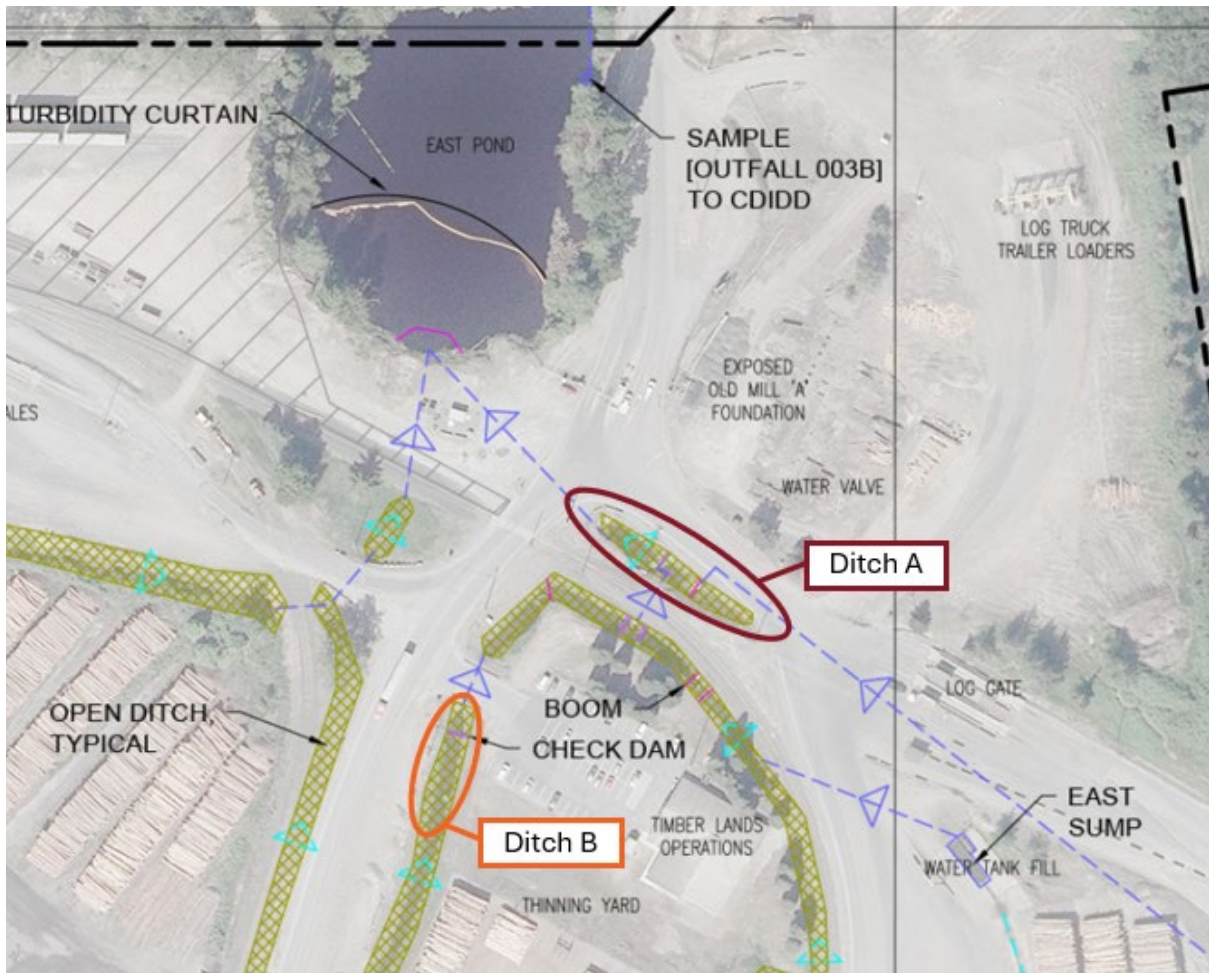
We visited two drainage ditches near the TOB during the inspection. I have identified the two ditches we visited in Figure 1. In the ditch identified as A in Figure 1, I noted that Weyerhaeuser did not modify this ditch to a riprap-lined ditch, as they did with many of the other conveyance ditches throughout the log sort and export yard. I observed vegetation along the sides and bottom of the ditch (Photo 1 through Photo 4, Appendix A). I noted solids accumulated in portions of the ditch (Photo 2, Appendix A). This ditch receives all runoff from the eastern portion of the log sort and export yard, including the export yard, debarker discharge, and the discharges from NDP's chips area. I observed the box where portions of the East Sump and eastern drainage ditches enter the ditch identified as A in Figure 1 (Photo 1 and Photo 3, Appendix A). I observed scum and float on the surface of the water in the conveyance ditch downstream of the bar screen and the discharge of East Sump and the eastern ditches (Photo 4, Appendix A). I also noted exposed soil and erosion along the area above the outlet culvert from the ditch to the East Pond (Photo 4, Appendix A). I observed two sets of floating booms in the ditch and noted that the booms appeared to be in good condition at the time of the inspection (Photo 1 and Photo 3, Appendix A).

At the ditch identified as B in Figure 1, I noted scum and solids accumulated on the surface of the ditch upstream of the boom, between the boom and check dam, and downstream of the check dam (Photo 5 through Photo 7, Appendix A). Weyerhaeuser modified this ditch from a vegetated ditch to a riprap lined ditch. I noted minimal vegetation growing along the western side of the conveyance ditch (Photo 5 and Photo 6, Appendix A). I also observed wood chips and debris accumulated along the northeastern side of the riprap near the check dam structure (Photo 5 and Photo 7, Appendix A). I observed the water level downstream of the check dam was below the outlet level for discharging to the next conveyance ditch (Photo 7, Appendix A).

Figure 1: Map of a portion of Weyerhaeuser's stormwater system at the log sorting and export yard.

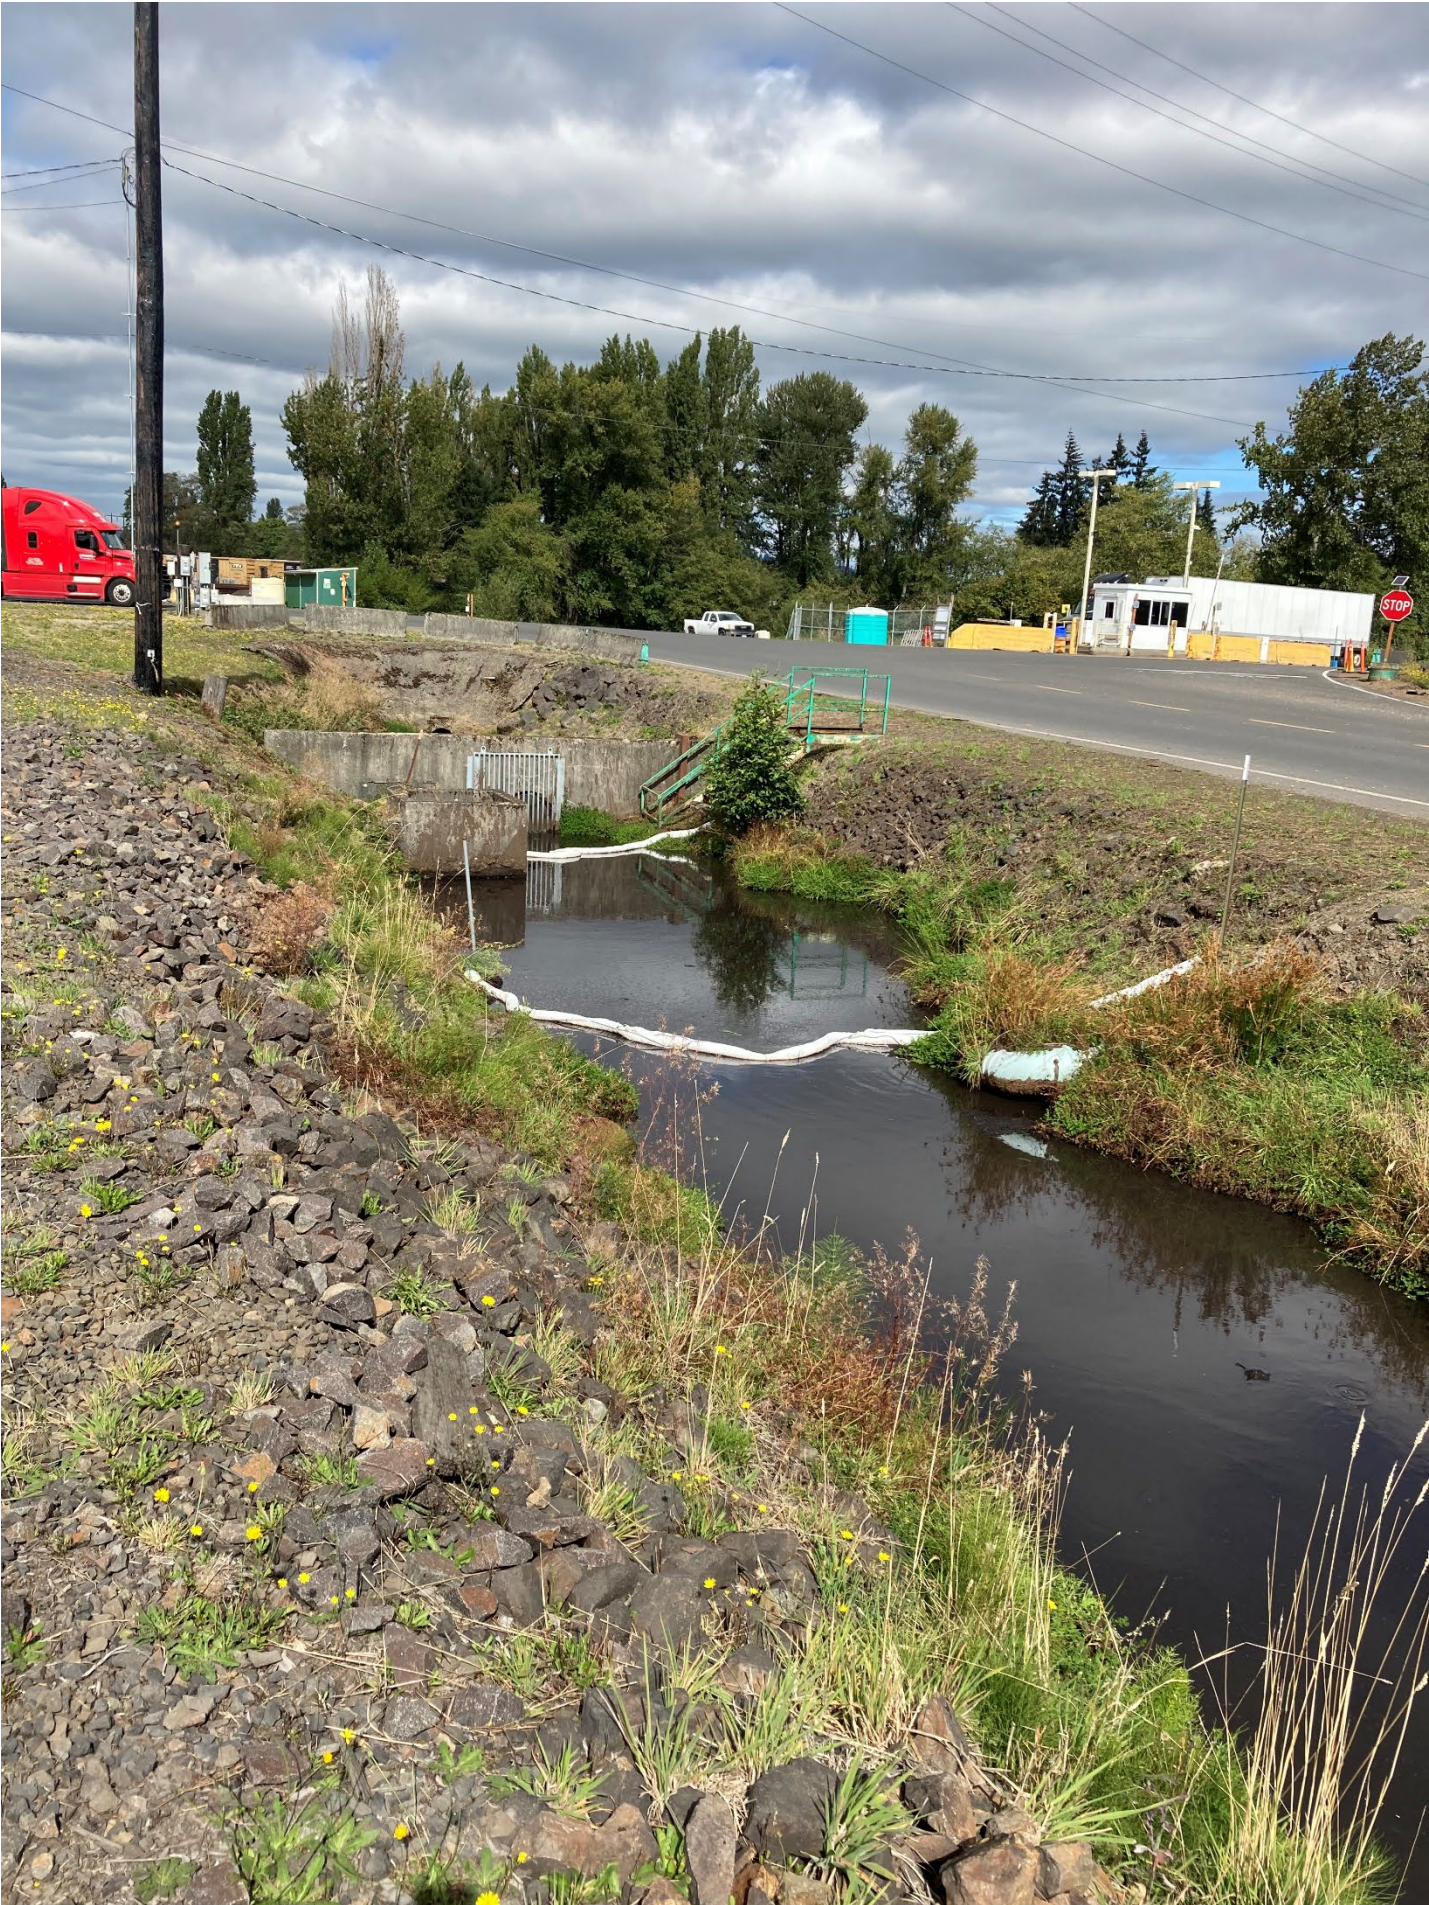
Photo 1: Conveyance ditch collecting runoff from the East Sump, Export Dock pump station, and eastern portion of the log sort and export yard.

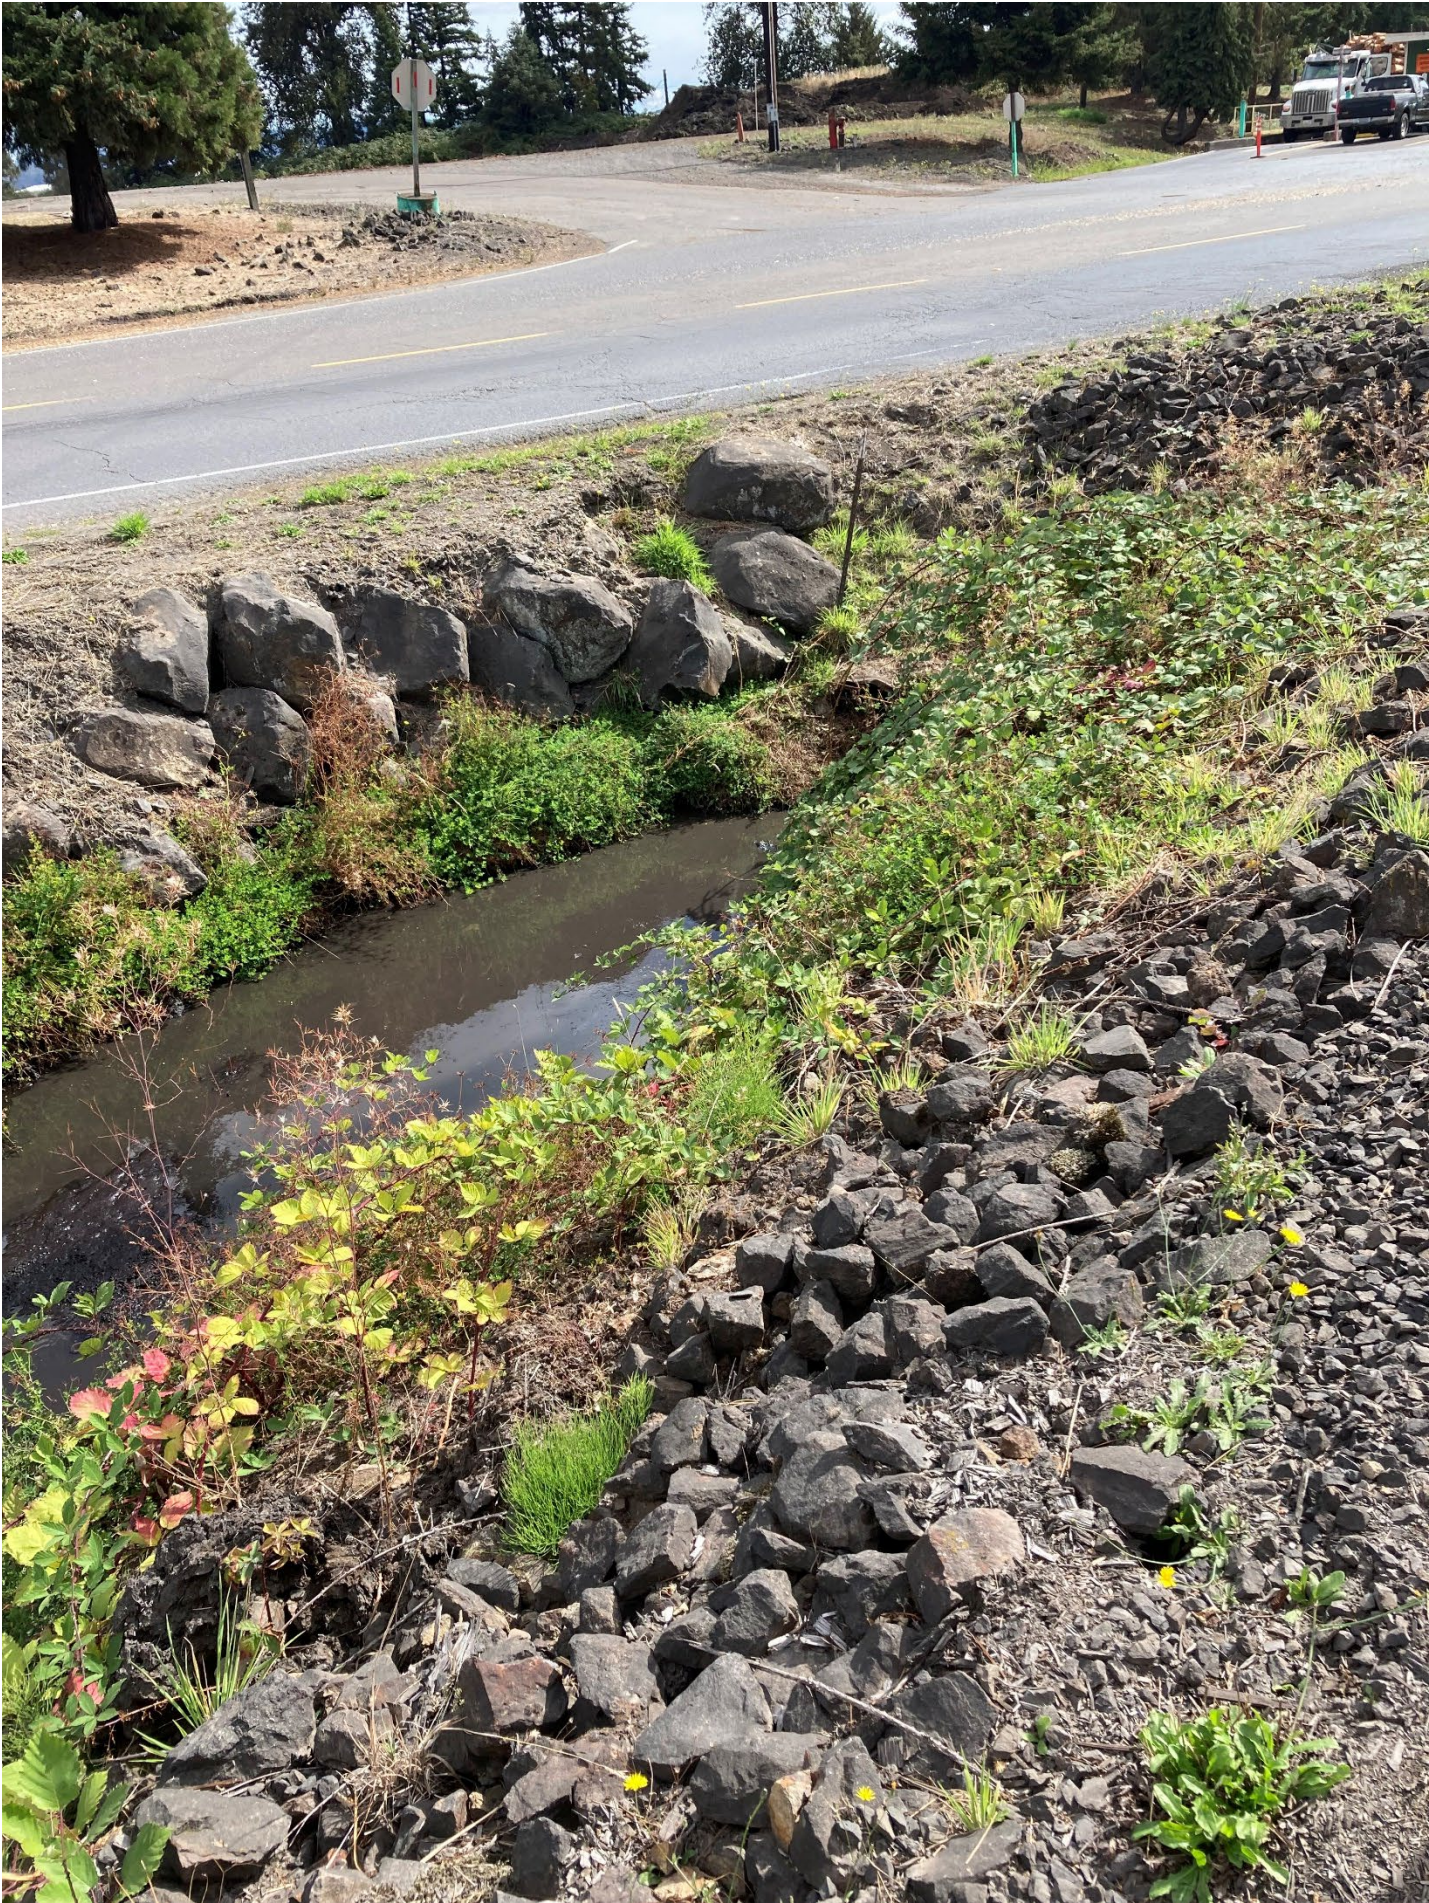
Photo 2: Drainage ditch north of TOB looking east toward the East Sump.

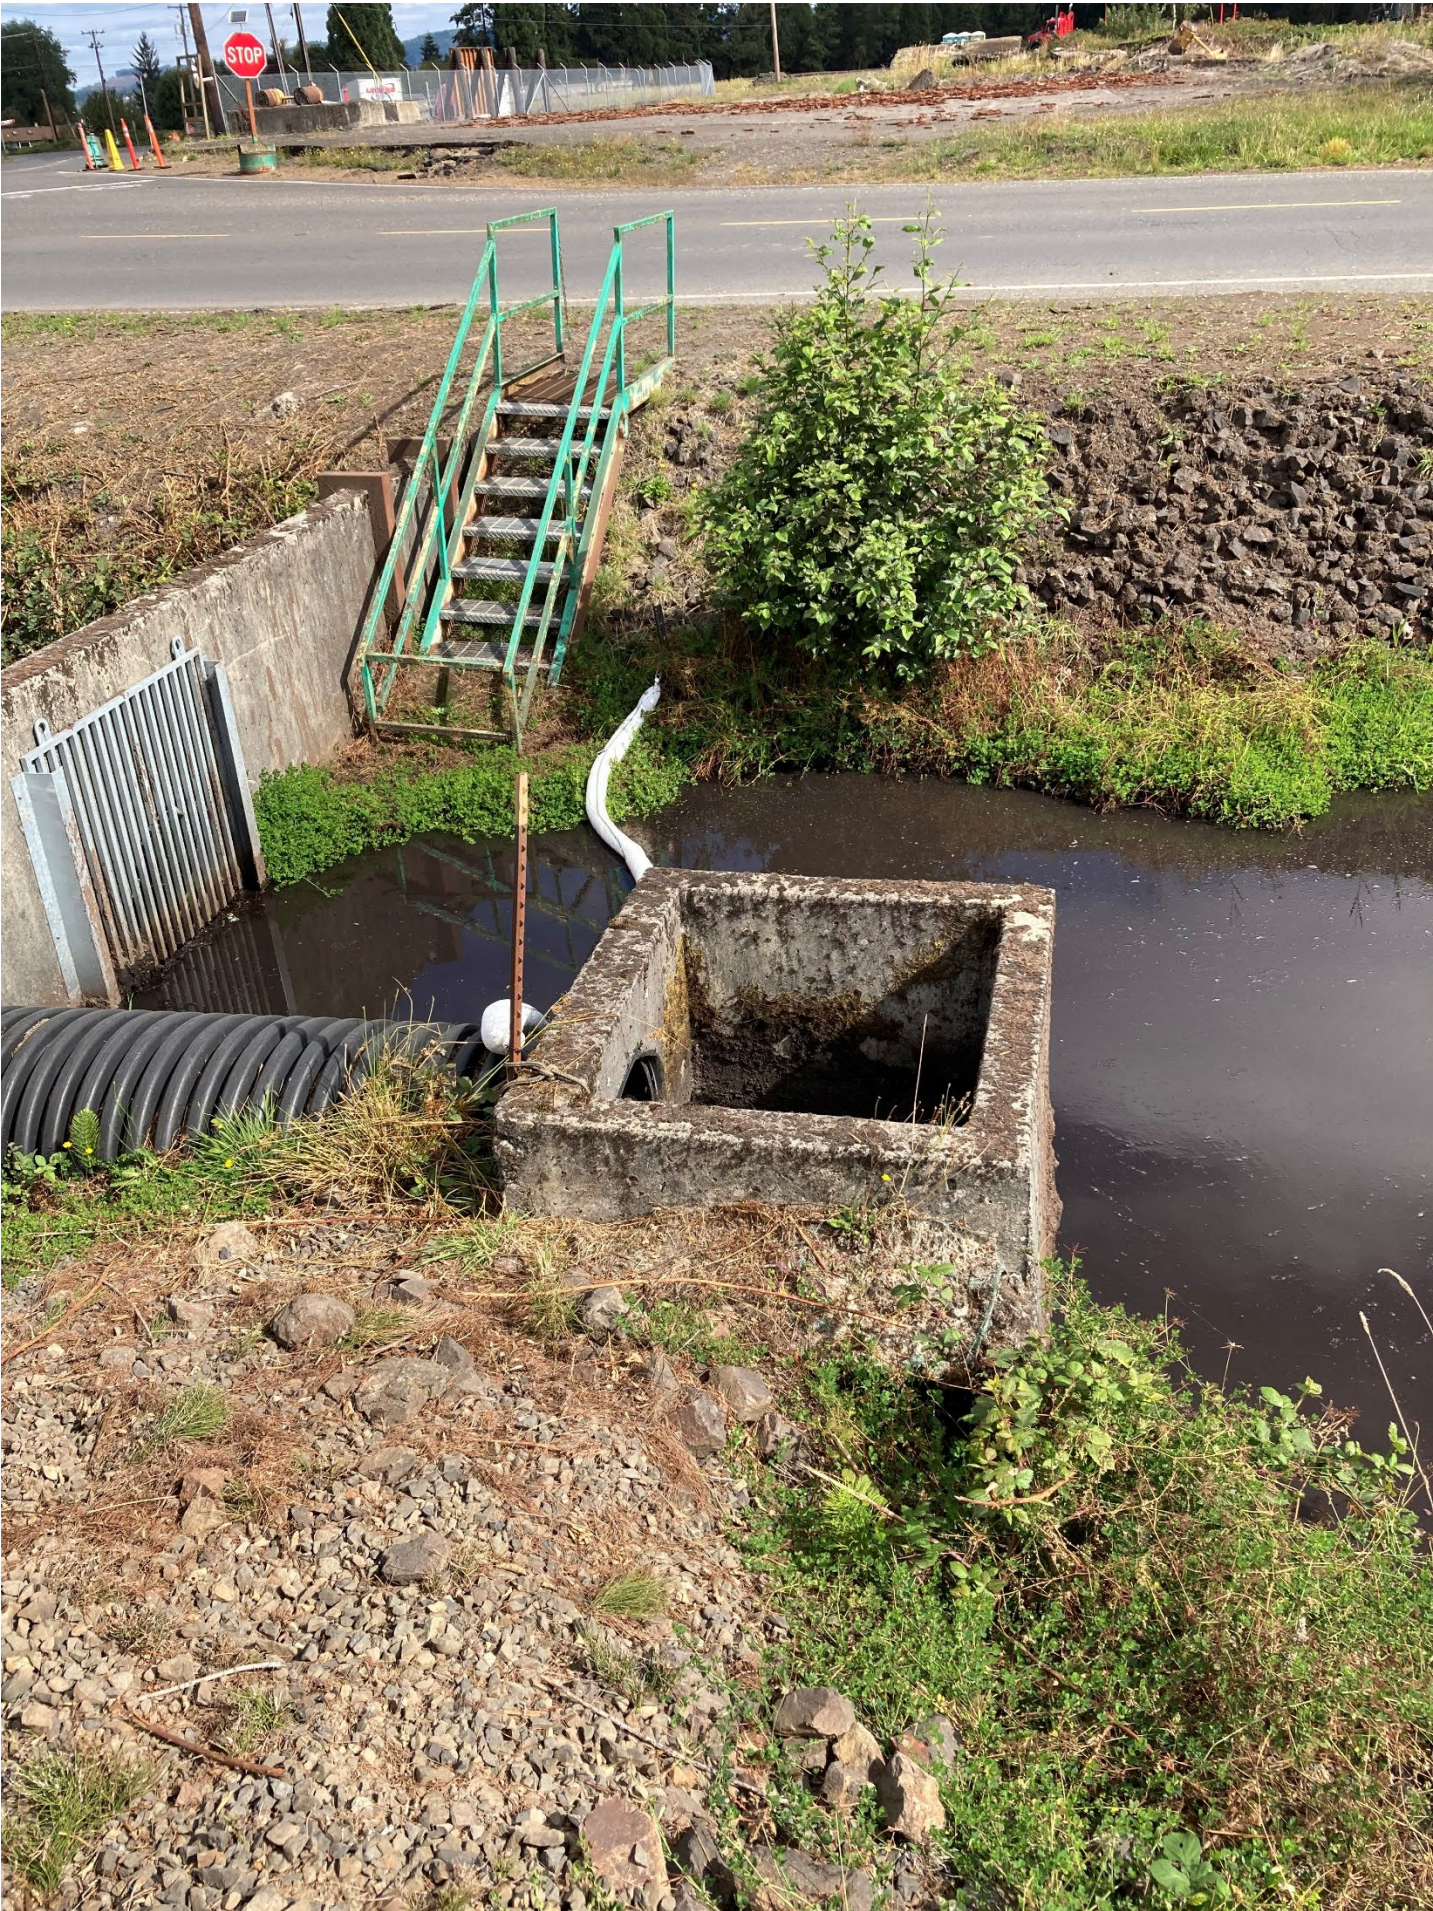
Photo 3: Inlet and bar screen at the conveyance ditch receiving the East Sump and eastern conveyance ditches runoff.

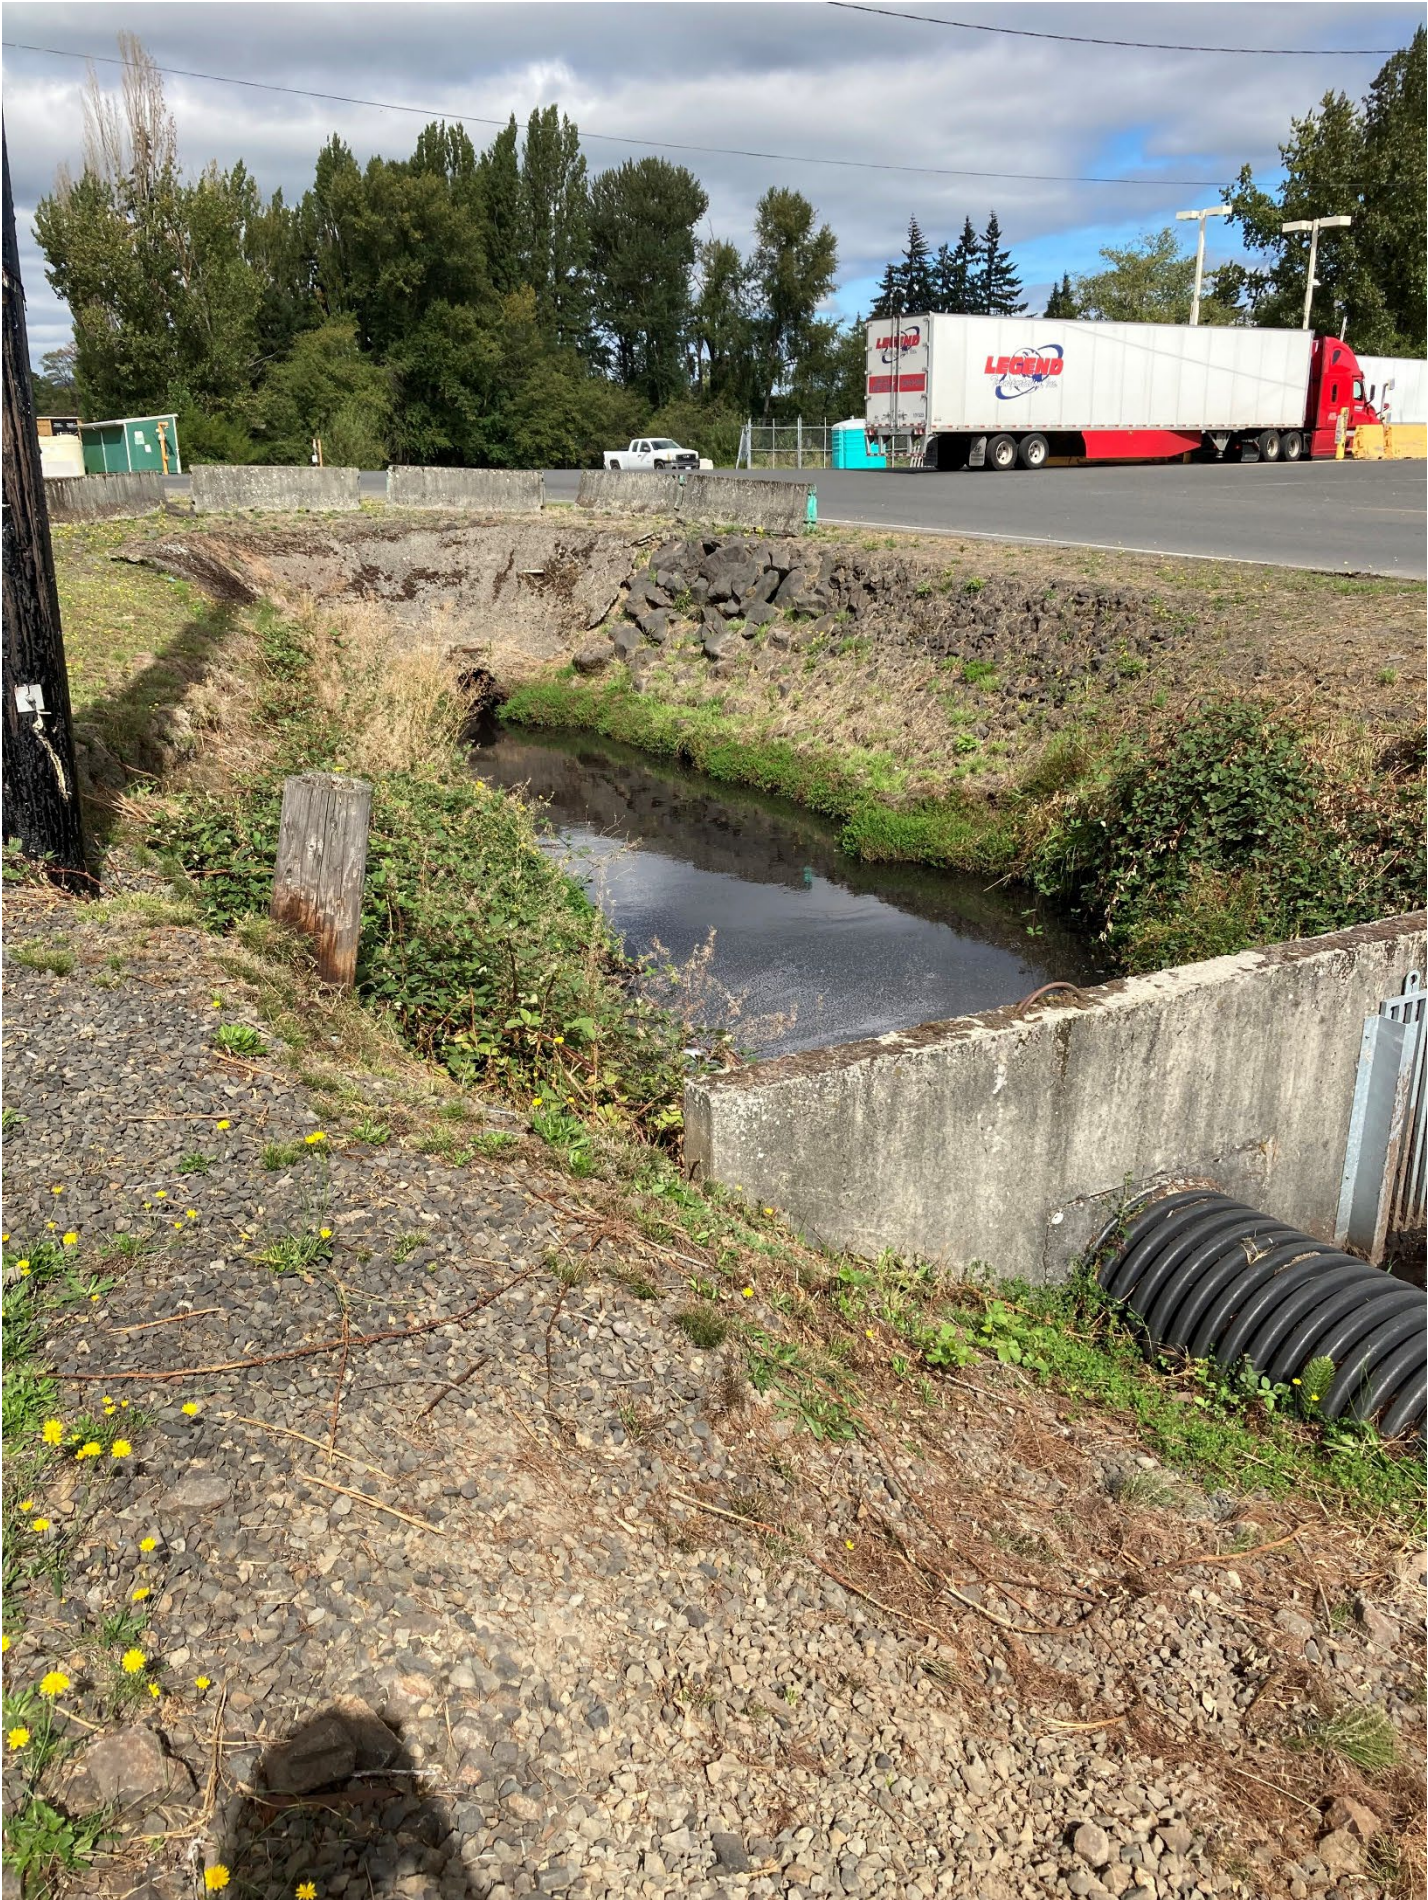
Photo 4: Conveyance ditch downstream of bar screen and inlet of East Sump, Export Dock pump, and eastern conveyance ditches.

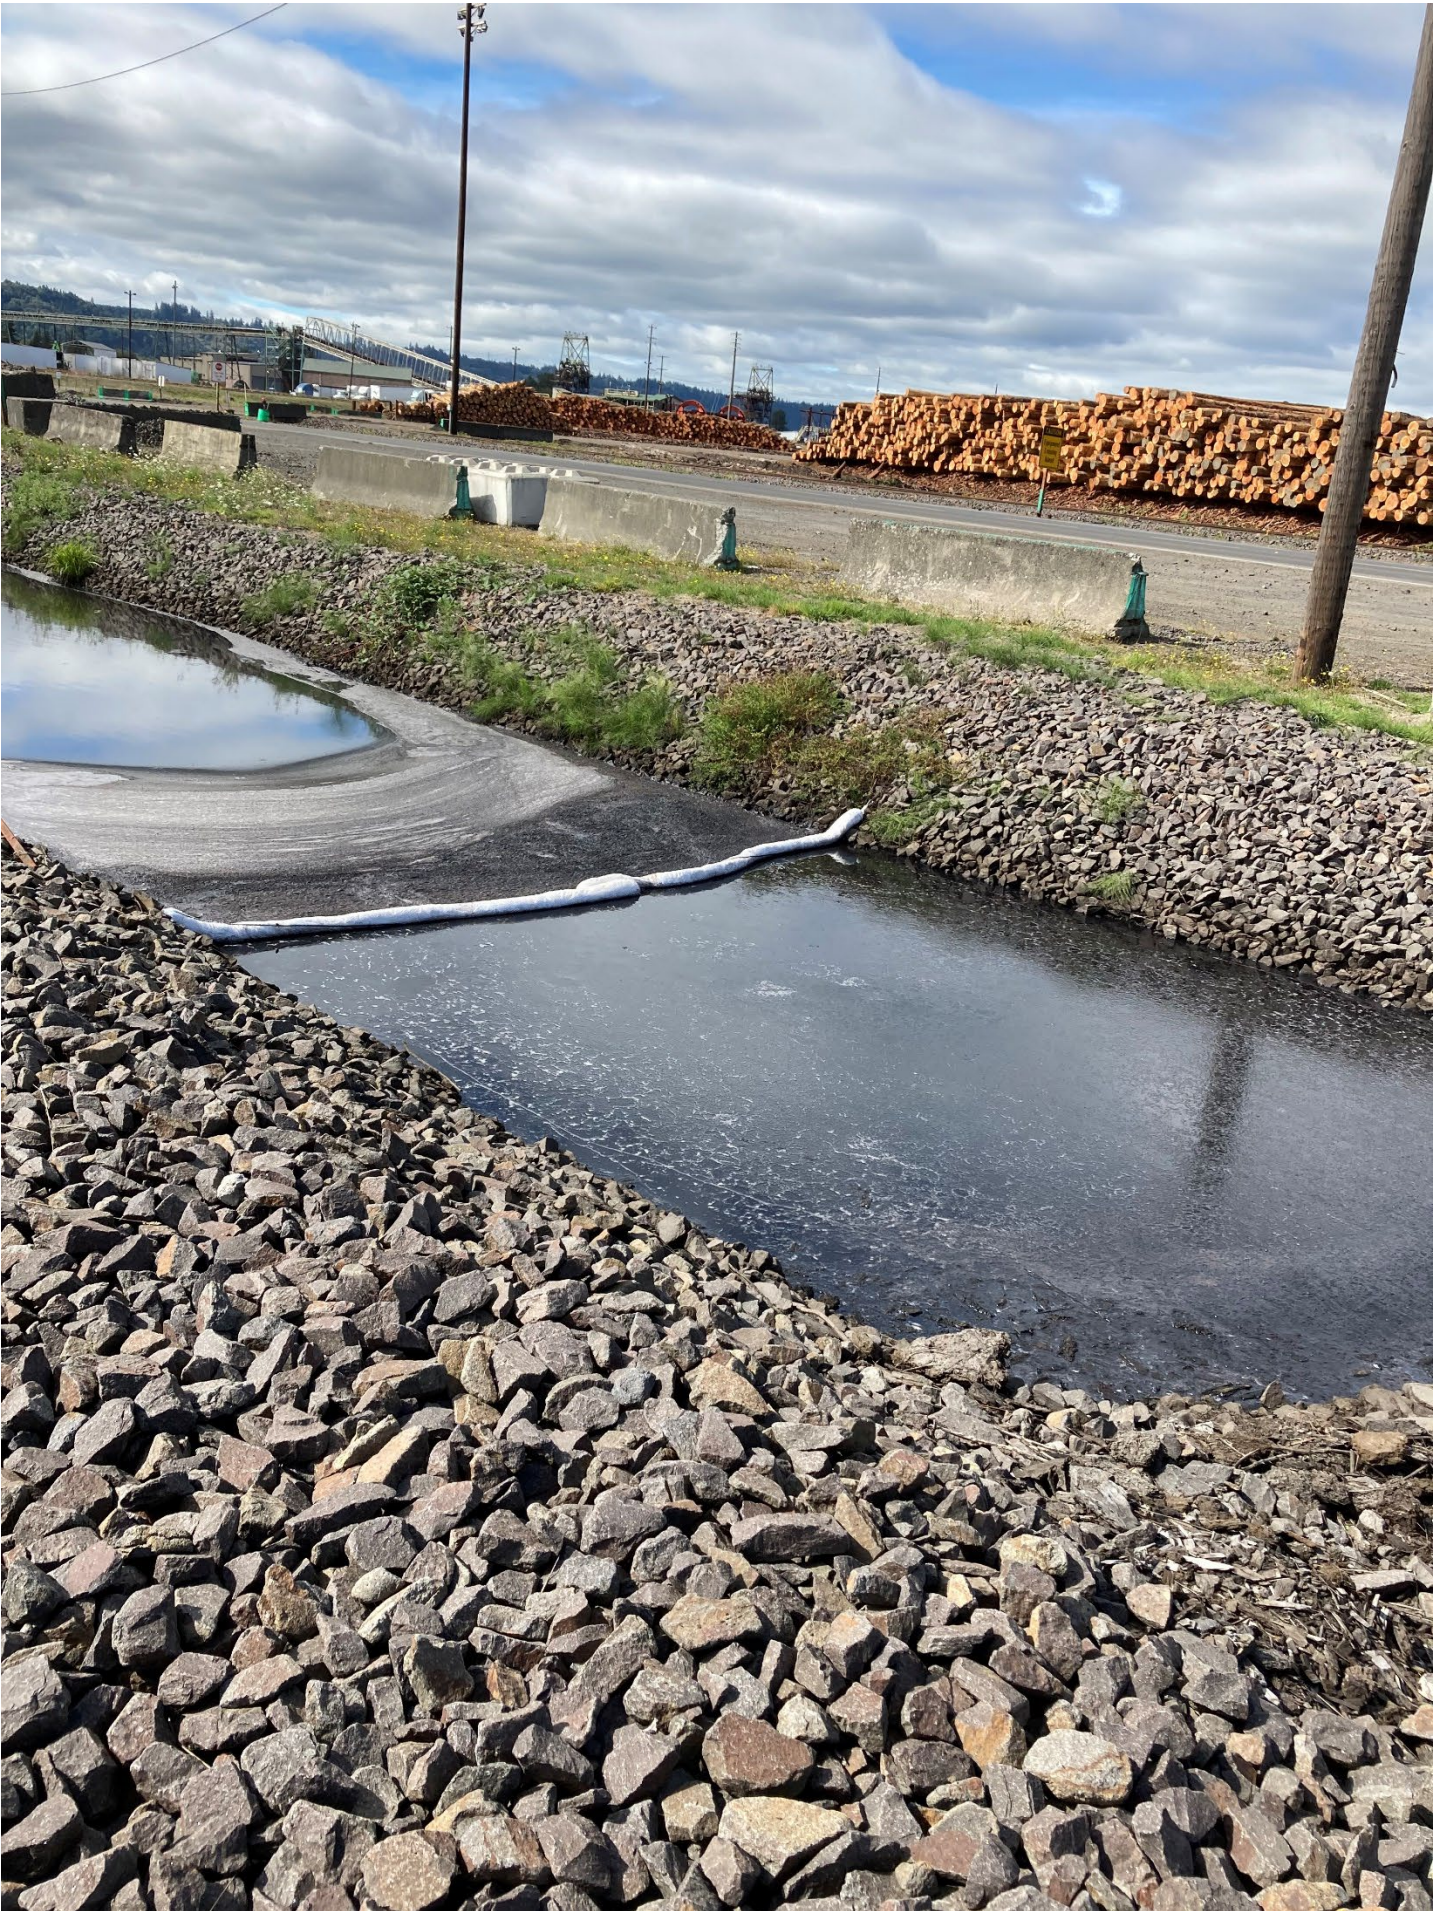
Photo 5: Conveyance ditch located west of TOB before the check dam structure.

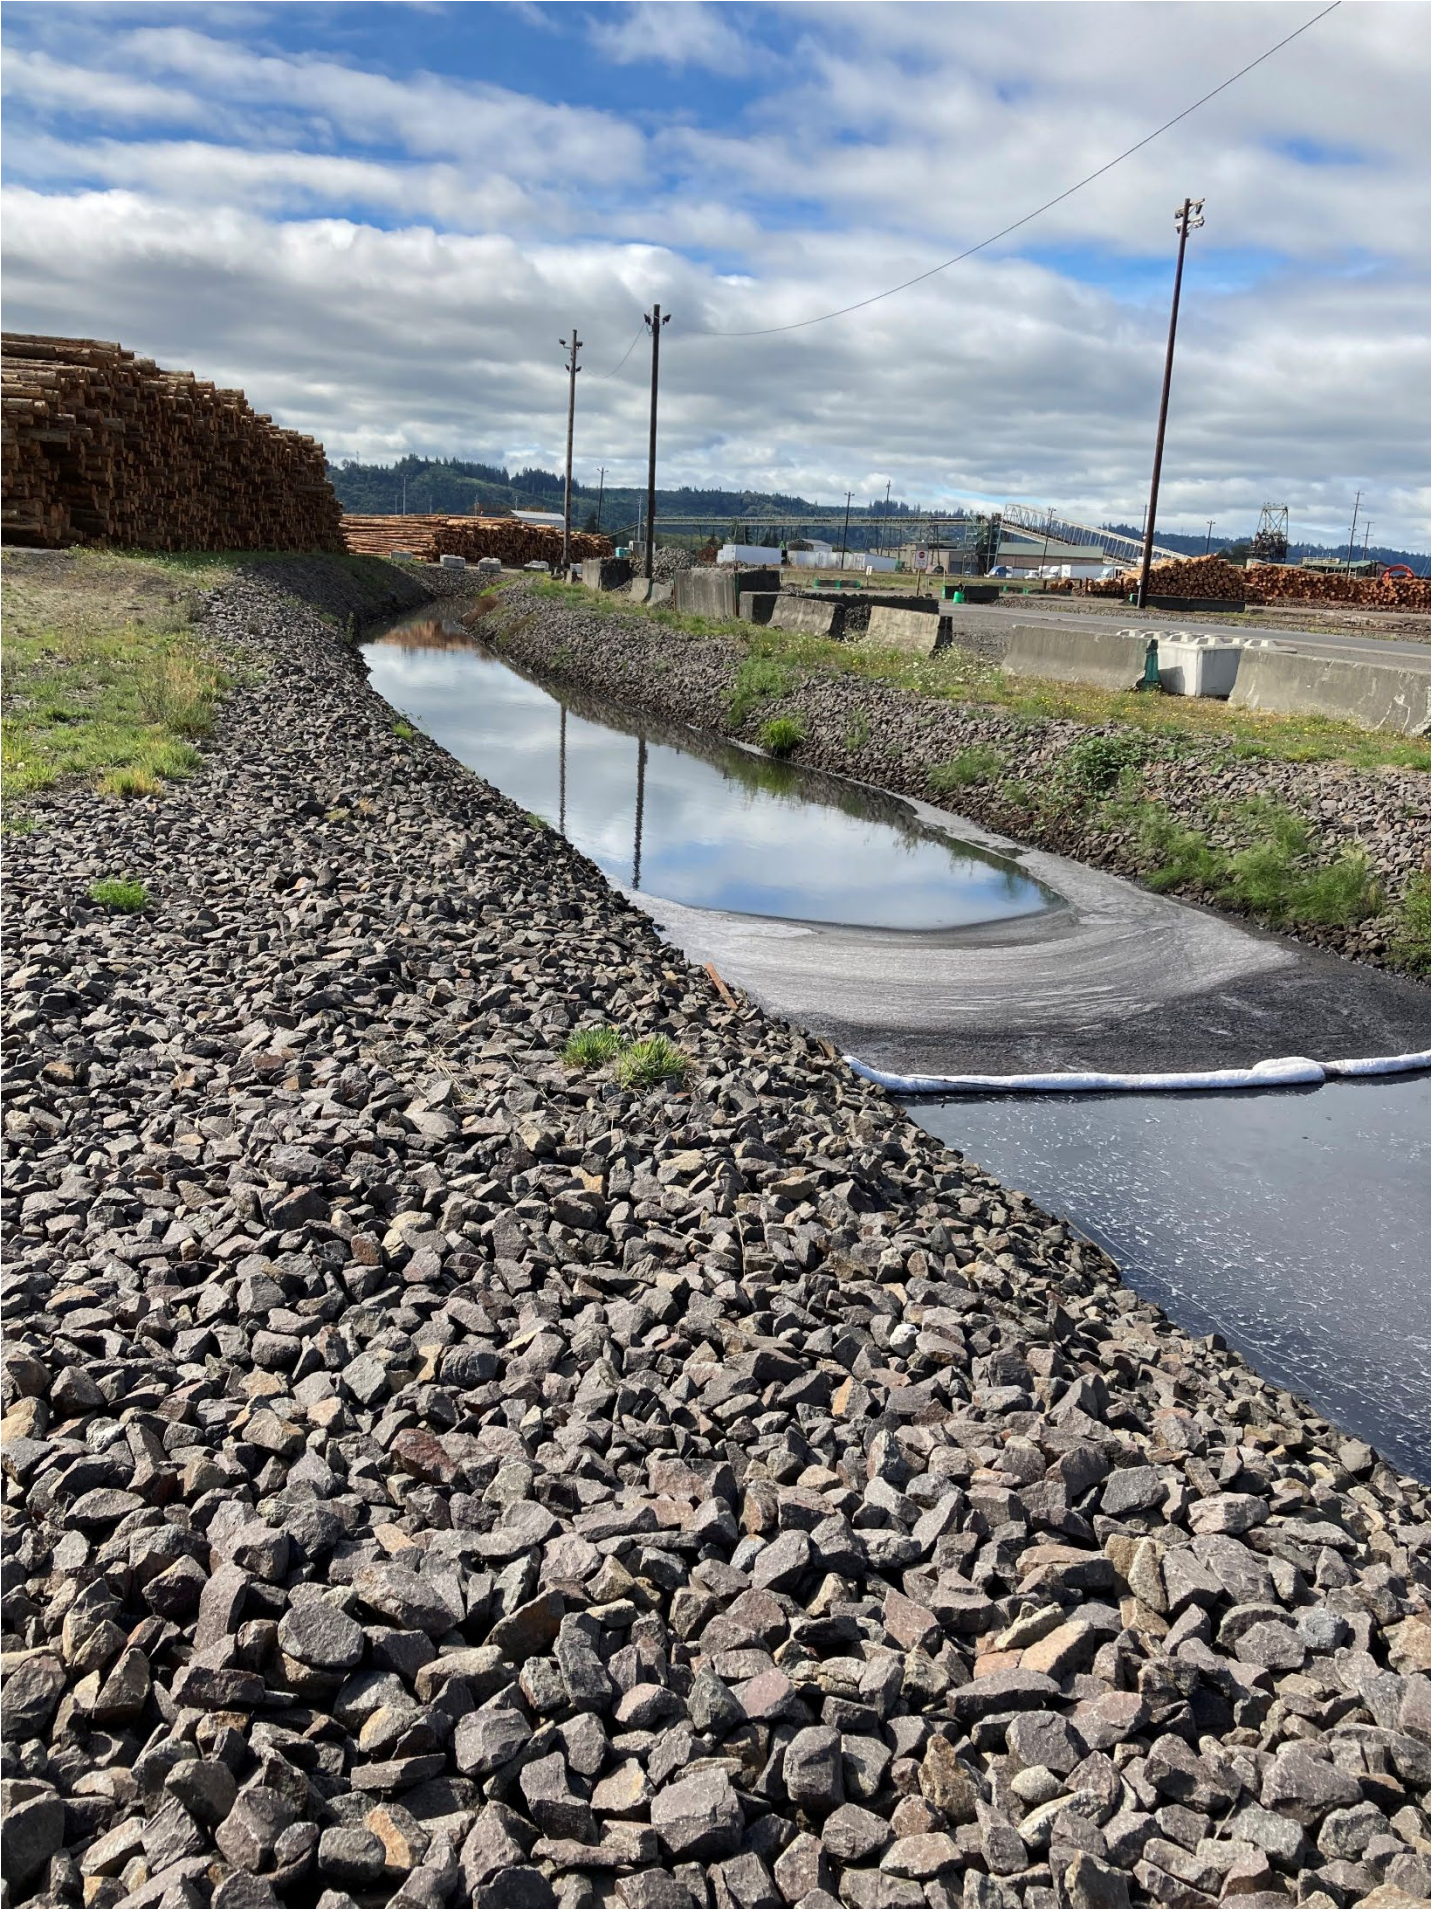
Photo 6: Conveyance ditch to the west of TOB looking south.

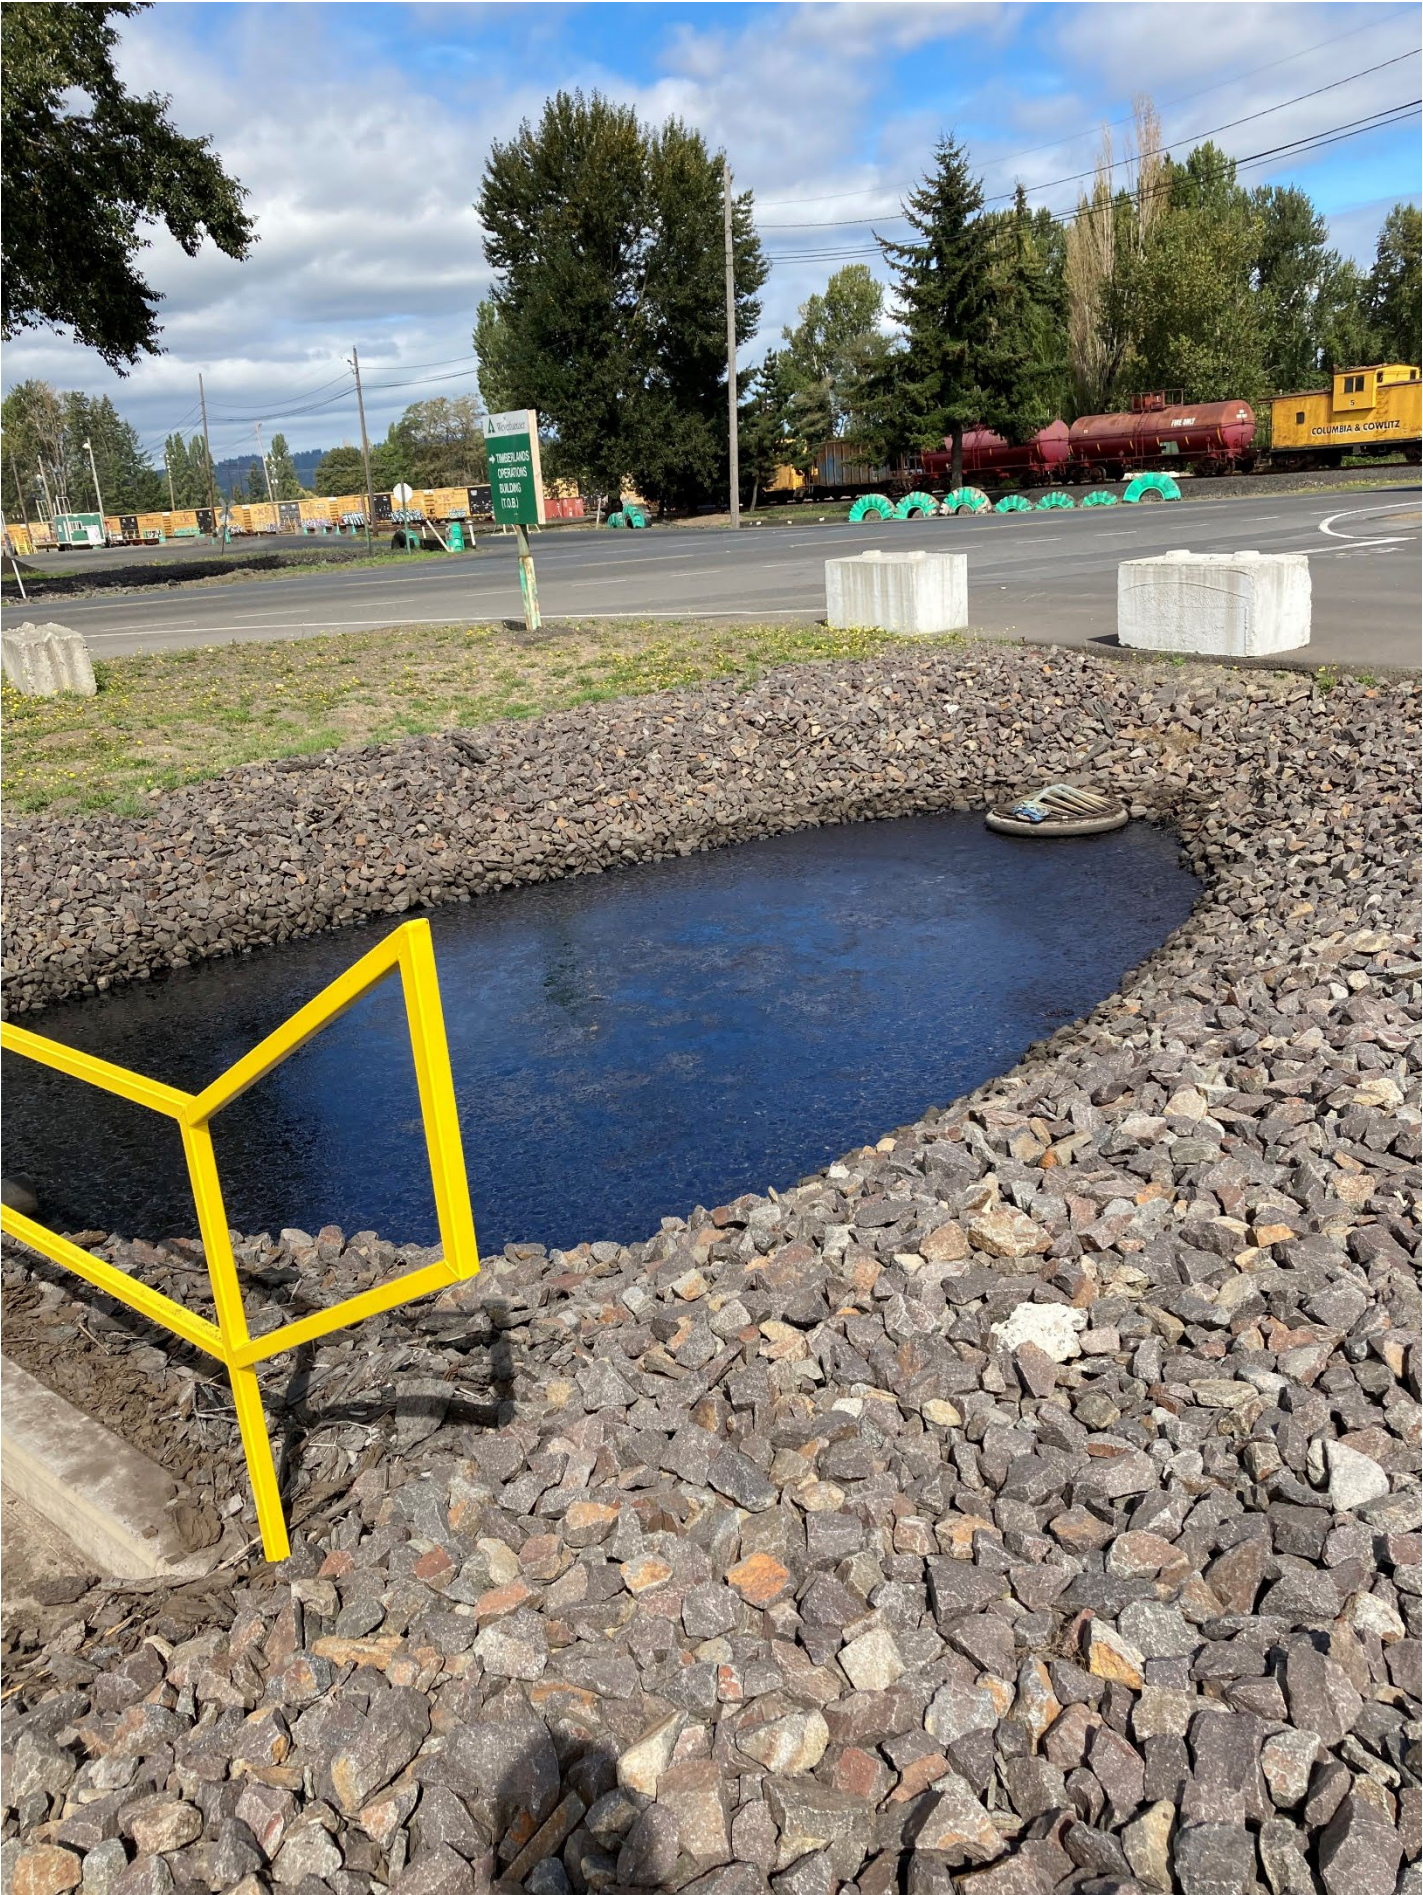
Photo 7: Conveyance ditch outlet downstream of the check dam located west of the TOB.
