**STATE OF WASHINGTON
DEPARTMENT OF ECOLOGY**

Re: September 2024 Announced Non-Sampling Water Quality Compliance Inspection Report

Permit Compliance Inspection Report

Facility Name and Address: Weyerhaeuser NR Company
1701, 2901, & 3539 Industrial Way
Longview, WA 98632

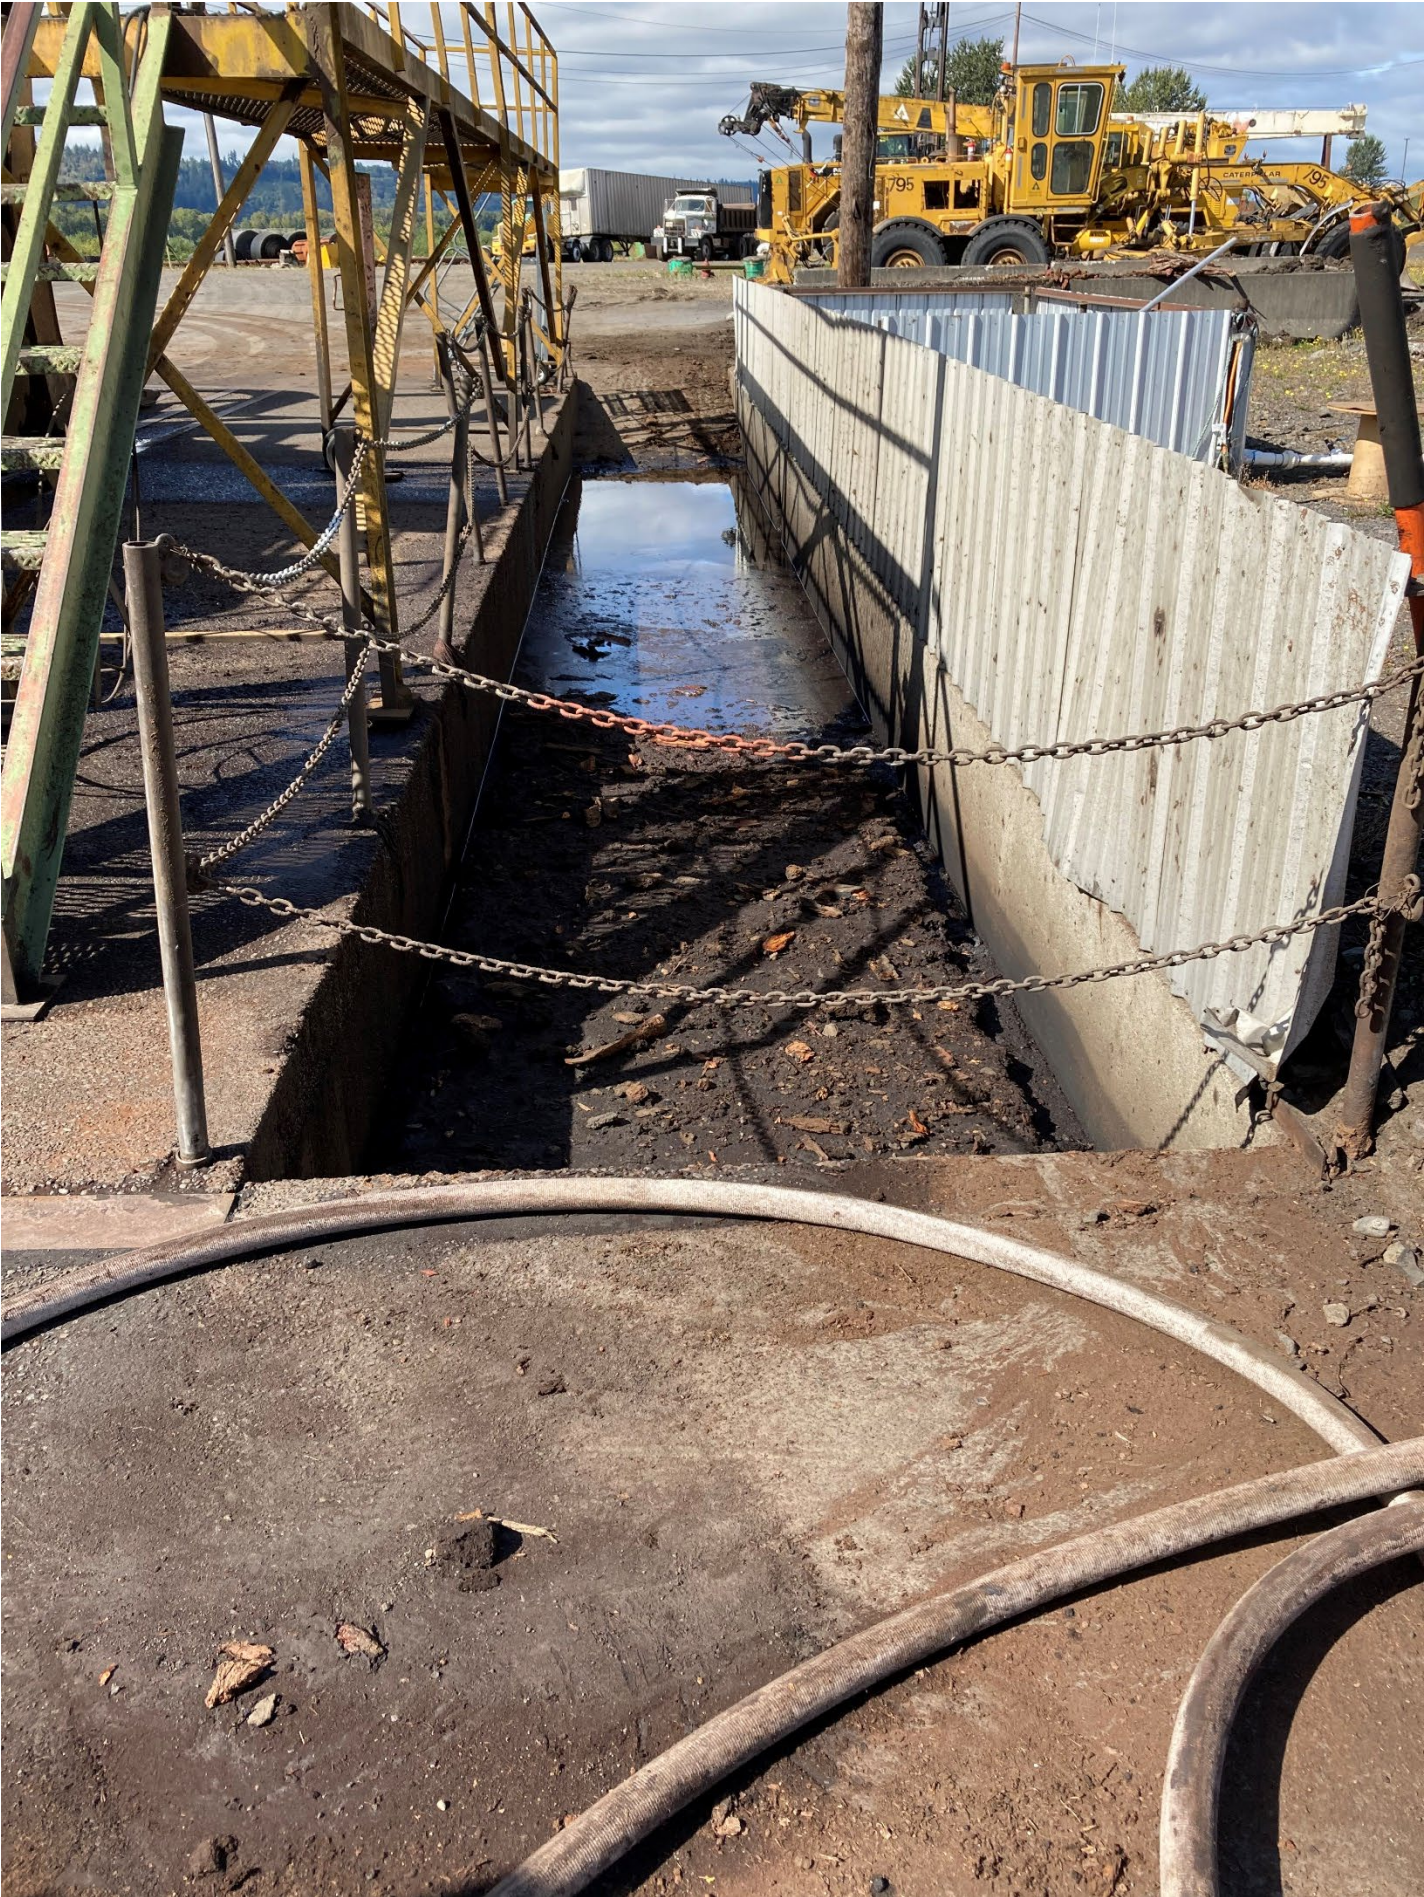
We visited Outfall 001B, the old oil-water separator, the bark storage area, and the discharge to NDP's Chips Scale Sump while at the Stacker Shop area. I noted wood solids and debris located in the Outfall 001B sump and scum in the basin that pumps to NDP's Industrial WWTP (Photo 8 and Photo 9, Appendix A). I asked Kevin how often Weyerhaeuser cleans out the Outfall 001B sump. Kevin reported they clean it out as needed, approximately one to two times a year.

Photo 8: Outfall 001B sump at the Stacker Shop.

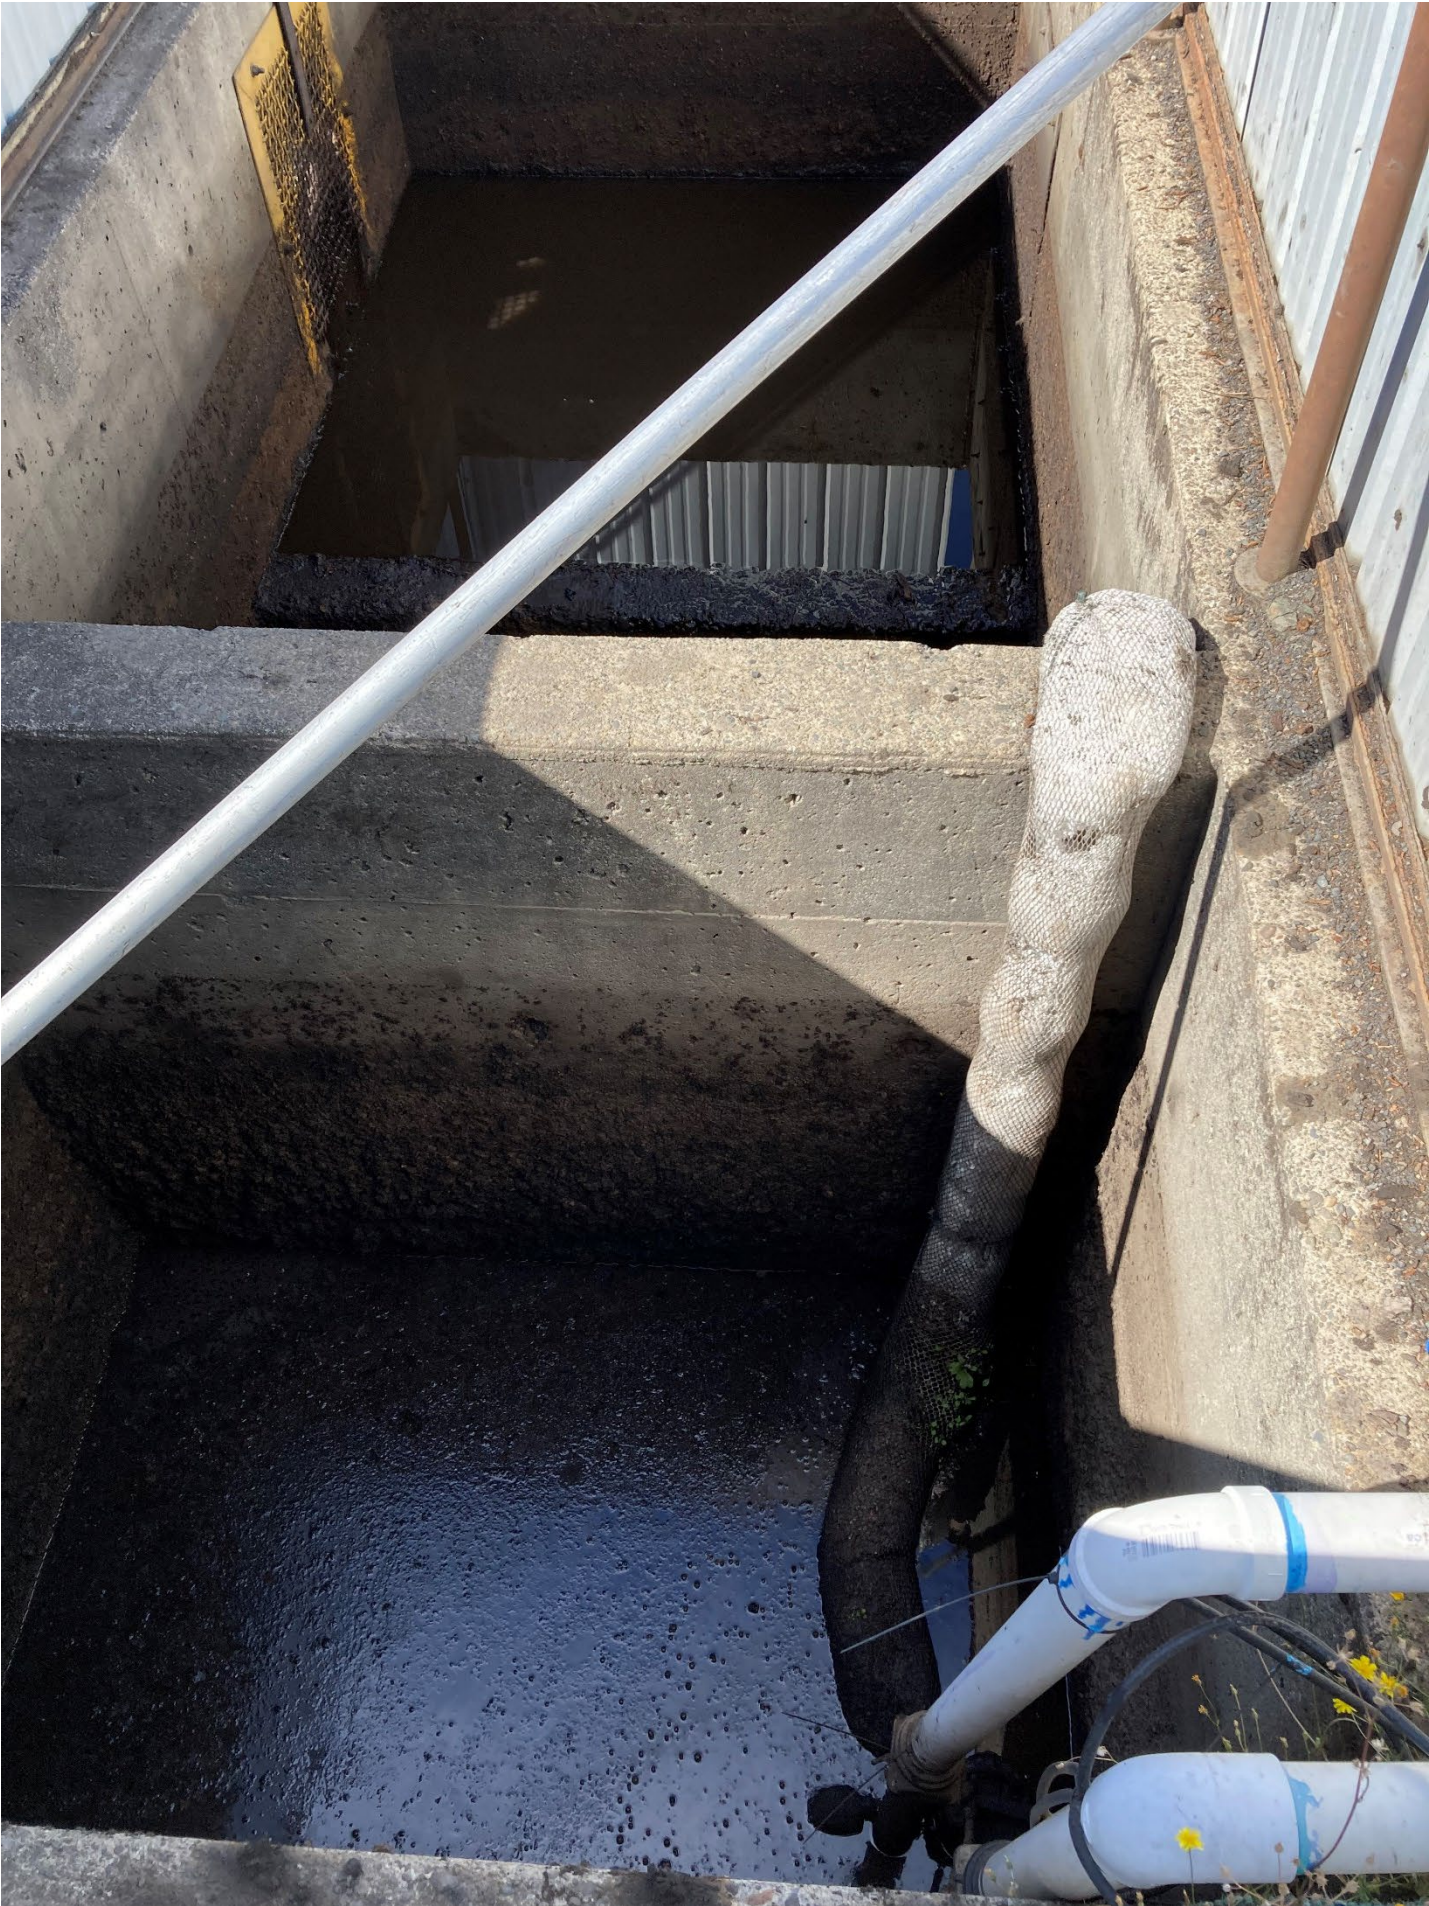
Photo 9: Scum and solids in the sump where Outfall 001B pumps to NDP’s Industrial WWTP.

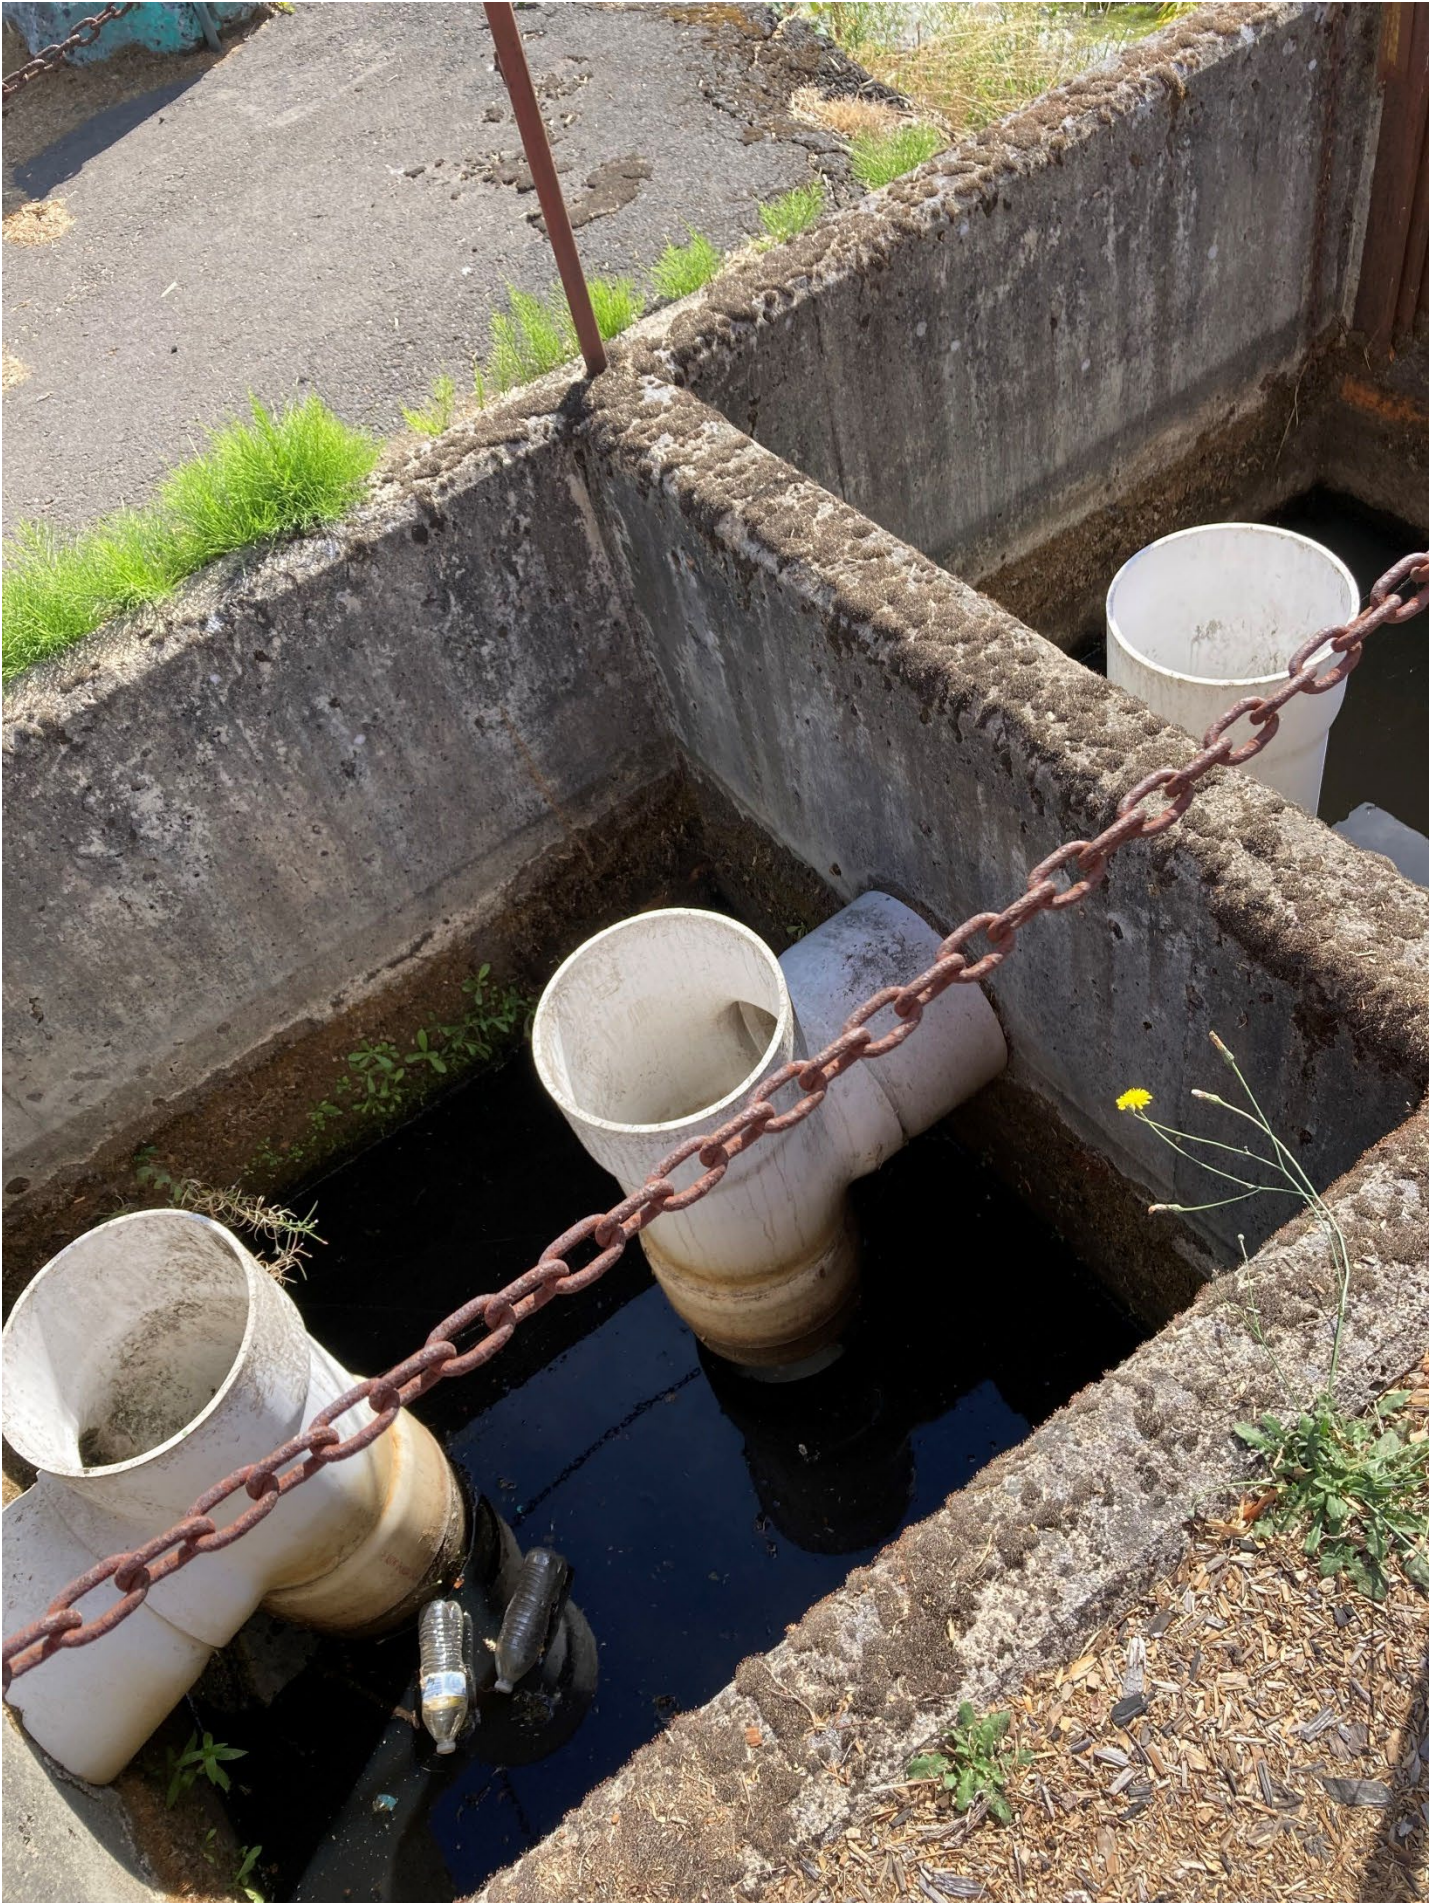
I observed standing water in the old oil-water separator and some floating trash; however, I did not observe a discharge from the old oil-water separator (Photo 10 and Photo 11, Appendix A). I did not observe an oil sheen at the time of the inspection. I asked Weyerhaeuser if they knew where the old oil-water separator discharges to. Weyerhaeuser's historic stormwater documentation shows this discharges to NDP's Chips Sump; however, NDP has reported it does not enter their Chips Sump. Dave walked across the street during the inspection and reported he believed the old oil-water separator discharged into one of NDP's drainage ditches located on the north side of the boundary road between the properties, south of NDP's Chips Sump. This ditch ultimately flows to

Photo 10: Old oil-water separator near the Stacker Shop and NDP’s chips area.

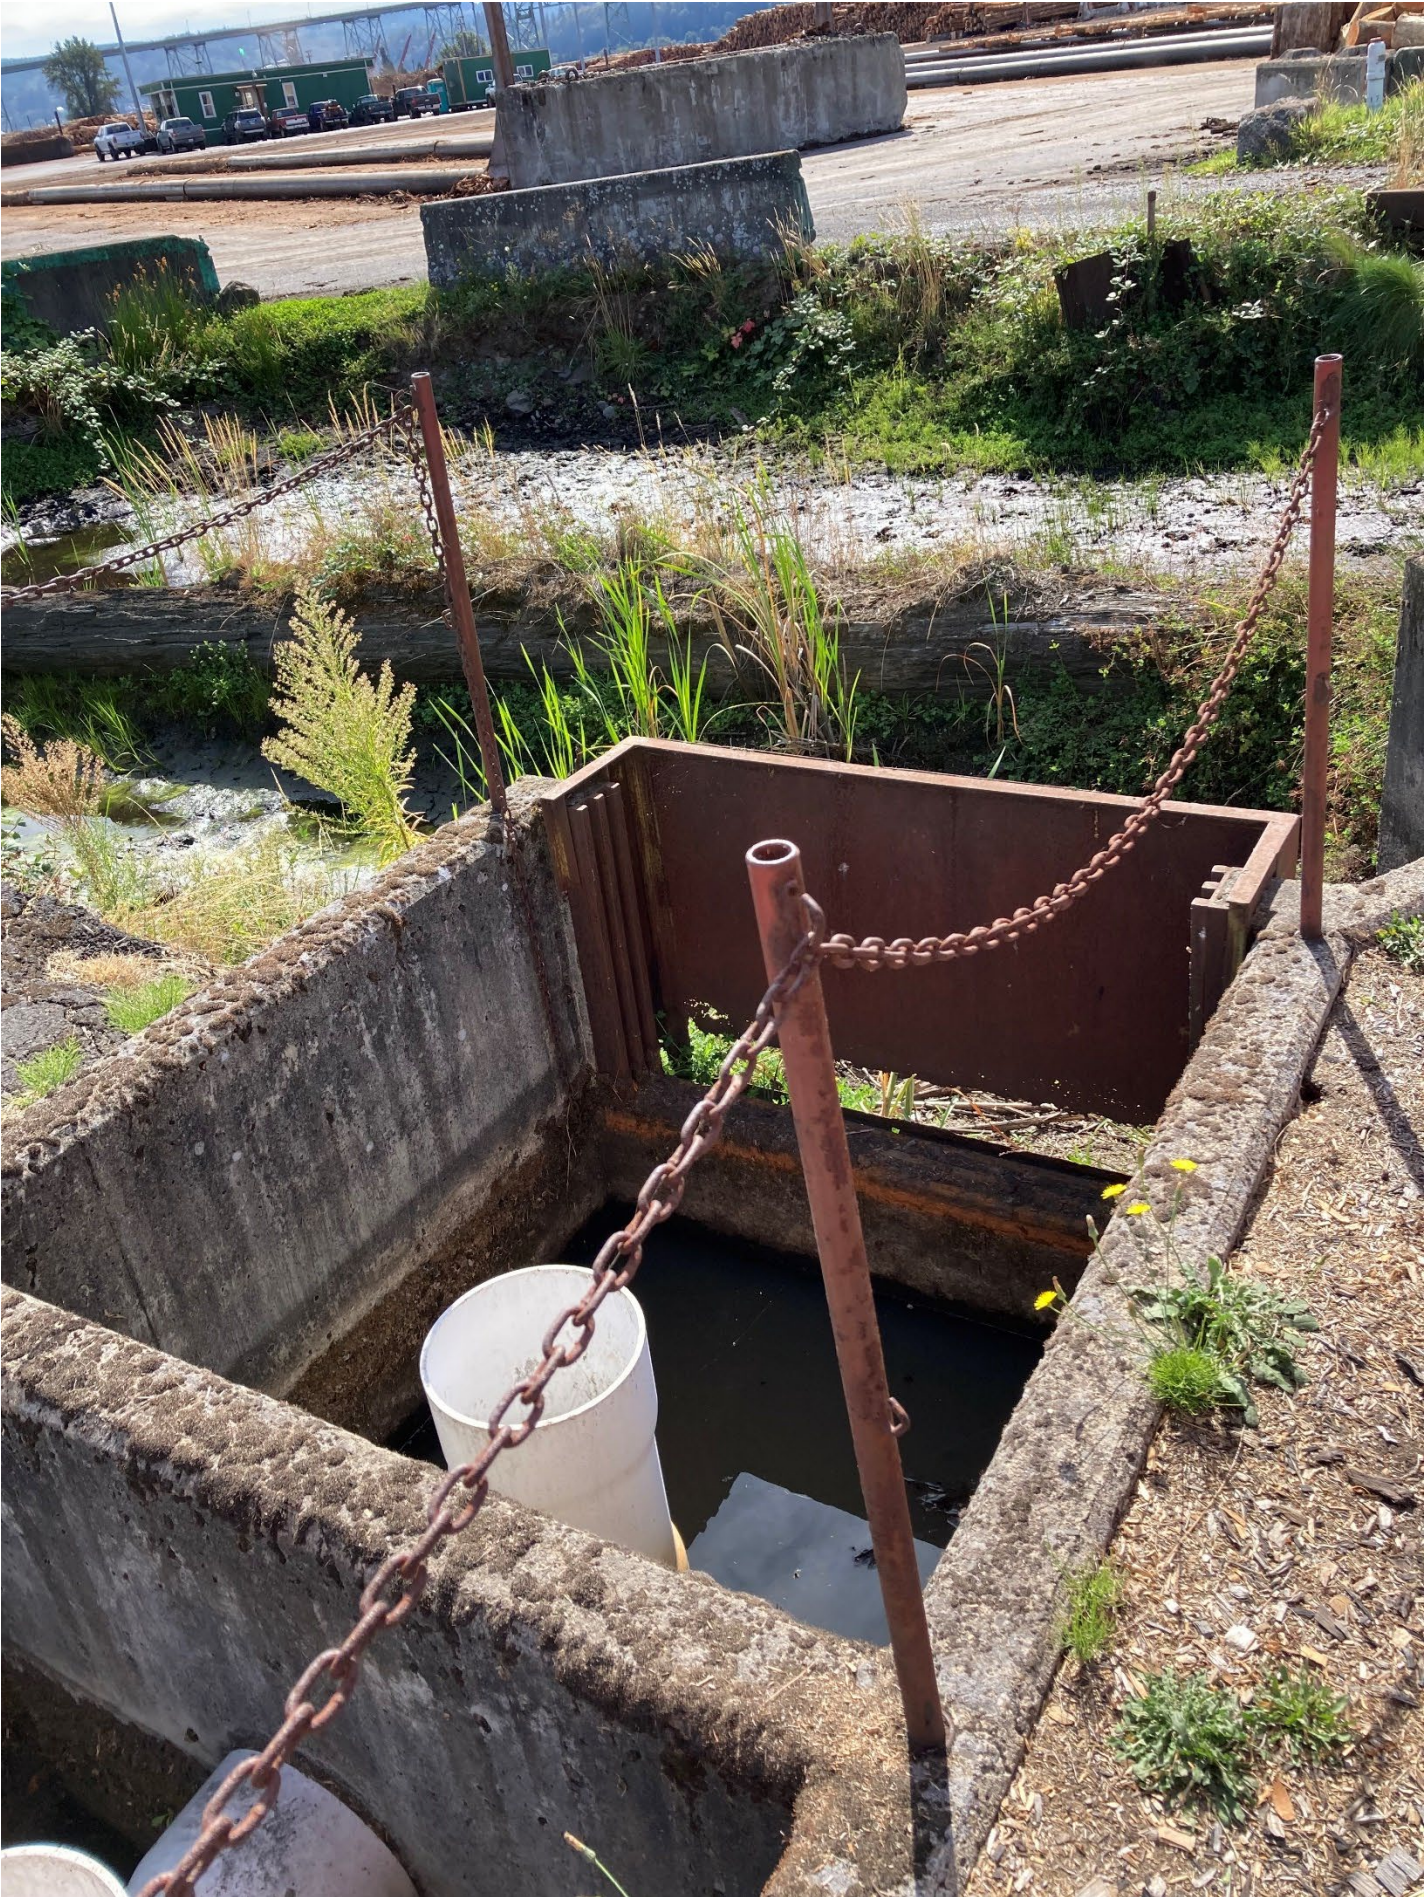
Photo 11: Old oil-water separator inlet near the Stacker Shop and NDP’s chips area.

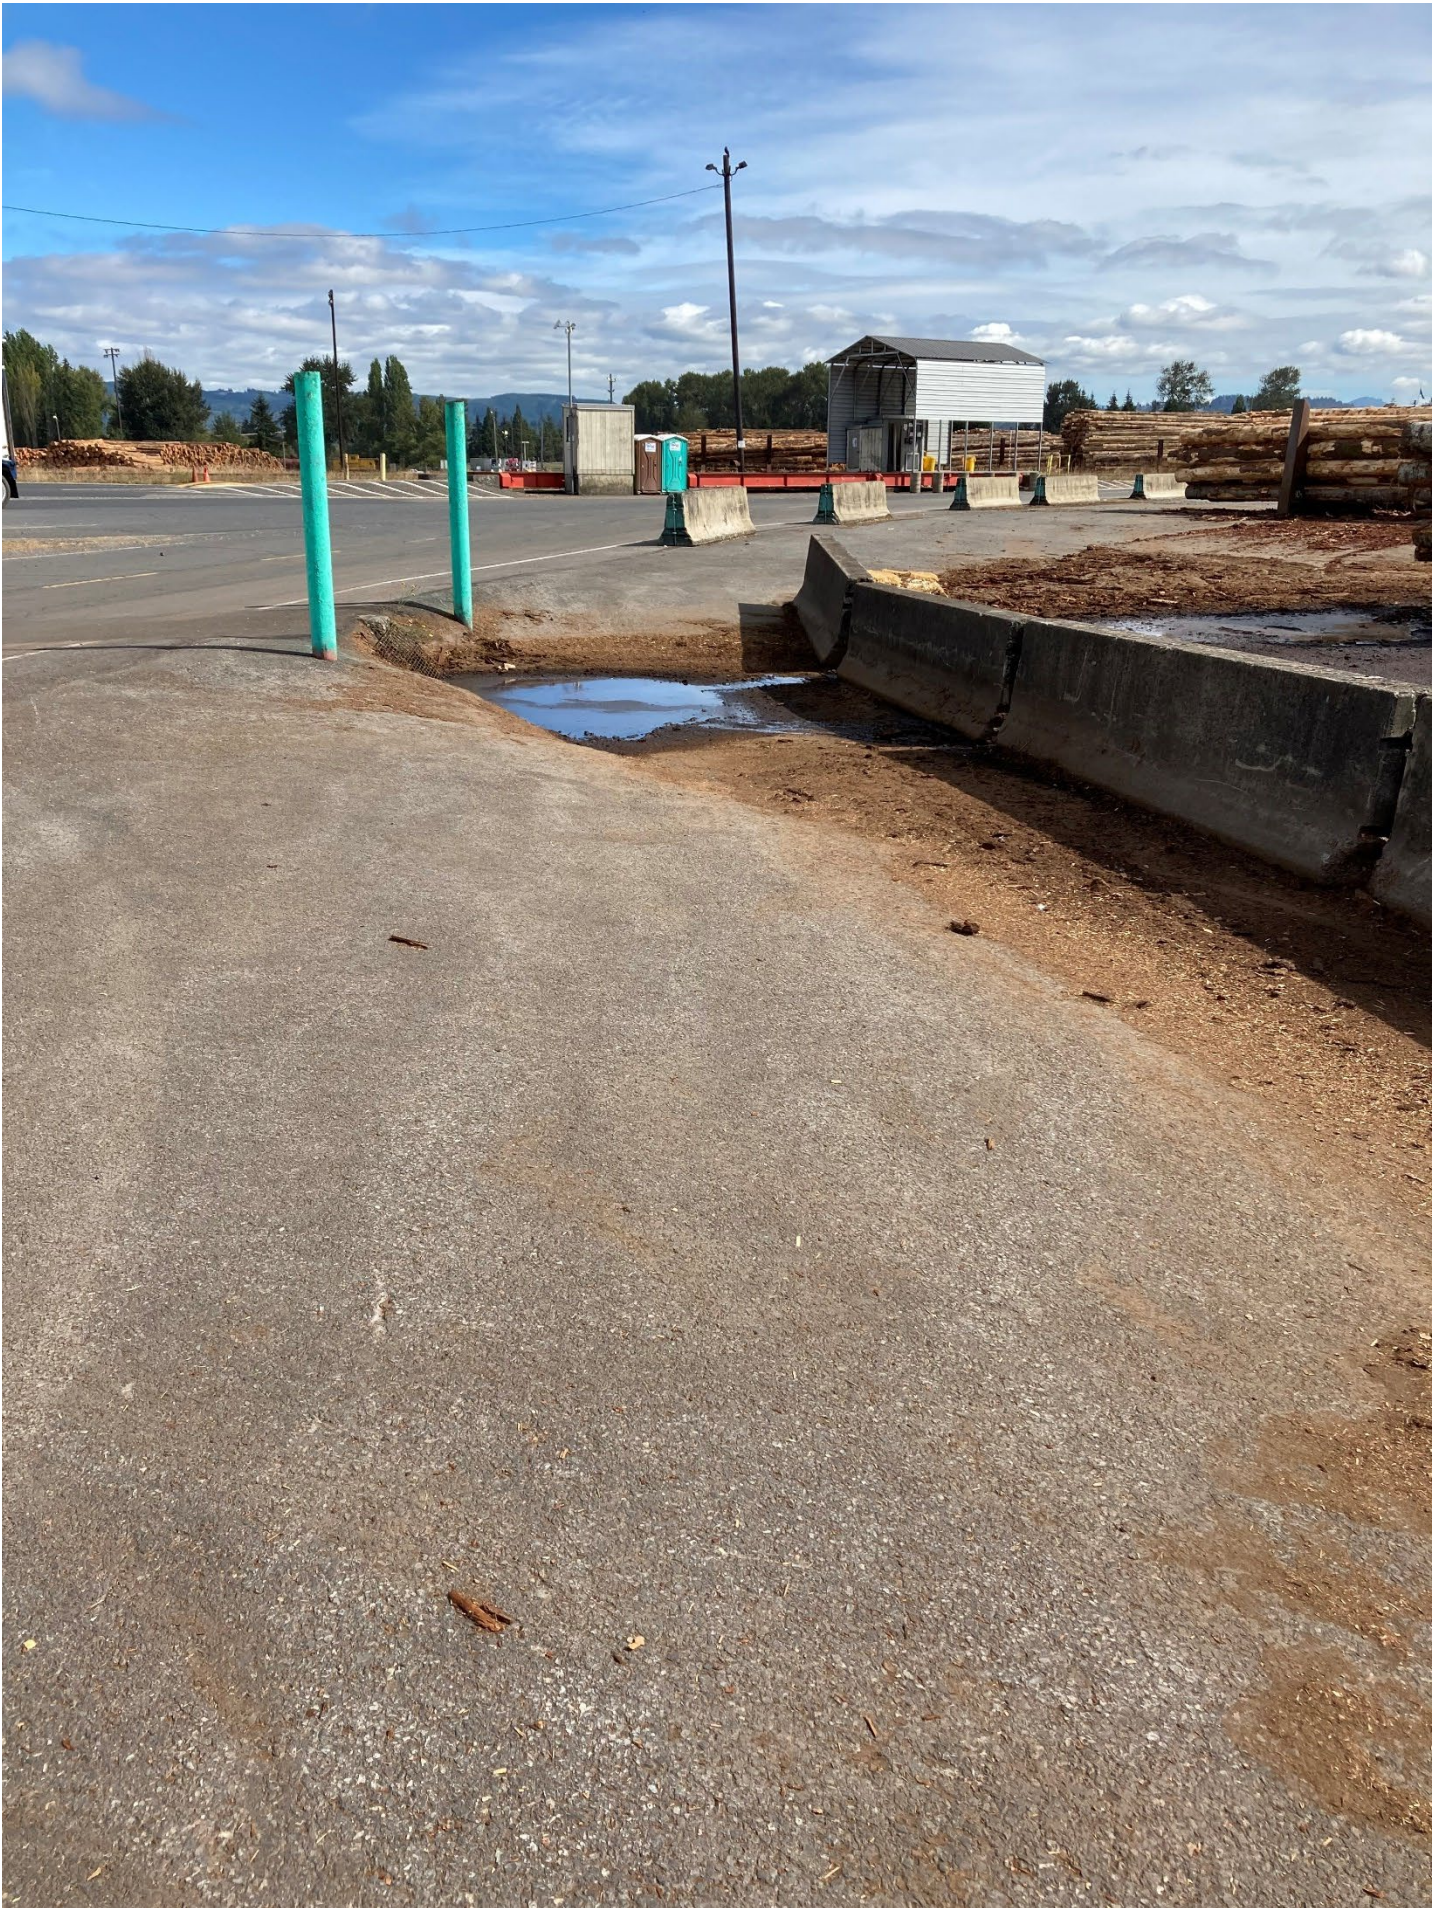
I observed woody materials, including bark and fines, accumulated in the area by the discharge to NDP's Chips Scale Sump (Photo 12 through Photo 15, Appendix A). I also observed standing water pooled at the bar screen and the jersey barriers at the discharge to NDP's Chips Scale Sump (Photo 12, Photo 14, and Photo 15, Appendix A). I did not observe water flowing through the bar screen to NDP's Chips Scale Sump at the time of the inspection (Photo 15, Appendix A); however, I did not inspect NDP's Chips Scale Sump during the inspection to see if there was flow from Weyerhaeuser entering the sump. I noted straw bales that appeared to be relatively new along the northeast and southwest sides of the existing jersey barriers and noted the straw bales appeared to be containing woody materials (Photo 12, Photo 13, and Photo 14, Appendix A).

Photo 12: Discharge to NDP’s Chips Scale Sump from Weyerhaeuser.

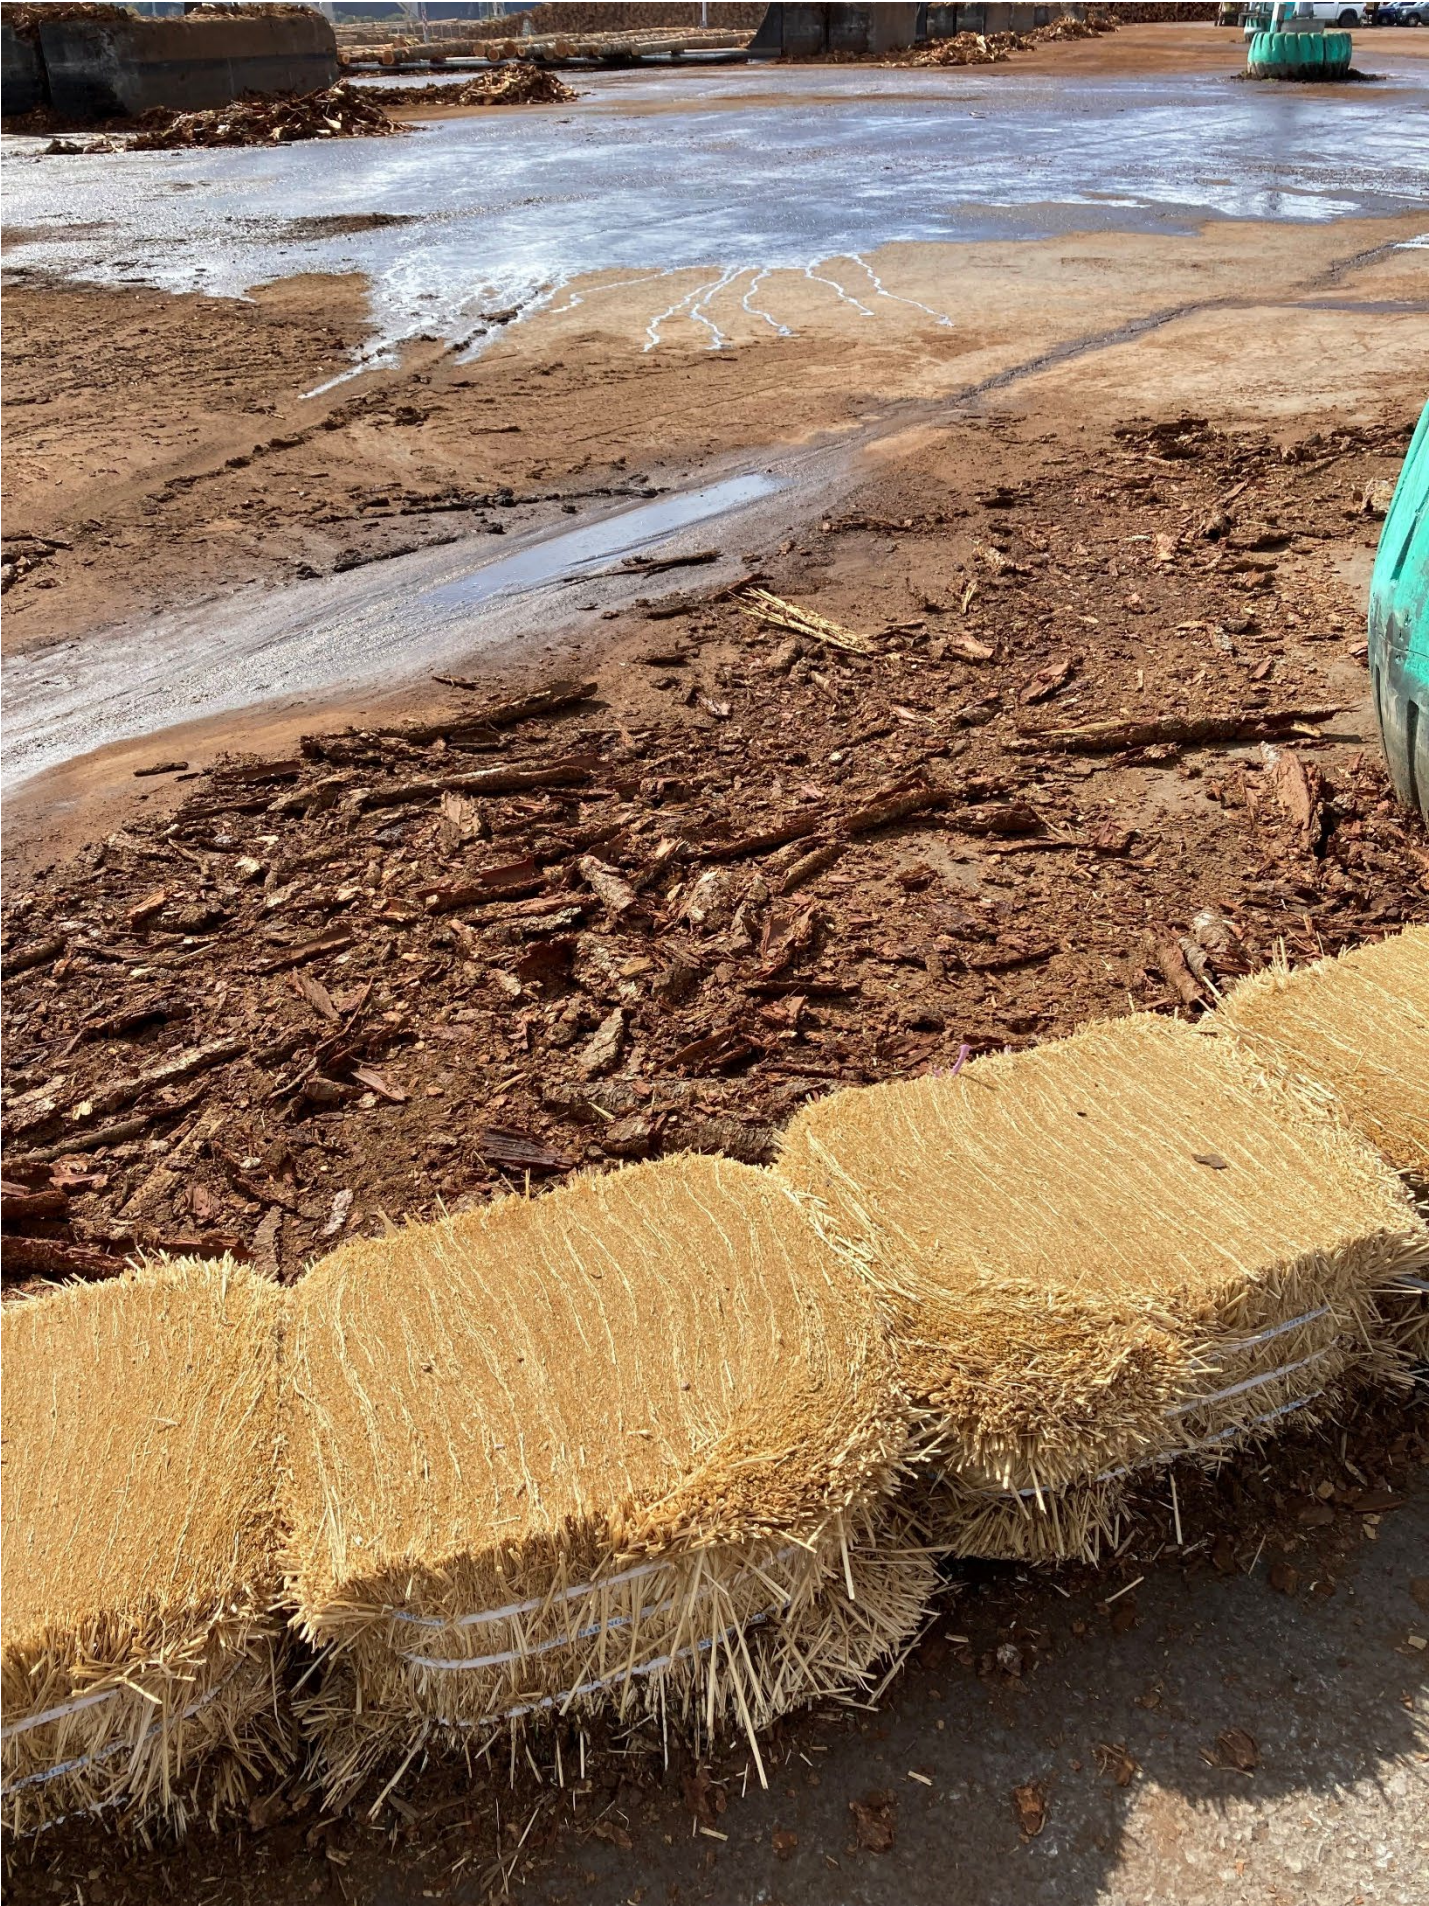
Photo 13: Straw bales and woody debris accumulated near Weyerhaeuser’s discharge to NDP’s Chips Scale Sump.

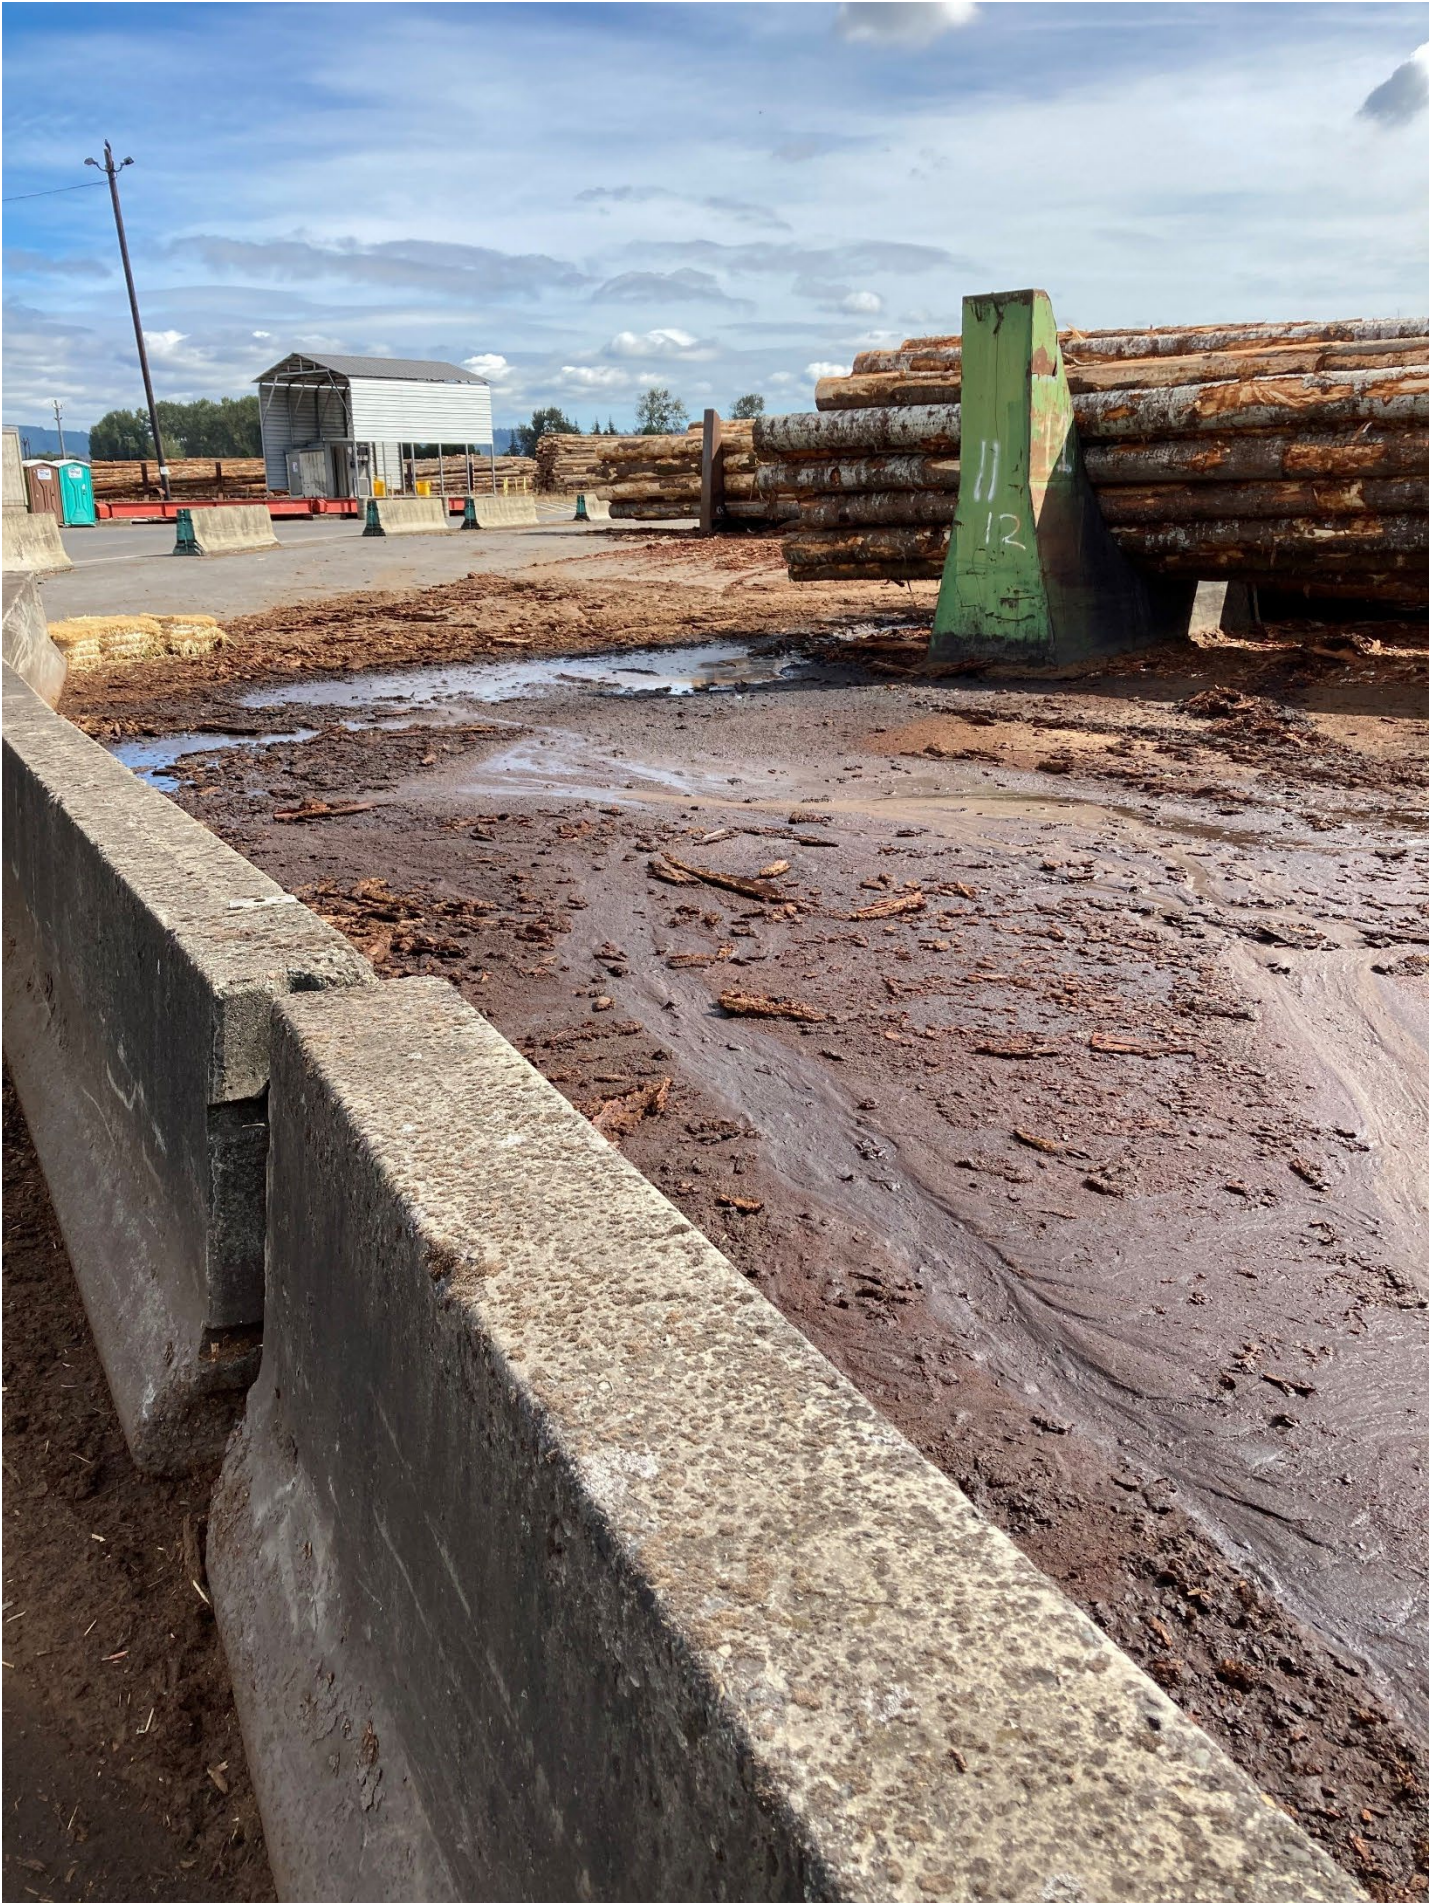
Photo 14: Wood fines and bark accumulated before jersey barriers near the discharge to NDP’s Chips Scale Sump.

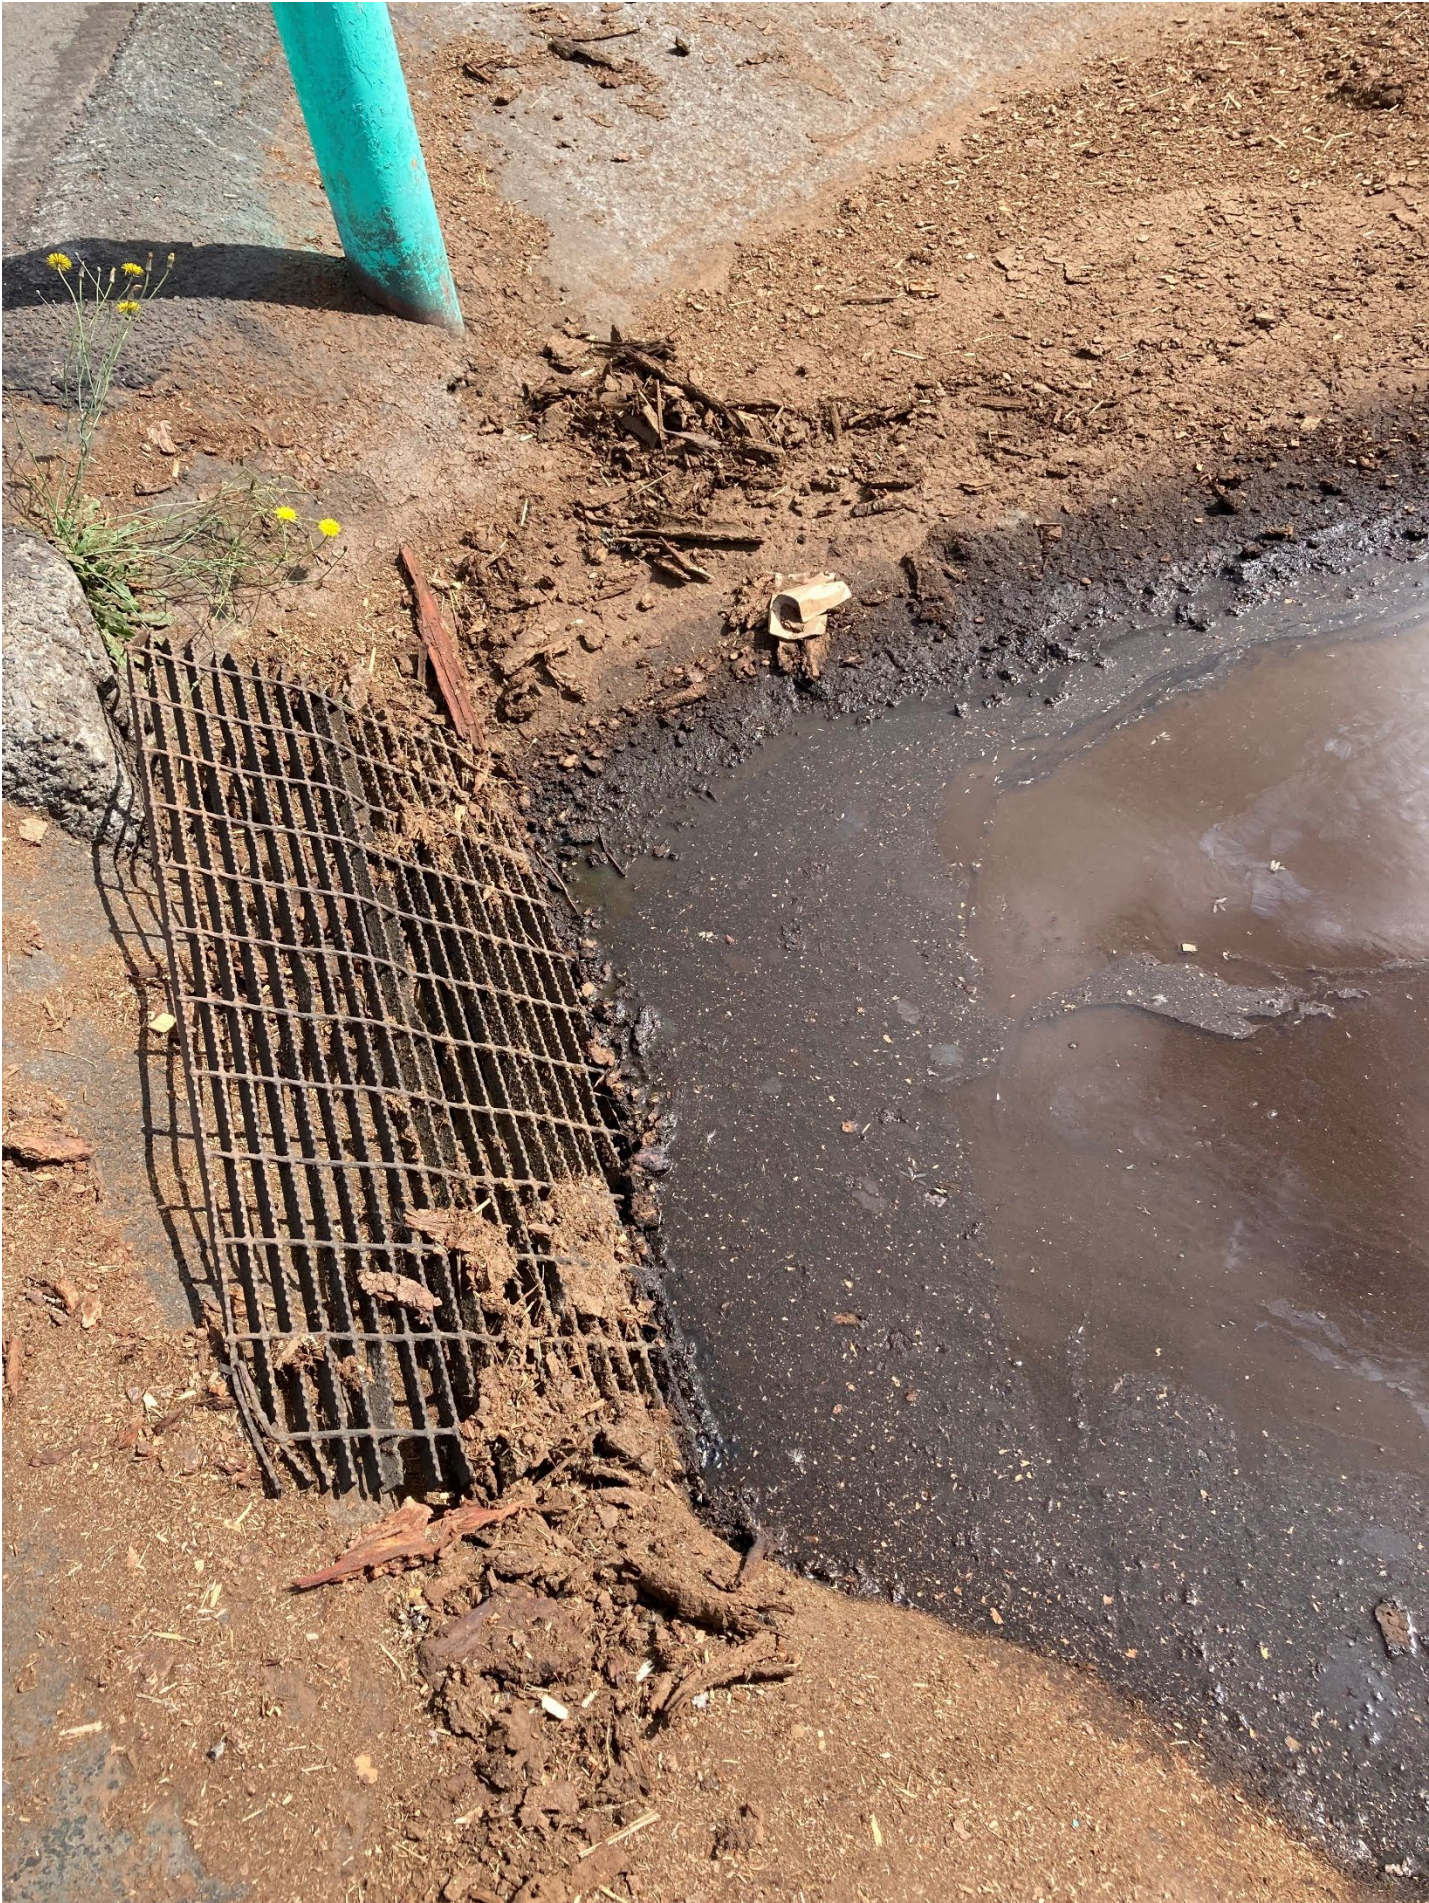
Photo 15: Bar screen at Weyerhaeuser’s discharge to NDP’s Chips Scale Sump.
