**STATE OF WASHINGTON
DEPARTMENT OF ECOLOGY**

Re: September 2024 Announced Non-Sampling Water Quality Compliance Inspection Report

Permit Compliance Inspection Report

Facility Name and Address: Weyerhaeuser NR Company
1701, 2901, & 3539 Industrial Way
Longview, WA 98632

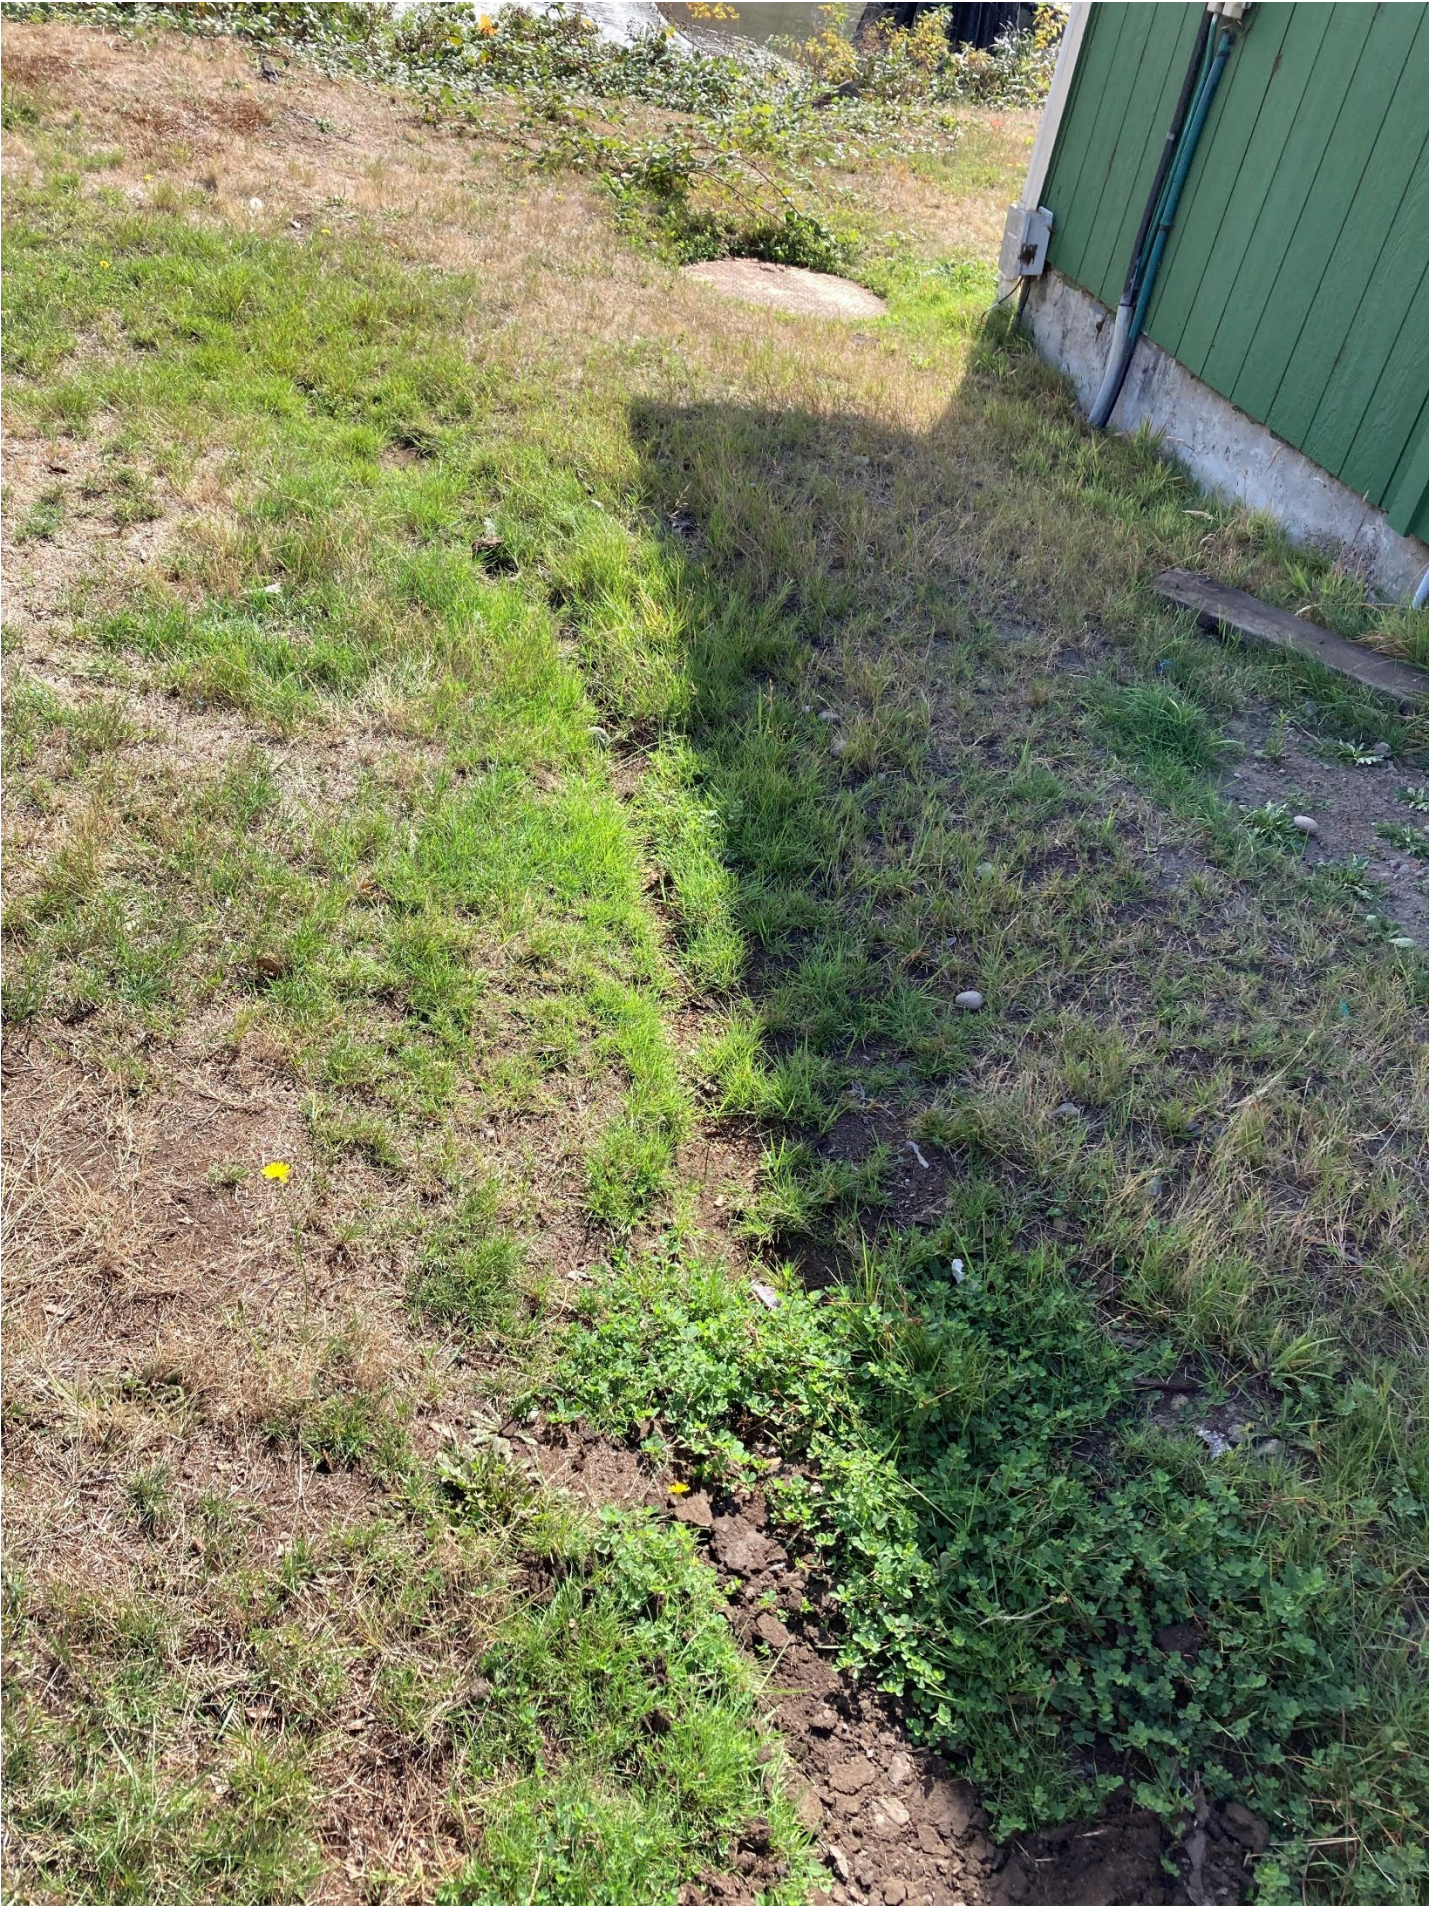
We visited the drainage near the Longshoreman's Lunchroom, the Export Dock Sump, and Outfall 009B during the inspection at the Export Dock area. In the past I've observed channeling in the grassy area near the Longshoreman's Lunchroom leading to a drop-off to the Columbia River. I've also noted standing water and an elevated jersey barrier directing runoff to the channeled area. On the day of the inspection, I noted a jersey barrier placed along the edge of the paved area and the grassy area diverting runoff flows away from this area. I observed some slight channeling in the grassy area; however, I did not observe any standing water, wet areas, or evidence of recent discharges (Photo 16 and Photo 17, Appendix A). During the inspection we discussed the feasibility of modifying the area to ensure no discharge or adding this drainage as an identified outfall in the permit.

Photo 16: Channel in the grassy area near the Longshoreman’s Lunchroom at the Export Dock.

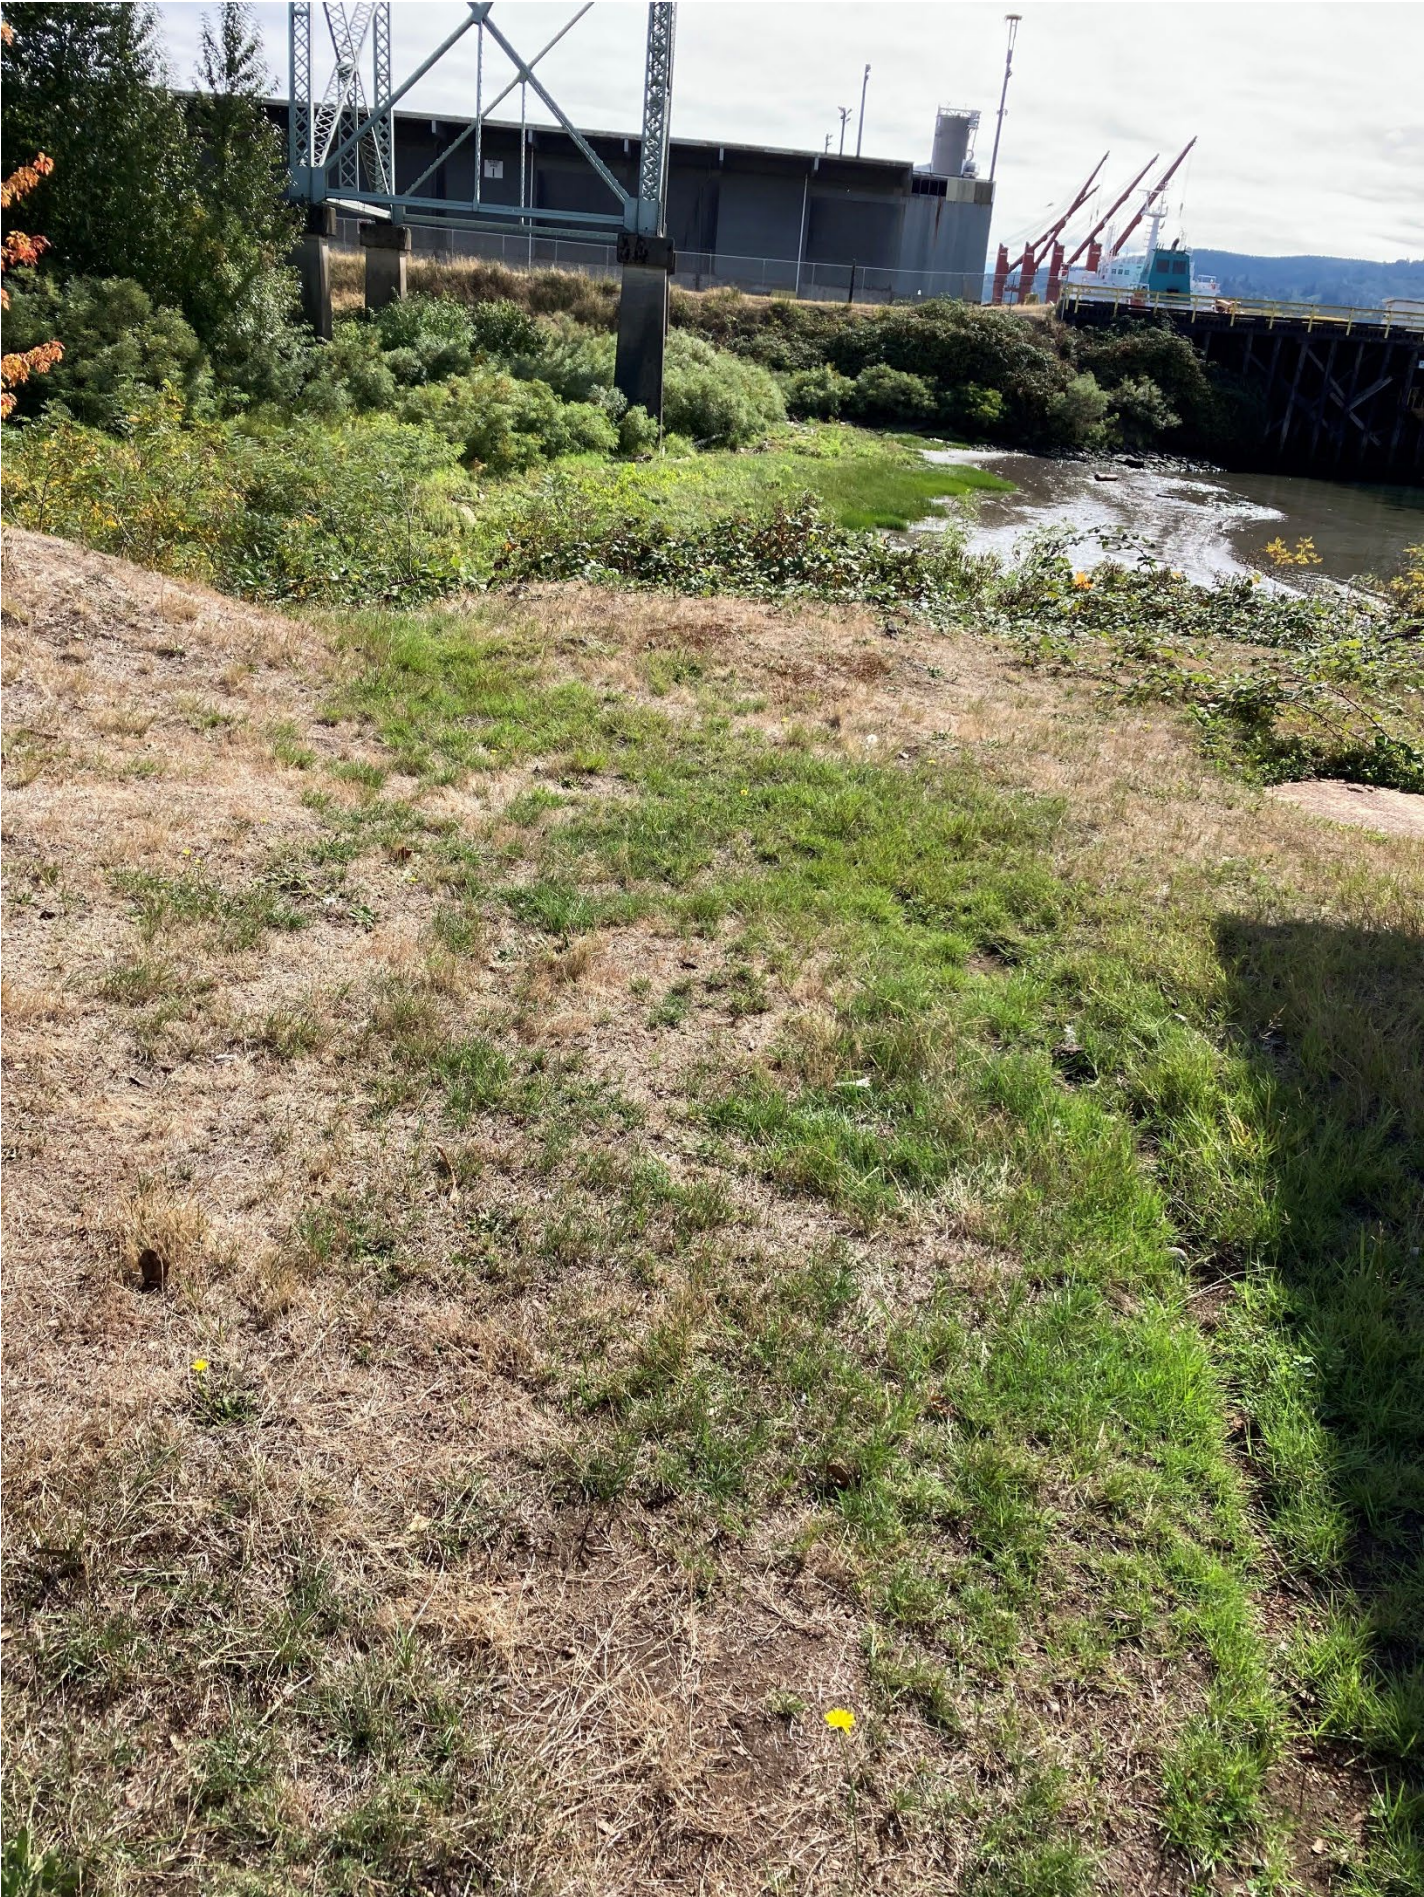
Photo 17: Channel near the Longshoreman’s Lunchroom at the Export Dock leading to the edge of the property toward the Columbia River.

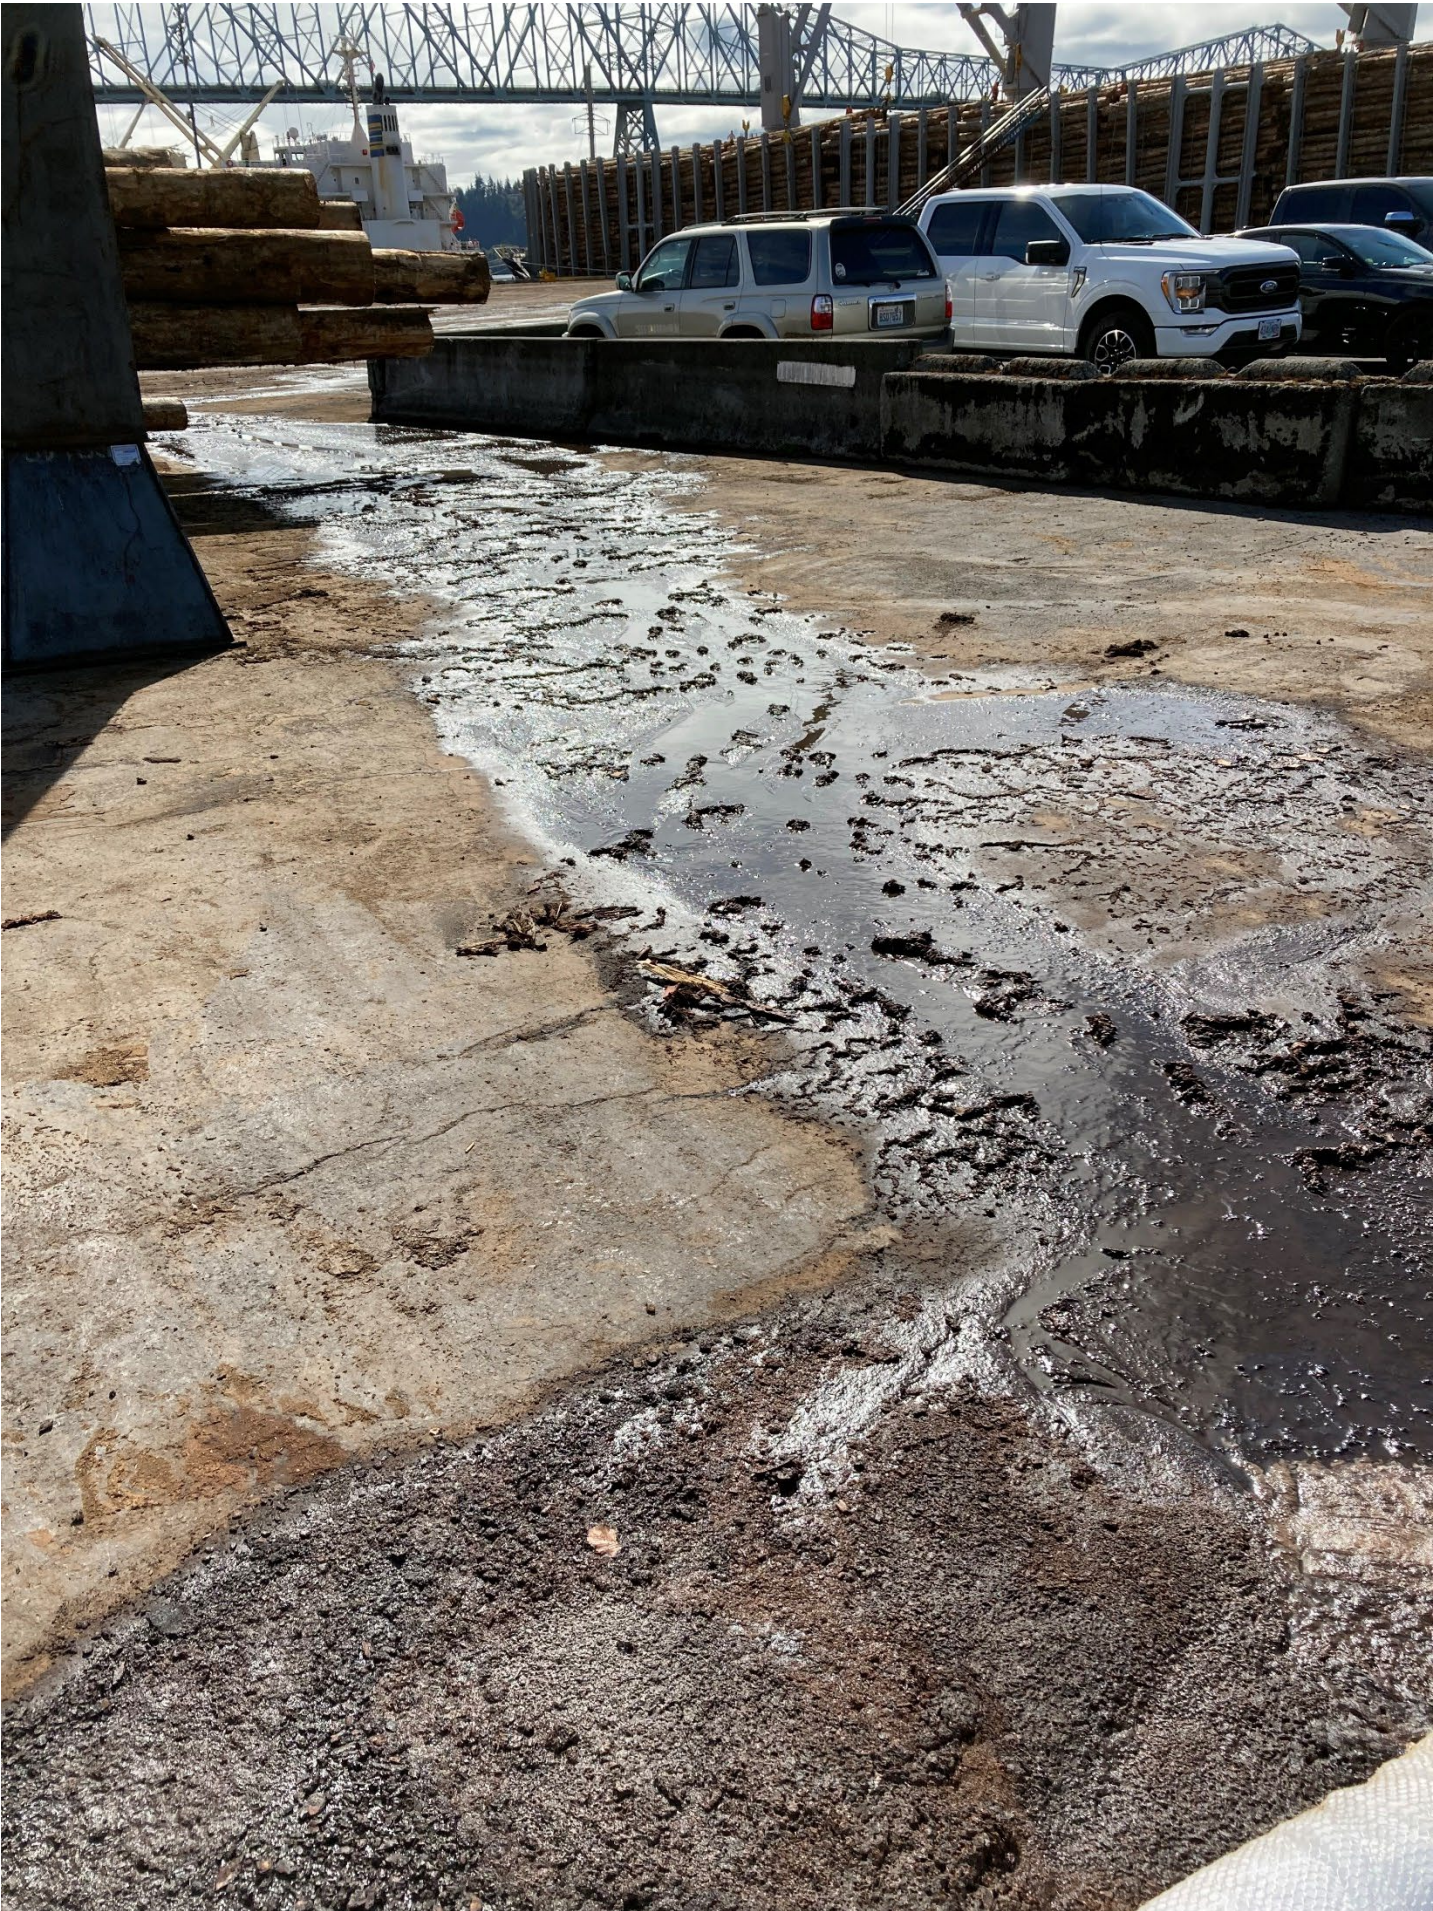
I noted runoff flowing to the Export Dock Sump from the east (Photo 18 and Photo 19, Appendix A). I noted wood fines accumulated in the path of the runoff (Photo 18 and Photo 19, Appendix A). I also observed bark and larger woody solids accumulated near the opening of the Export Dock Sump (Photo 20, Appendix A). I did not observe the pumps operating at the Export Dock Sump at the time of the inspection. I asked Weyerhaeuser how frequently they inspect and clean out the Export Dock Sump. Weyerhaeuser reported they inspect the sump weekly and clean out the sump as needed.

Photo 18: Runoff flowing to the Export Dock Sump from the east.

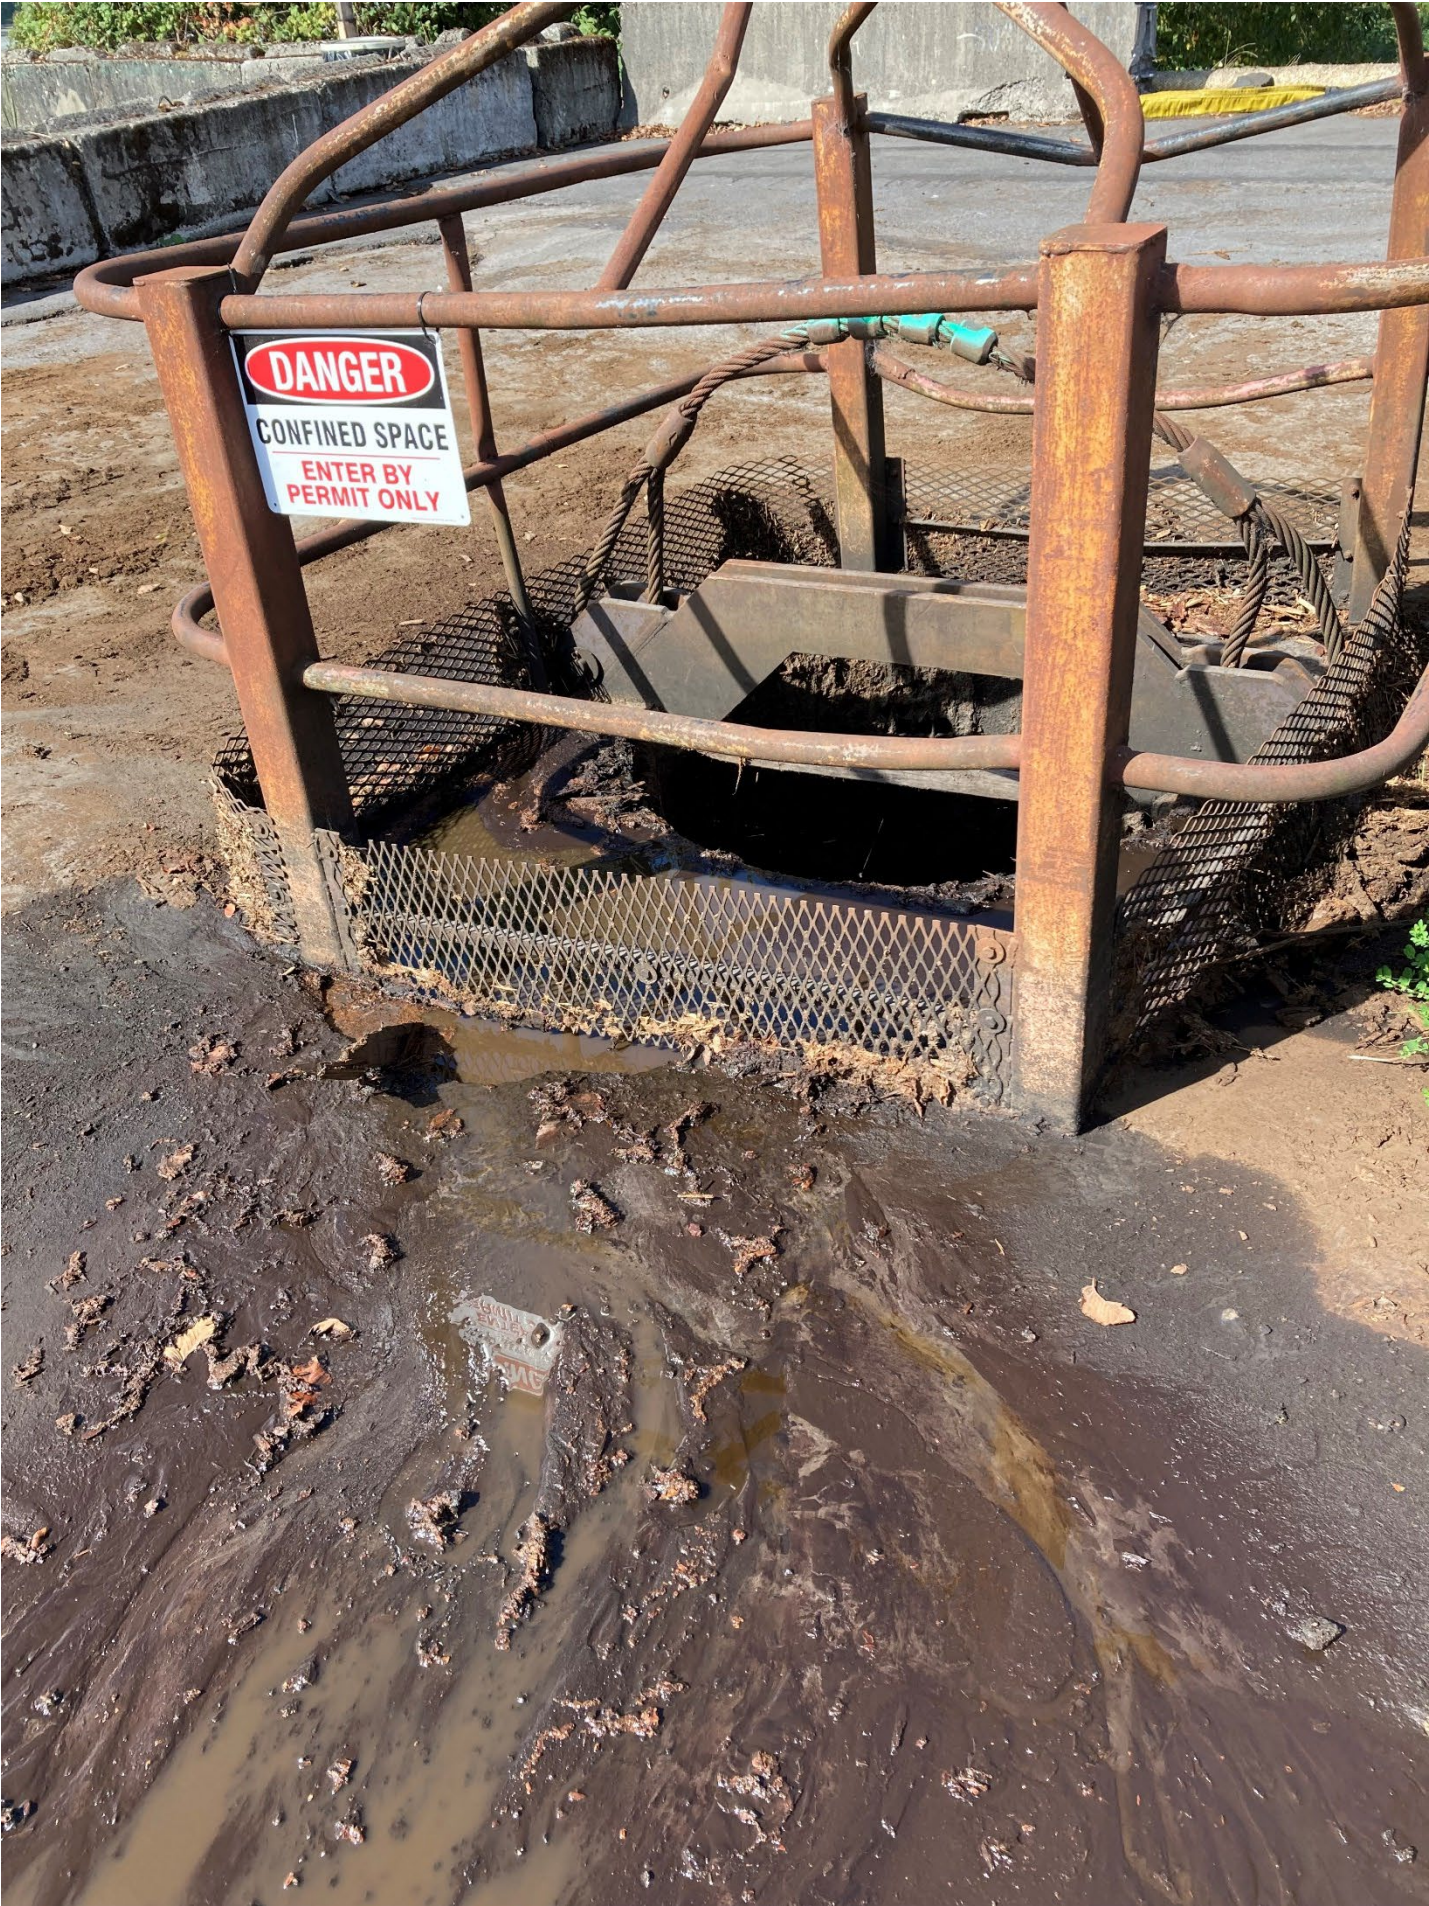
Photo 19: Runoff entering the Export Dock Sump.

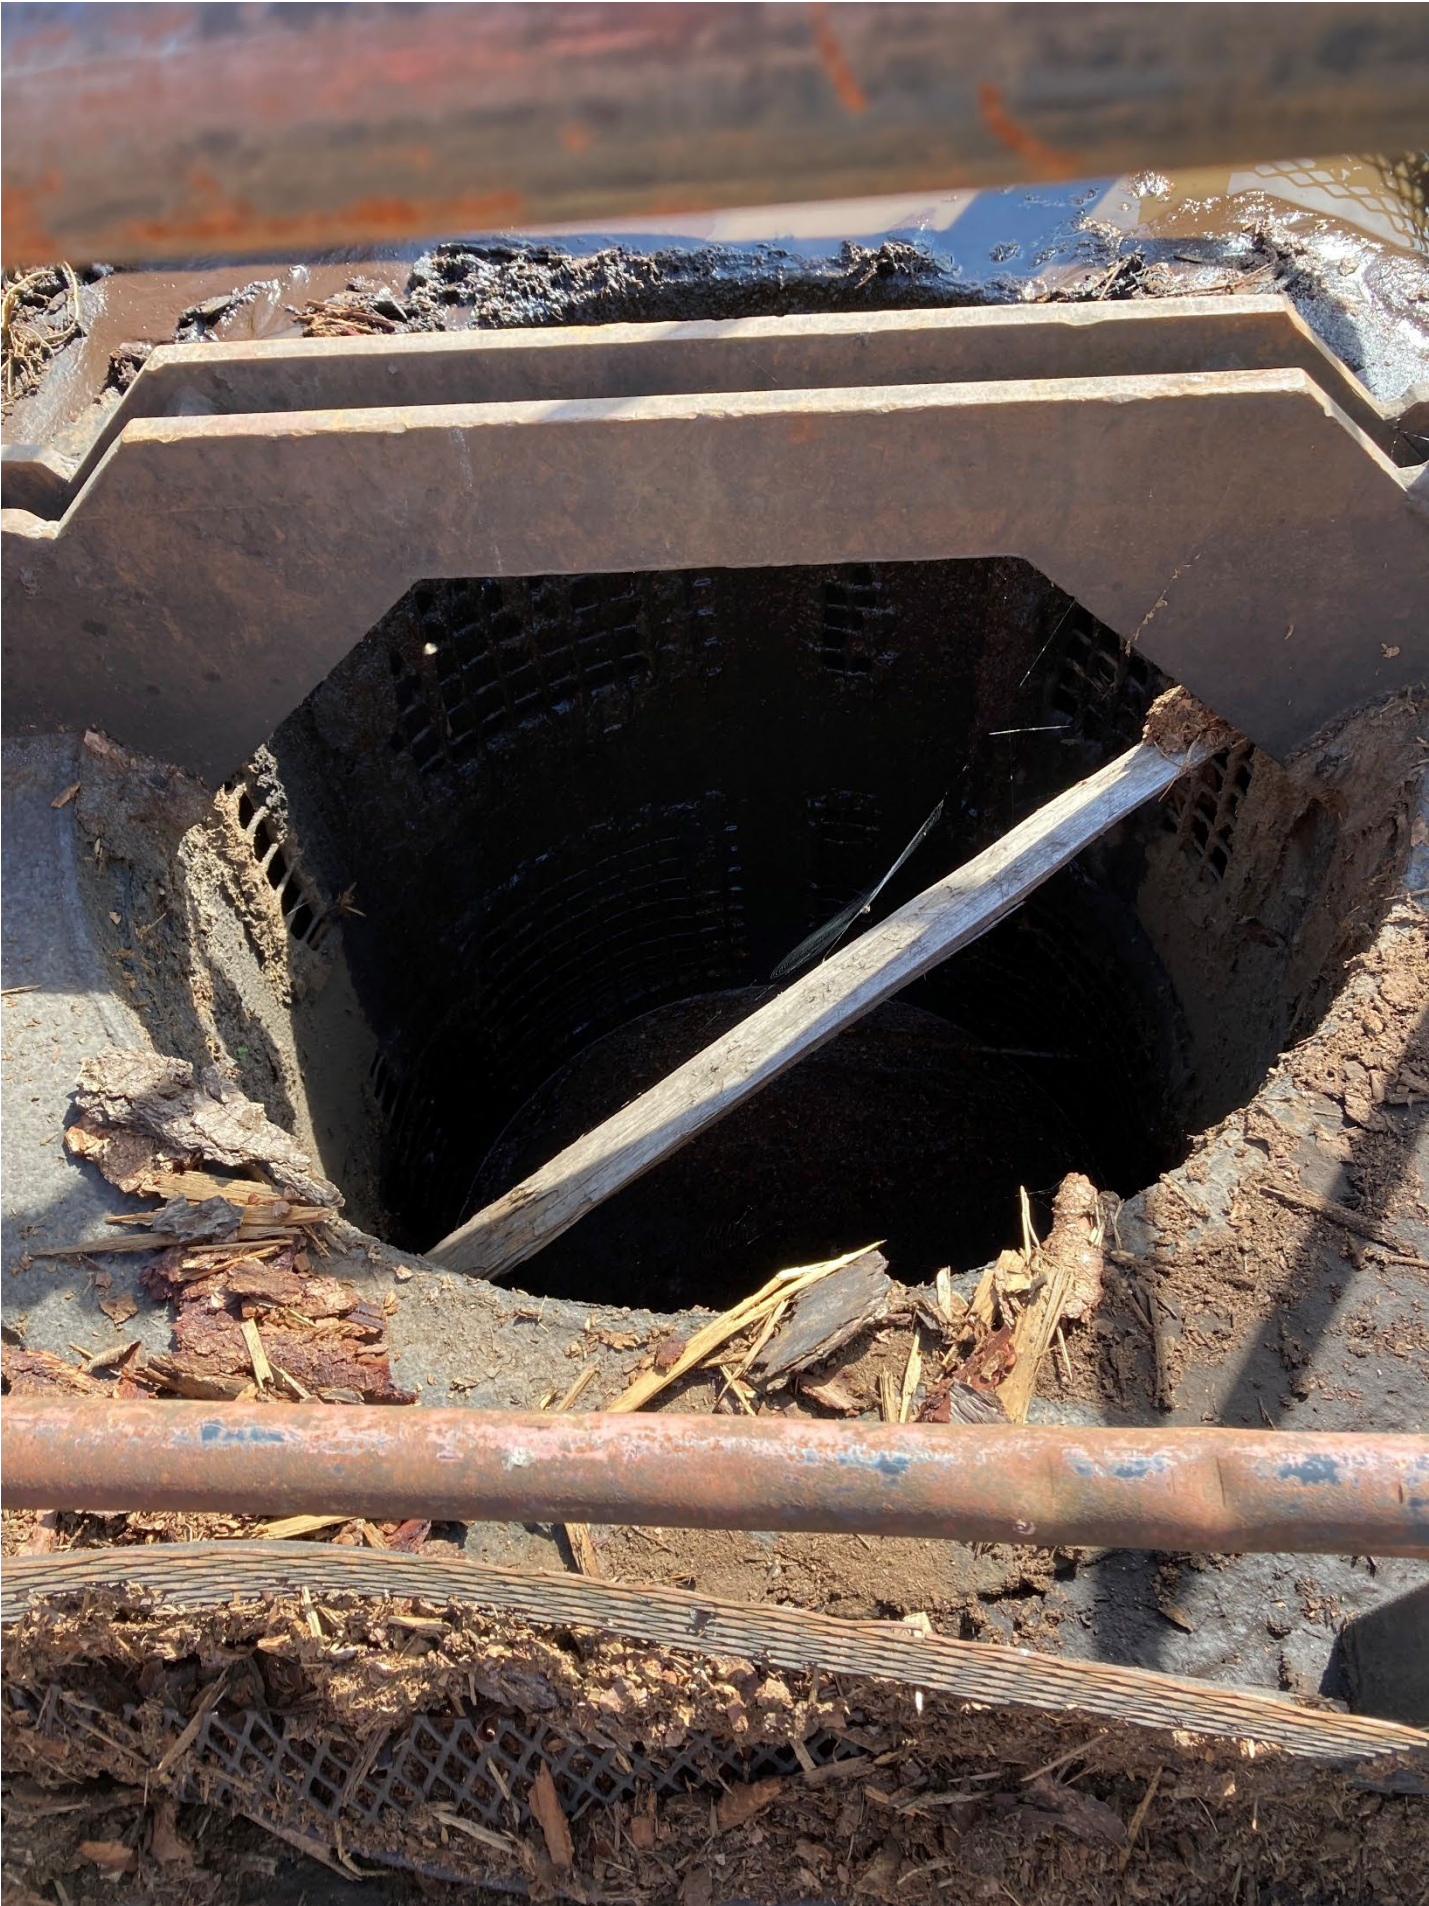
Photo 20: Export Dock Sump.

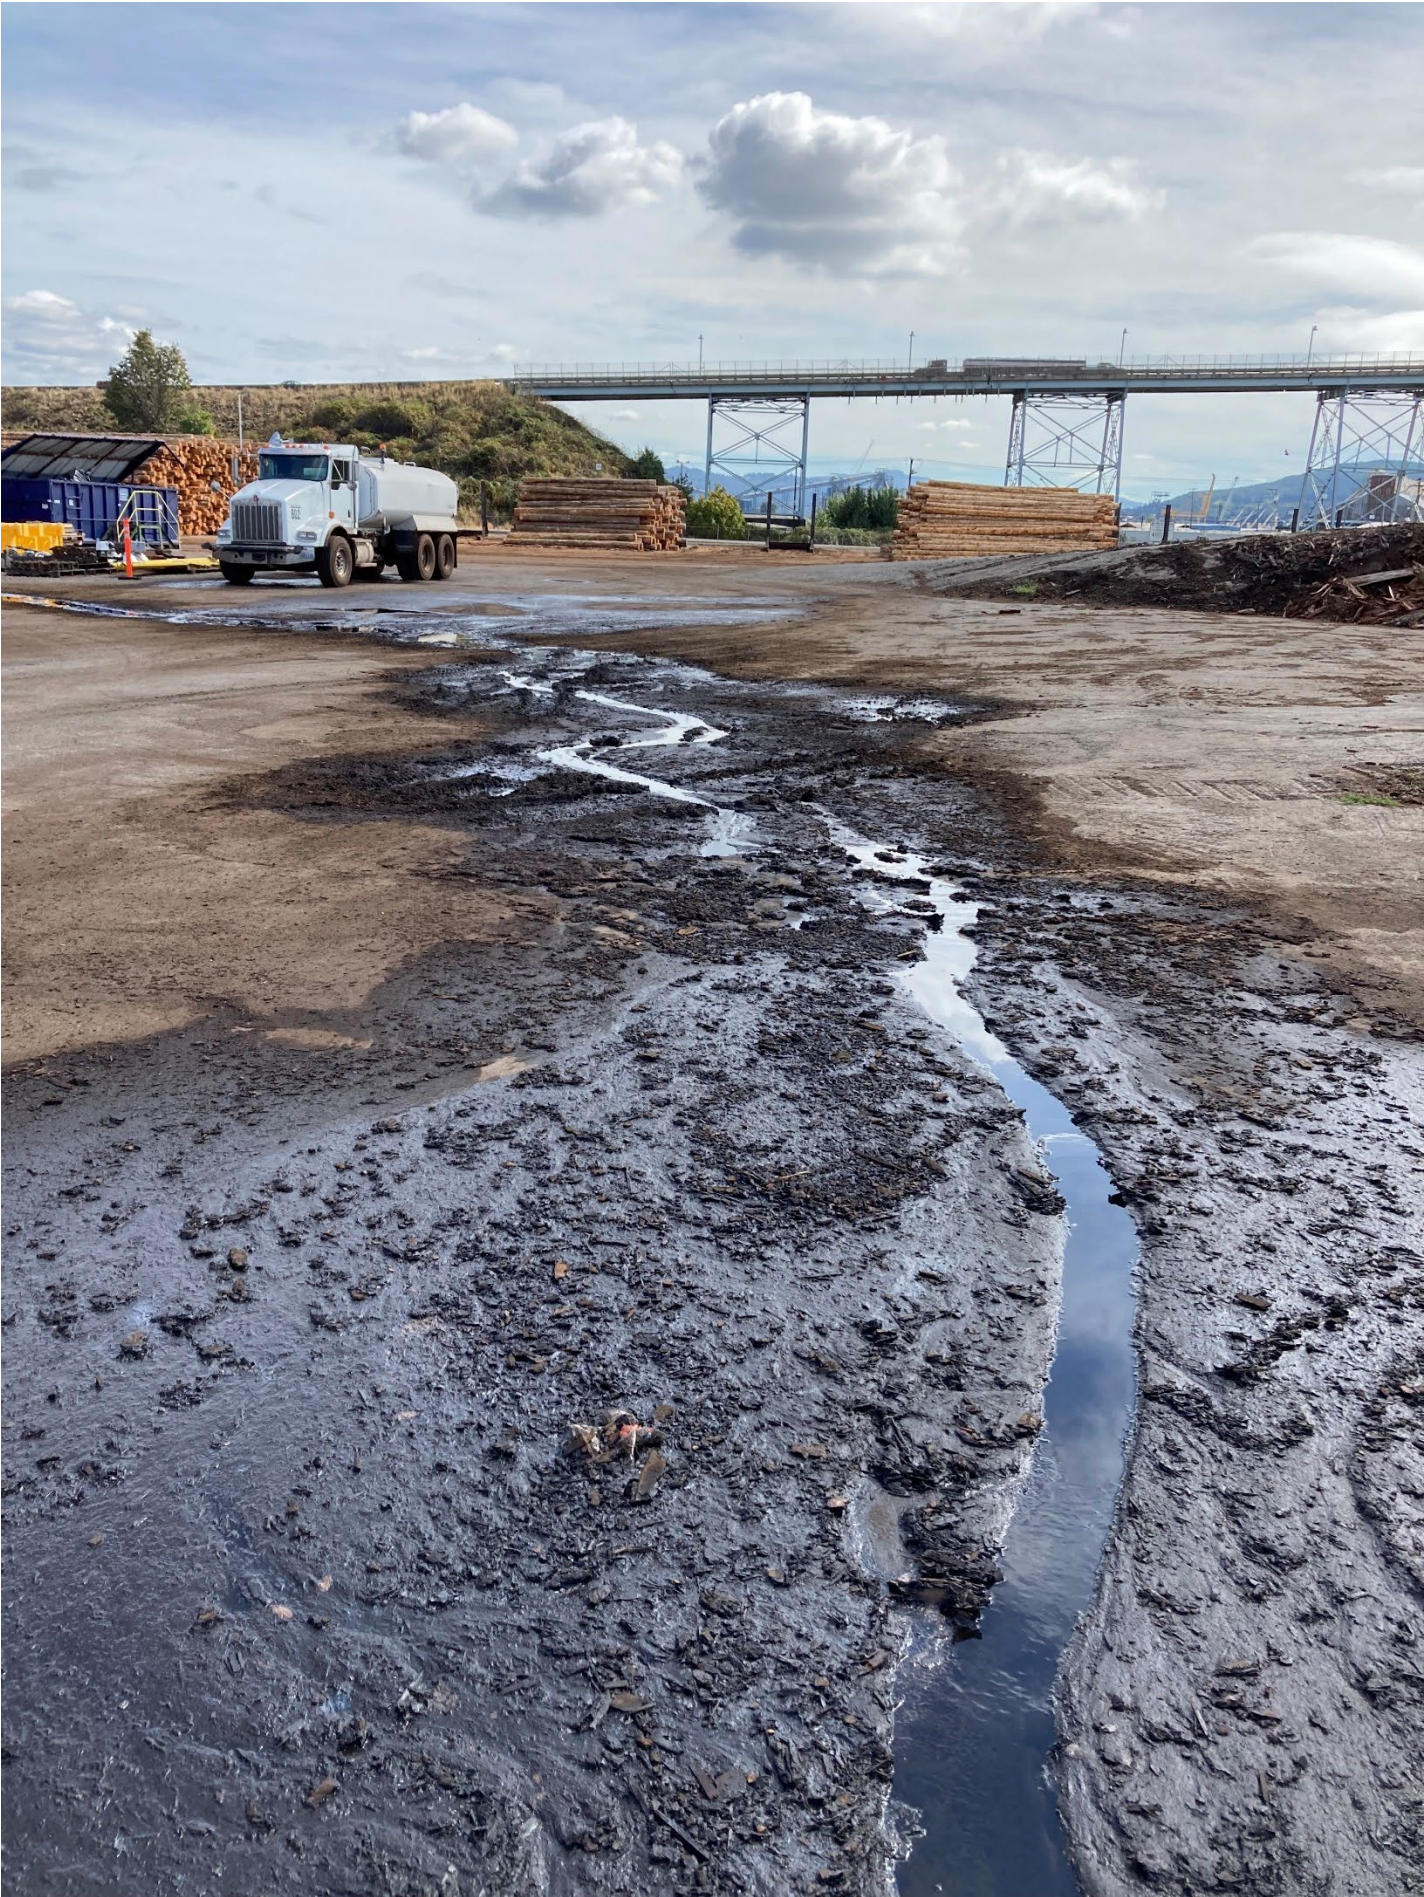
I observed the runoff from the Debarker operation. Runoff flows overland to the East Sump. Weyerhaeuser was not operating the Debarker during the inspection. I noted significant solids accumulated on the ground in the area of the surface runoff that appeared to be primarily wood fines with some bark and wood chips (Photo 21, Appendix A). I asked Weyerhaeuser how frequently they wash the Debarker and discharge to the East Sump. Weyerhaeuser reported they wash the Debarker every time it's used. I also asked Weyerhaeuser how frequently they clean the accumulated solids from the ground in the area of the runoff. Weyerhaeuser reported they clean solids as needed.

Photo 21: Debarker area discharge overland to East Sump.

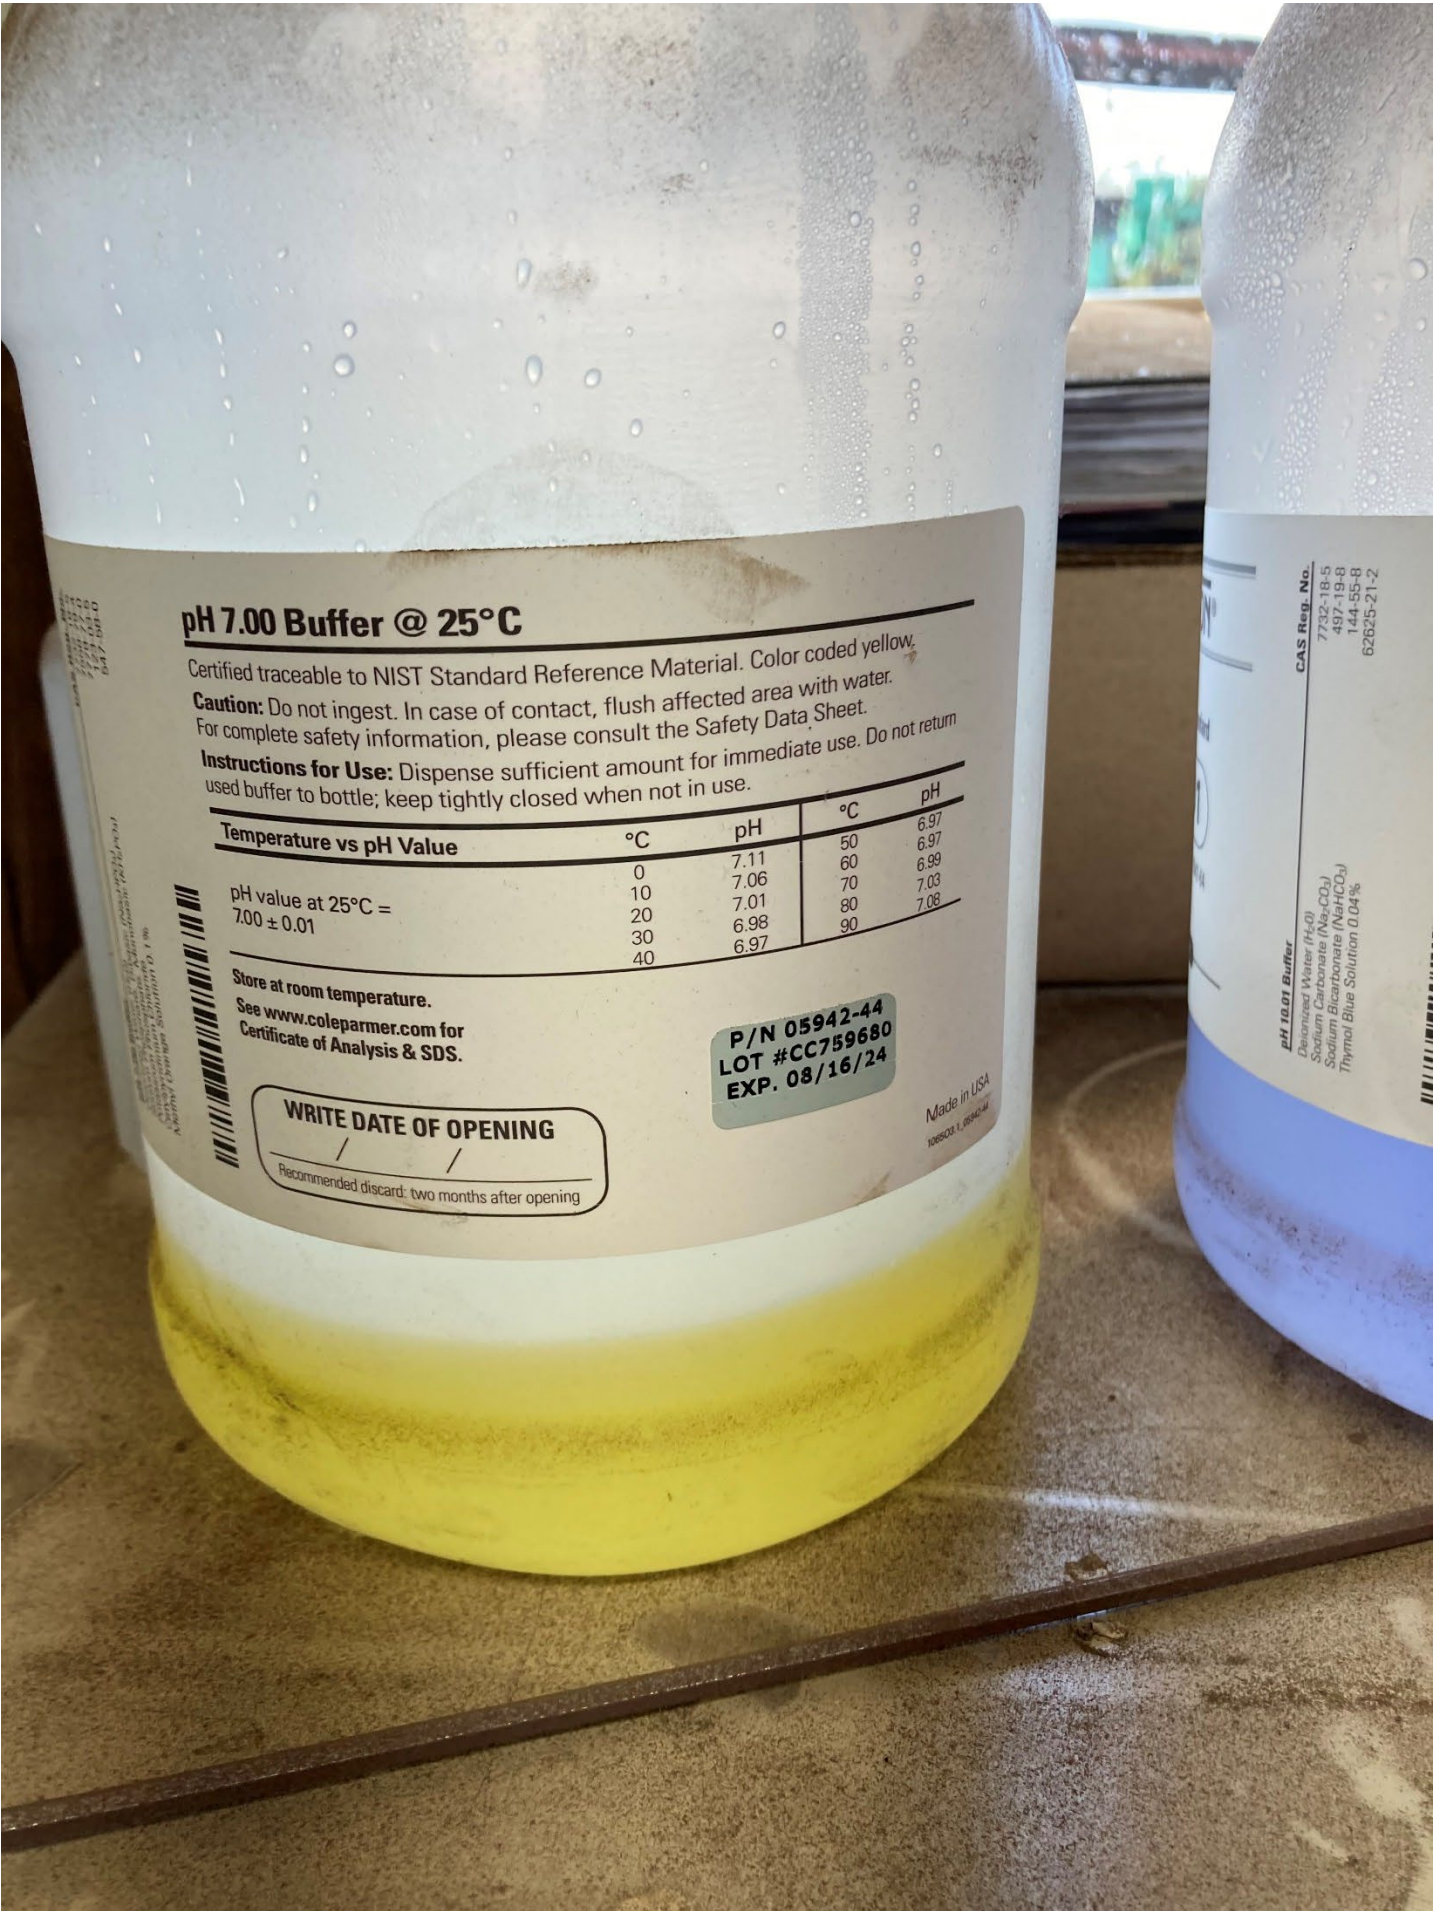
Weyerhaeuser stores their pH buffer solutions at the Debarker Lunchroom. I inspected the 7.0 and 10.0 standard unit (SU) buffer solutions during the inspection and noted both had expiration dates of August 16 and August 18, 2024, respectively (Photo 22 and Photo 23, Appendix A). Weyerhaeuser only had a small bottle of 4.0 SU buffer solution at the Debarker Lunchroom without an expiration date. Kevin stated that operators transfer buffer solution from the larger bottles into the small bottles for calibrations before use. Kevin thought that operators had used all the 4.0 SU buffer solution from the large bottle and only had the small bottle left.

Photo 22: pH 7.0 SU buffer solution bottle at the Debarker Lunchroom.

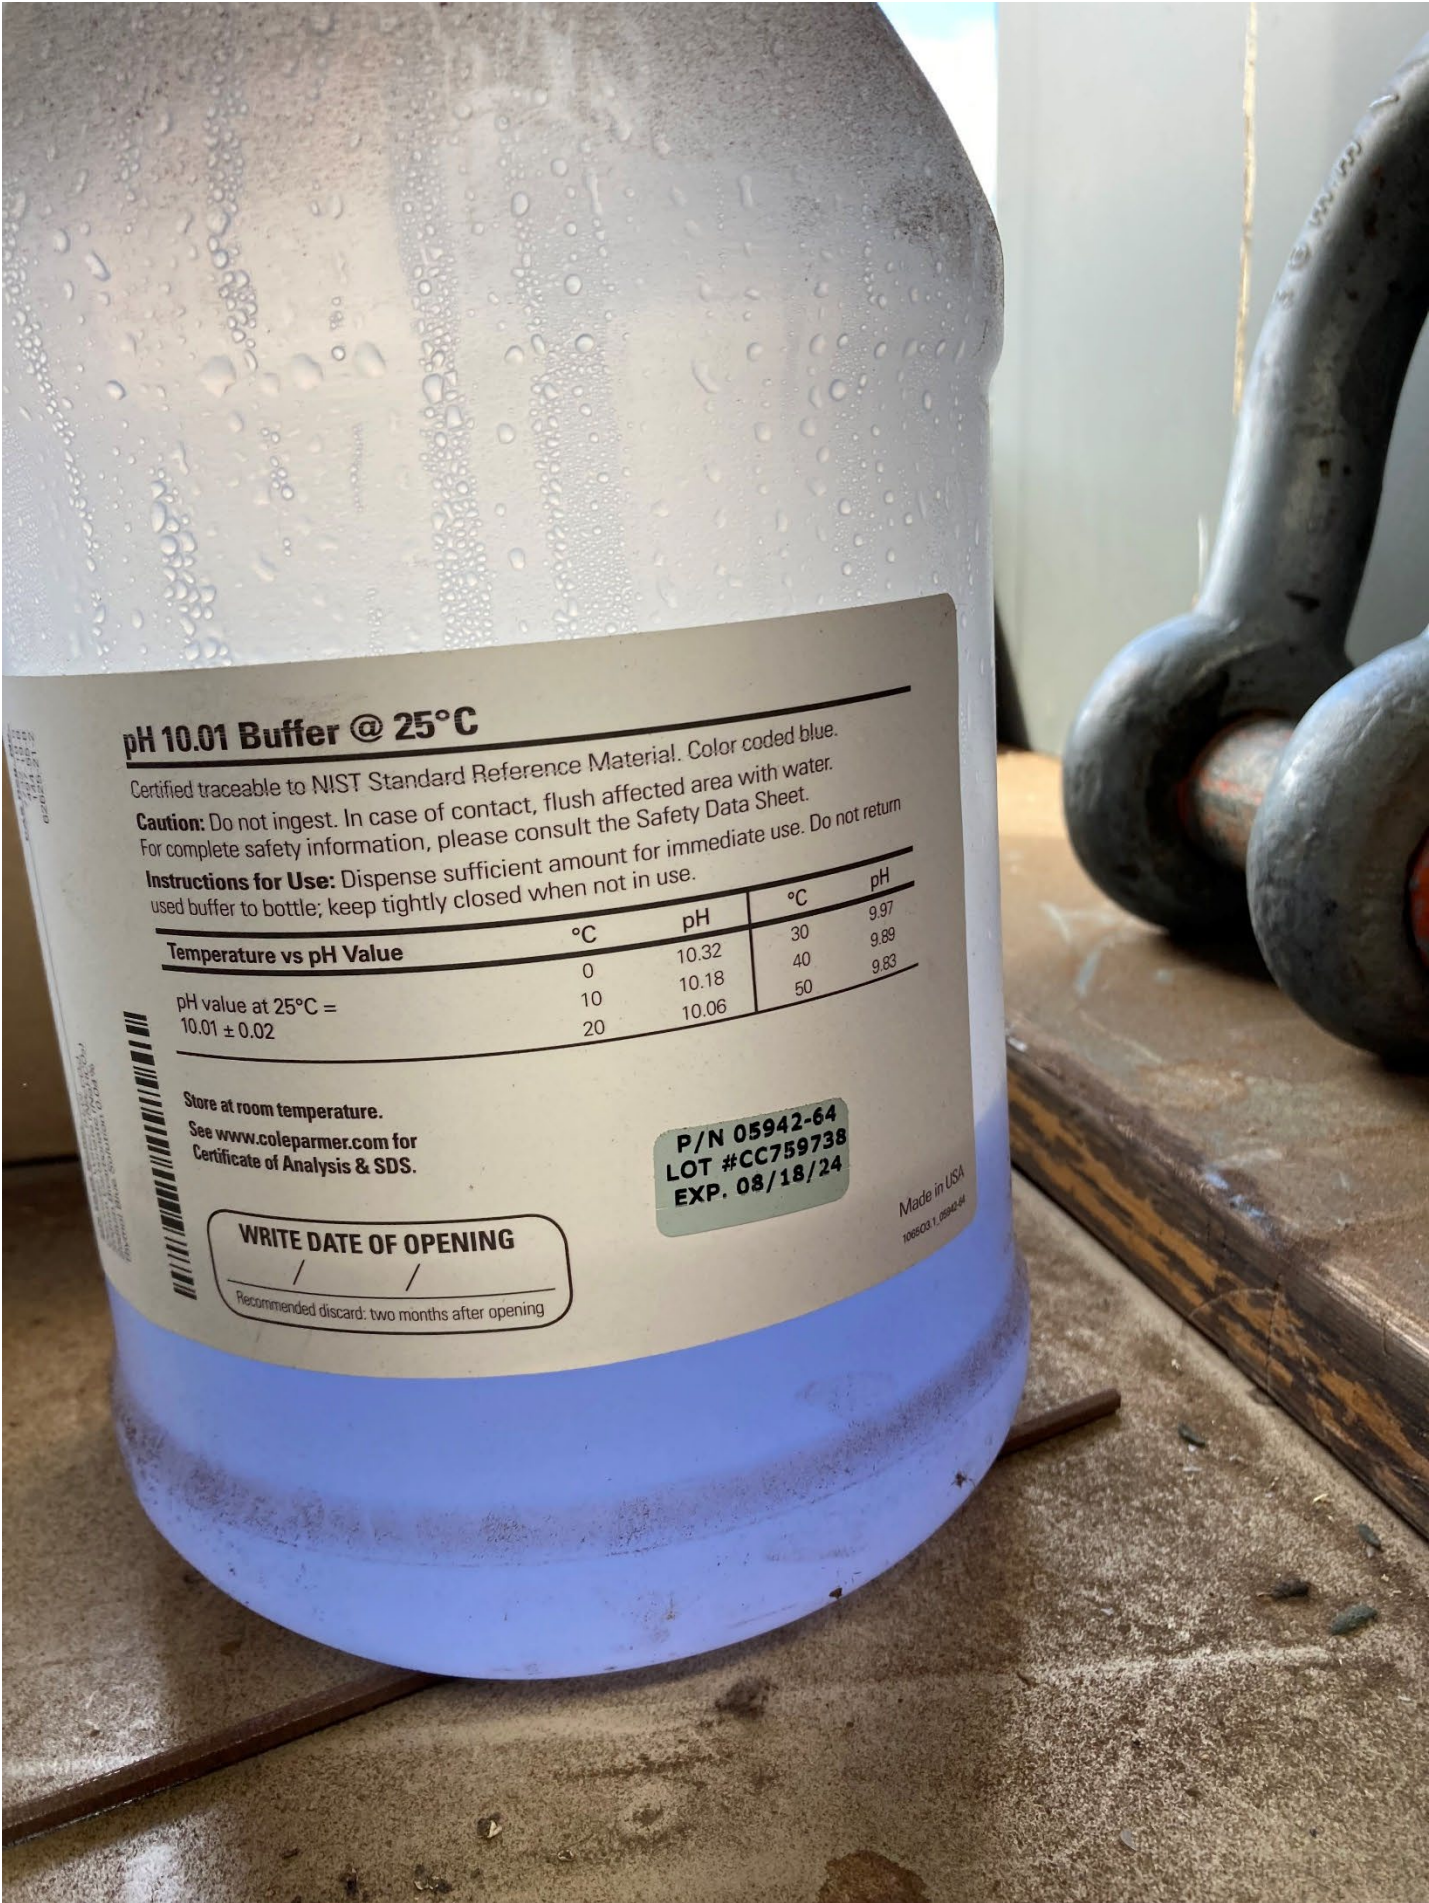
Photo 23: pH 10.0 SU buffer solution bottle at Debarker Lunchroom.
