**STATE OF WASHINGTON
DEPARTMENT OF ECOLOGY**

Re: September 2024 Announced Non-Sampling Water Quality Compliance Inspection Report

Permit Compliance Inspection Report

Facility Name and Address: Weyerhaeuser NR Company
1701, 2901, & 3539 Industrial Way
Longview, WA 98632

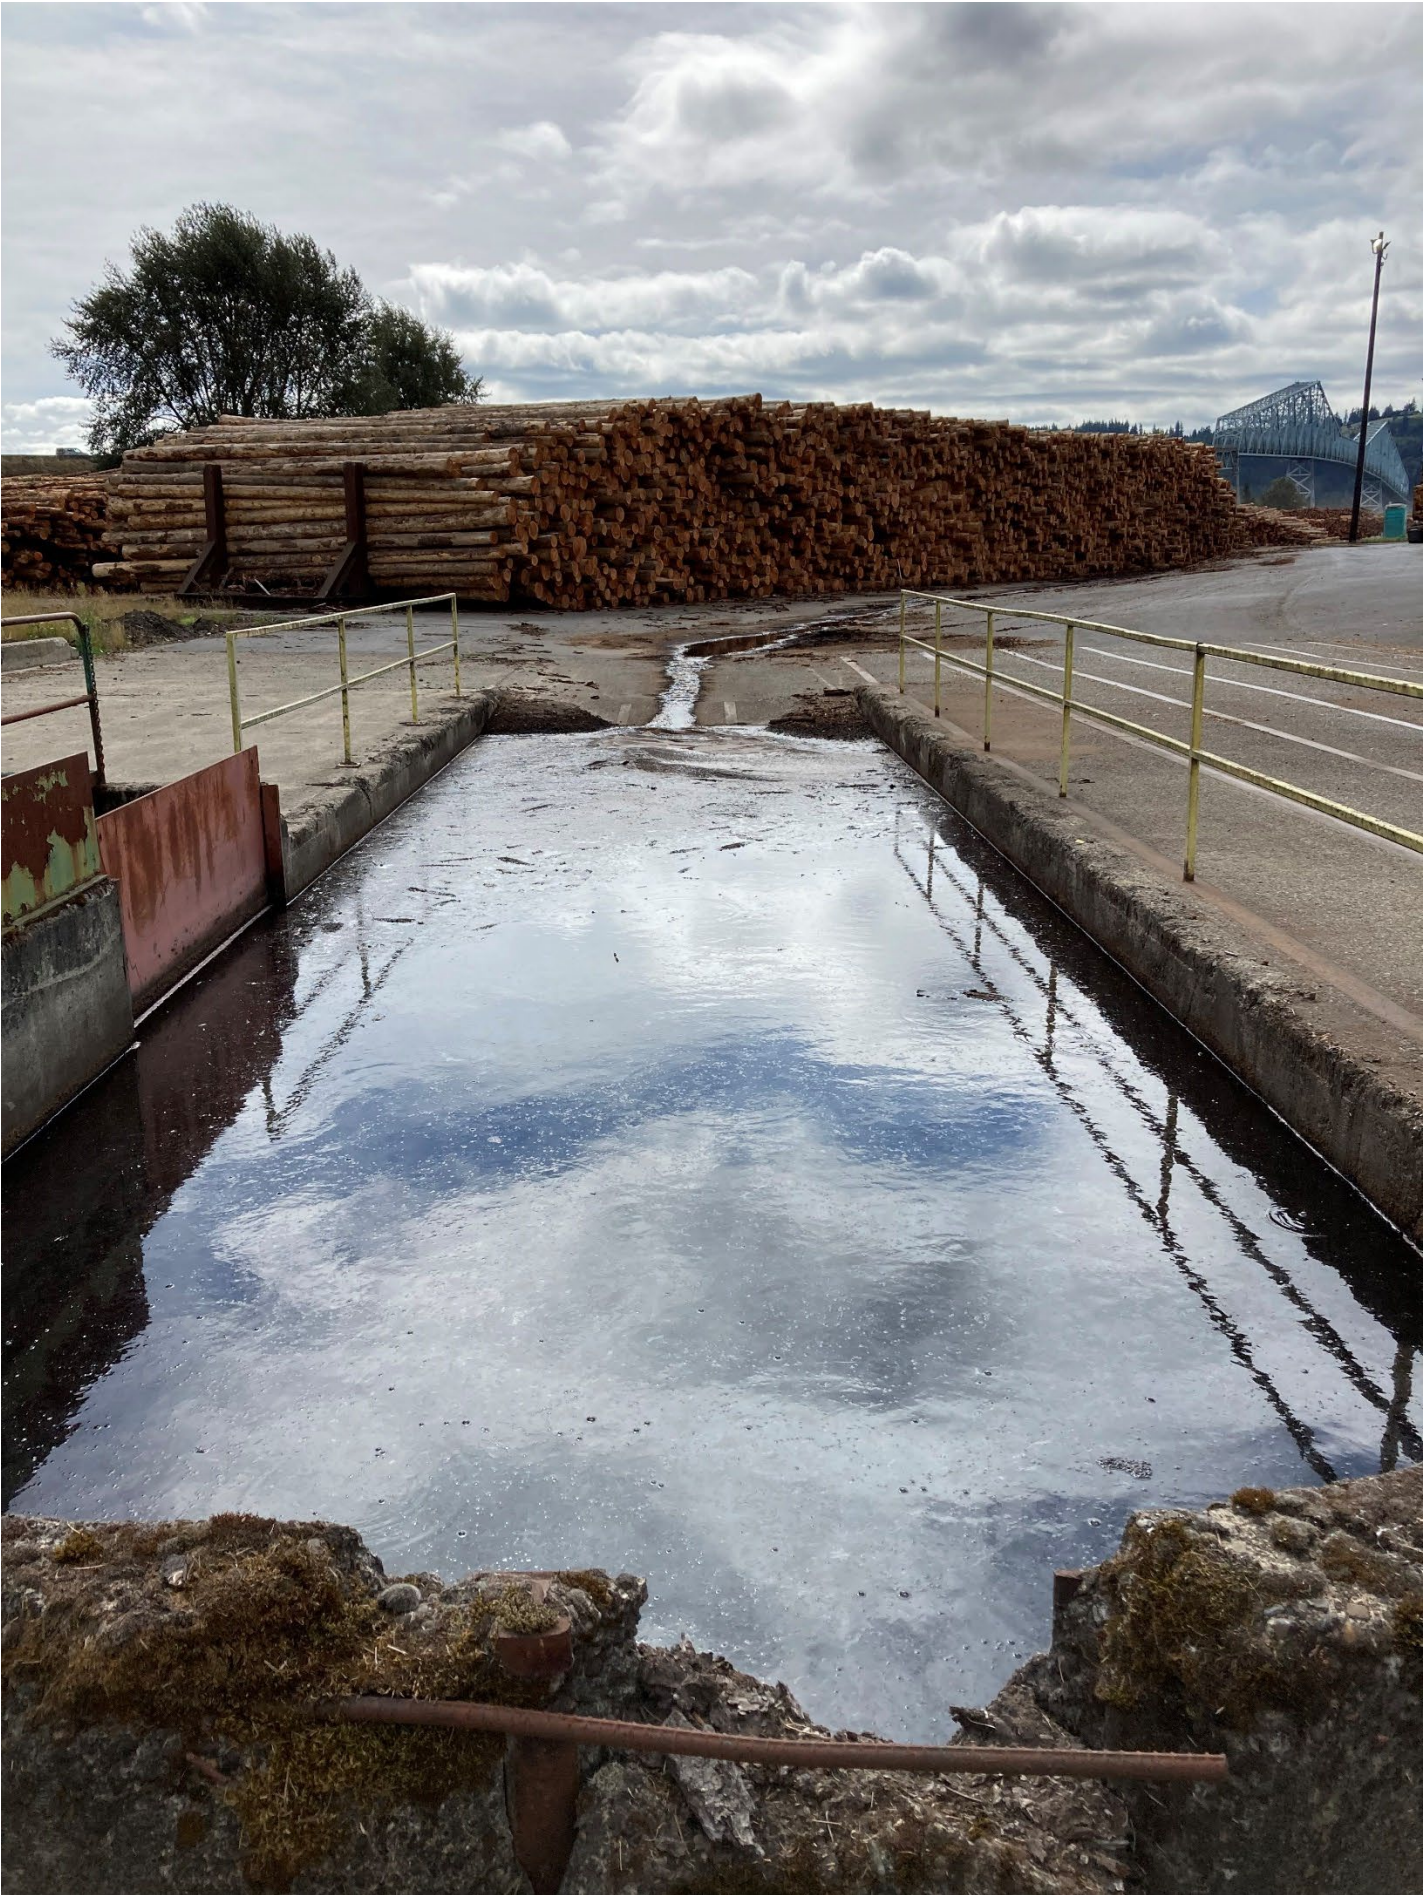
Photo 24: East Sump.

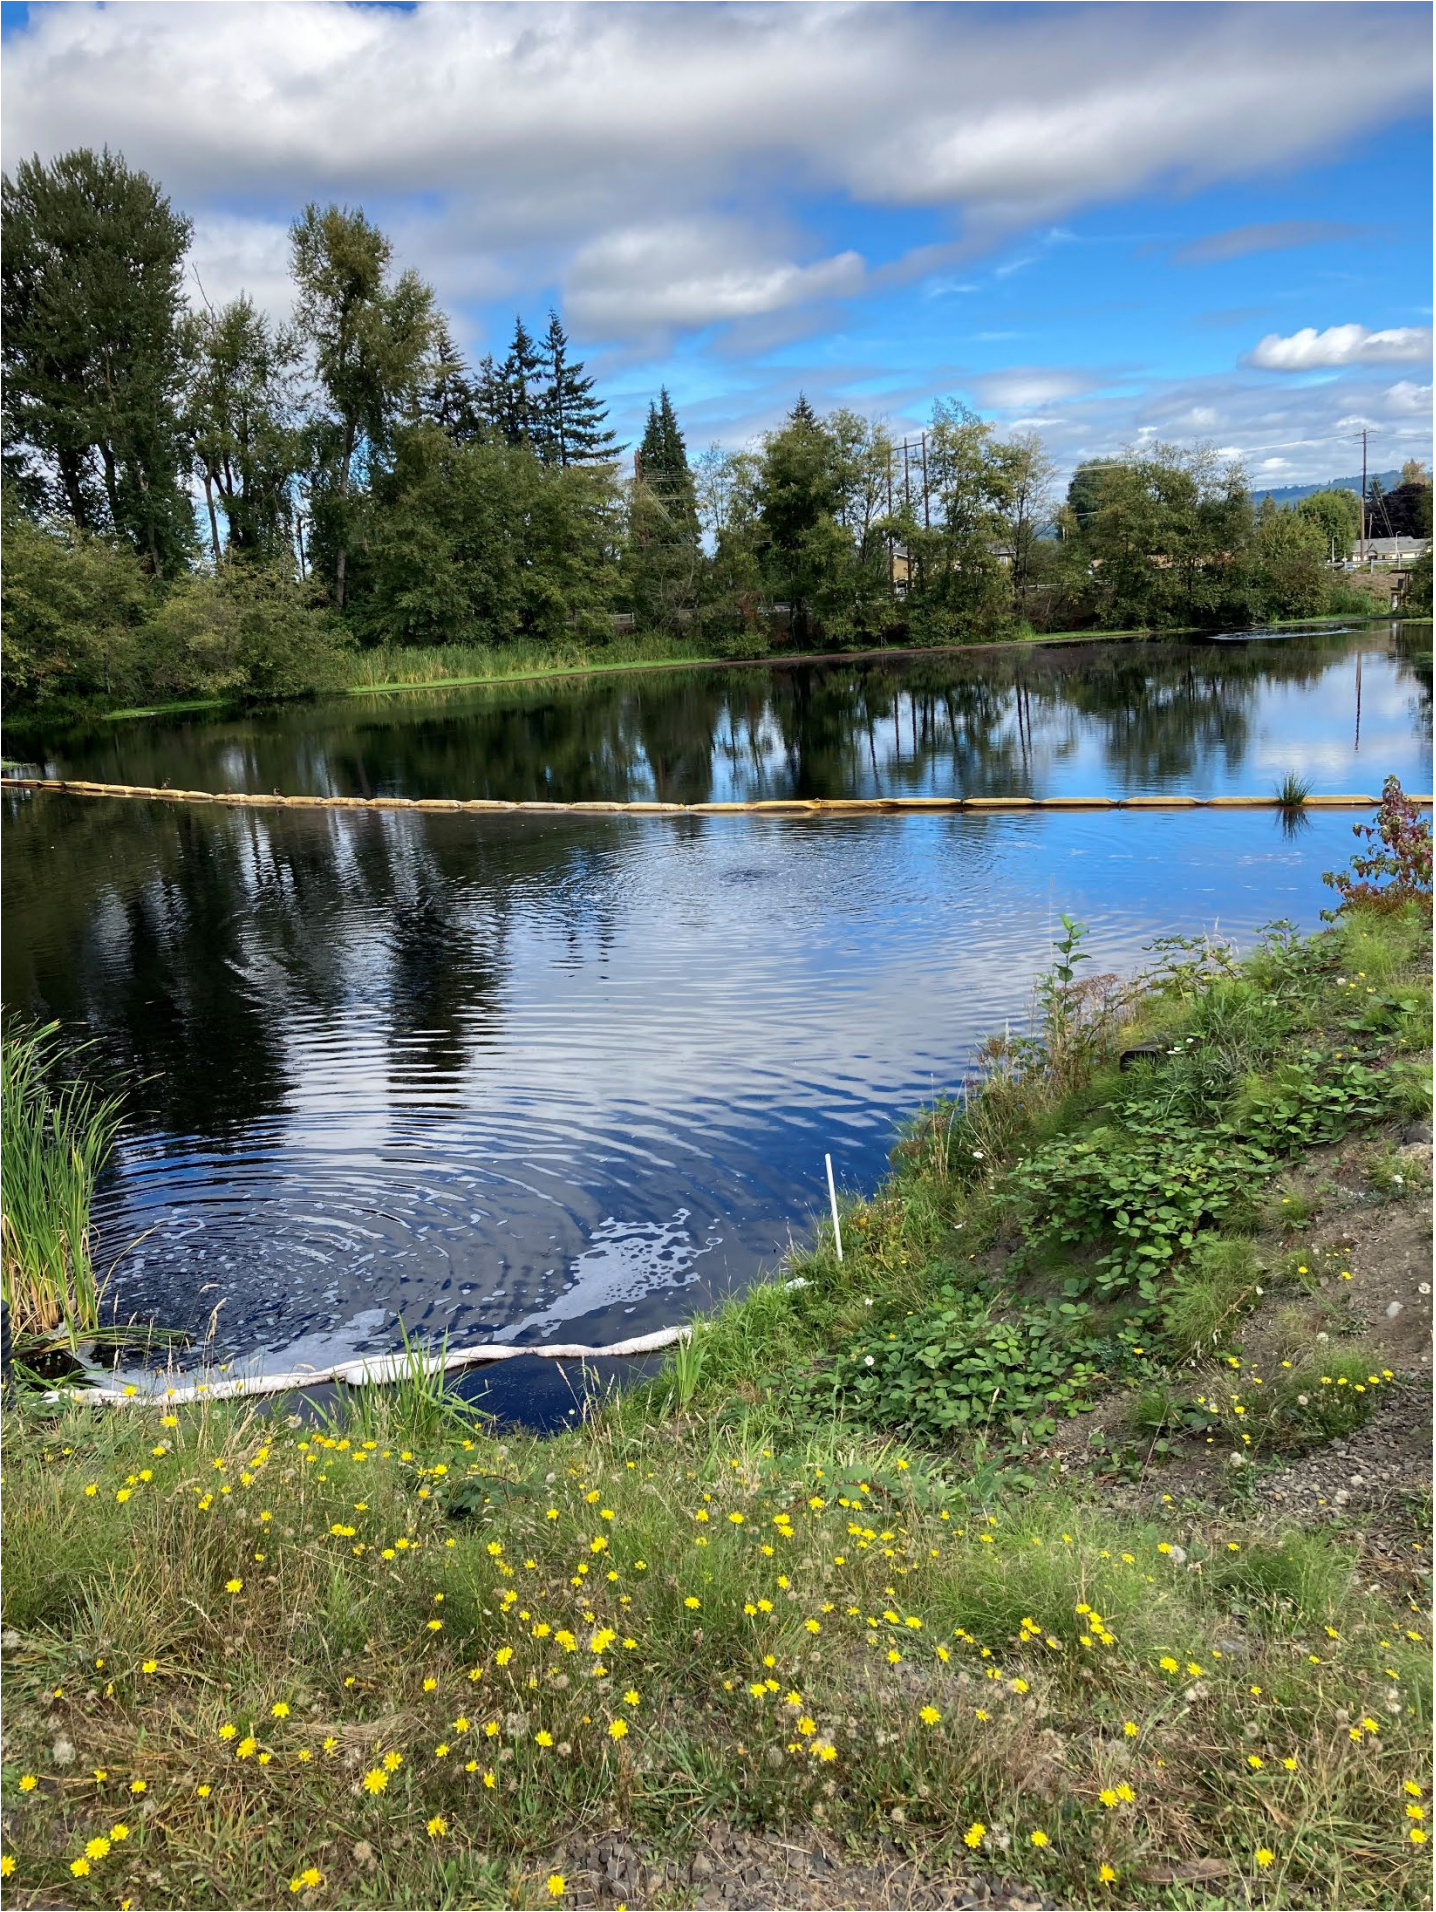
Photo 25: Inlet to the East Pond.

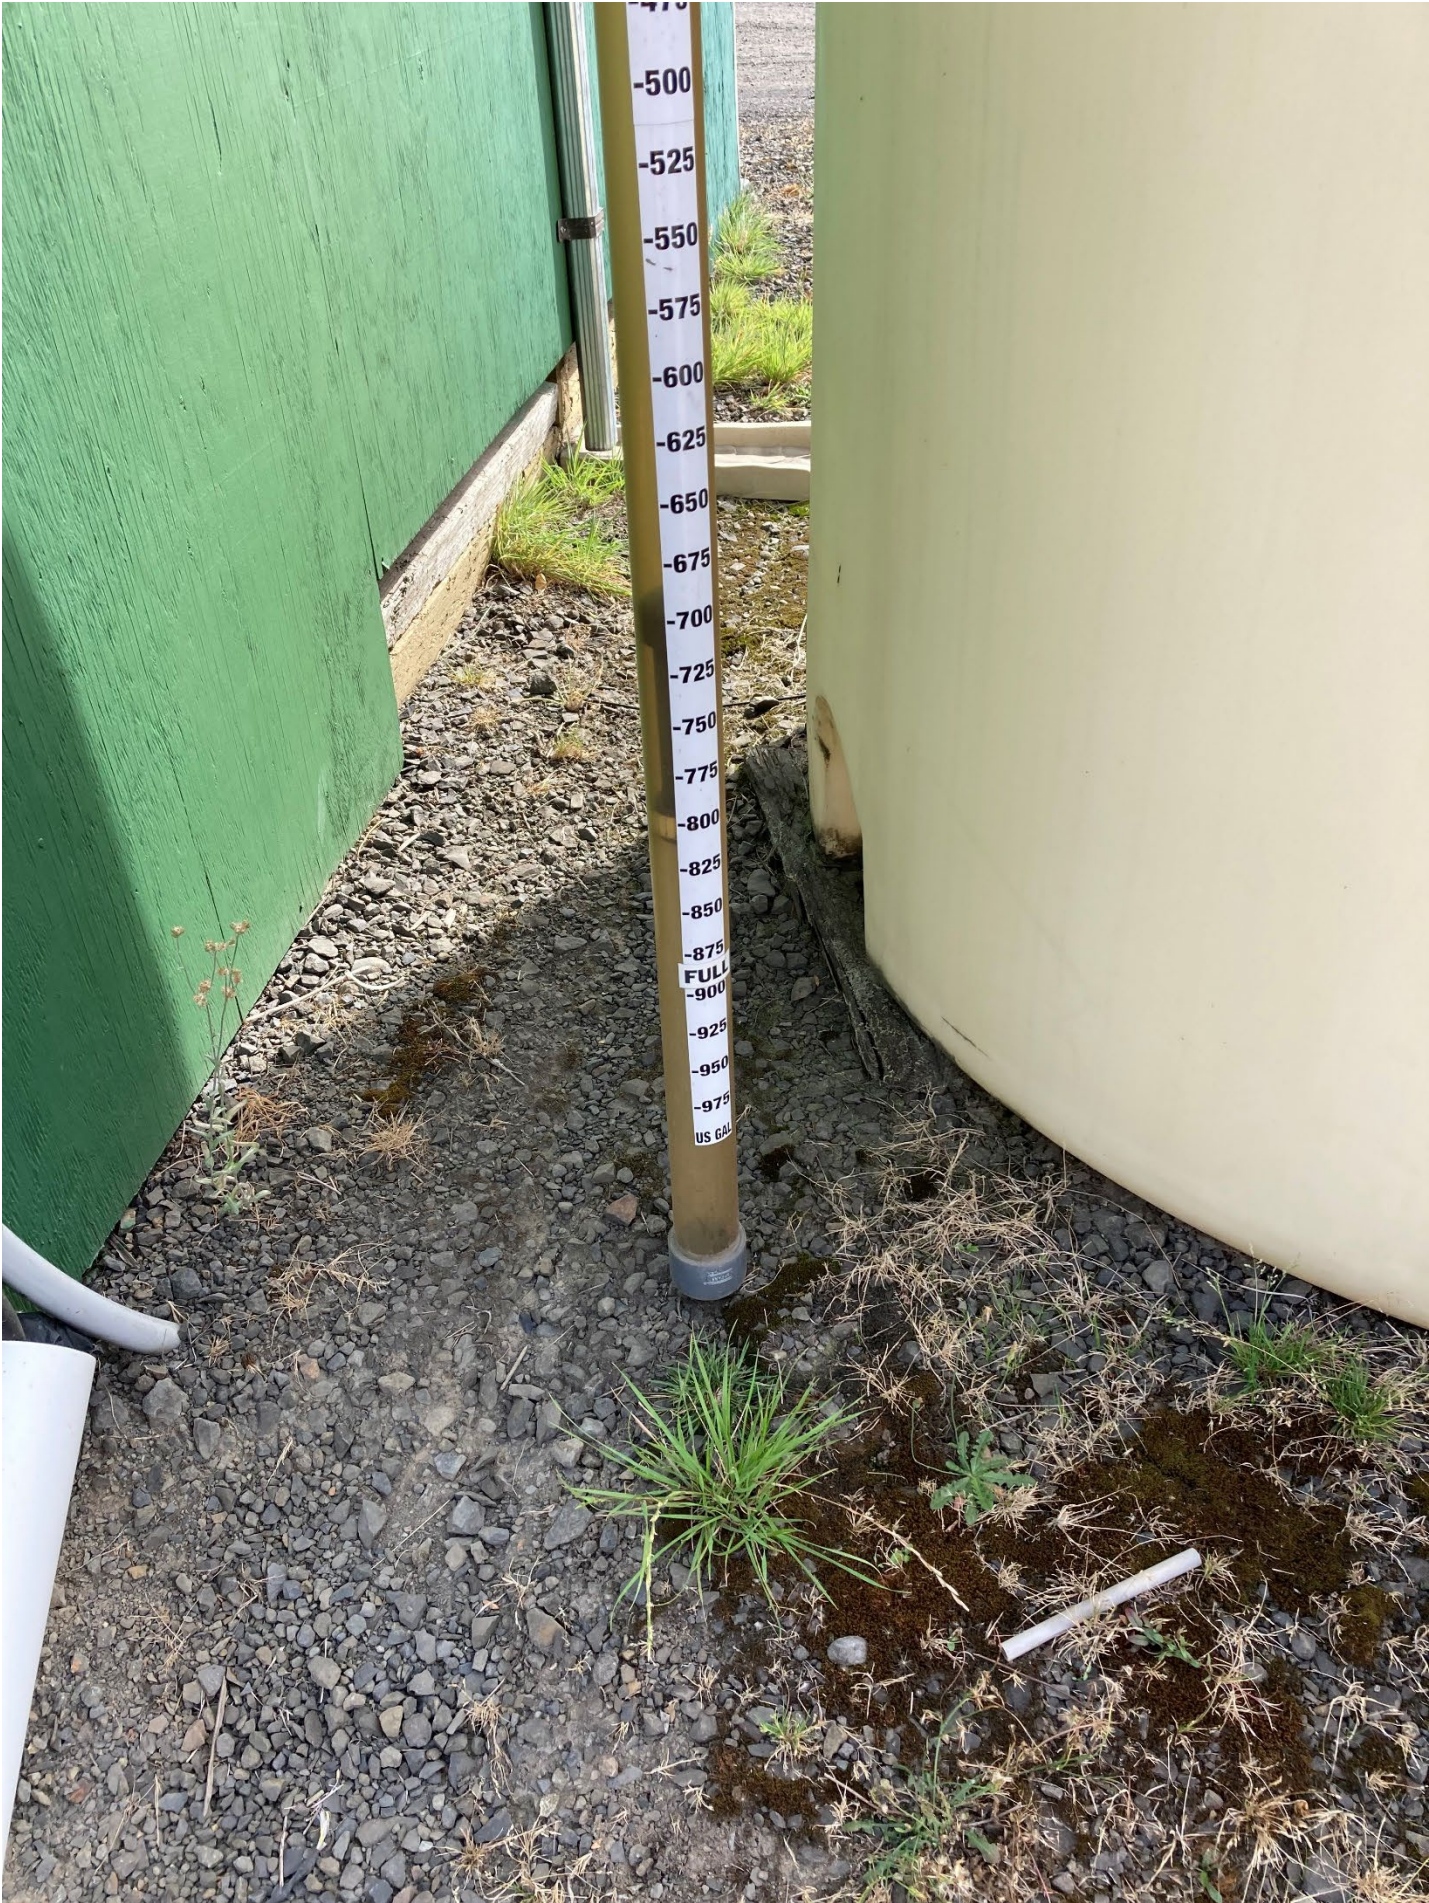
We visited the East Pond inlet, shack, sodium hydroxide tank, and Outfall 003B during the inspection. Weyerhaeuser completed dredging of the East Pond in February through April 2024. I observed two pumps operating on the inlet side of the turbidity curtain and one pump in the distance on the downstream side of the turbidity curtain (Photo 25, Appendix A). The water at the inlet appeared generally clear and I did not note any areas with apparent solids accumulation. I observed the level of the sodium hydroxide tank was approximately 800 gallons on the date of the inspection (Photo 26, Appendix A).

Photo 26: Sodium hydroxide tank level indicator.

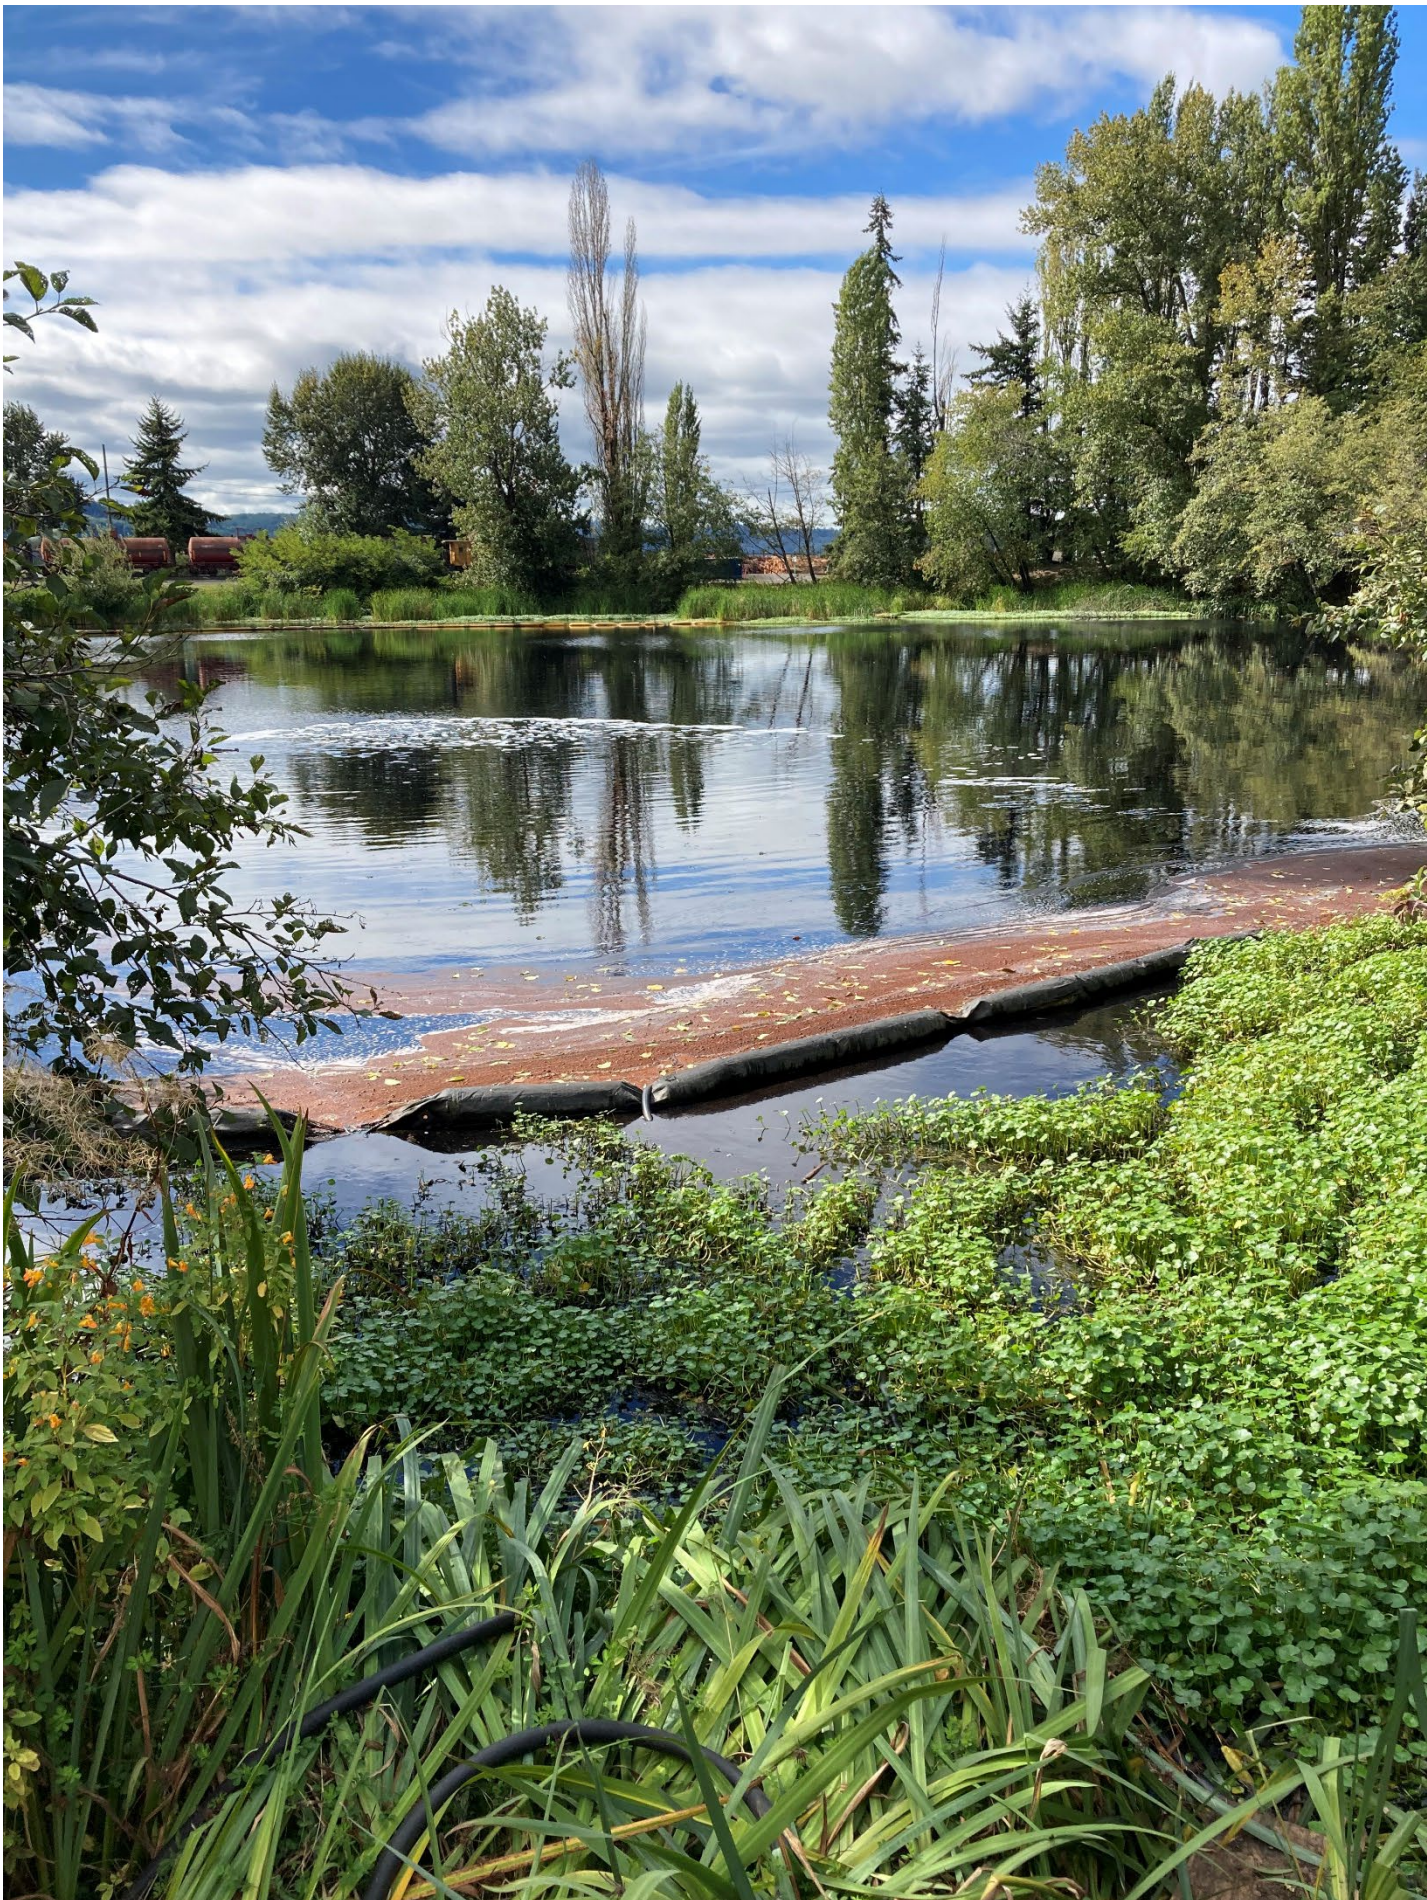
I observed the discharge from Outfall 003B and the north side of the East Pond near Outfall 003B (Photo 27 and Photo 28, Appendix A). I noted vegetation growing along the edge of the pond near Outfall 003B and floating material on the surface of the water; however, the boom appeared to be containing the floating solids and preventing them from discharging at Outfall 003B. I also observed one of the pumps in the pond operating (Photo 27, Appendix A). I observed a discharge from three of the four weirs, with a slight trickle of water flowing over the North weir. The discharge appeared relatively clear with no floating solids, and I noted some foam on the surface of the water discharging into the pipe to CDID Ditch #3. I did not observe an oil sheen in the discharge and did not note any abnormal or significant odors from the discharge on the day of the inspection (Photo 28, Appendix A).

Photo 27: East Pond looking from the Outfall 003B sampling and discharge platform.

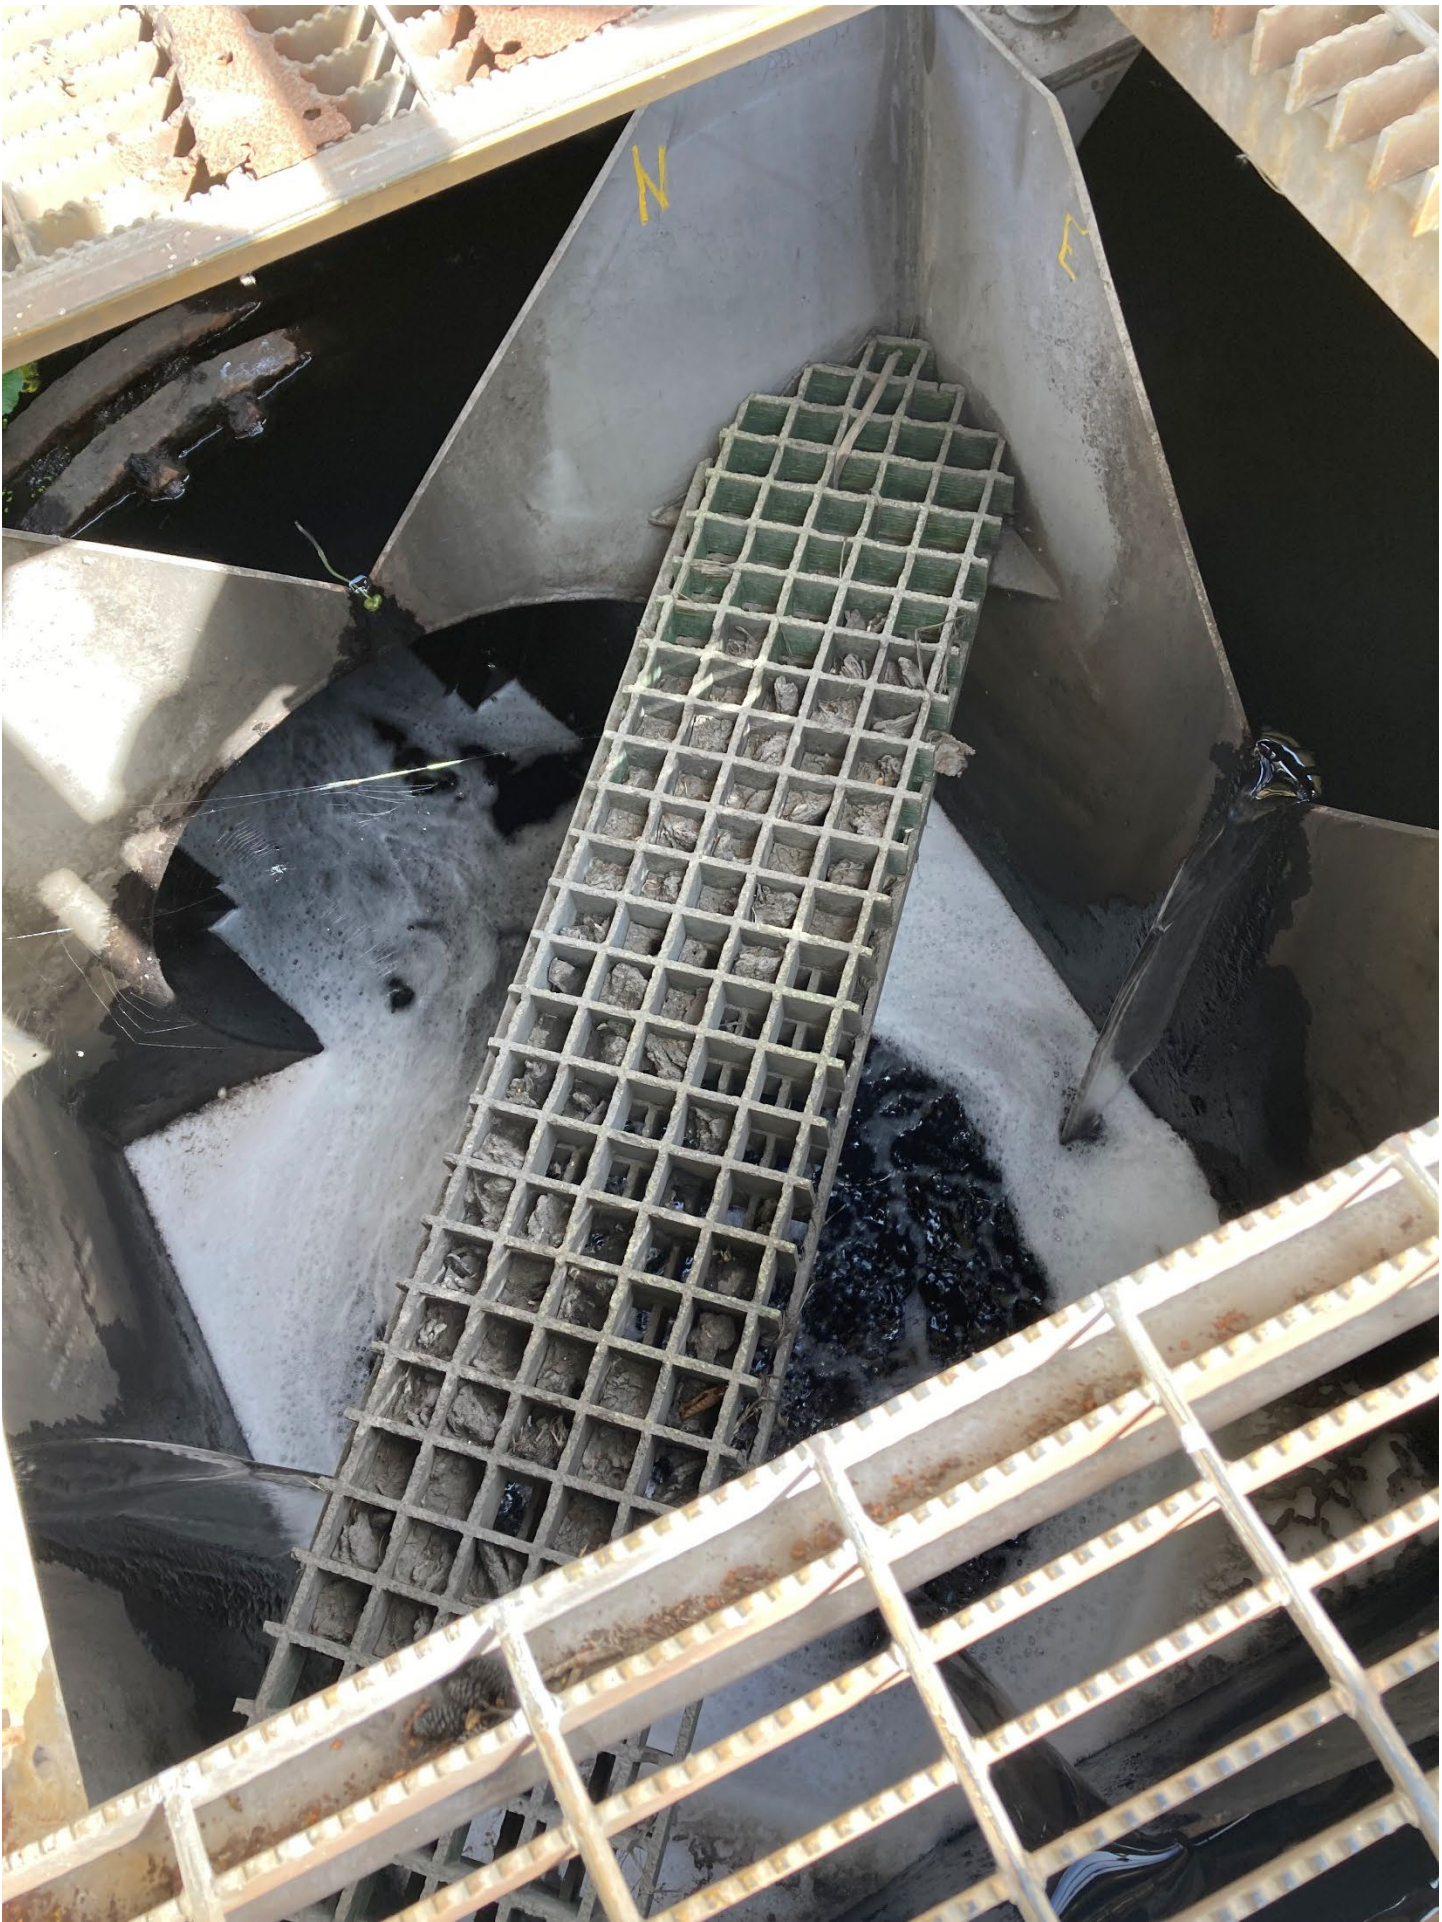
Photo 28: Outfall 003B discharge to CDID Ditch #3 and effluent weirs.

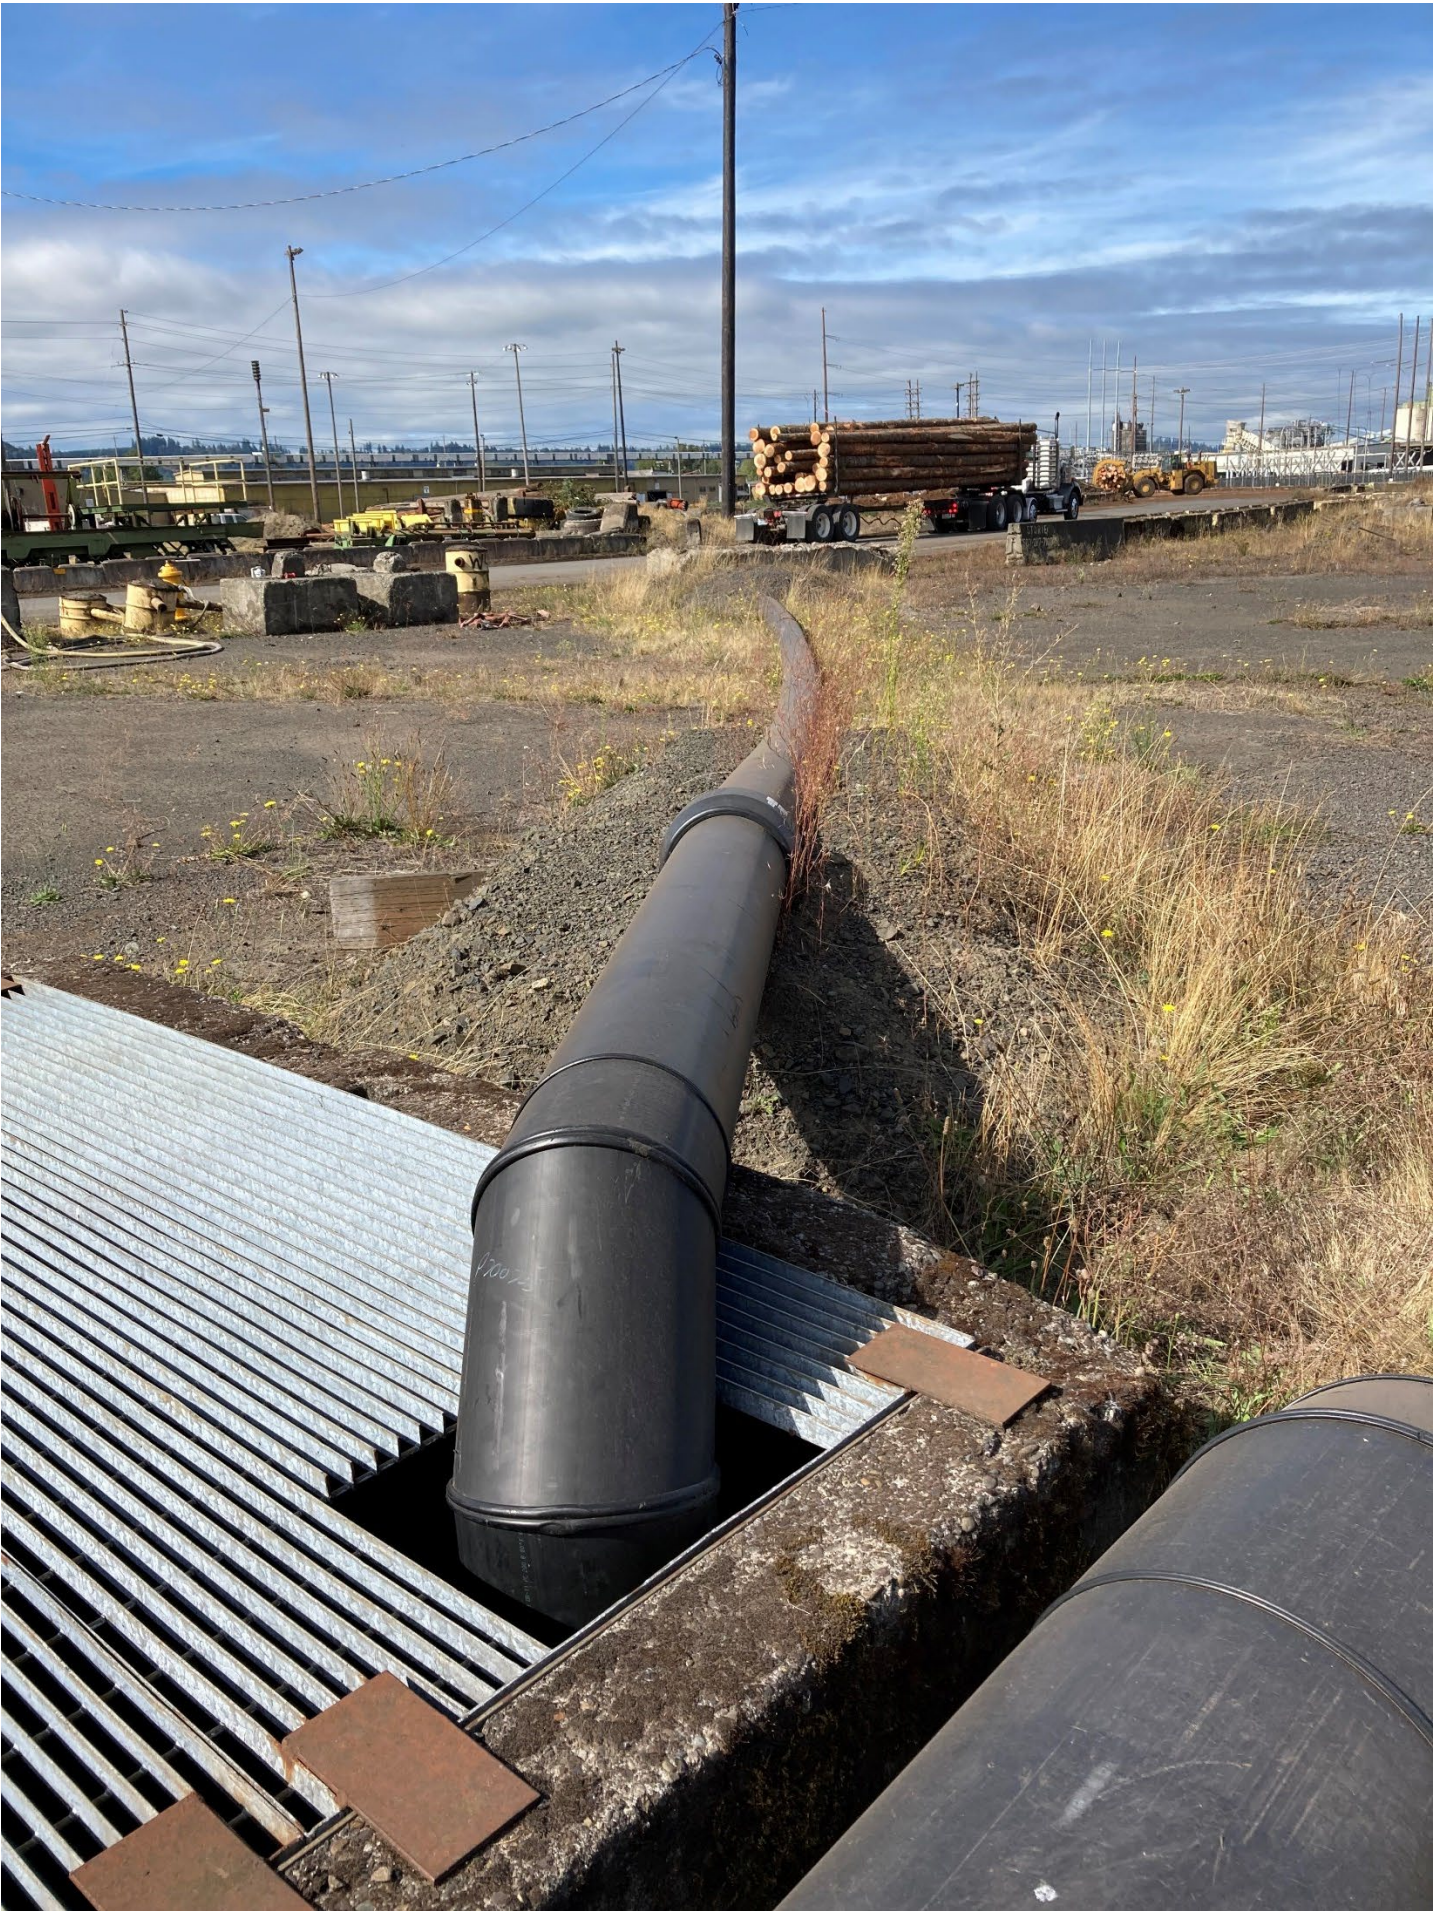
Photo 29: Pipe from Pump Station 6 (Outfall 002B) entering Pump Station 7 (Outfall 005B).

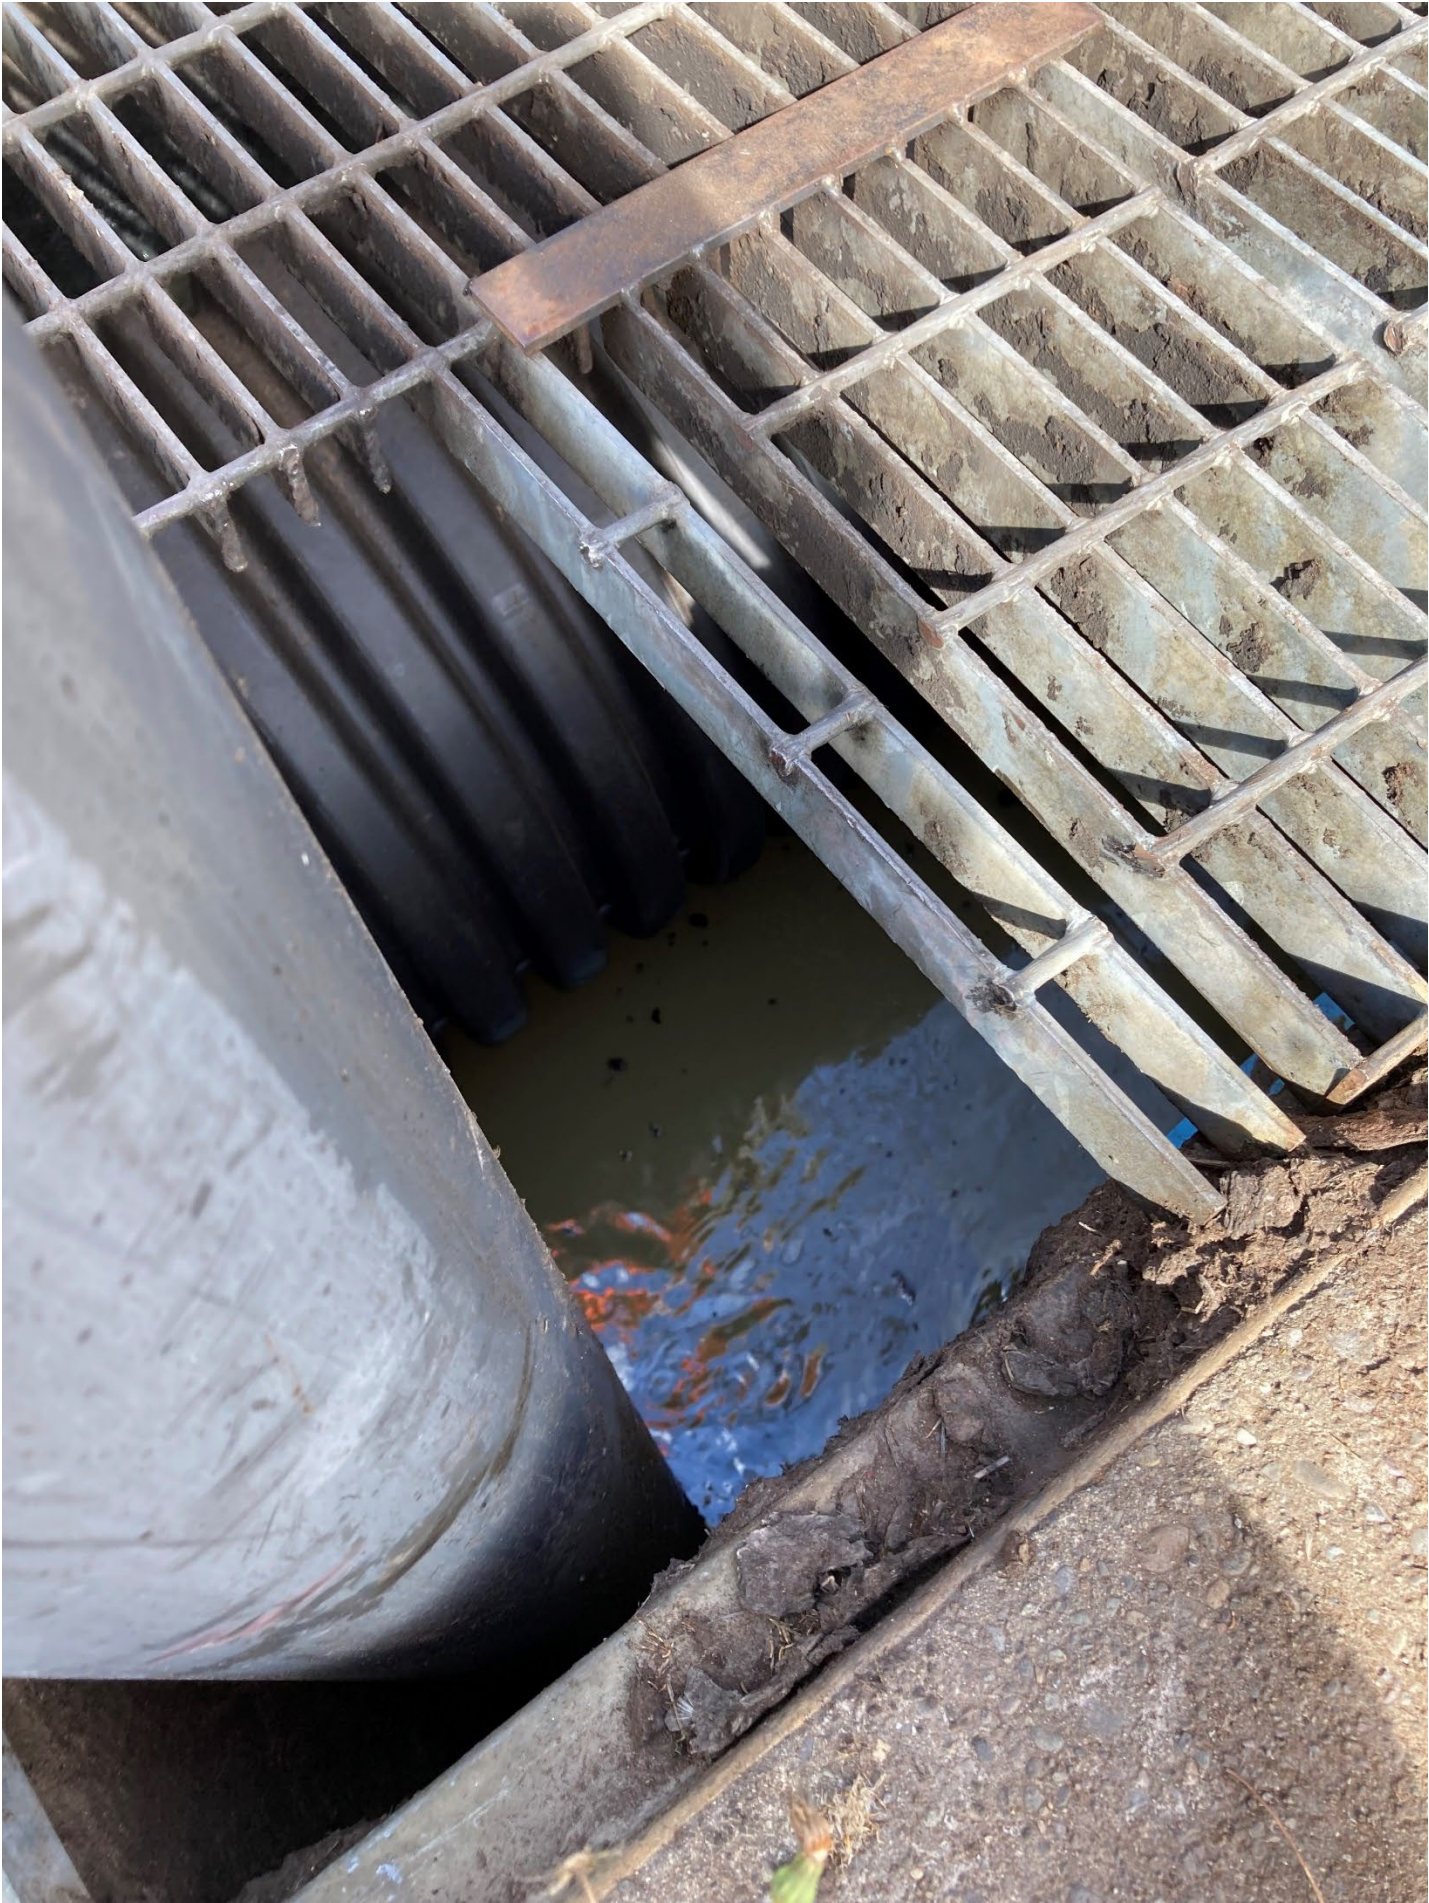
Photo 30: Pump Station 6 (Outfall 002B) sump and Pipe A.

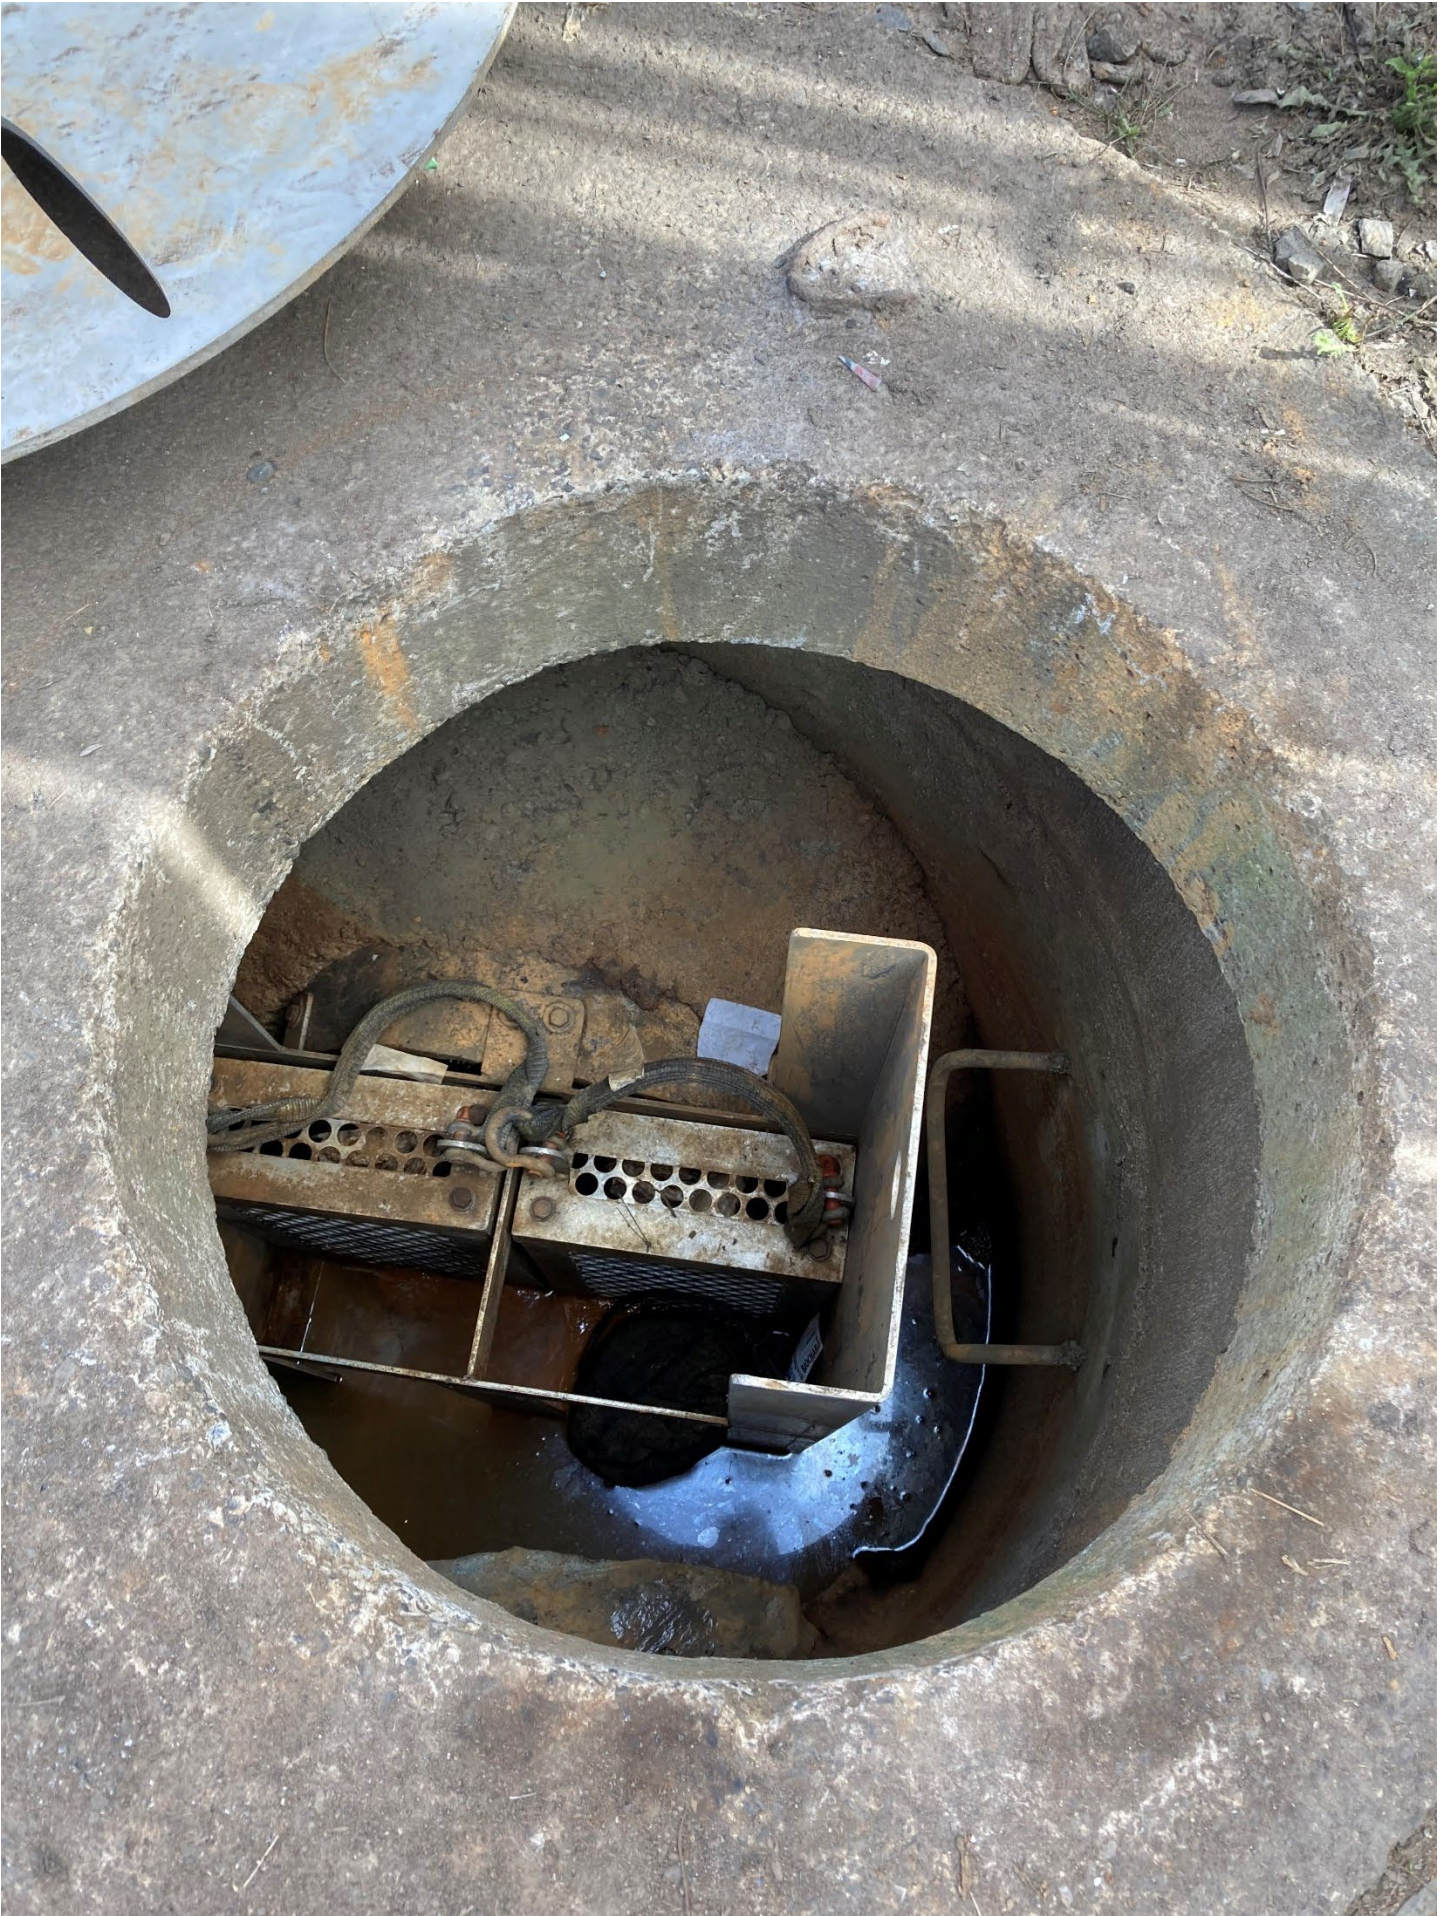
Weyerhaeuser how often they change out or clean the filtration and treatment medias. Dave reported he cleans the oyster shells and replaces the biochar bags as needed. Dave also reported he last changed out the biochar bags and cleaned the oyster shells approximately 2 weeks ago. I noted a sheen on the surface of the water before the filtration and treatment media in one of the manhole catch basins (Photo 31, Appendix A). I could not see the water exiting the manhole.

Photo 31: Manhole catch basin filtration structure in the Pipe A drainage area.
