**STATE OF WASHINGTON
DEPARTMENT OF ECOLOGY**

Re: September 2024 Announced Non-Sampling Water Quality Compliance Inspection Report

Permit Compliance Inspection Report

Facility Name and Address: Weyerhaeuser NR Company
1701, 2901, & 3539 Industrial Way
Longview, WA 98632

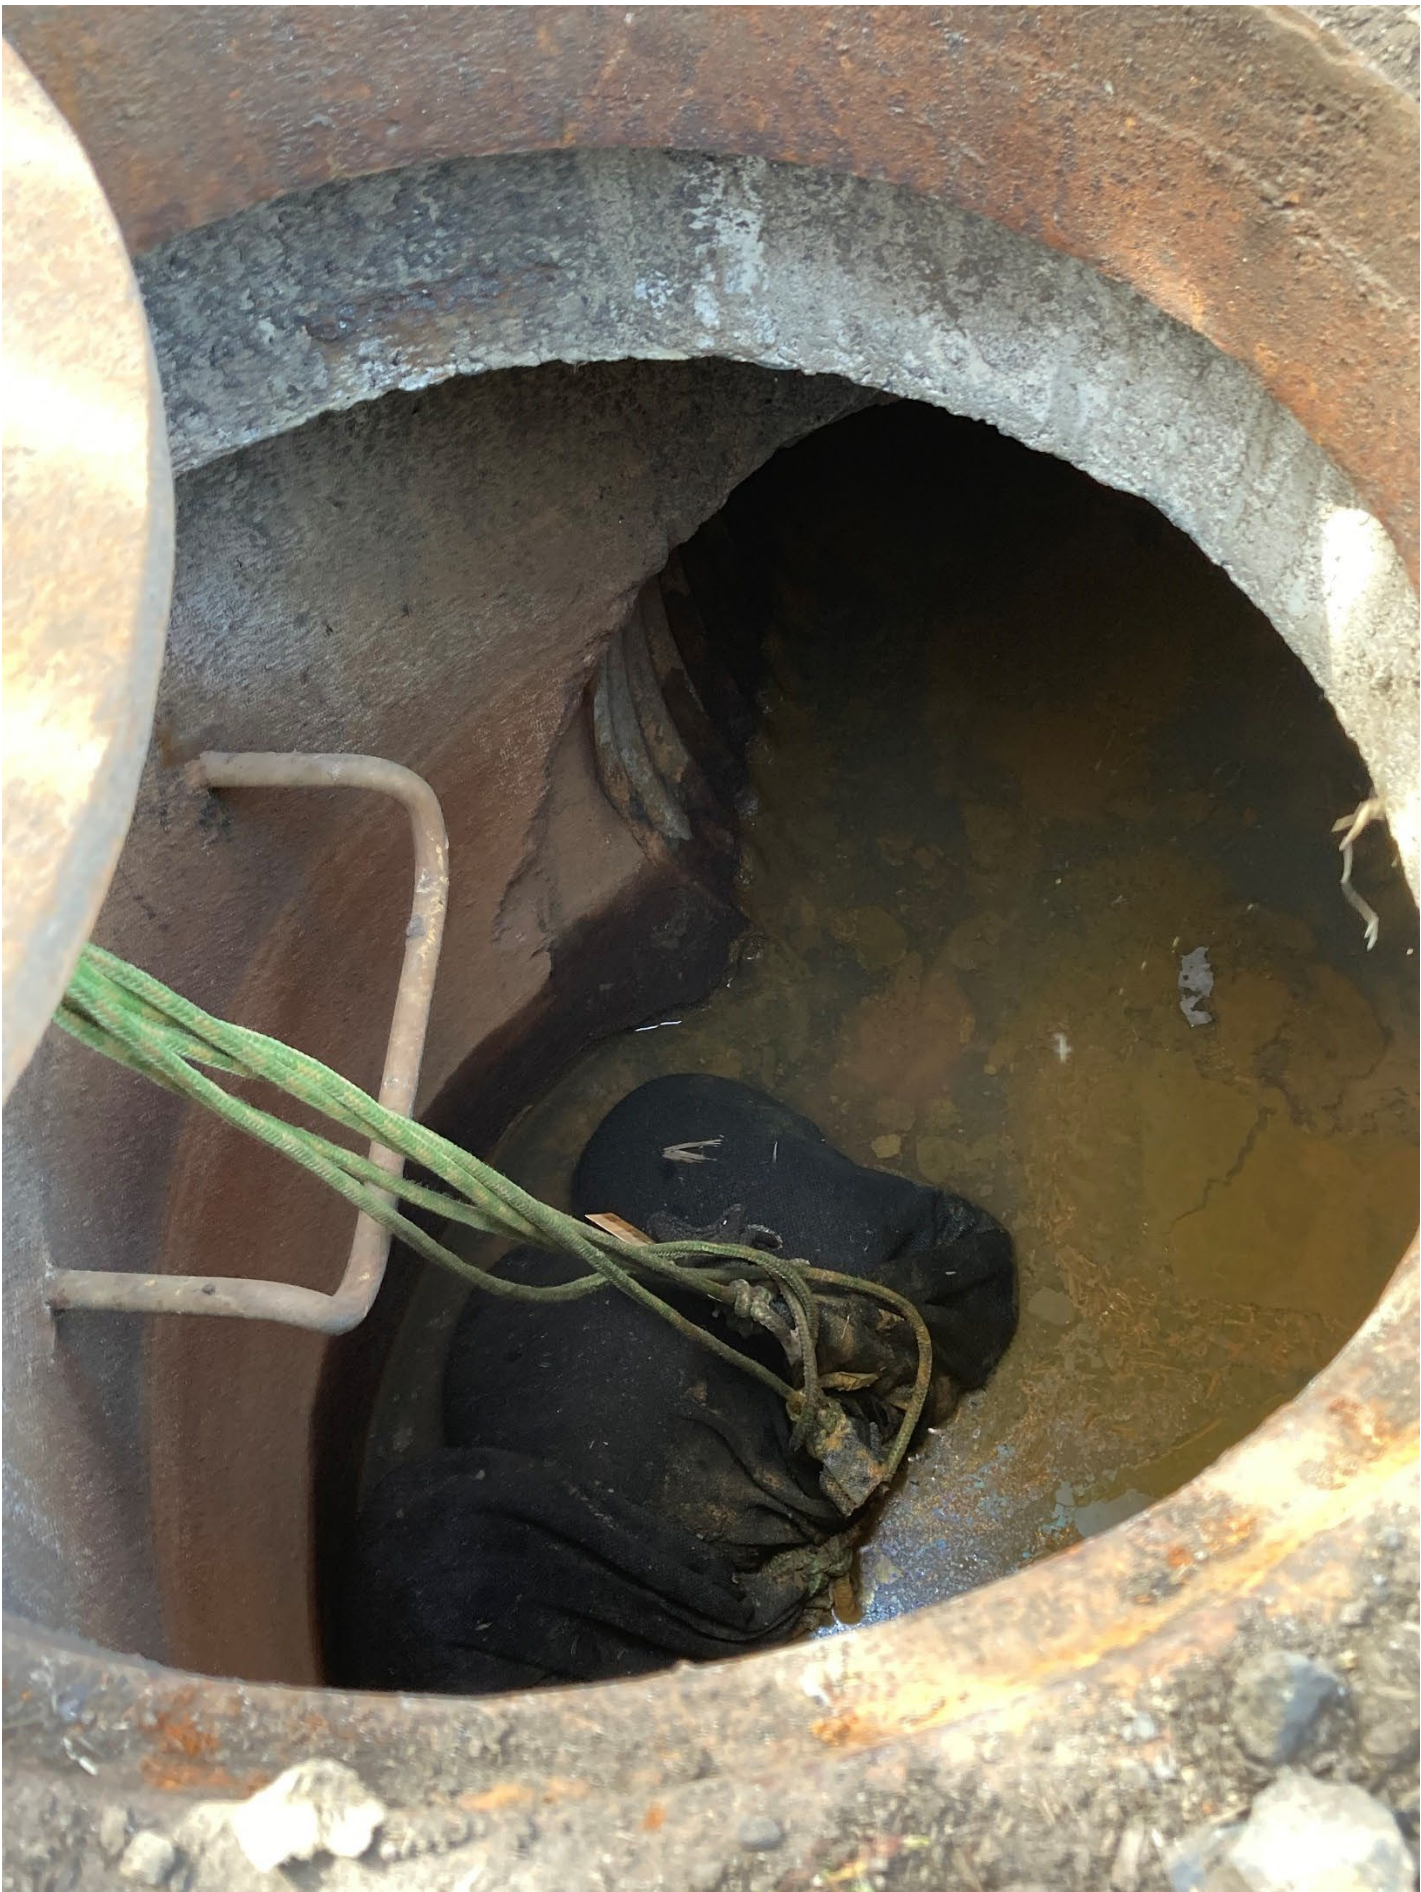
We visited another manhole catch basin located south of the manhole with the filtration structure. Weyerhaeuser did not install a filtration structure in this manhole; however, they have inserted biochar bags in this manhole as well. I observed a metallic-appearing sheen on the surface of the water in this manhole and observed the water in the manhole was a slightly opaque brown-orange color (Photo 32 and Photo 33, Appendix A).

Photo 32: Manhole catch basin in the Pipe A drainage area.

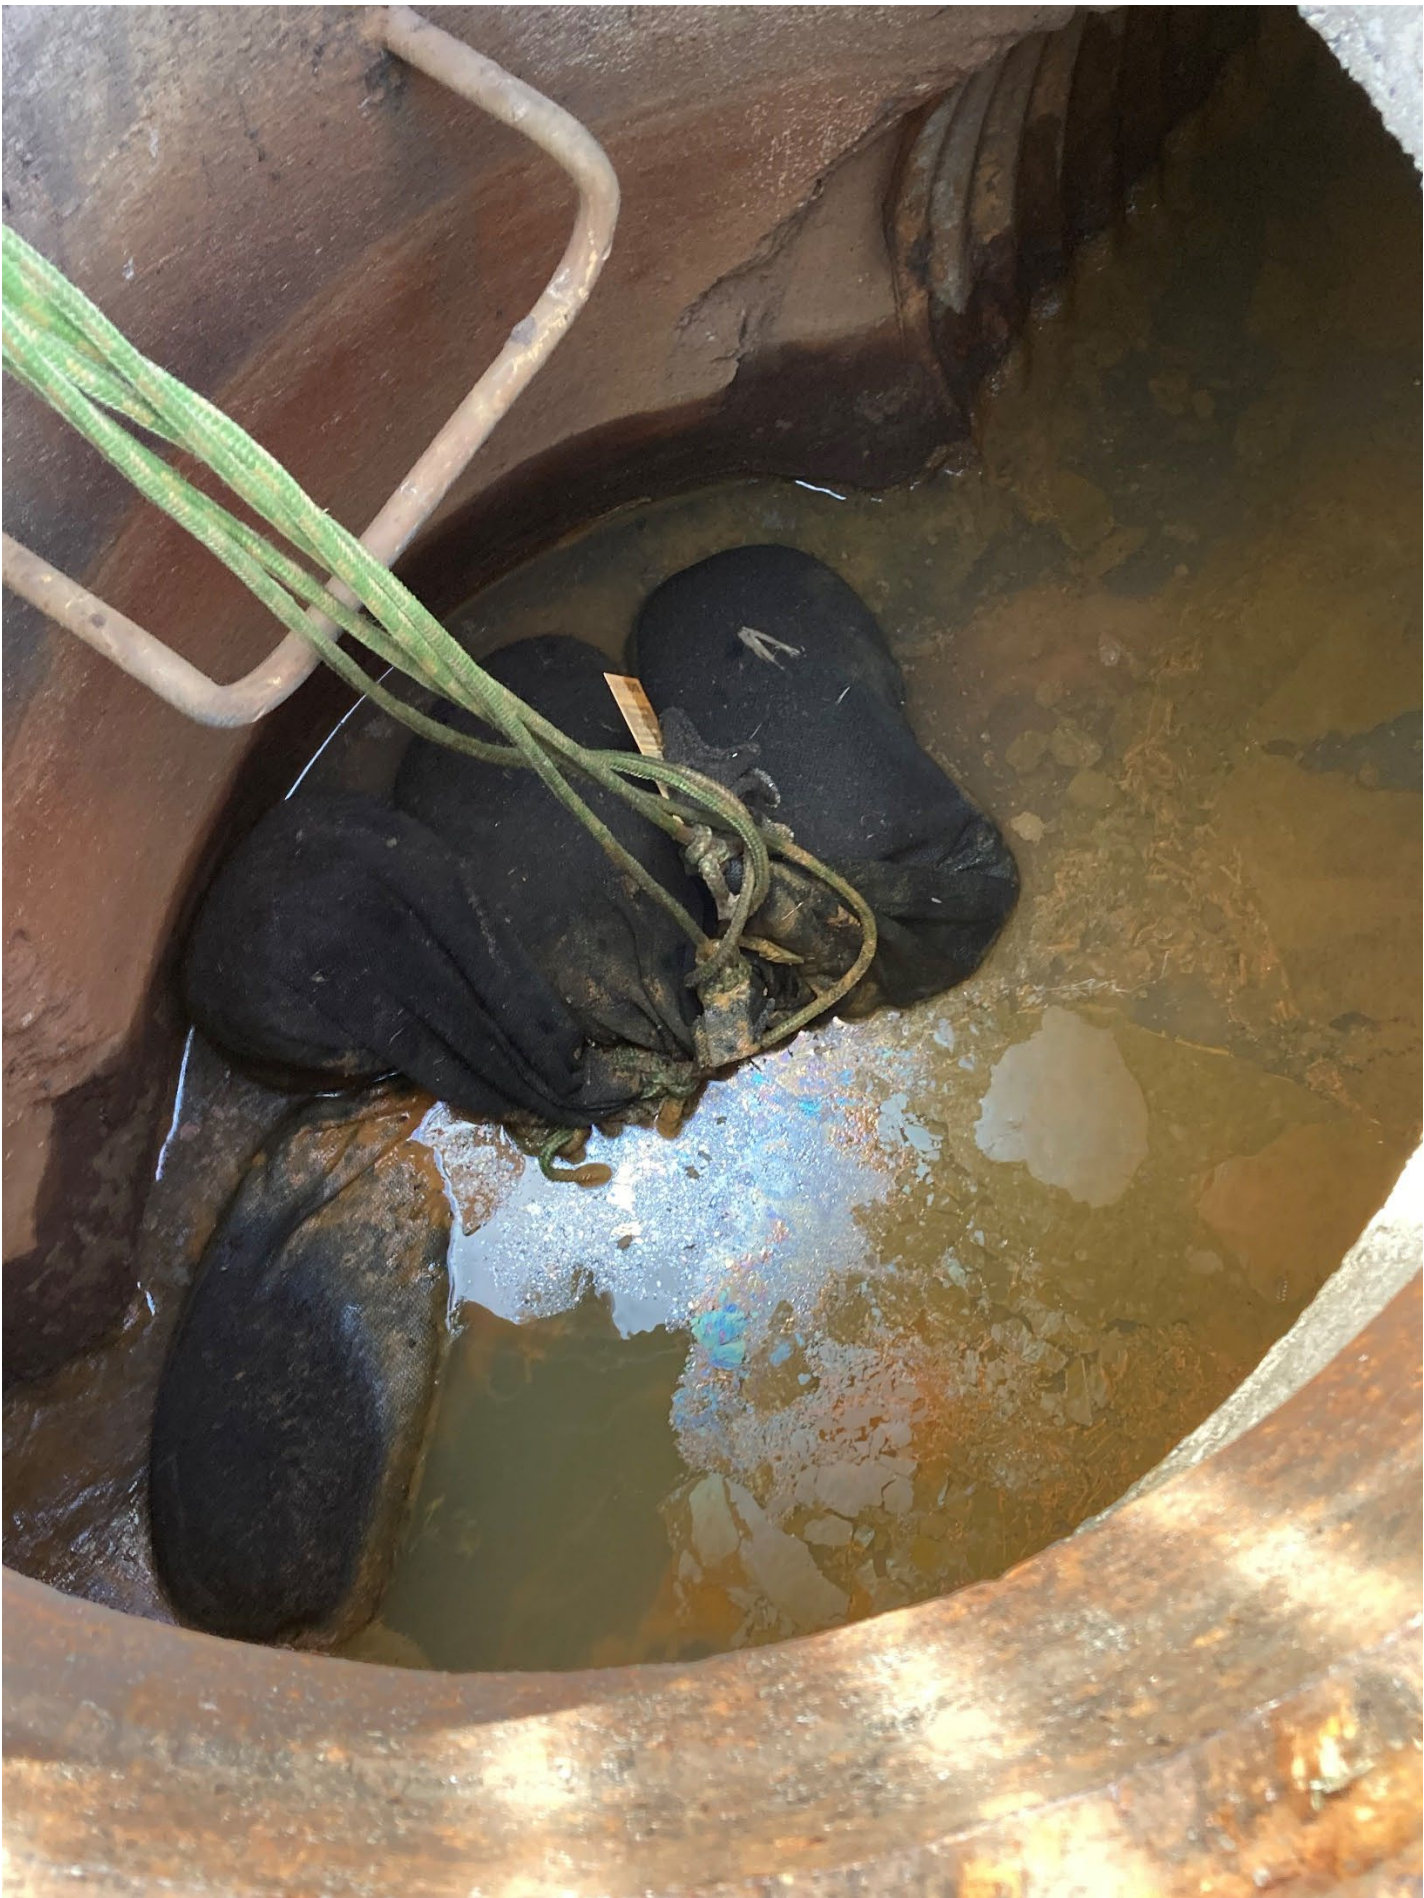
Photo 33: Biochar bags in a manhole catch basin in the Pipe A drainage area.

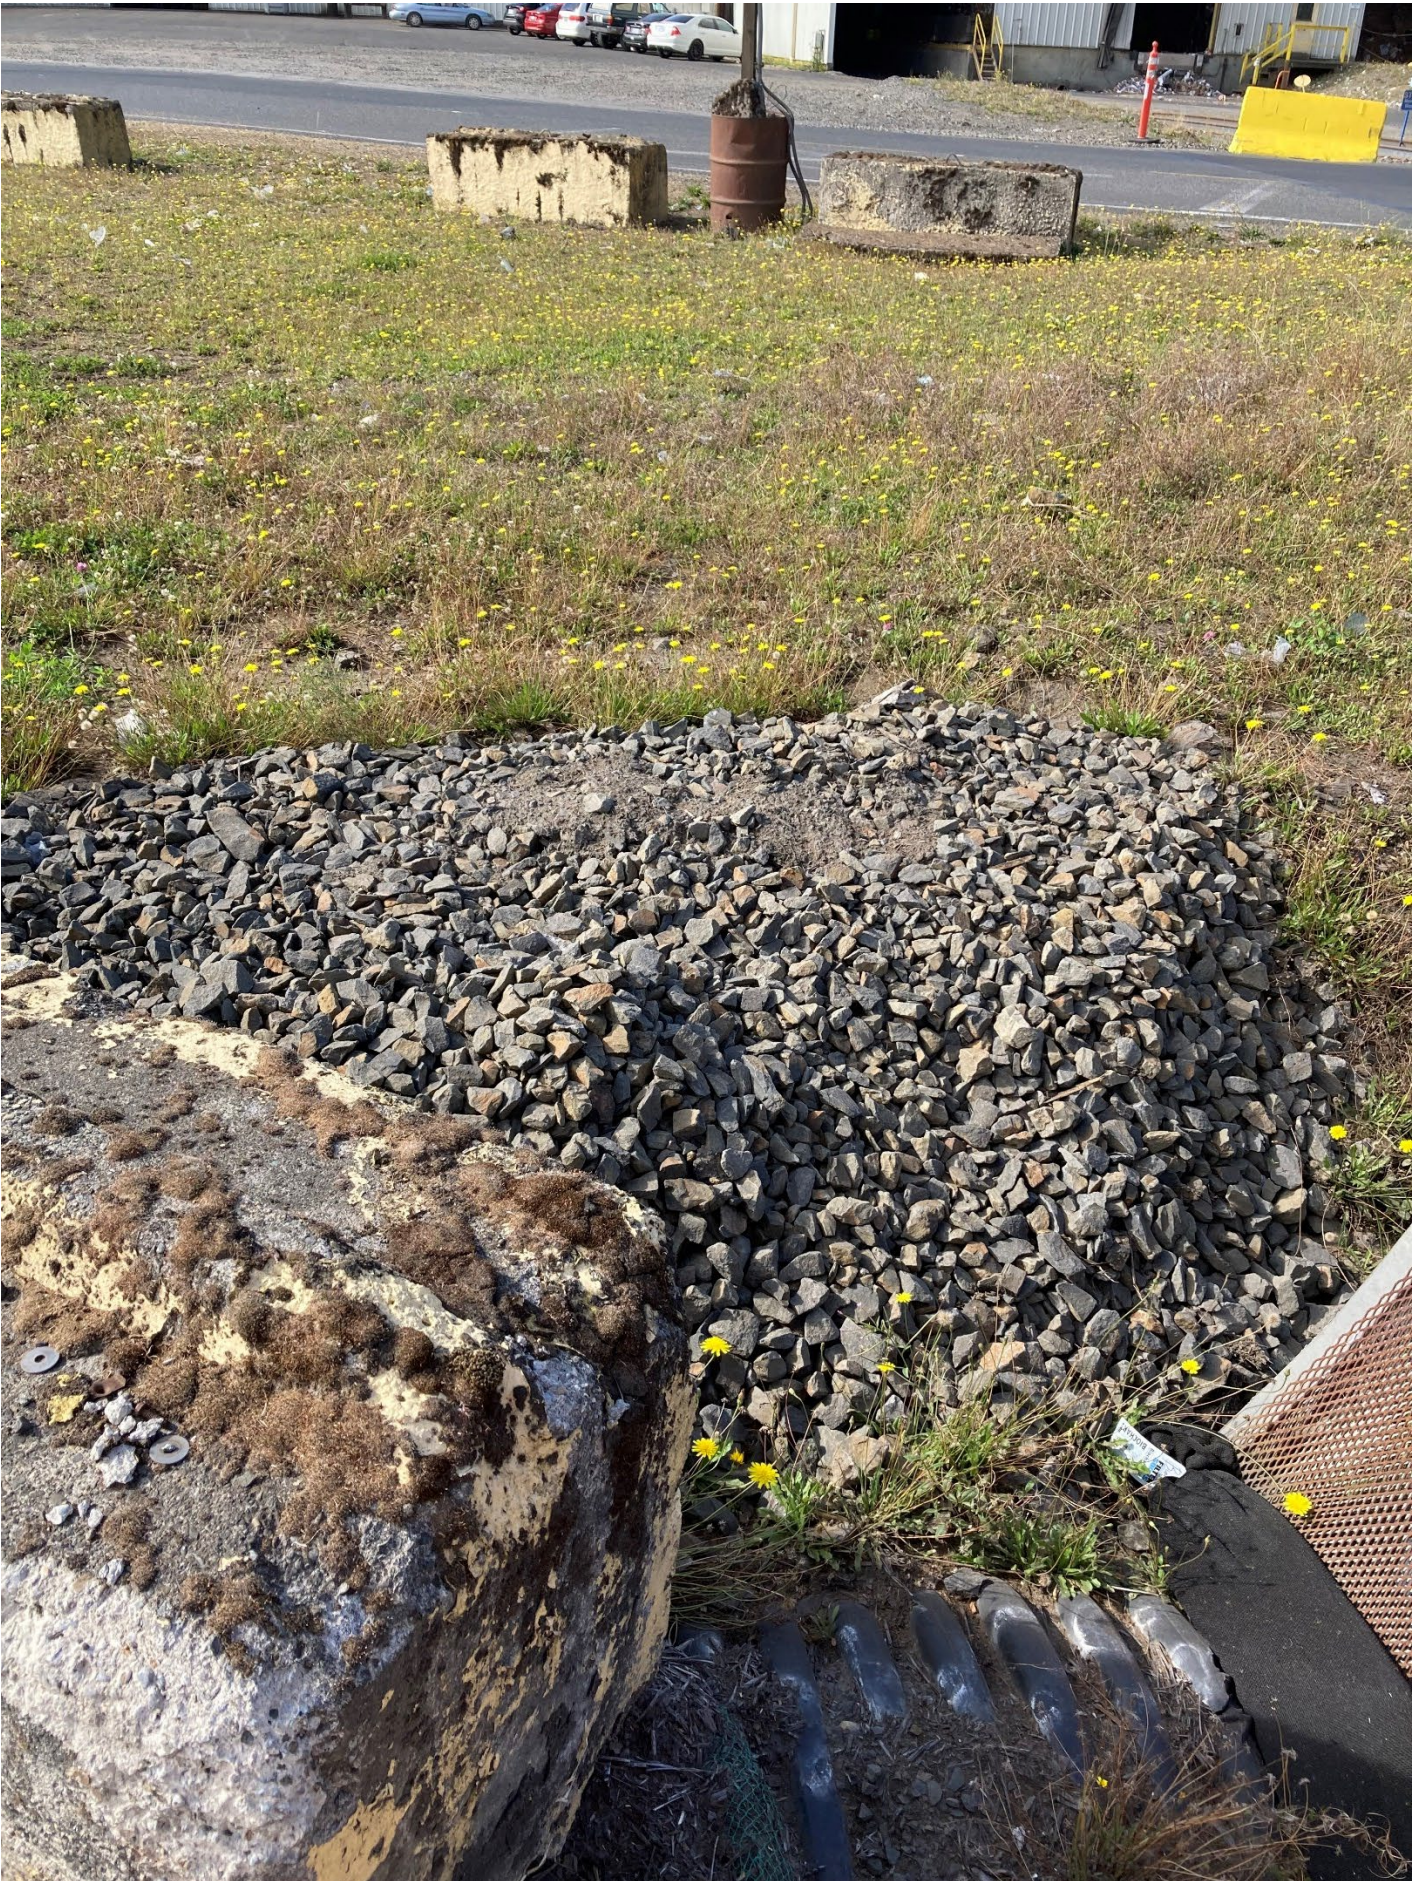
Photo 34: Rock installed near a stormwater drainage ditch in the Pipe A drainage basin.

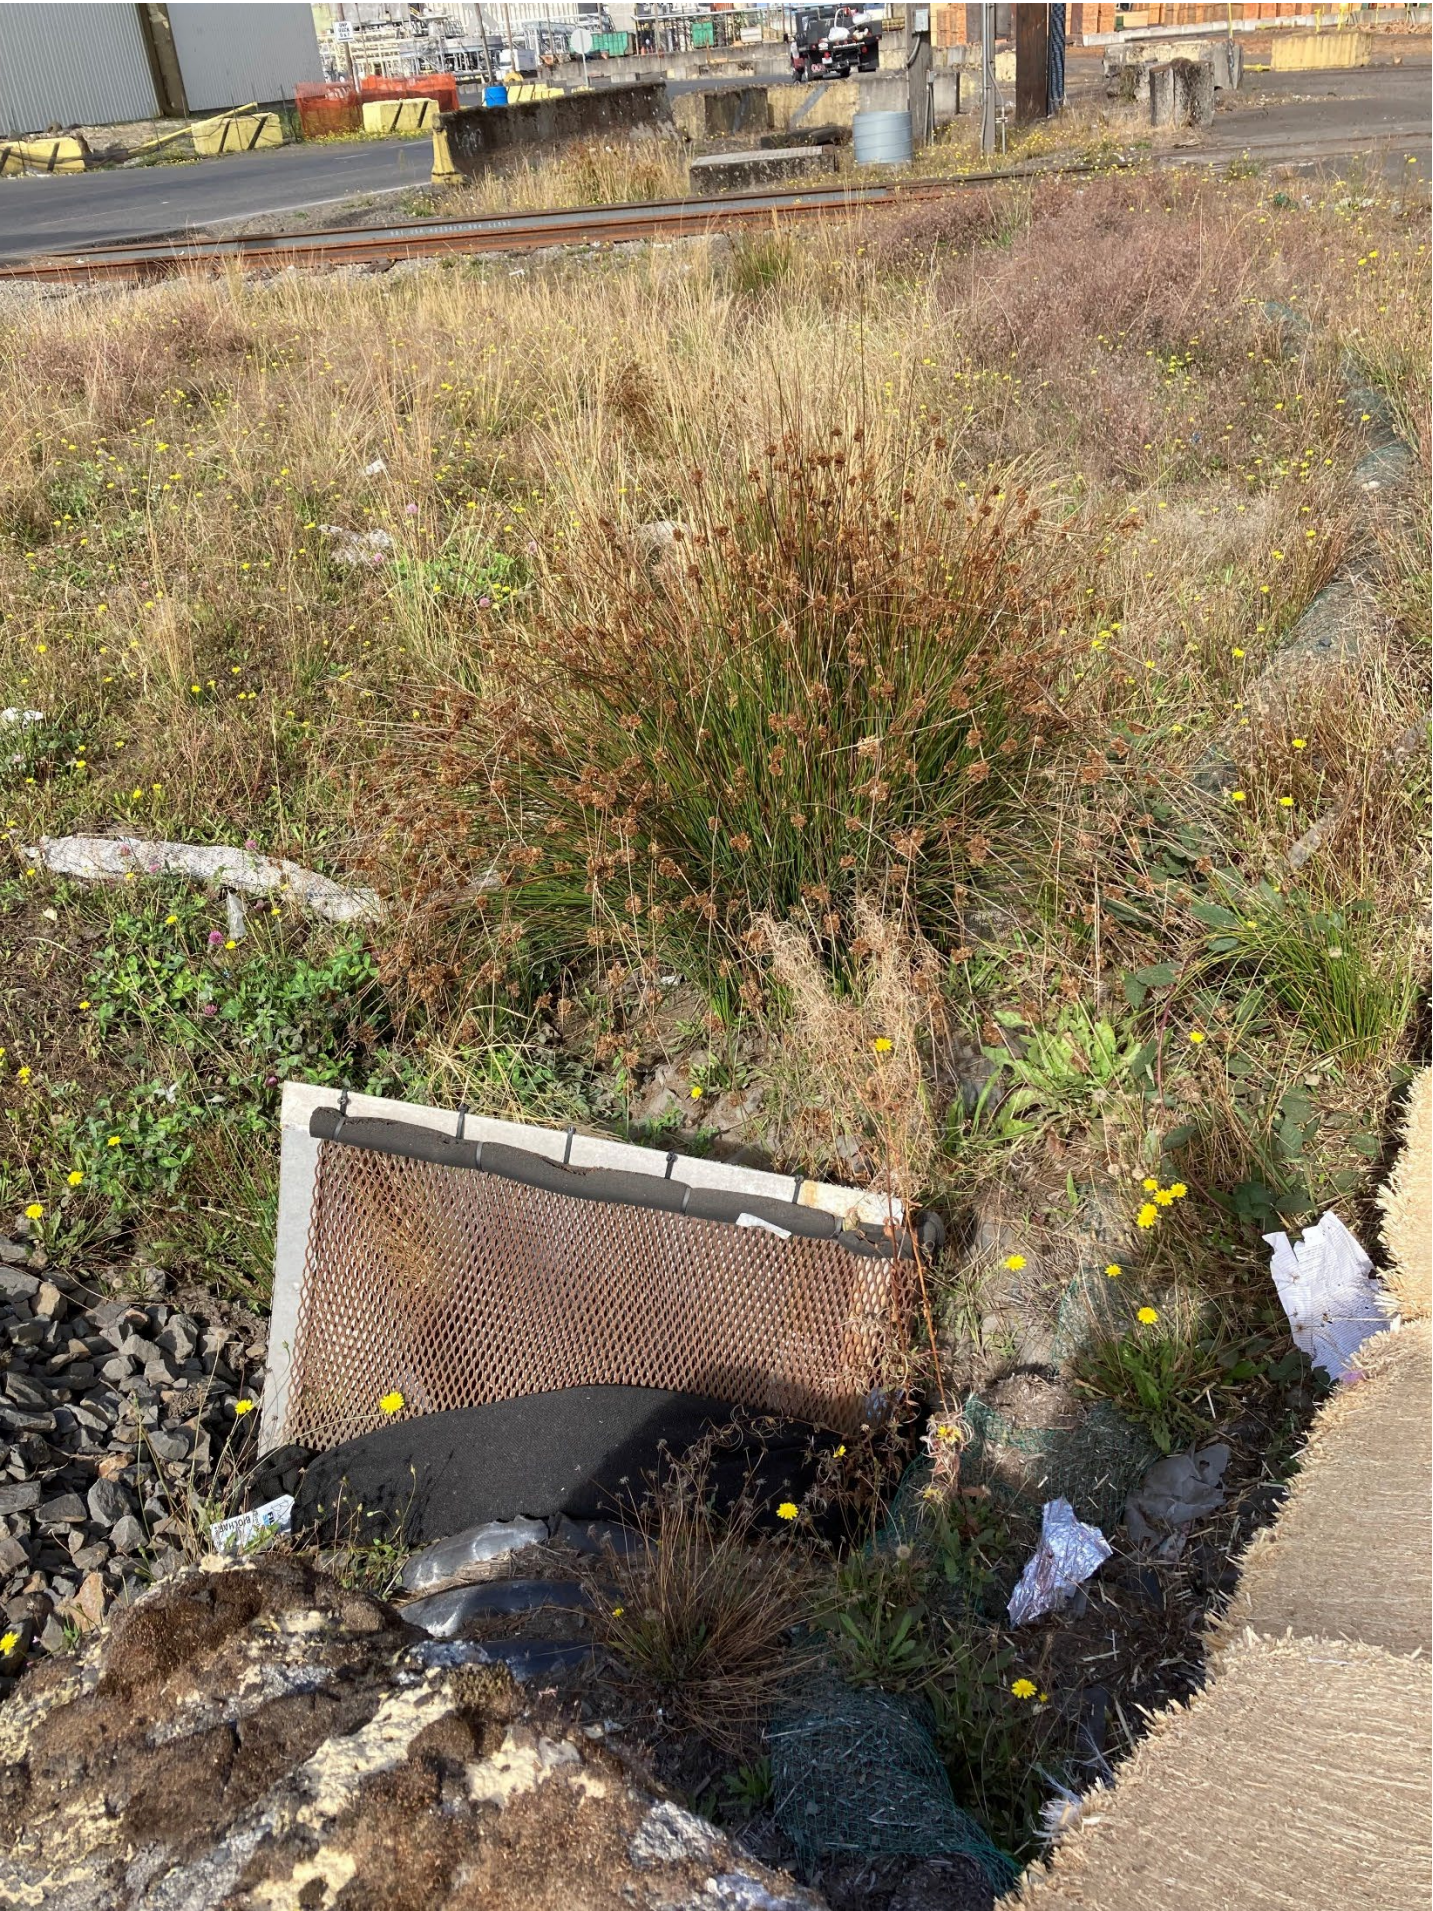
Photo 35: Stormwater culvert screen and drainage ditch in the Pipe A drainage basin.

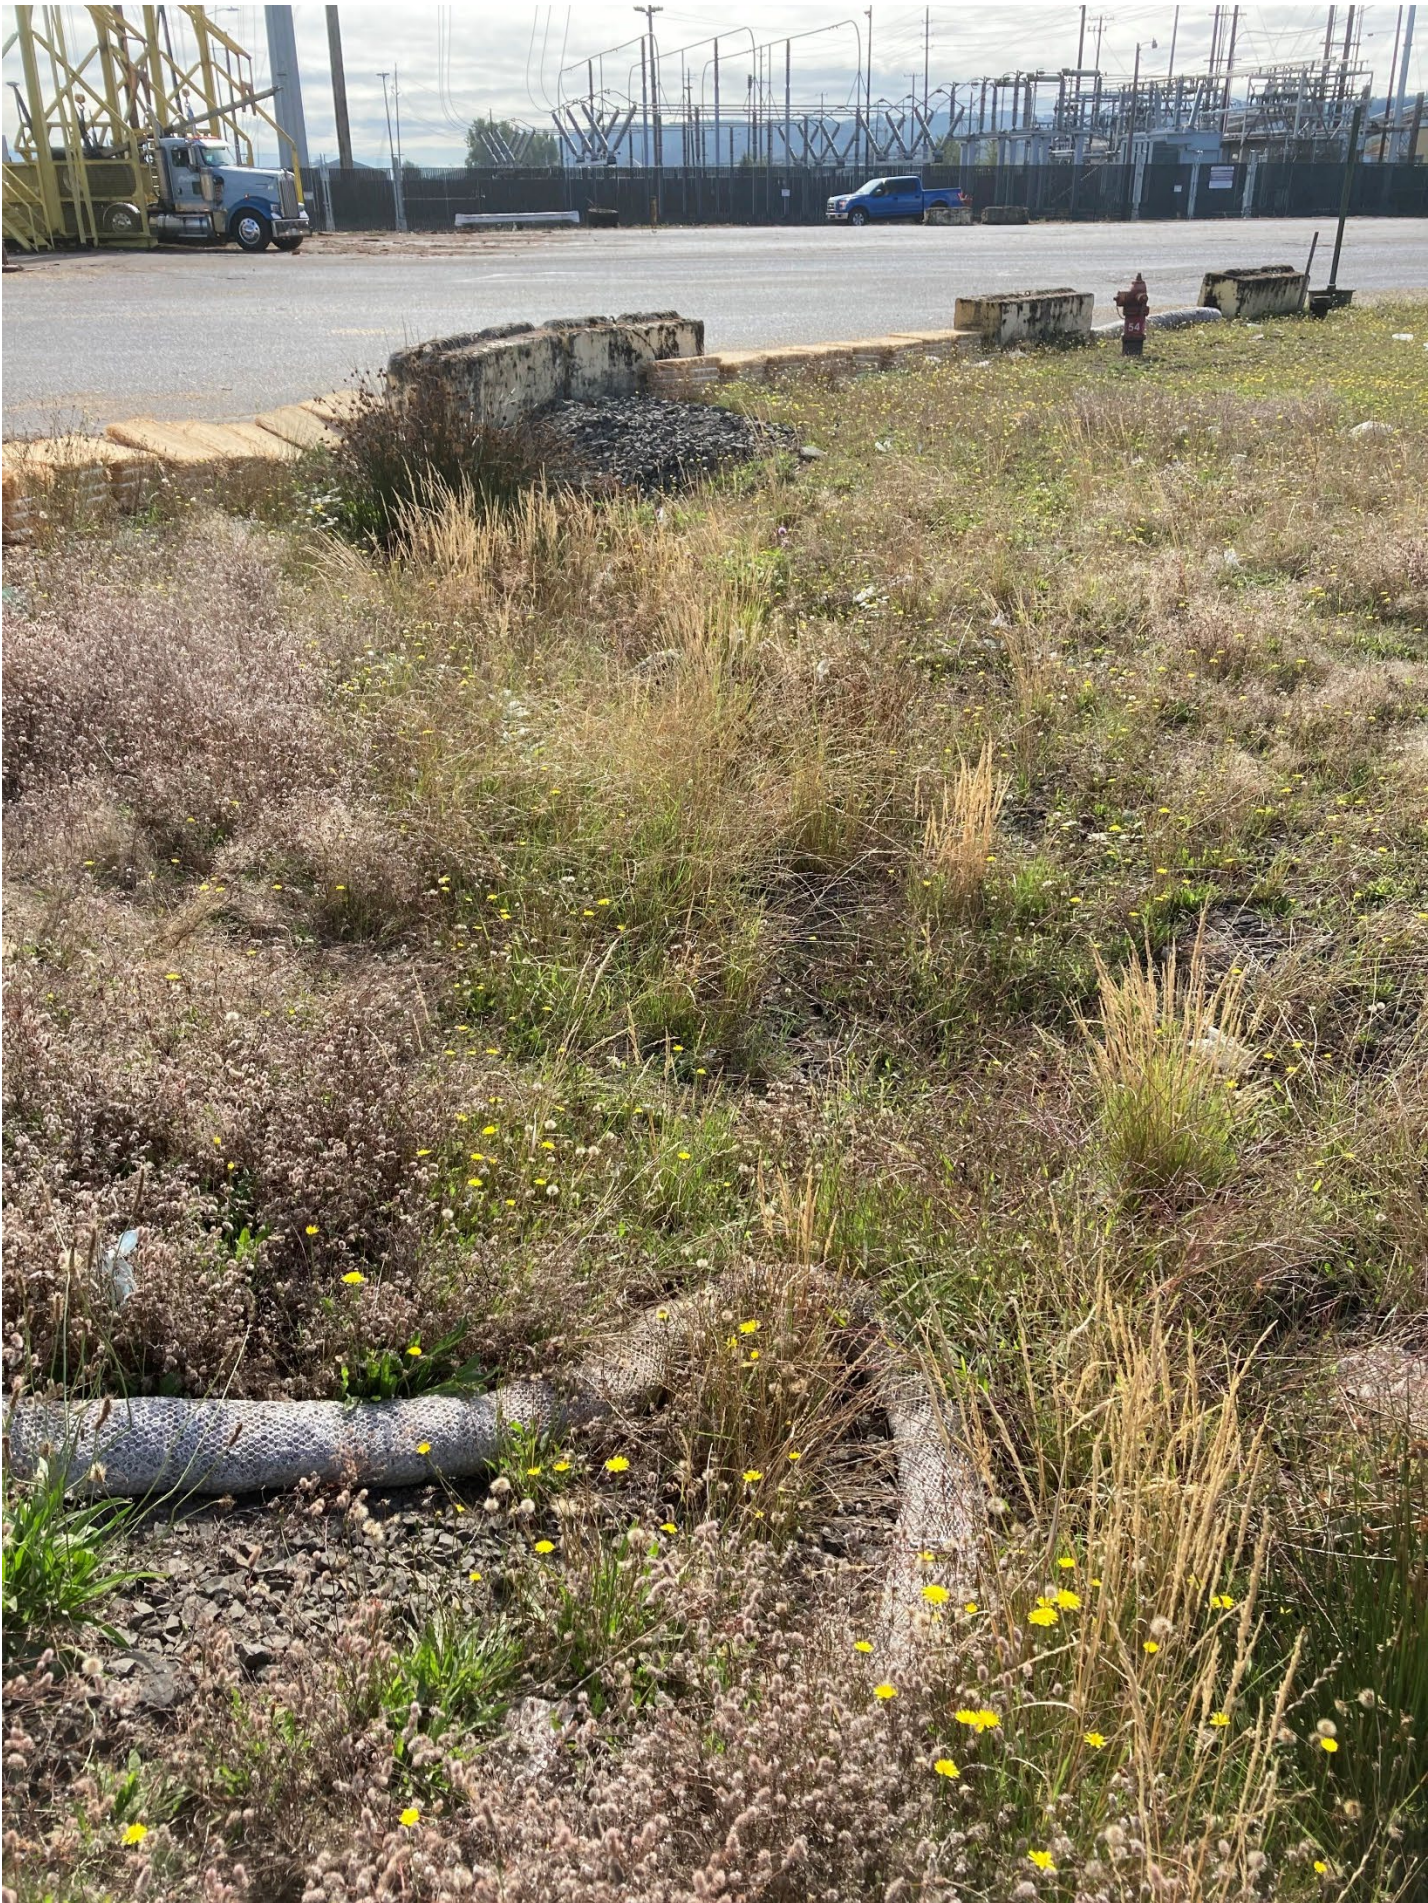
Photo 36: Vegetated stormwater drainage ditch located in the Pipe A drainage basin.

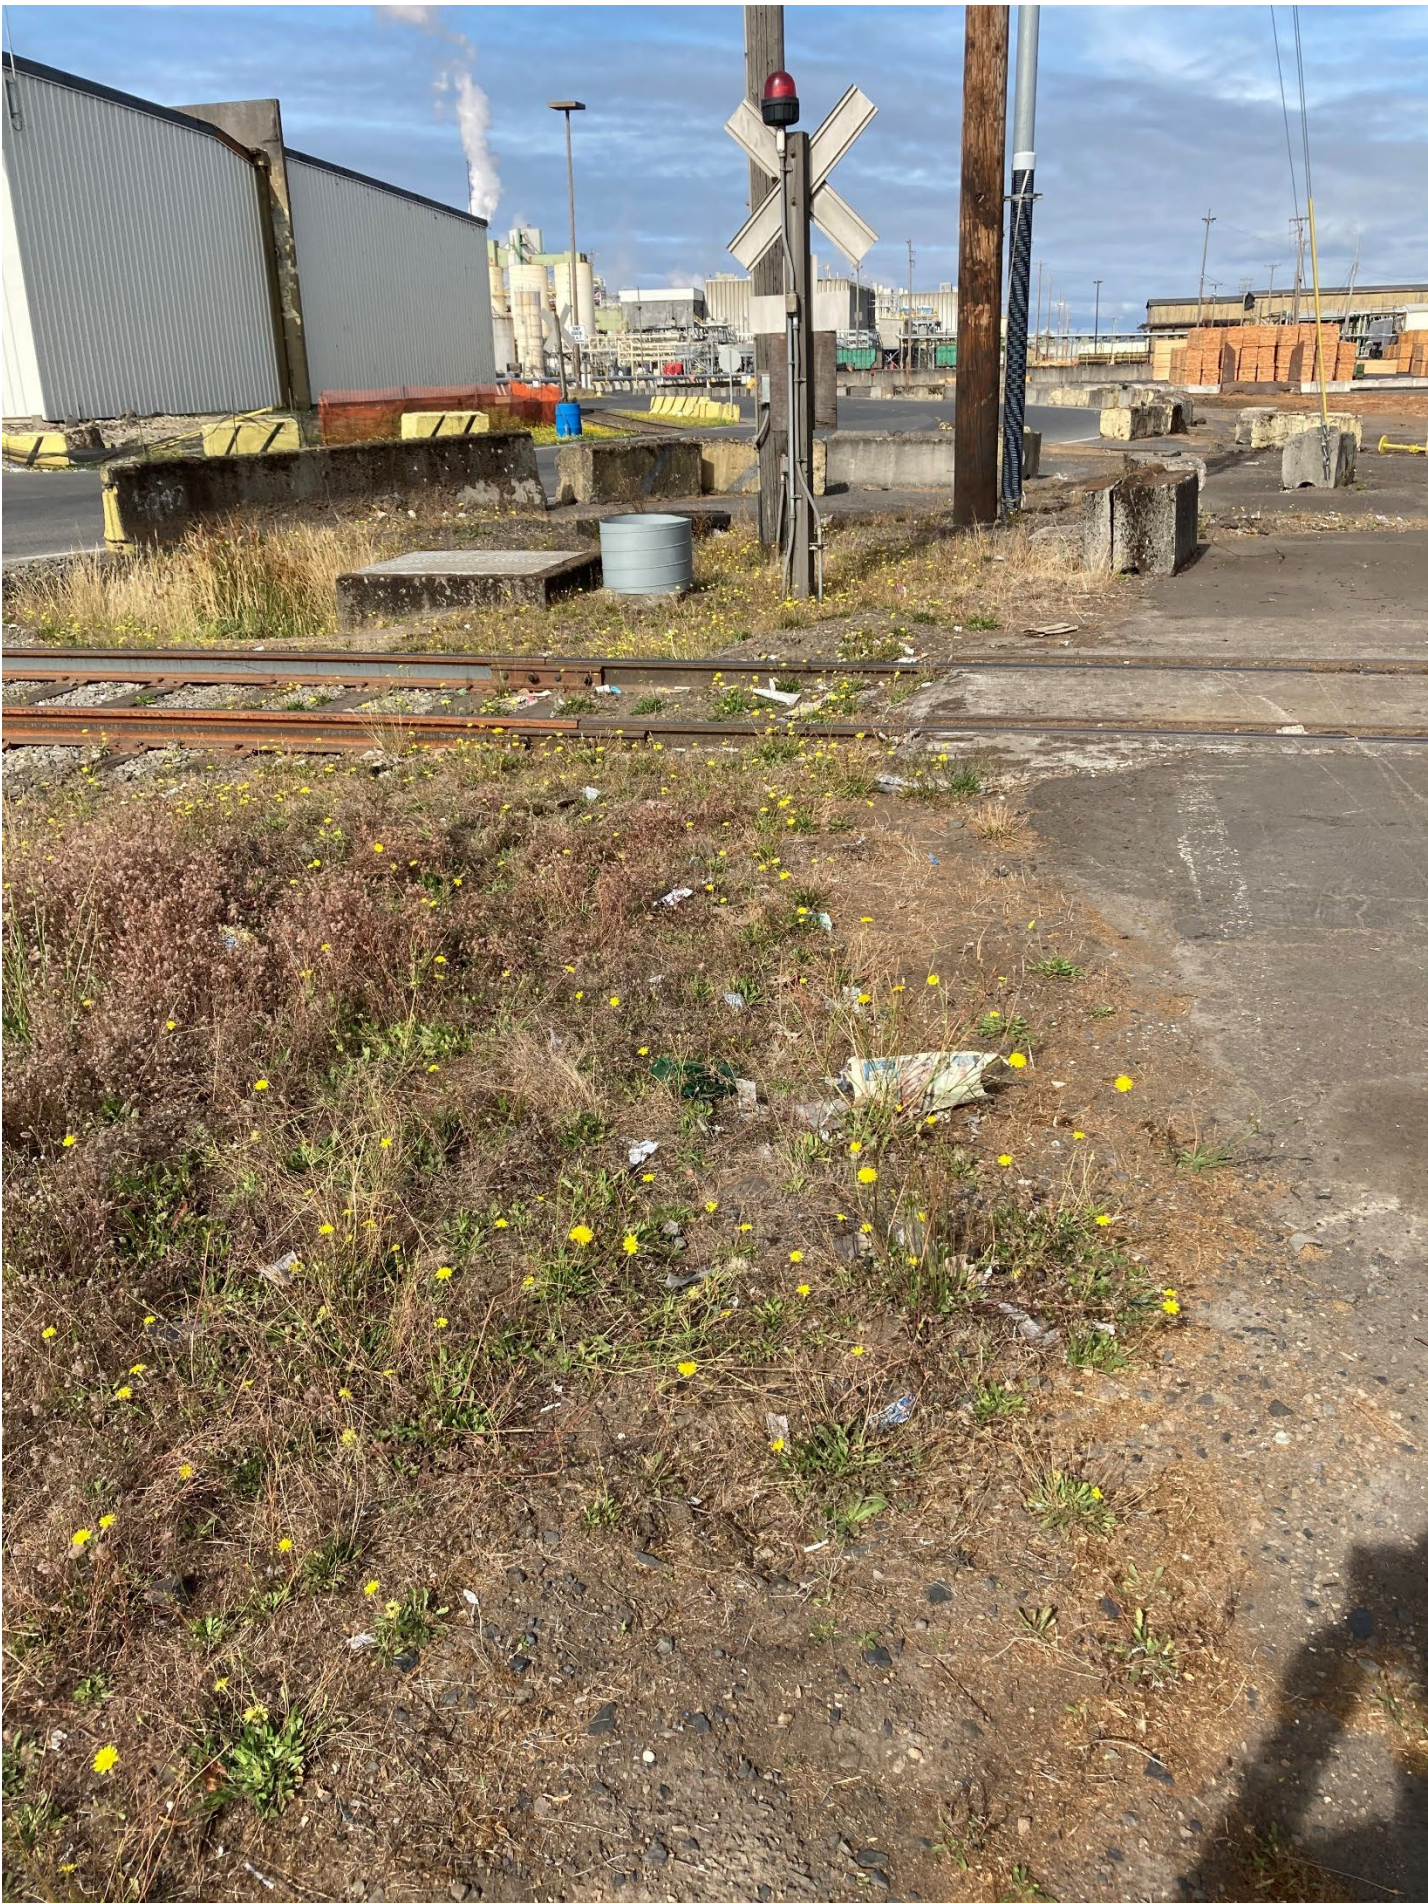
Photo 37: Railroad tracks near the stormwater drainage ditch in the Pipe A drainage basin.

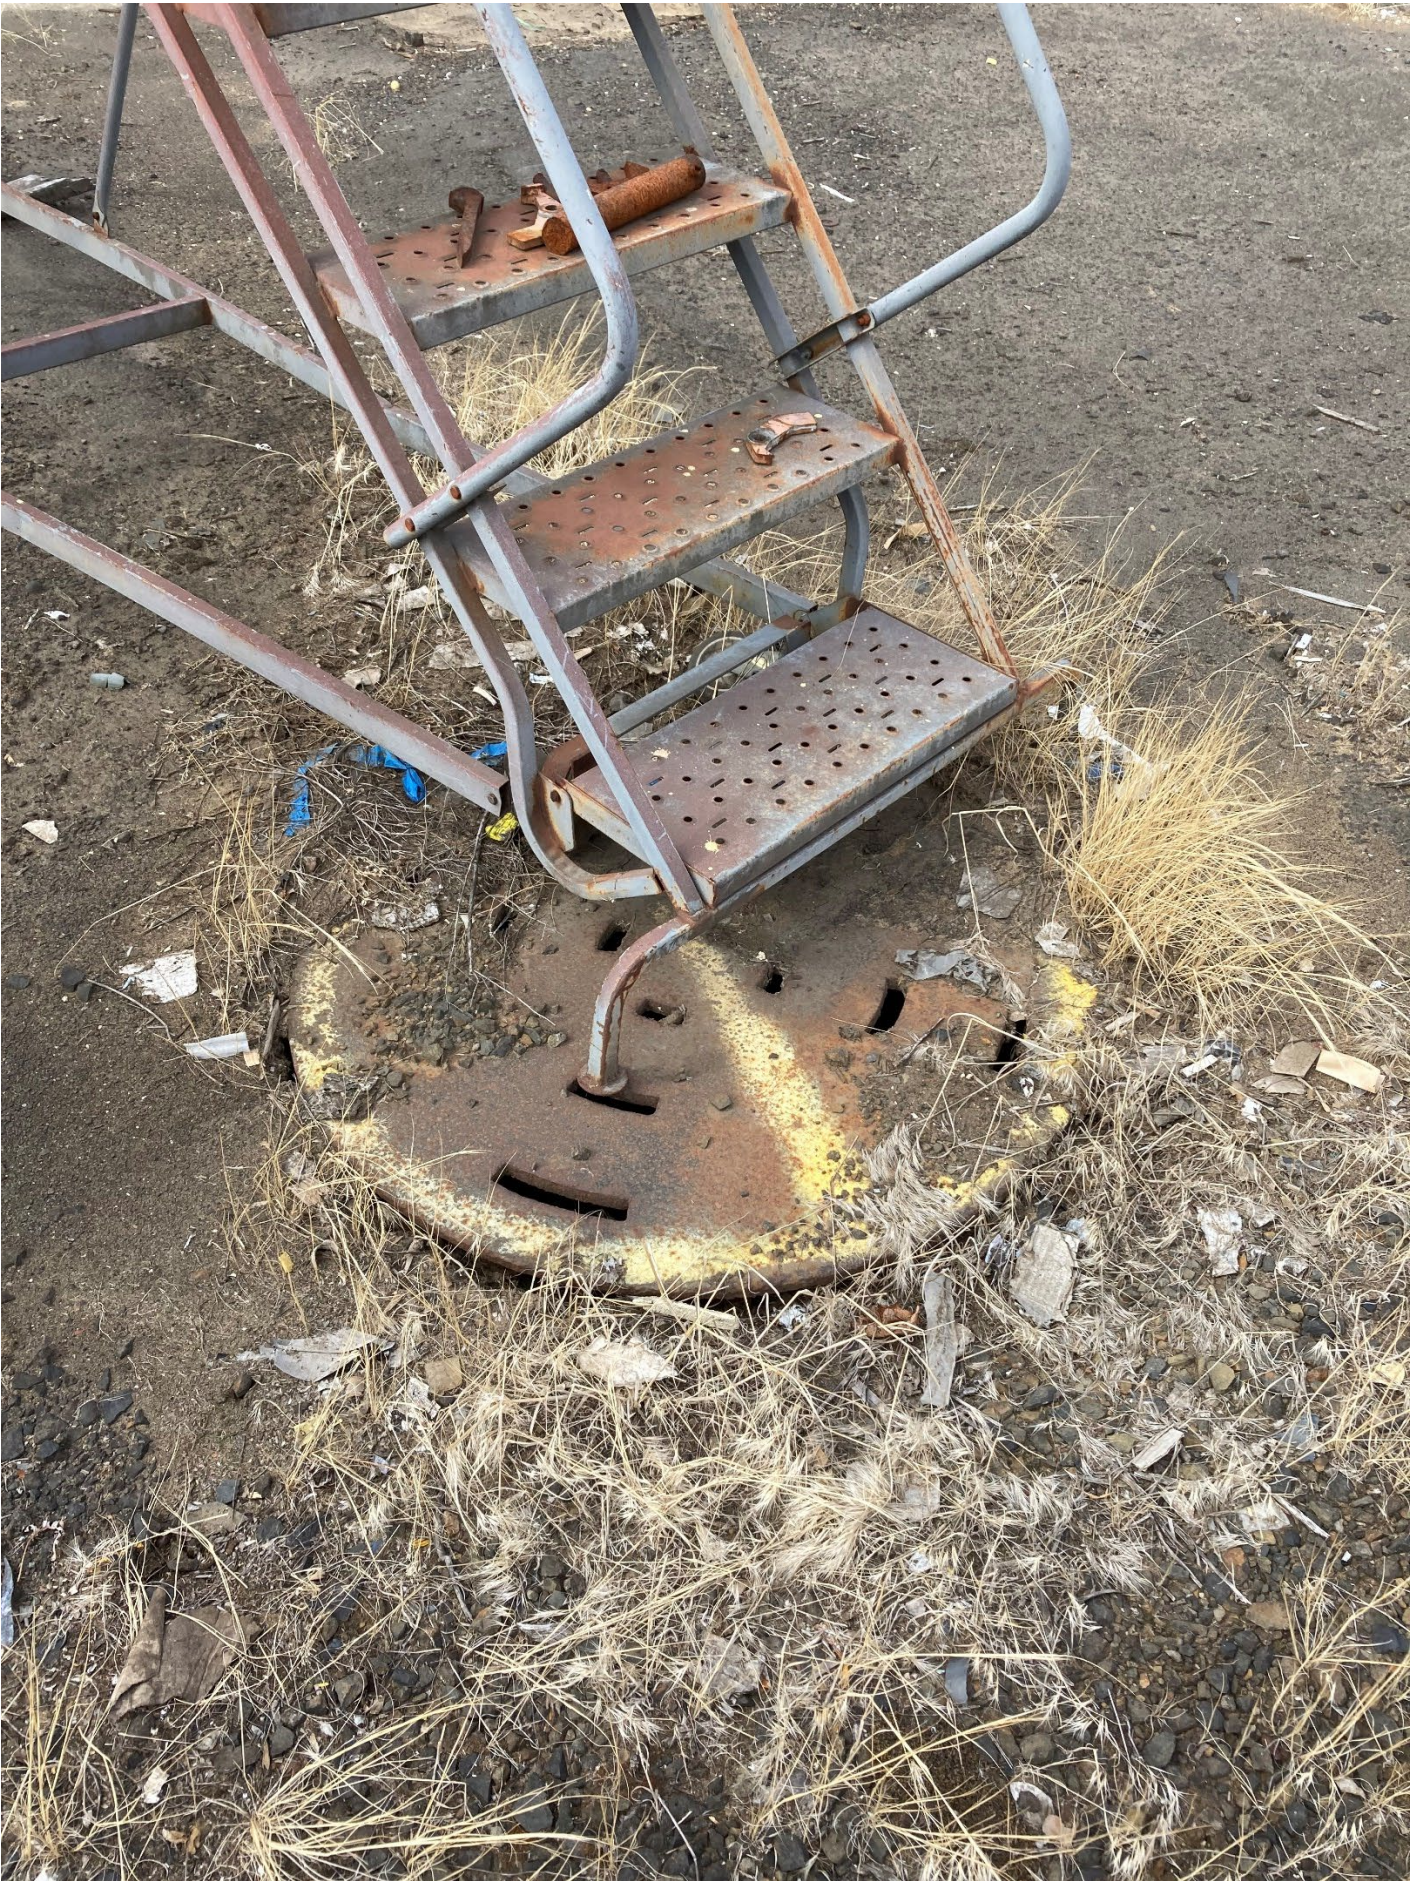
Photo 38: Stormwater catch basin on the neighboring CLC property apparently within the Pipe N drainage basin.

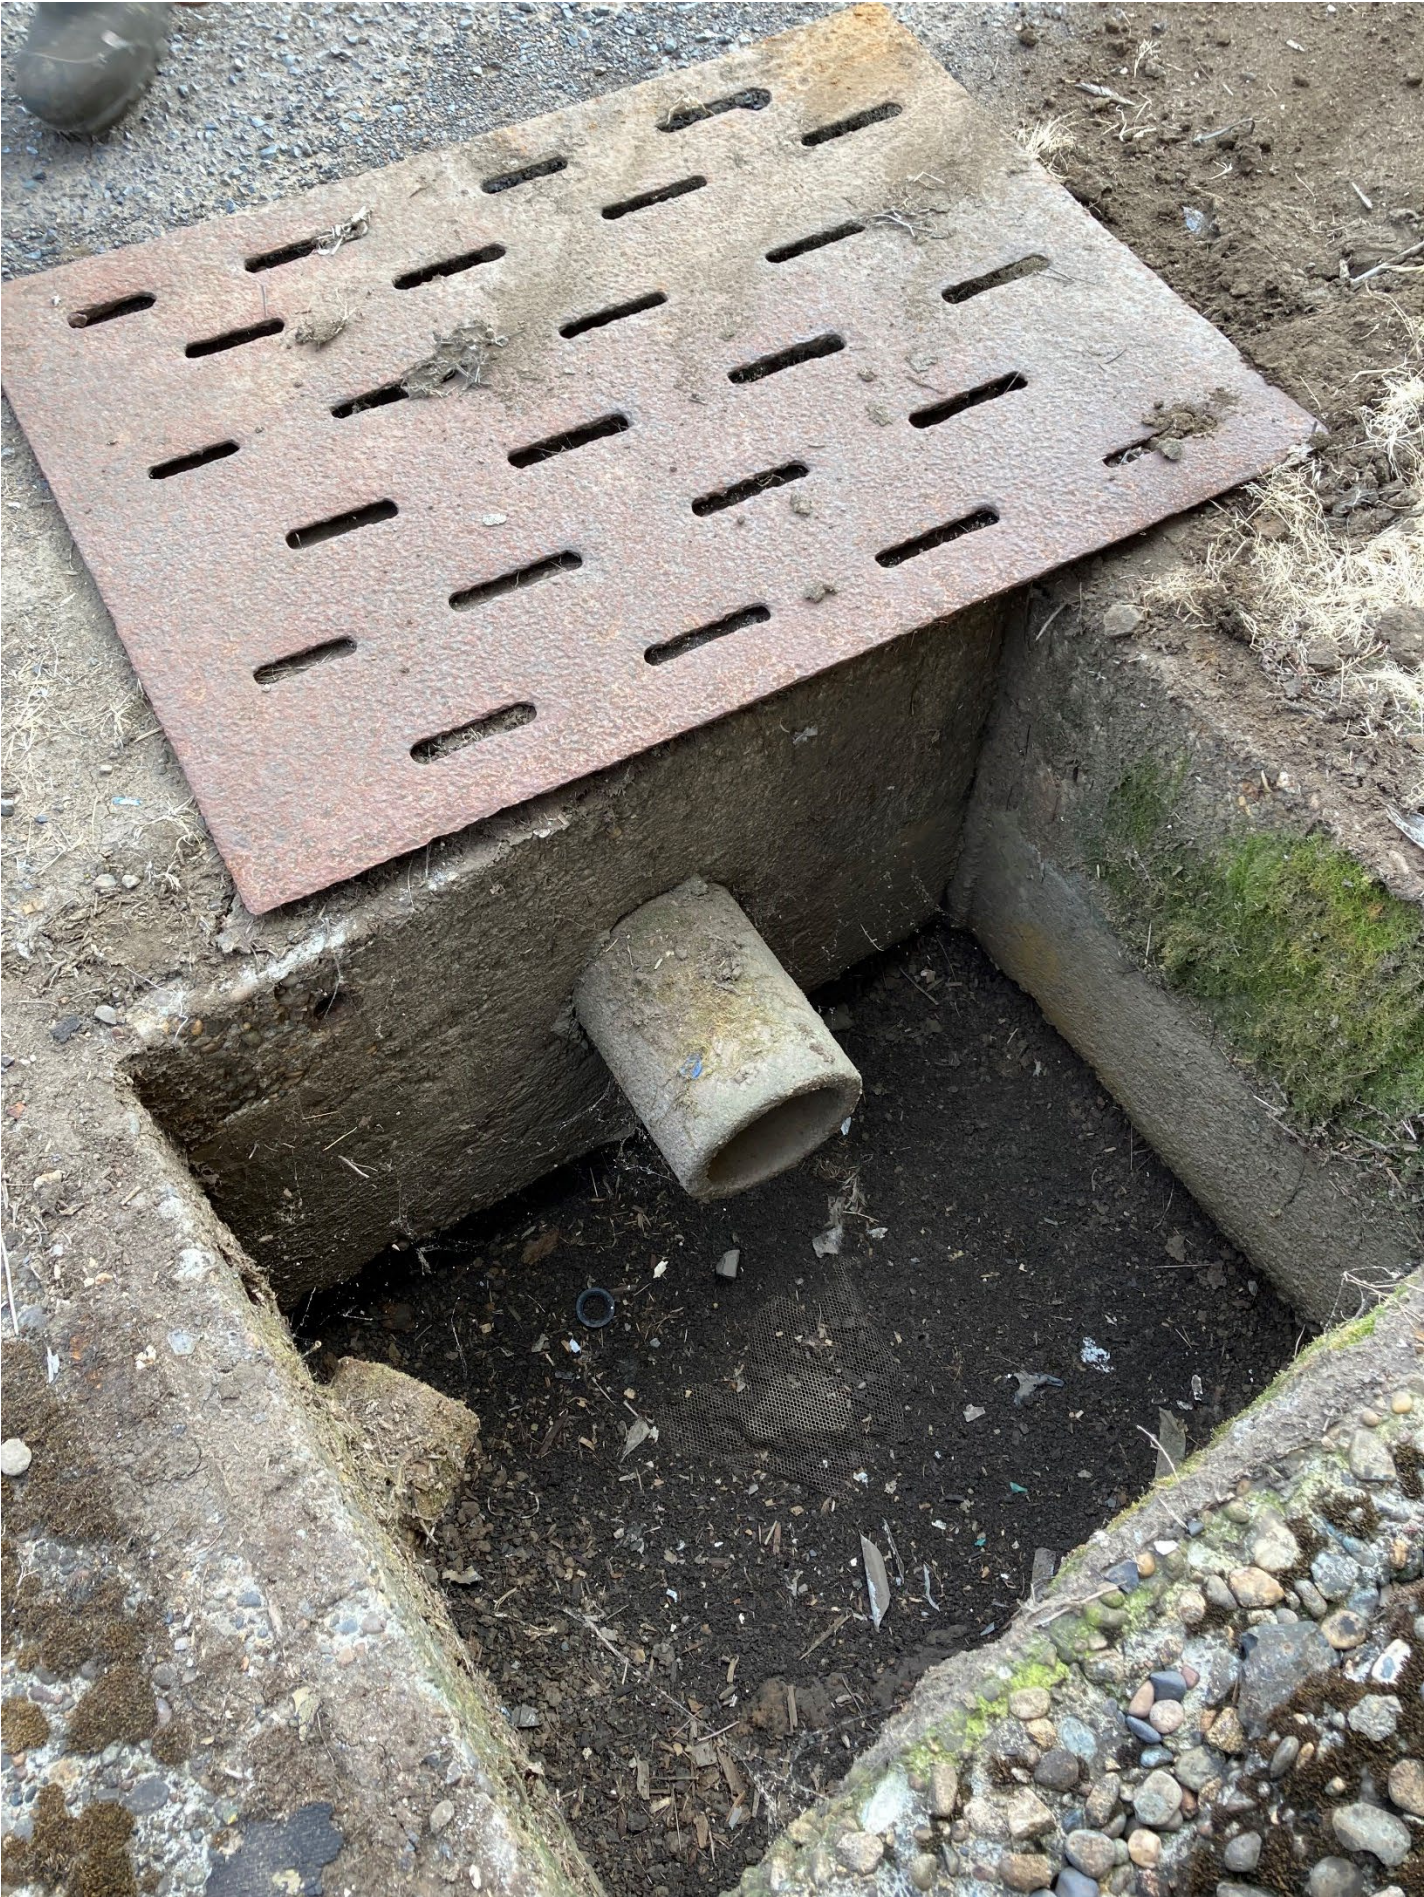
Photo 39: Stormwater sump near CLC’s Locomotive Shop apparently within the Pipe N drainage basin.
