**STATE OF WASHINGTON
DEPARTMENT OF ECOLOGY**

Re: September 2024 Announced Non-Sampling Water Quality Compliance Inspection Report

Permit Compliance Inspection Report

Facility Name and Address: Weyerhaeuser NR Company
1701, 2901, & 3539 Industrial Way
Longview, WA 98632

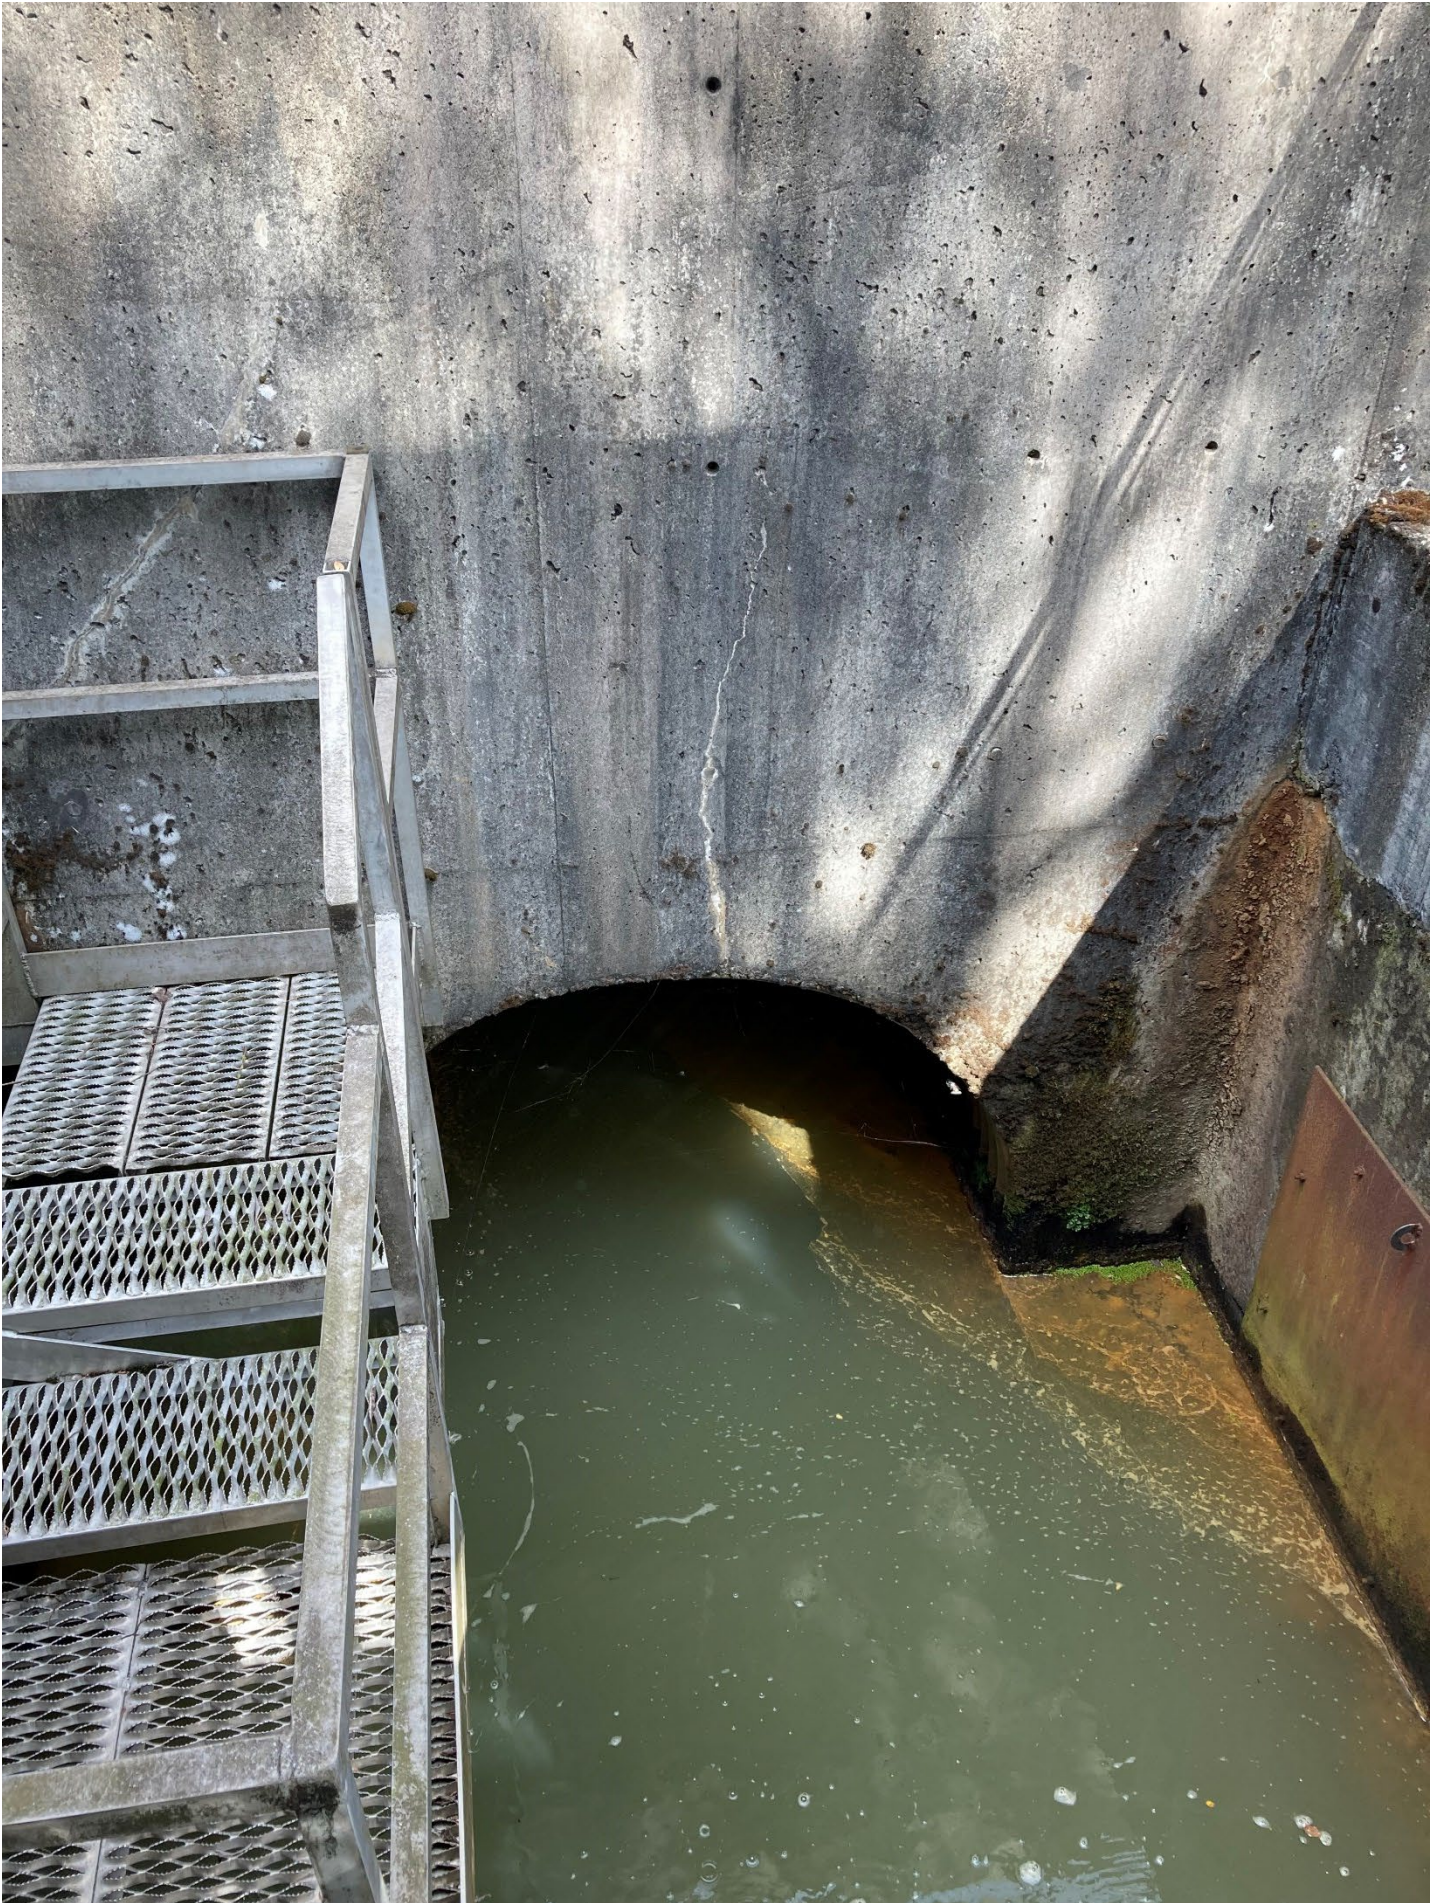
We visited Outfall 004B during the inspection. I noted flow over the v-notch weir and exiting through the culvert at the time of the inspection (Photo 40, Appendix A). I noted the water flowing over the v-notch weir appeared to be relatively clear without notable solids. I did not observe a sheen on the surface of the water. I observed the water entering the Outfall 004B sump from the east and west sides of the Northern Drainage Ditch. I noted the water coming from the western side of the ditch appeared to be relatively clear and had a slightly blue-green color (Photo 41, Appendix A). I did not observe notable solids in the water at the time of the inspection. I noted the water coming from the eastern side of the ditch appeared to be more opaque and a brown-orange color (Photo 42, Appendix A). I also noted some algae growth on the surface of the water.

Photo 40: Outfall 004B discharge to CDID Ditch #3.

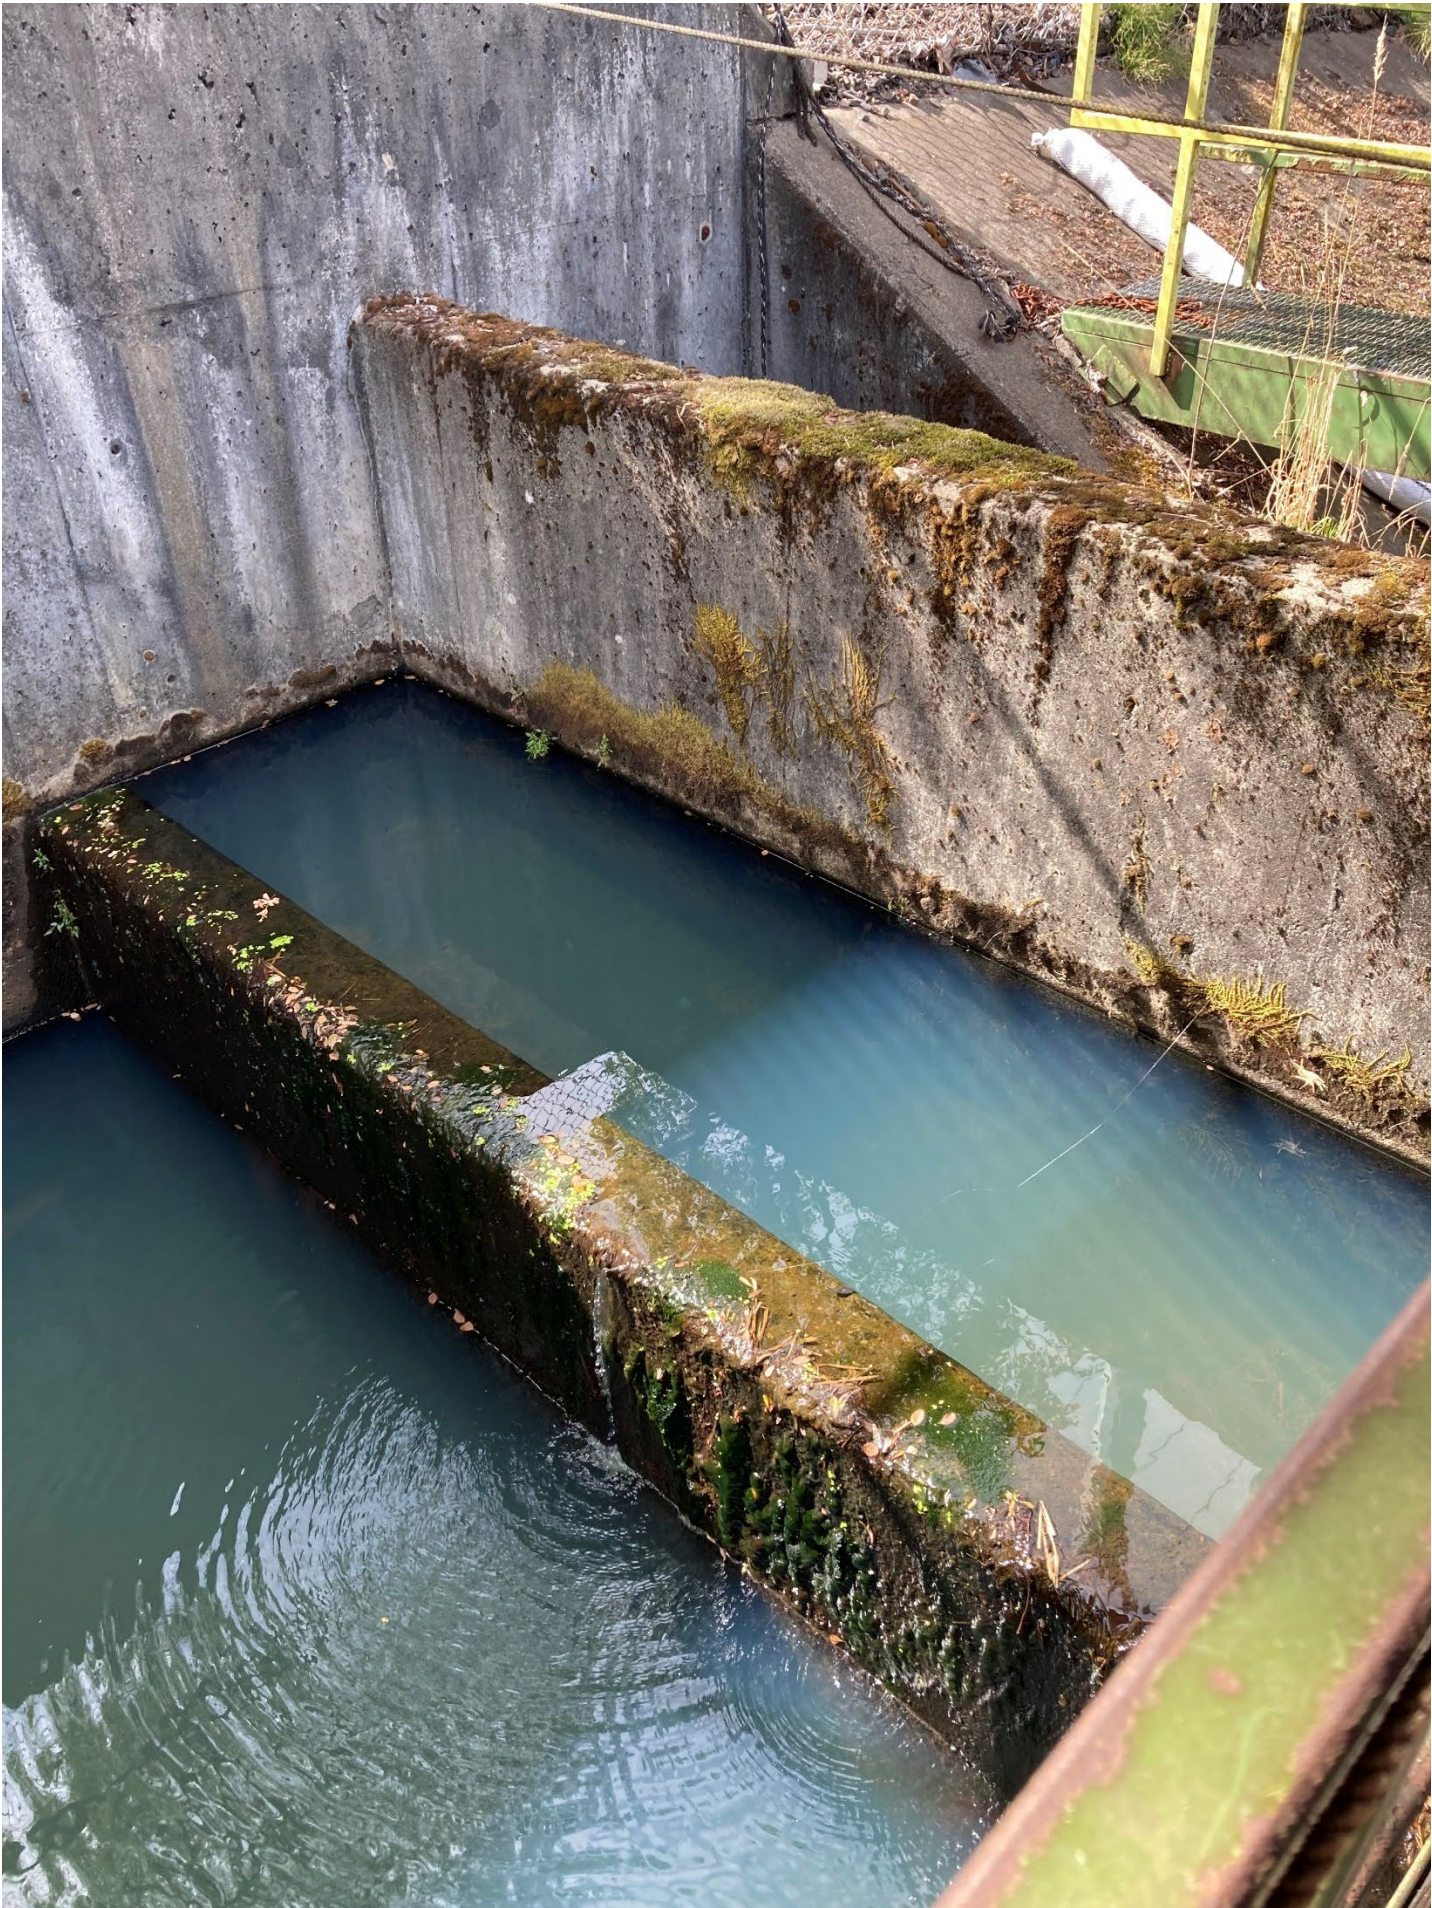
Photo 41: Northern Drainage Ditch discharge into the Outfall 004B sump from the western side of the ditch.

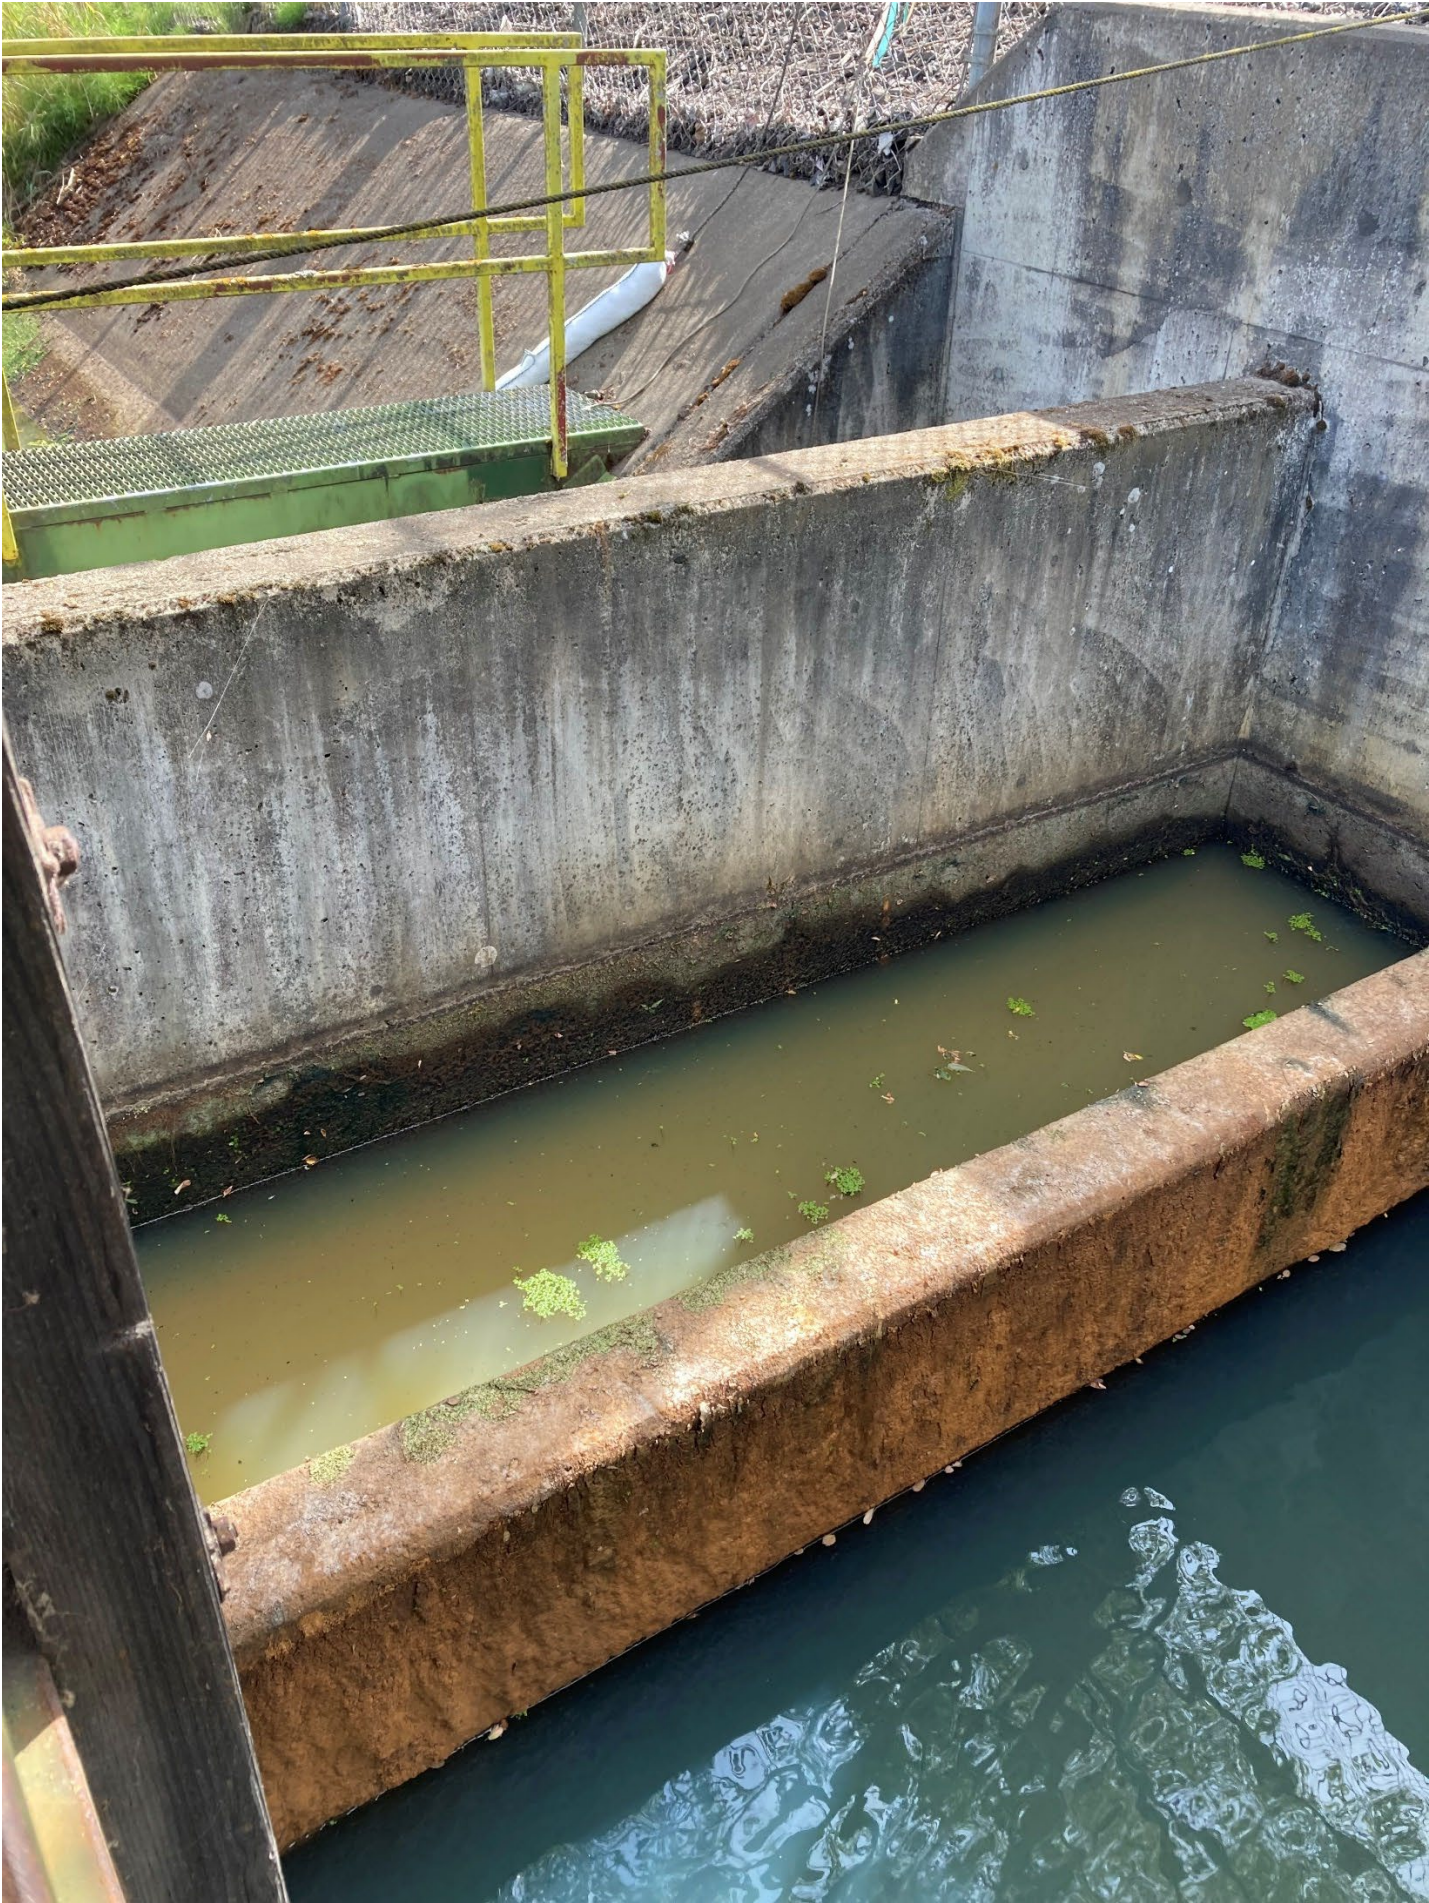
Photo 42: Northern Drainage Ditch discharge into Outfall 004B sump from the eastern side of the ditch.

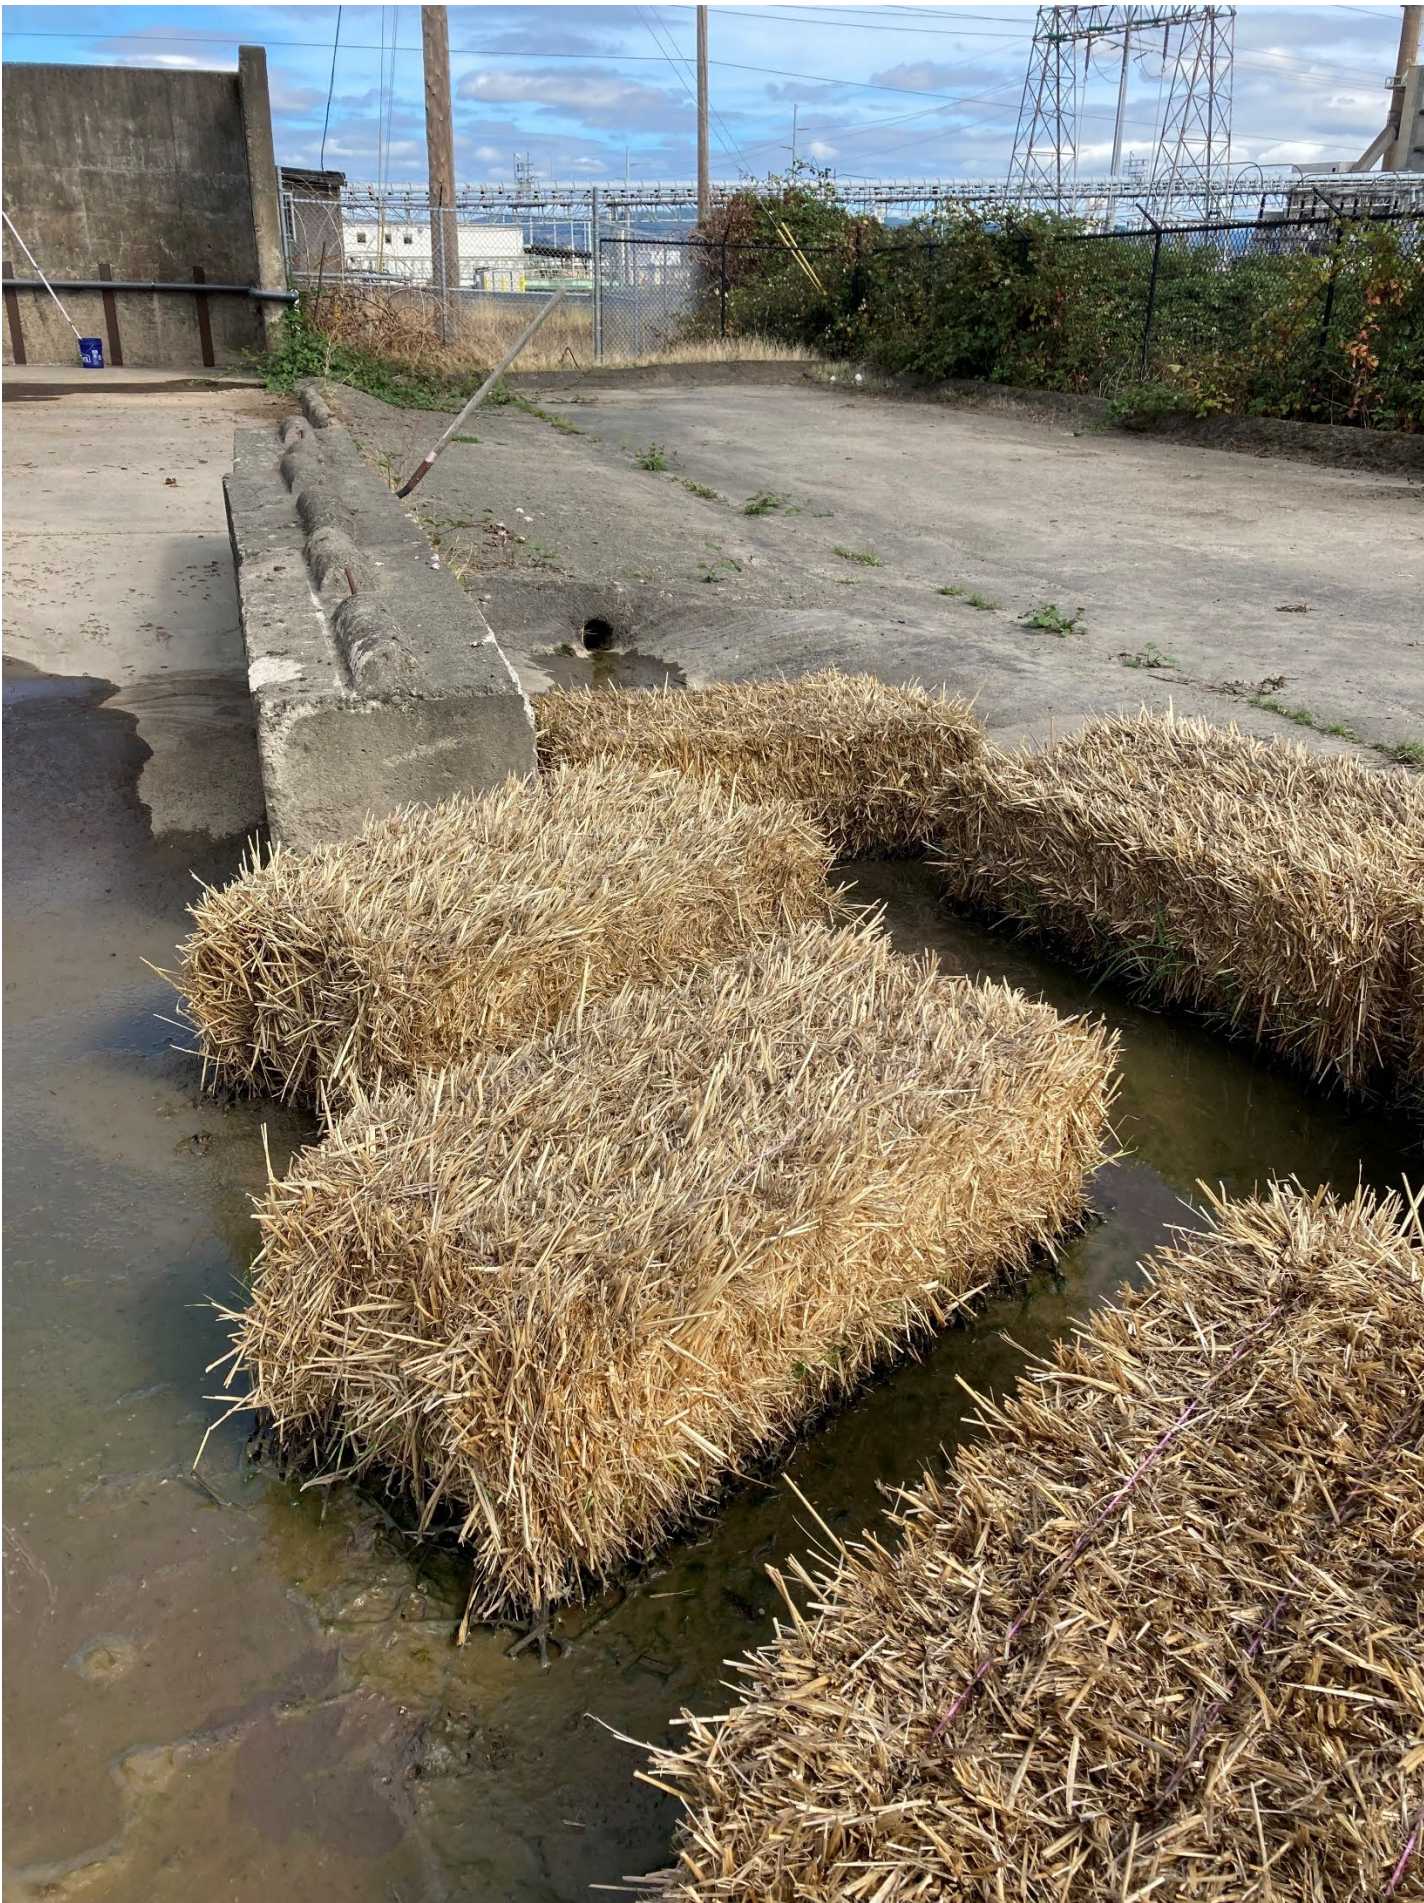
Photo 43: Outfall 008B discharge to NDP’s Industrial WWTP.
