# Permit Compliance Inspection Report

## Water Quality Program

Facility Name & Address: Darigold Sunnyside Inc  
400 Alexander Road, Sunnyside WA

Date(s) of Inspection: 1/23/2025

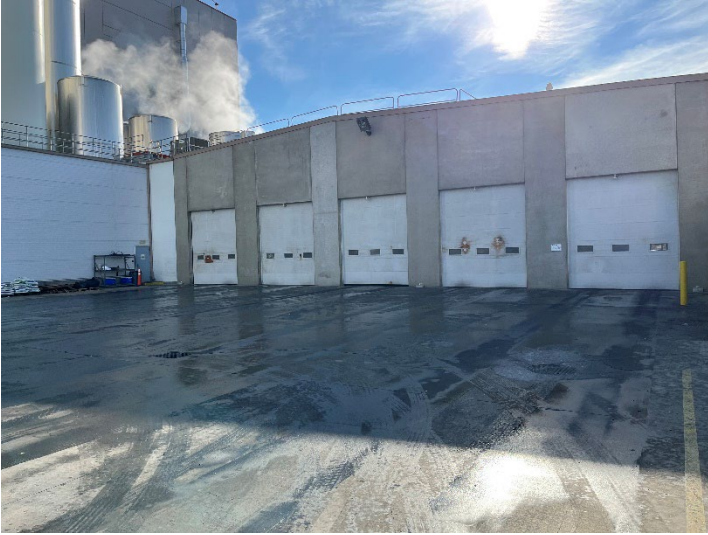
**Photo 1 [IMG\_0380]**

**Description: Milk truck wash bay approach.**

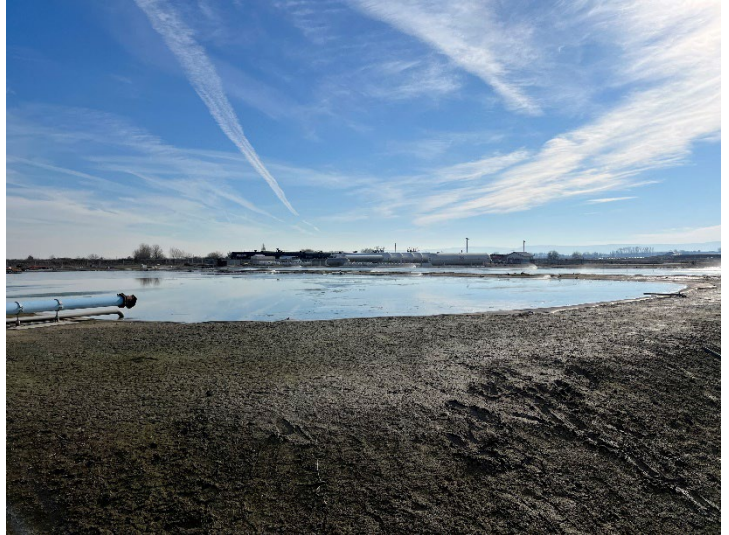
**Photo 2 [IMG\_0381]**

This factory has two lined stormwater ponds. The ponds are currently at near full capacity, as they have accumulated stormwater from the last two winters. The ponds can no longer receive stormwater. As a result, the company has decided to discharge future stormwater to the irrigation joint drain on Midvale Avenue and report it on the discharge monitoring reports. They are planning to evaporate the ponds this year and prepare for next winter. The rest of the facility has not changed significantly from the 12/17/2021 report. They are currently making about 15 million pounds of cheese monthly and receive about 120 milk trucks per day.

**Description: Two stormwater evaporation ponds at near full capacity.**

Evap ponds 100% full, need evaporators. Stormwater  
from 23/24 winter + 24/25 wet december.

Please read **BMP F6.30 Evaporation ponds** in the Eastern Washington SWMM, starting on page 658. Please bring your evaporation ponds into compliance with the SWMM.

**Due date:** 180 days from receipt of report.

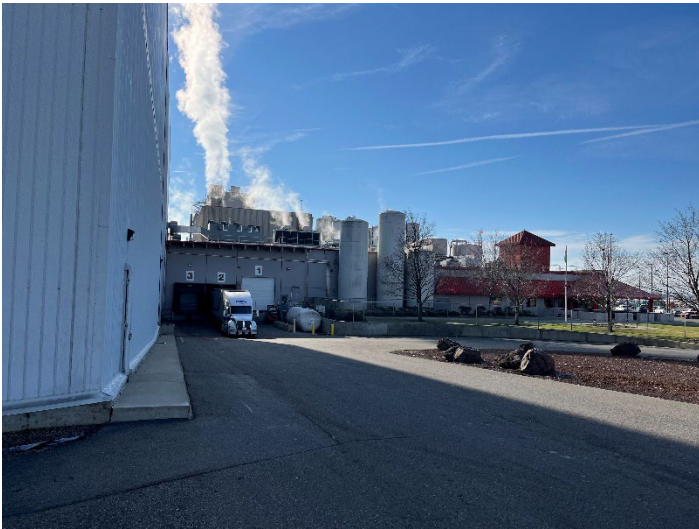
**Photo 3 [IMG\_0382]**

**Description: Loading bay that discharges stormwater to outfall 2.**

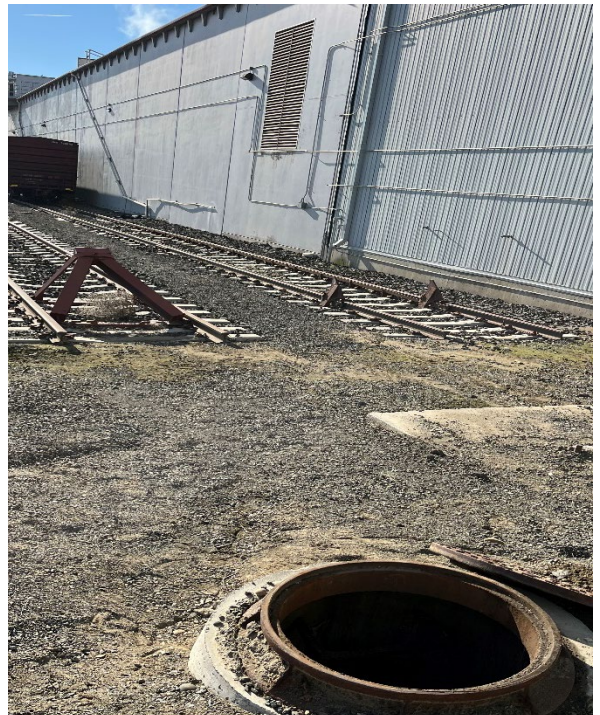
**Photo 4 [IMG\_0383]**

**Description: East side of building that discharges stormwater to outfall 3.**
