Permit Compliance Inspection Report
Water Quality Program
Northwest Region Office

Facility Name and Address: Milagro II
15530,15616, 15608, 15606 2nd Pl W
Lynnwood, WA 98037

Permit Number: WAR313371

Permit Type: Construction Stormwater General Permit

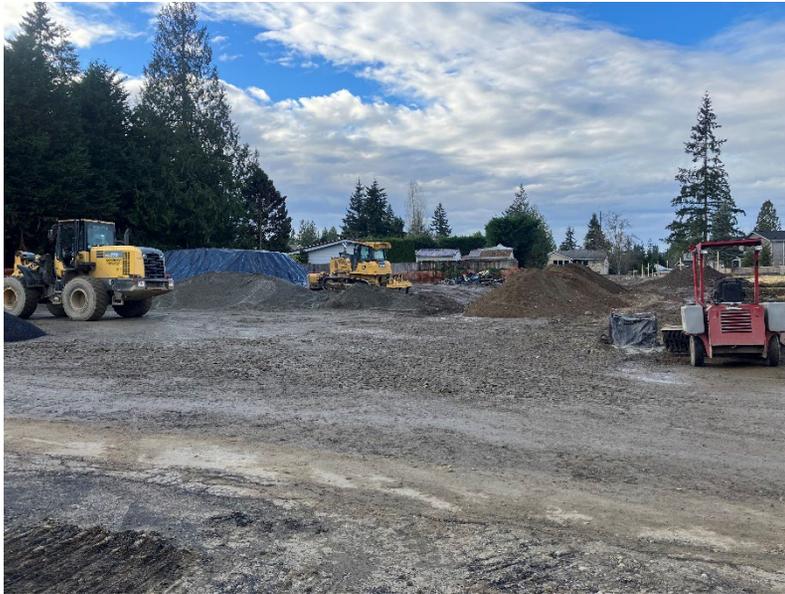
Photo 1 [IMG_1814]

Along 2nd PI W, the construction entrance needed maintenance and stabilization (**Photo 1**). There was significant sediment track out onto the road, 2nd PI W (**Photos 2-3**). The roadway, 2nd PI W, needed to be cleaned and the sediment removed. Mainly in the area closer to the construction entrance, there were empty cans with the potential to pollute left on the ground (**Photos 4-9**). These cans needed to be properly disposed of to minimize the discharge of pollutants. In several areas onsite, there were exposed and unworked soils and stockpiles (**Photos 10-14**). The permittee must **not** allow soils to remain exposed and unworked for more than **2 days** during the wet season (October 1 - April 30).

Description: Construction entrance along 2nd PI W.

Establish Construction Access: Failure to meet S9.D.2.b, and S9.D.2.d: Along 2nd PI W, the construction entrance needed maintenance and stabilization. There was significant sediment track out onto the road, 2nd PI W. The roadway, 2nd PI W, needed to be cleaned and the sediment removed. **Stabilize access** points with a pad of quarry spalls, crushed rock, or other equivalent BMPs, to minimize tracking sediment onto roads. If sediment is tracked off site, clean the affected roadway thoroughly at the end of each day, or more frequently as necessary (for example, during wet weather). Remove sediment from roads by shoveling, sweeping, or pickup and transport of the sediment to a controlled sediment disposal area. Install and maintain adequate

construction access to prevent track-out off-site. Clean the affected roadway thoroughly **at the end of each day**, or more frequently **as necessary**. **Immediately begin. Address no later than 10 days from the date this report is issued.**

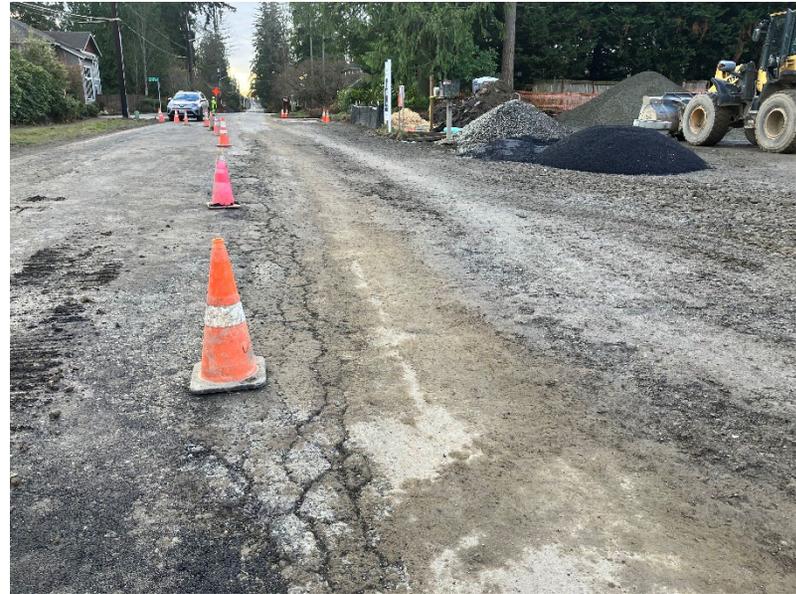
Photo 2 [IMG_1815]

Description: Significant sediment track out onto the road, 2nd PI W.

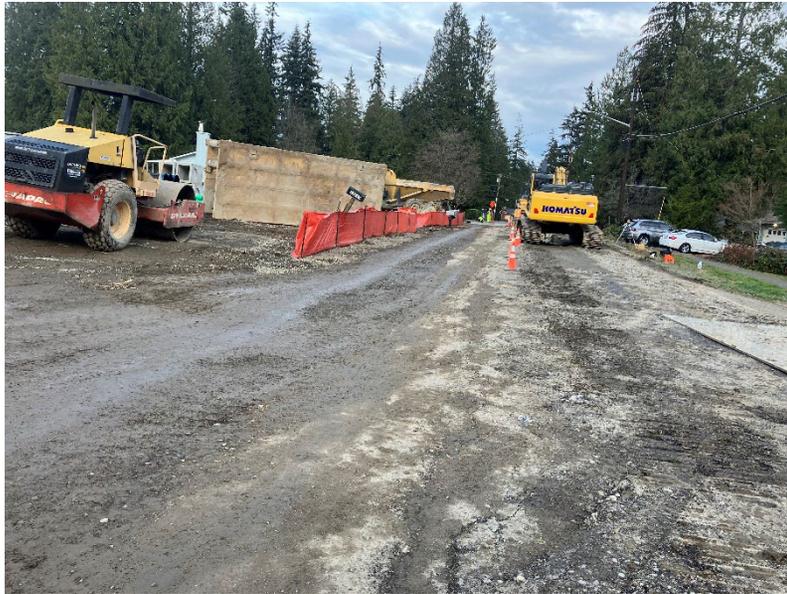
Photo 3 [IMG_1816]

Description: Significant sediment track out onto the road, 2nd PI W.

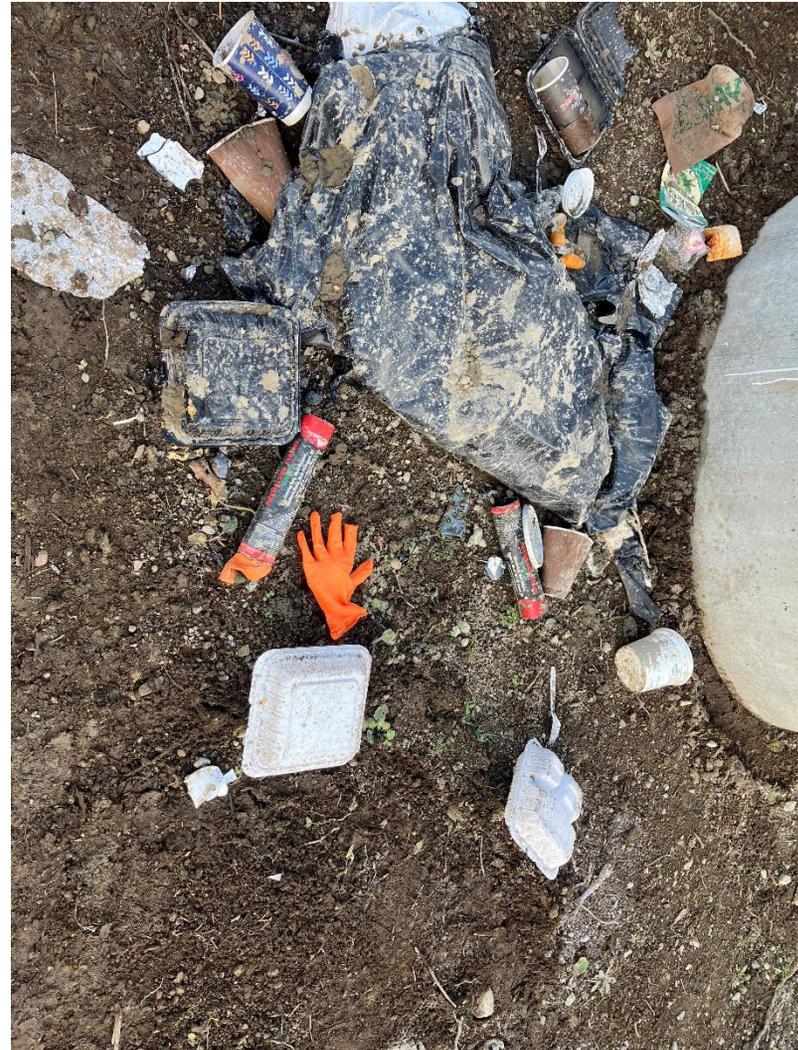
Photo 4 [IMG_1826]

Description: Empty cans with the potential to pollute left on the ground.

Control Pollutants: Failure to meet S9.D.9.a: Mainly in the area closer to the construction entrance, there were empty cans with the potential to pollute left on the ground. These cans needed to be properly disposed of to minimize the discharge of pollutants. Handle and dispose of all pollutants, including waste materials and demolition debris that occur on site in a manner that does not cause contamination of stormwater. Design, install, implement and maintain effective pollution prevention measures to minimize the discharge of pollutants, as set forth in permit conditions S1.D.1, S9.D.9. **Immediately begin. Address no later than 10 days from the date this report is issued.**

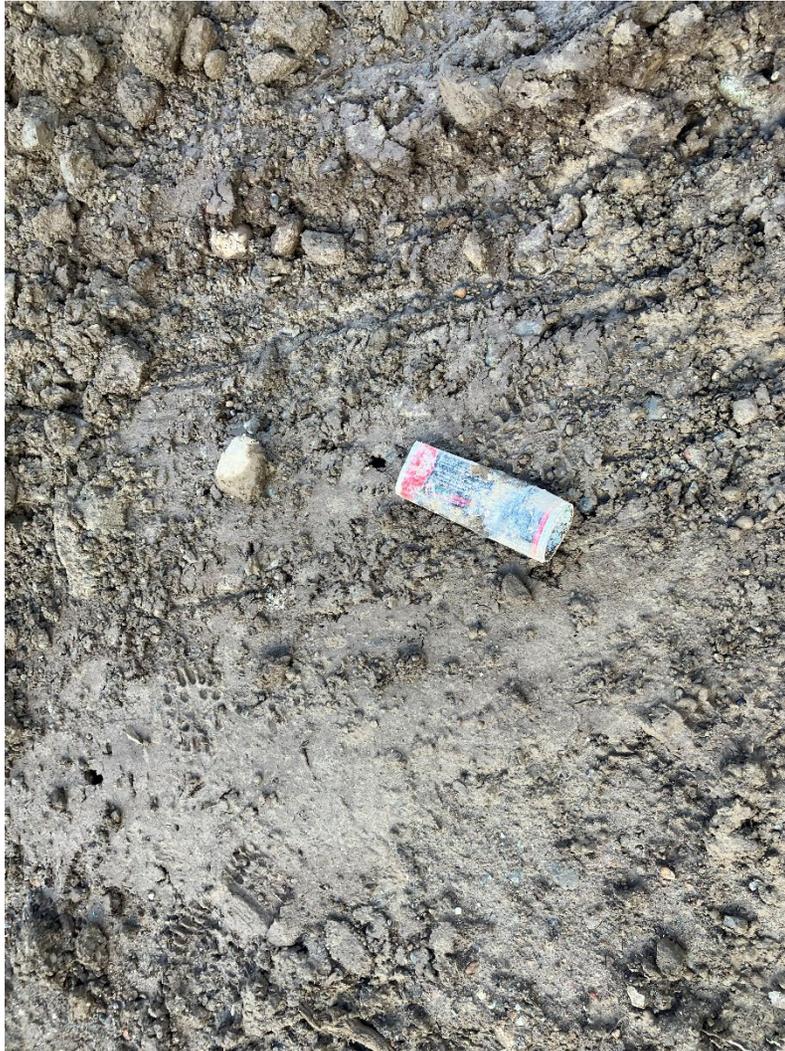
Photo 5 [IMG_1836]

Description: Empty can with the potential to pollute left on the ground.

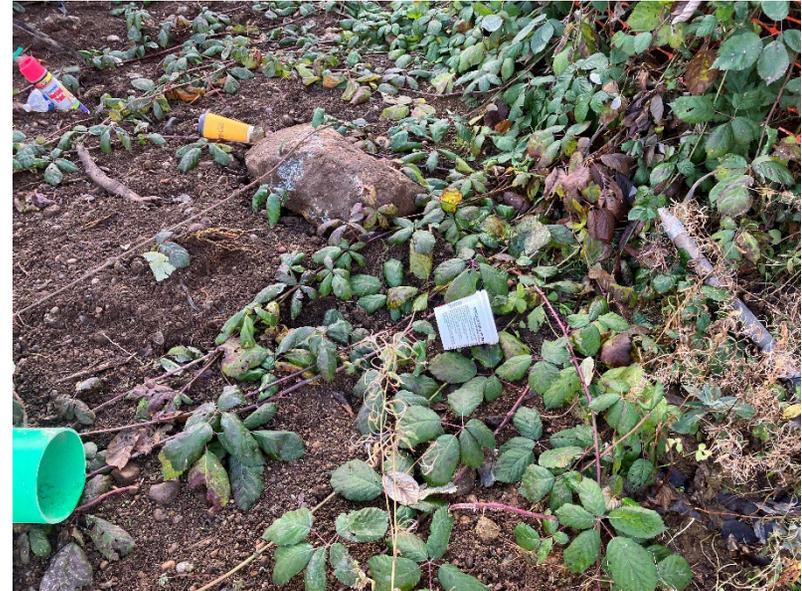
Photo 6 [IMG_1837]

Description: Container with the potential to pollute left on the ground.

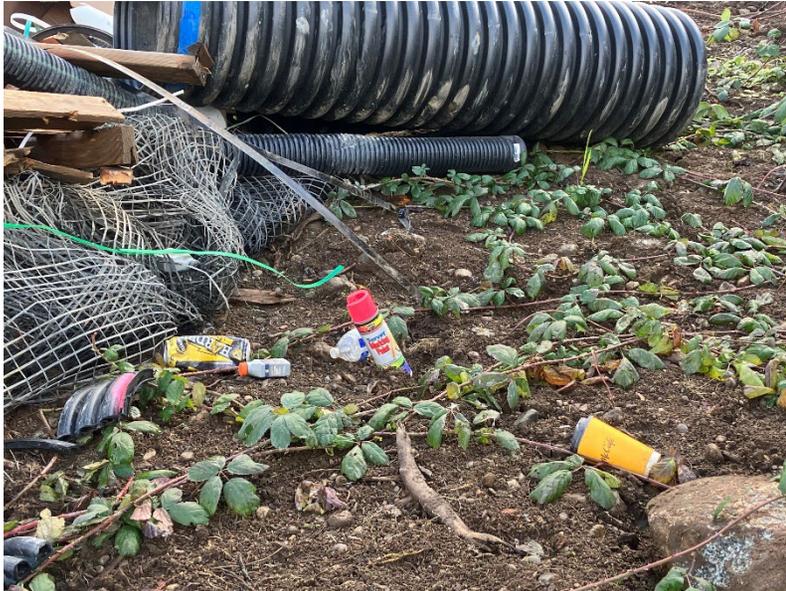
Photo 7 [IMG_1838]

Description: Can with the potential to pollute left on the ground.

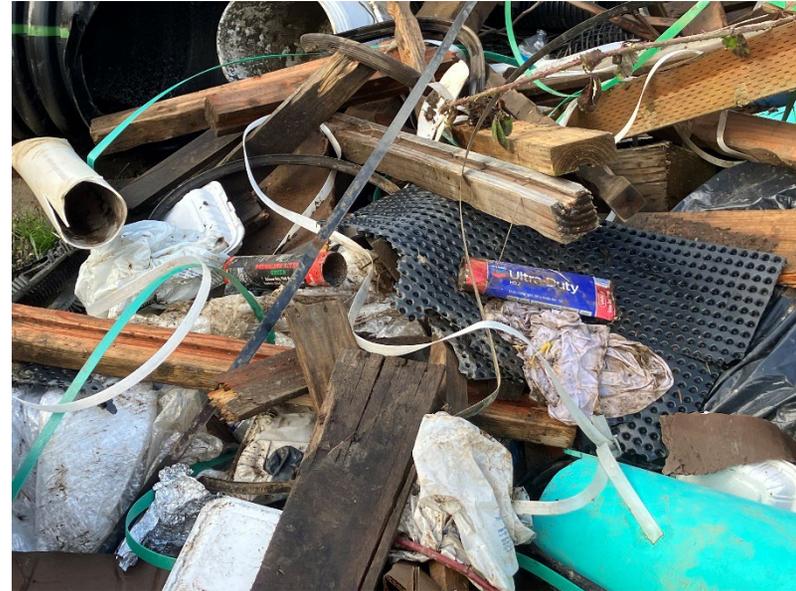
Photo 8 [IMG_1839]

Description: Empty cans with the potential to pollute in a pile of trash.

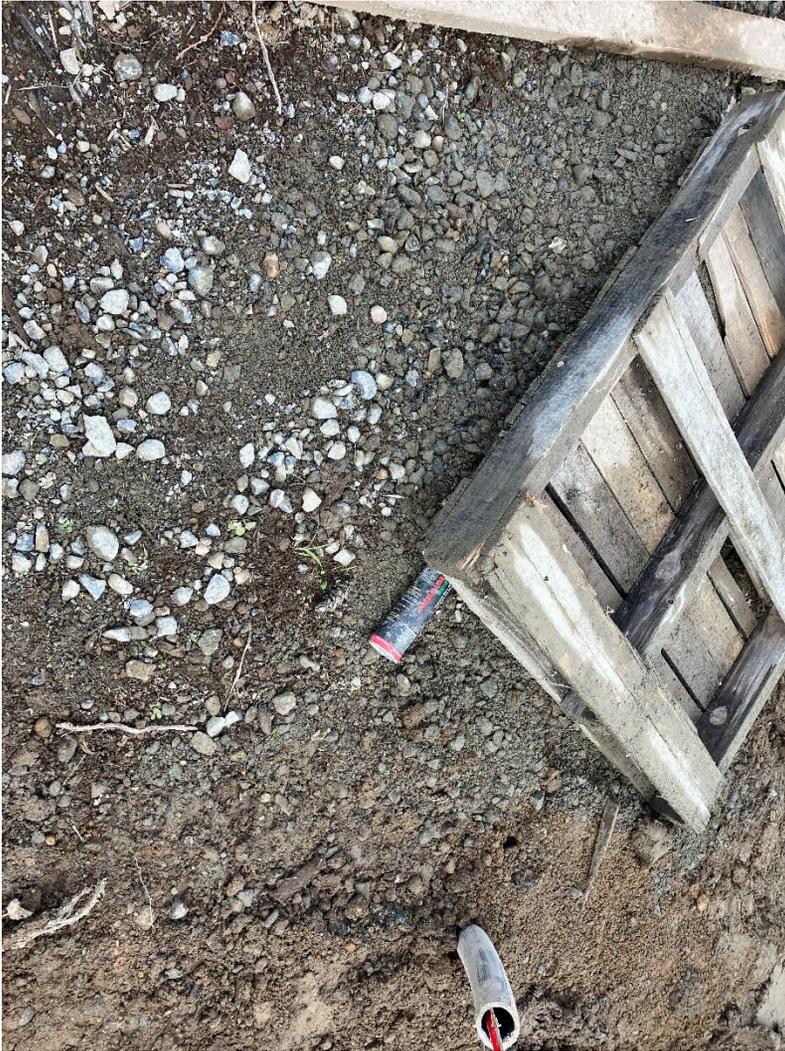
Photo 9 [IMG_1855]

Description: Empty can with the potential to pollute left on the ground.

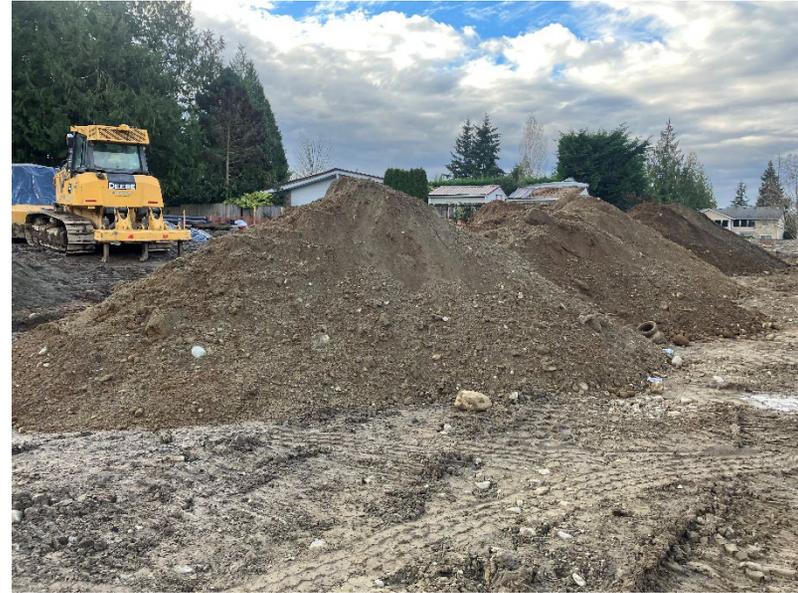
Photo 10 [IMG_1822]

Description: Exposed stockpiles near the entrance.

Stabilize Soils: Failure to meet S9.D.5.a and S9.D.5.d: In several areas onsite, there were exposed and unworked soils and stockpiles. The Permittee must stabilize exposed and unworked soils by application of effective BMPs that prevent erosion. Applicable BMPs include, but are not limited to: temporary and permanent seeding, sodding, mulching, plastic covering, erosion control fabrics and matting, soil application of polyacrylamide (PAM), the early application of gravel base on areas to be paved, and dust control. Stabilize exposed and unworked soils, including stockpiles, by application of effective BMPs to prevent erosion, as set forth in permit condition S9.D.5.a and timeline in S9.D.5.d. The Permittee must not allow soils to remain exposed and unworked for more than the time periods set forth below to prevent erosion west of the Cascade Mountains Crest: During the dry season (May 1 - September 30): **7 days** or During the wet season (October 1 - April 30): **2 days**. **Immediately begin. Address no later than 2 days from the date this report is issued.**

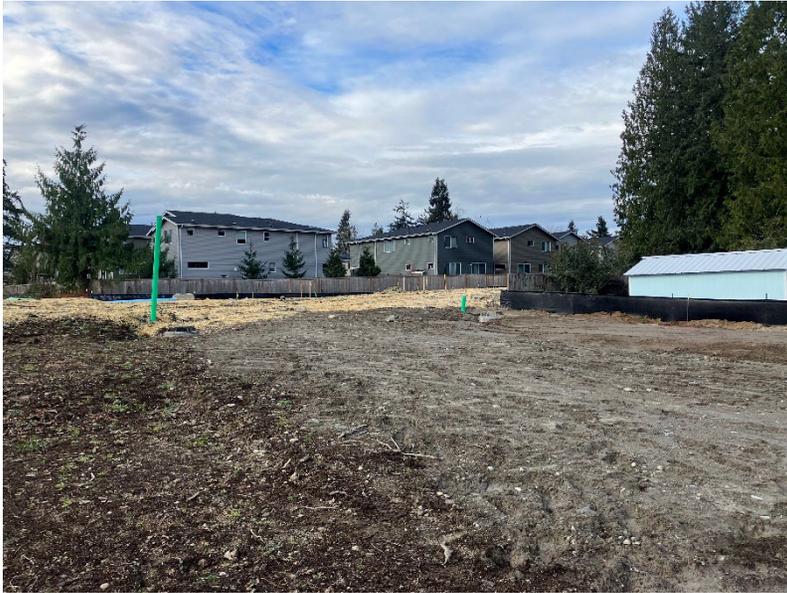
Photo 11 [IMG_1832]

Description: Exposed soils in the northeastern area of the site.

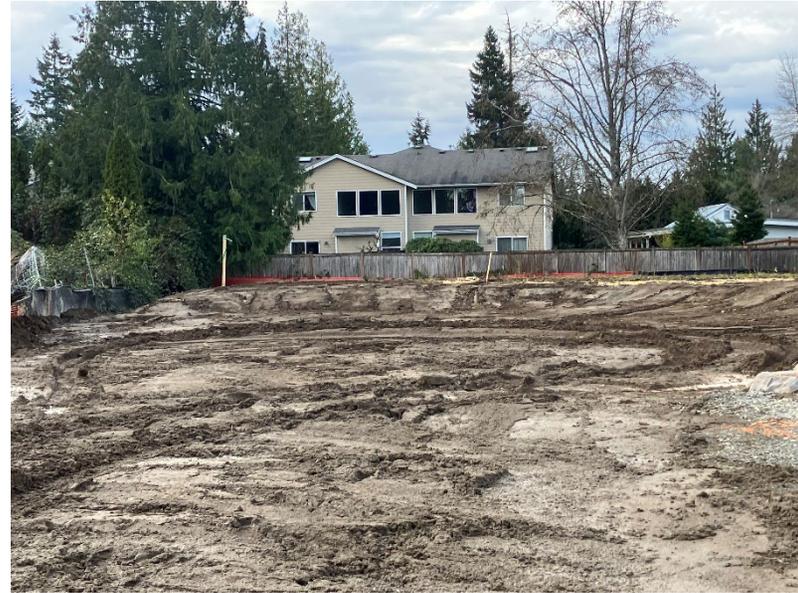
Photo 12 [IMG_1843]

Description: Exposed soils in the western area of the site.

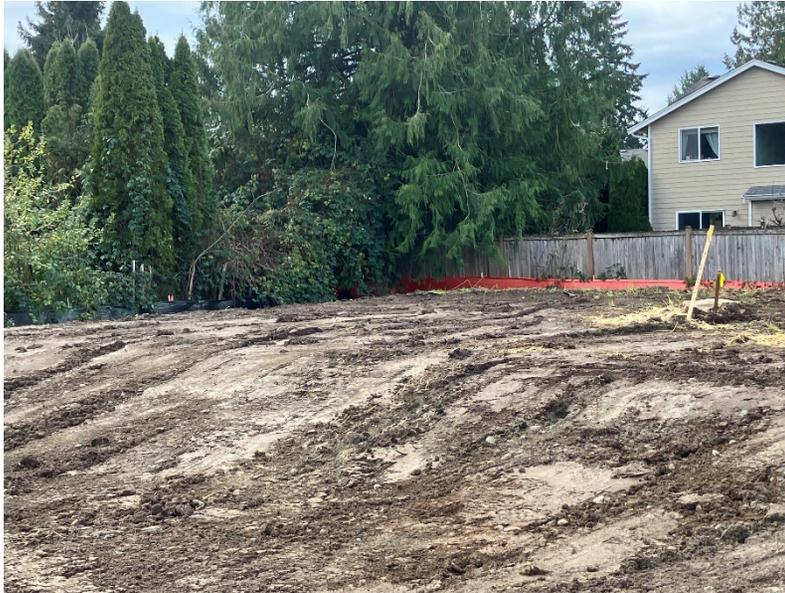
Photo 13 [IMG_1844]

Description: Exposed soils in the western area of the site.

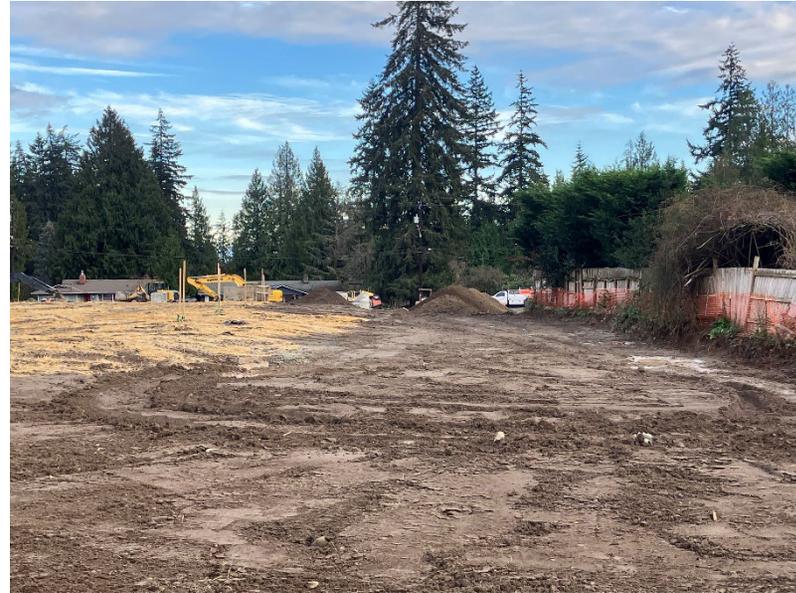
Photo 14 [IMG_1851]

Description: Exposed soils in the western area of the site.
