STORMWATER COMPLIANCE INSPECTION REPORT

State of Washington Department of Ecology
1250 W Alder St, Union Gap, WA 98903

Name and Location of Site Inspected Milne Fruit 804 Bennett Avenue Prosser WA 99350	Entry Time 11am Exit Time 12pm
	GPS Lat: Long:
	Entrance: 46.201749 -119.776058 Discharge: 46.201546 -119.778180
	Additional Participants:
On-Site Representative(s): Name(s)/Title(s)/Contact number(s) or E-mail Bruce DeJong, Plant Engineer, 509.876.2611 x1260, bdejong@milnefruit.com	
Responsible Official(s): Bruce DeJong, Michael Sorenson	
Samples Taken? <input type="checkbox"/> Yes <input checked="" type="checkbox"/> No Photos Taken? <input checked="" type="checkbox"/> Yes <input type="checkbox"/> No

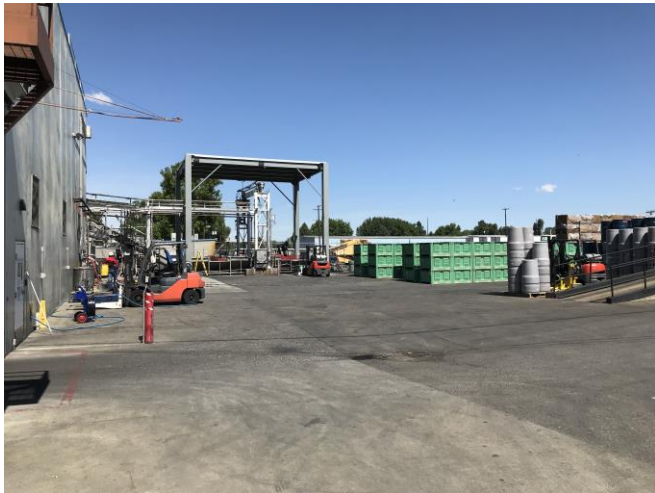
FIGURE 1: MOST OF OUTSIDE OPERATIONS DRAIN INTO THE PROSSER POTW SANITARY SEWER

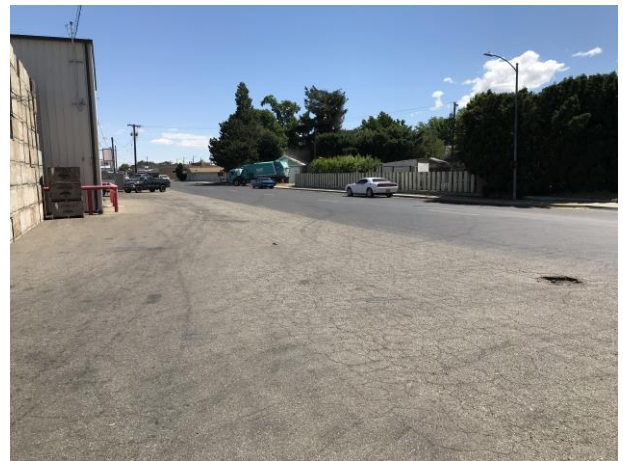
FIGURE 2: ON THE EAST SIDE OF PARCEL ABOUT 20 FEET WIDTH OF THEIR PROPERTY DRAINS INTO THE PROSSER CITY STORM SEWER

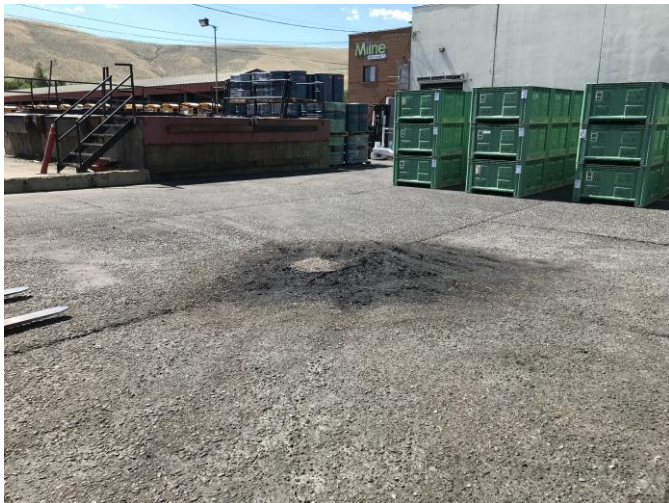
FIGURE 3: NORTH SIDE DRAIN ON ACID PITTED CONCRETE FROM FRUIT JUICES. DRAINS TO SANITARY SEWER

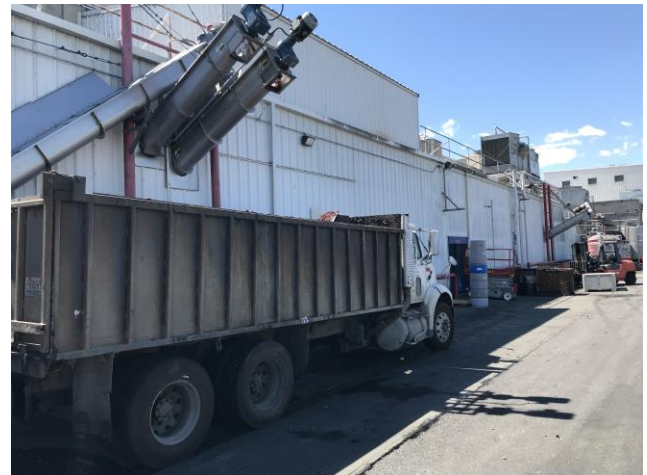
FIGURE 4: WASTE LOADING AREA. ALSO DRAINS TO SANITARY SEWER OR RAILROAD GRAVEL SWAIL TO WEST.

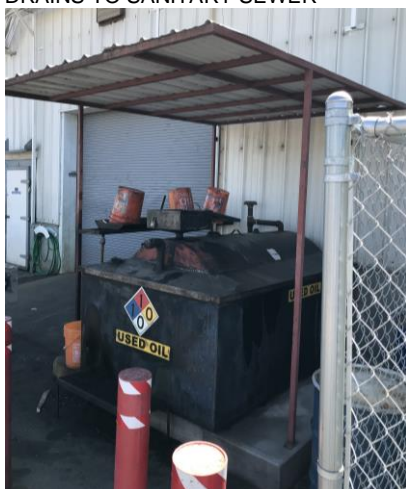
FIGURE 5: USED OIL, SECONDARY CONTAINMENT AND COVER. SPILL KIT UNKNOWN.

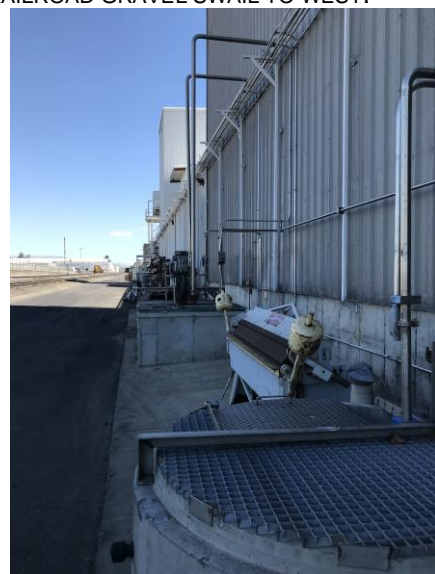
The non-contact cooling water has no anti-scalant in it according to Bruce, they use soft water. pH and temperature of non-contact cooling water are measured and calibrated monthly, see figure 12. There is a first flush catchment (figure 6), pump, and lift station on the west side of building for all the west side drains and cooling unit drips. This is permanently routed to the sanitary sewer, Prosser POTW.

FIGURE 6: ALMOST ENTIRE WEST SIDE OF FACILITY DRAINS TO THIS SUMP PUMP "FIRST FLUSH" SYSTEM, WHICH IS ROUTED TO POTW

Citation reference	Page #	Specific Violation	Action	Due date
Condition S3.B.1	Pg. 11	SWPPP needs update	Update SWPPP map to reflect current usage of first flush system, and clarify the SW corner drain system, sample point.	60 days from receipt of report
Condition S3.B.4.b.i.3	Pg. 16	Preventative maintenance	Clean drains and catchbasins which run directly to river culverts.	60 days receipt of report
S3.B.4.c	Pg. 15	Locate spill kits within 25 feet of all stationary fueling stations, fuel transfer stations, mobile fueling units, and used oil storage/transfer stations	Provide spill kits	60 days from receipt of report
Condition S4.B	Pg. 19	The Permittee shall sample the discharge from each designated location at least once per quarter	Contact laboratory and prepare stormwater sample bottles on site	60 days from receipt of report
S4.B.2.d	Pg. 20	Notify Ecology of any changes or updates to sample locations, discharge points, and/or outfalls by submitting an "Industrial Stormwater General Permit Discharge/Sample Point Update Form"	Update your discharge monitoring sample point	30 days from receipt of report

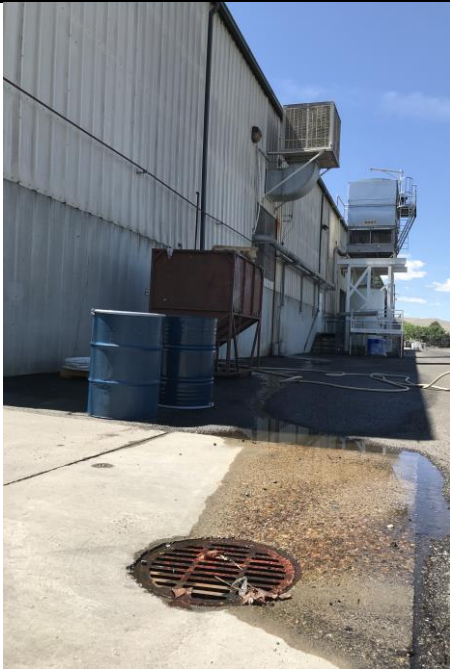
FIGURE 7 COOLING UNITS CONDENSATE DRAINS TO SUMP FIRST FLUSH SYSTEM.

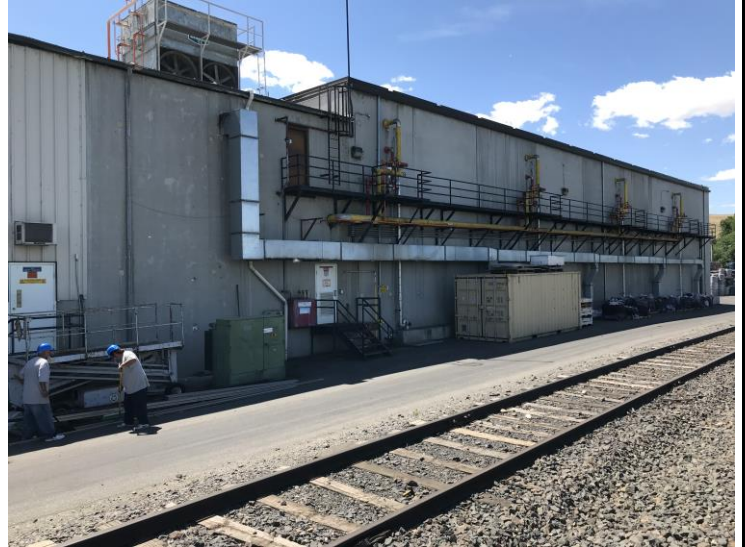
FIGURE 8 SOUTHWEST CORNER. ALL STORM DRAINS FOR THIS SECTION OF PROPERTY LEAD TO CULVERT UNDER RAILWAY.

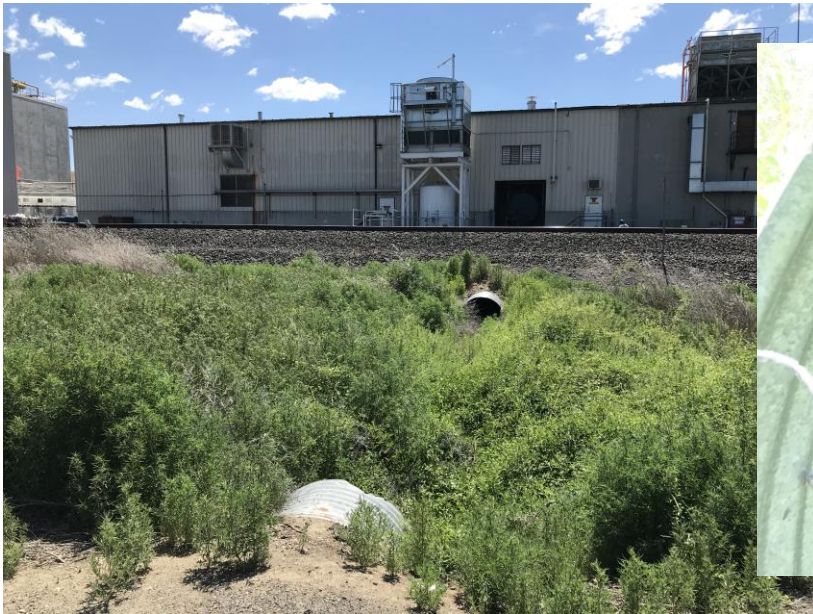
The SW corner of the property has multiple storm water catchment grates and piping that ultimately lead to two culverts and out to the Yakima river (figure 9). This area has an unknown capacity before it overflows the built up sediment in the final culvert, and should be calculated. The main area of concern for stormwater is the SW corner of property.

FIGURE 9 CULVERTS LEAD TO YAKIMA RIVER

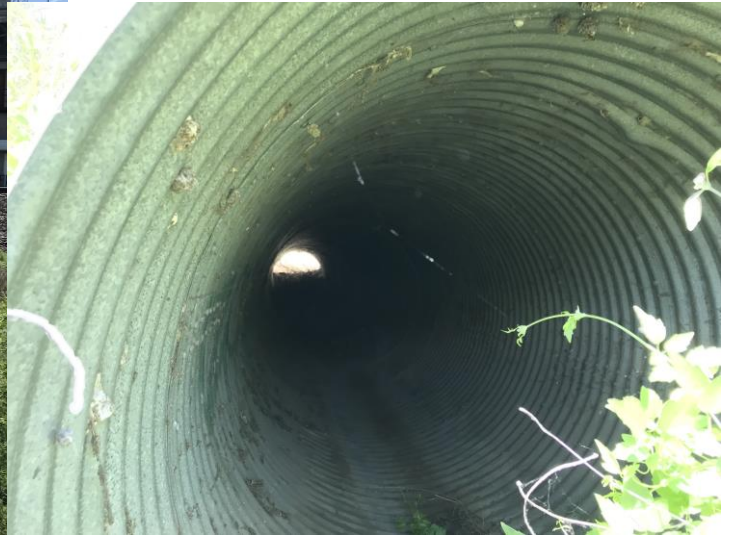
Majority of site drains to sanitary sewer line to the Prosser POTW. The southwest face of property has storm drain lines that discharge into a series of 2 culverts leading directly to the Yakima river with a patch of vegetation infiltration between the two culverts. The second culvert has sediment built up over half of the exit pipe. East face of parcel has an approx. 20 foot wide area of asphalt that drains from their parcel to the municipal storm sewer line, however this appears to be mostly employee parking, with some truck and forklift traffic.

FIGURE 10 SEDIMENT HAS FILLED IN THIS CULVERT'S FINAL OUTFALL HALFWAY. END OF CULVERT IS TO BE DESIGNATED AS THE COMPLIANCE SAMPLING POINT.

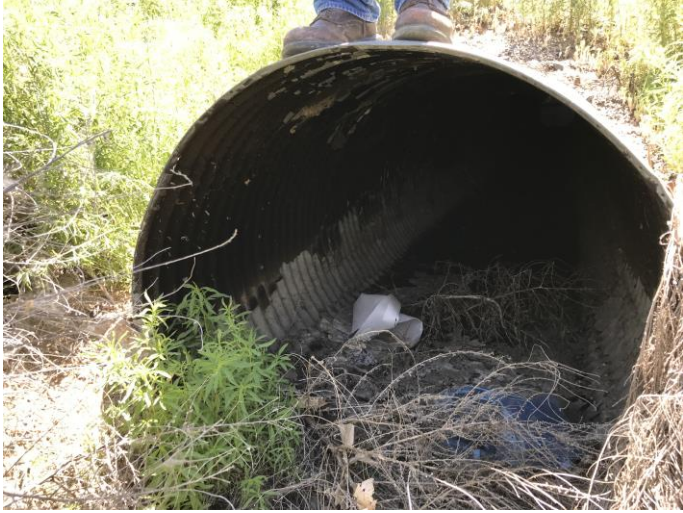
FIGURE 11 FIRST CULVERT IS ALSO SLOWLY FILLING WITH SEDIMENT.

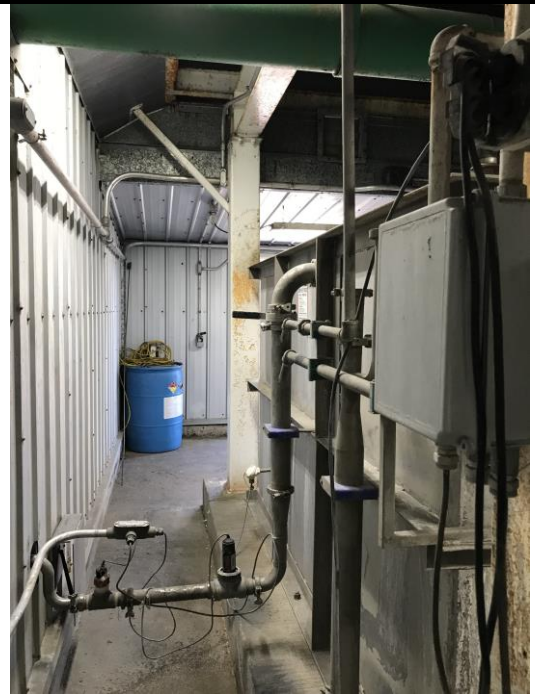
FIGURE 12 NON-CONTACT COOLING WATER PH AND TEMPERATURE METERS
