State of Washington Department of Ecology
Northwest Regional Office
**STORMWATER COMPLIANCE INSPECTION
REPORT**

Name and Location of Facility Inspected Jorgensen Forge Corporation 8531 E. Marginal Way S. Seattle, WA 98108-4018	Entry Time 9:45 am	Permit Effective Date 1-01-10
	Exit Time 2:30 pm	Permit Expiration Date 1-01-15

PHOTO ADDENDUM

Jorgensen Forge, Seattle

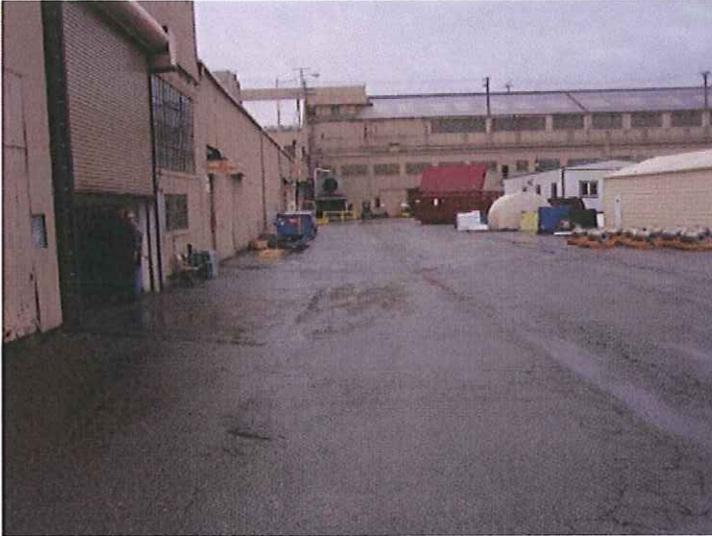
#1. DESCRIPTION: Jorgensen Forge occupies approximately 20 acres on the Duwamish River. The buildings are in the shape of an "L". Most of the outside areas are concrete or asphalt.

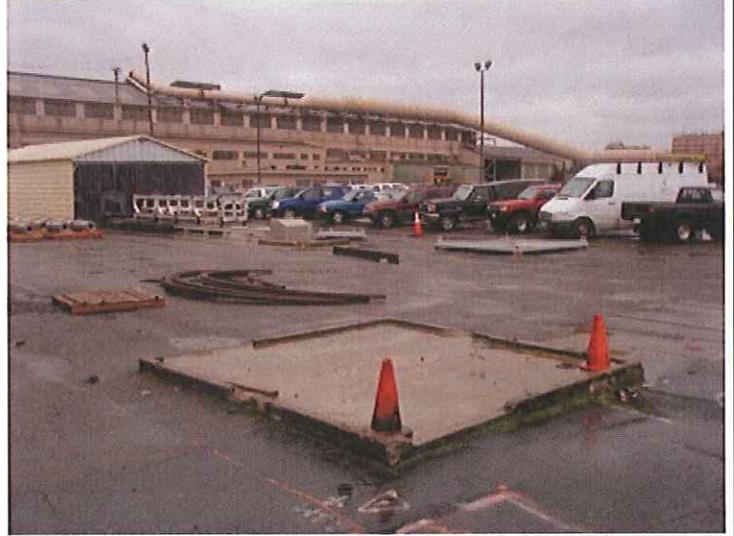
#2. DESCRIPTION: The Duwamish River is beyond the large tan overhead ducting. The facility has no overwater structures or any water-side operations.

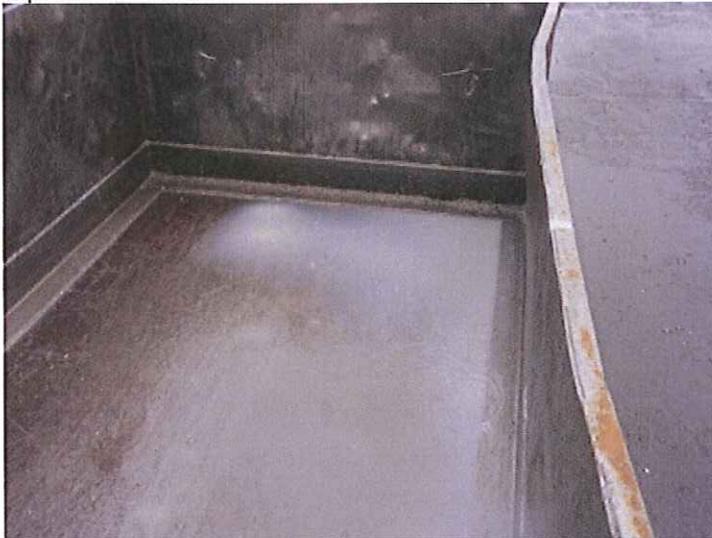
The facility stores a lot of scrap metal outside in various types of bins and dumpsters. A whitish cutting oil/coolant could be seen at the bottom of a scrap metal storage bin and cutting oil/coolant could be seen on the pavement nearby (see Photos #3, 4).

#3. DESCRIPTION: The facility stores a lot of scrap metal outside in various types of bins and dumpsters. A whitish cutting oil/coolant can be seen at the bottom of this scrap metal storage bin.

The facility stores a large amount of scrap material outside in metal bins, dumpsters and bunkers. The new NPDES Industrial Stormwater General Permit requires: "No later than July 1, 2010, Keep all dumpsters under cover or fit with a lid that must remain closed when not in use" (see Photos # 3-6 and 11, 12).

Miscellaneous scrap materials and wastes stored outside should be inventoried and covered as necessary. Dumpsters with lids must be kept closed when not in use.

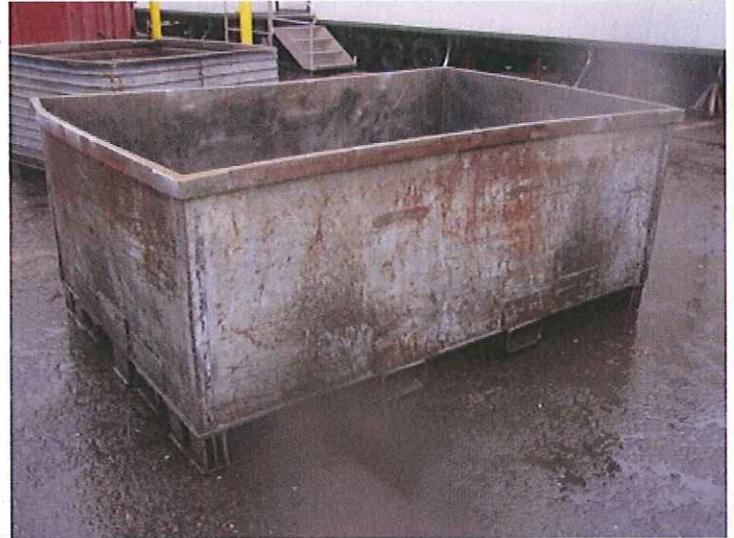
#4. DESCRIPTION: Cutting oil/coolant could be seen on the pavement near this scrap metal bin. Scrap metal stored in bins or dumpsters outside must be provided with proper cover.

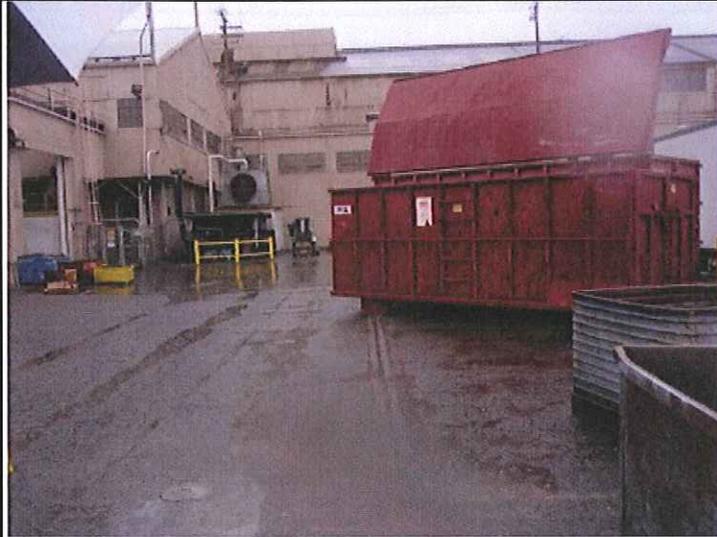
#5. DESCRIPTION: Of these two dumpsters, one has a lid and one does not. Procedures must be developed to ensure the lid is closed when access is not necessary.

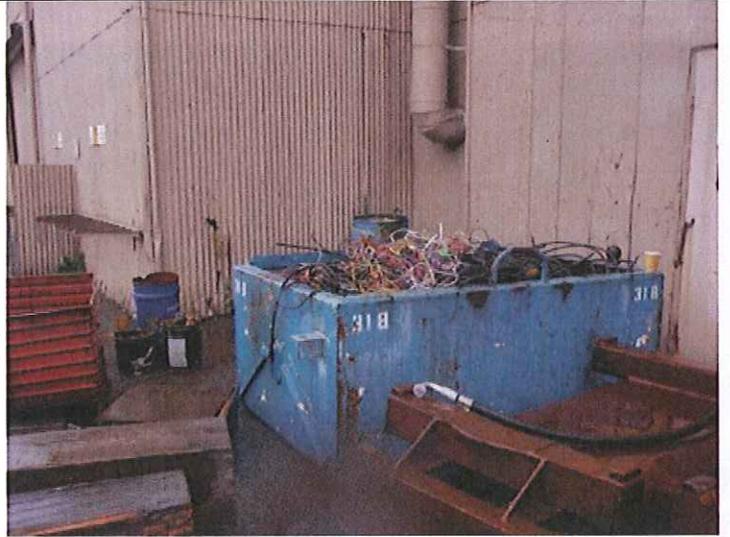
#6. DESCRIPTION: Miscellaneous scrap materials and wastes should be inventoried and stored inside or covered as necessary.

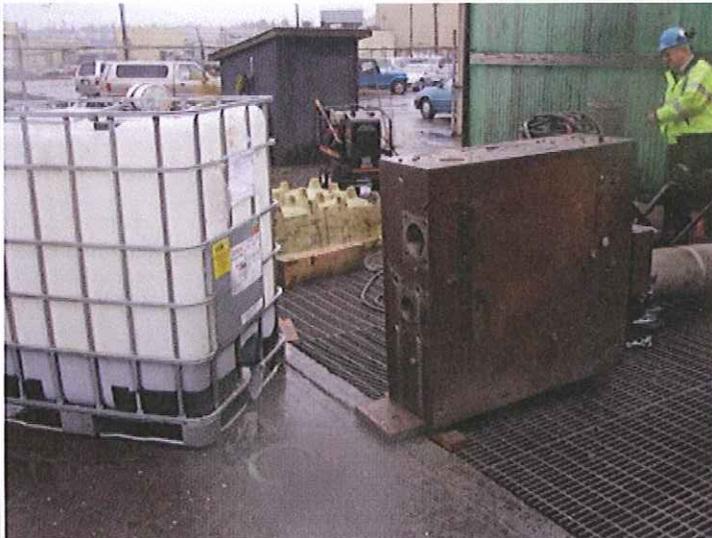
The pressure wash/steam cleaning station is located near the laboratory (see Photos # 7, 8, 10). This facility is plumbed to the sanitary sewer through an oil/water separator. All wash-water is defined as process wastewater and cannot be discharged to the storm drainage system. Some of the area around the pressure wash/steam cleaning station flows to the storm drainage system. The footprint of the cleaning station must be clearly depicted on the Site Map in the SWPPP and on the ground with markings or a painted line. It must be clear to everyone working in the vicinity of the cleaning station, which areas drain to the sanitary sewer and which to the storm drainage system.

#7. DESCRIPTION: The grated area is for pressure washing and steam cleaning. The grated area is plumbed to the sanitary sewer. Chemicals and petroleum products must be provided with proper containment.

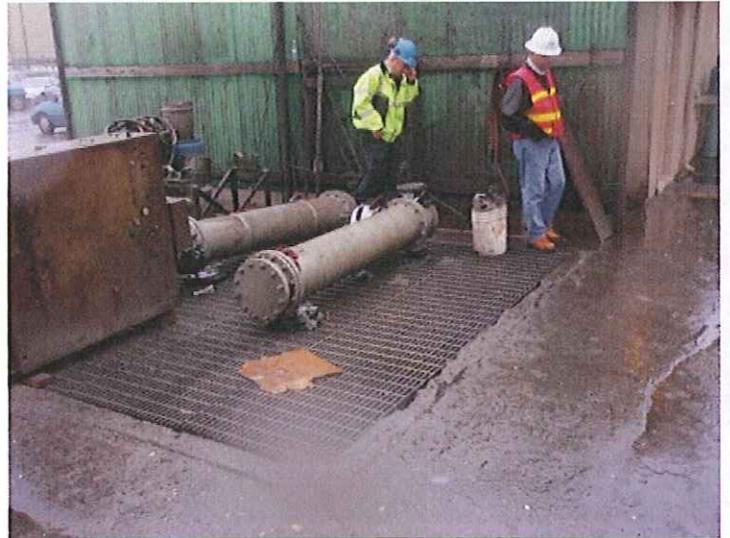
#8. DESCRIPTION: All wash-water is defined as process wastewater and cannot be discharged to the storm drainage system. Some of the area around the grating flows to the storm drainage system. The facility must clearly mark the "footprint" of the area that flows to the sanitary sewer. The Site Map in the SWPPP should be updated to clarify which areas are tributary to the sanitary sewer and which go to the storm drainage system in this area.

The footprint of the cleaning station must be clearly depicted on the Site Map in the SWPPP and on the ground with markings or a painted line.

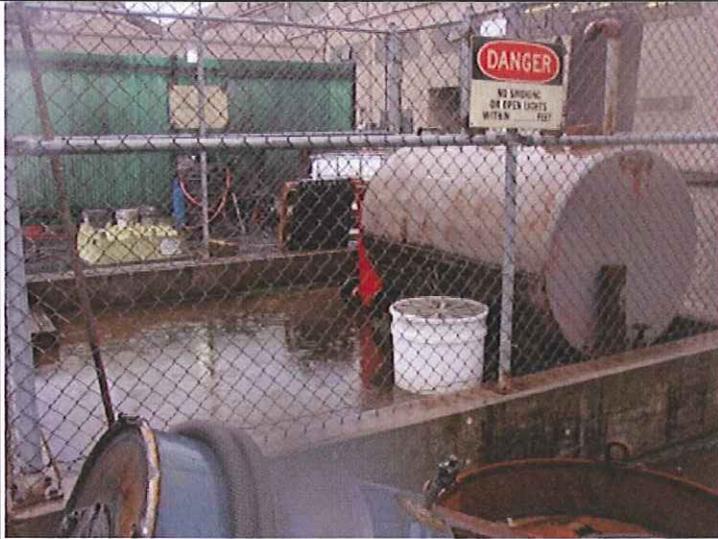
#9. **DESCRIPTION:** The facility must provide adequate cover and containment for all liquid petroleum and chemical products and wastes stored outside.

The facility must provide adequate cover and containment for all liquid petroleum and chemical products and wastes stored outside.

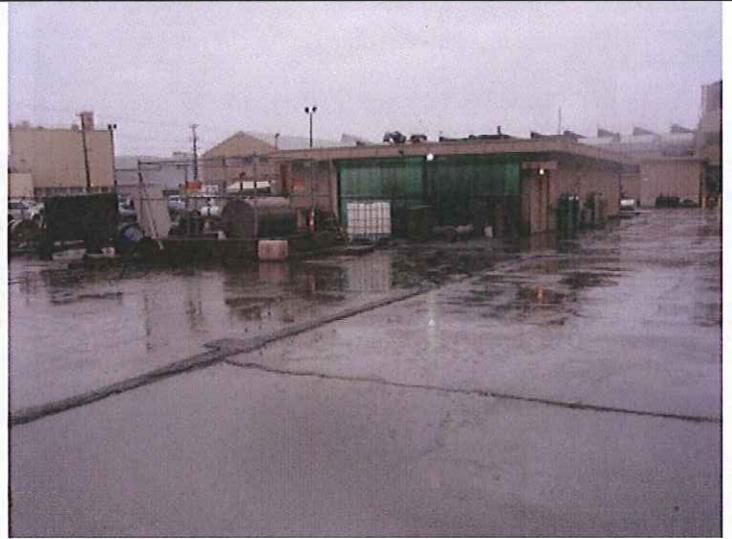
#10. **DESCRIPTION:** The footprint of the area tributary to the sanitary sewer needs to be clearly delineated so staff knows if wastewater may be flowing to storm drains.

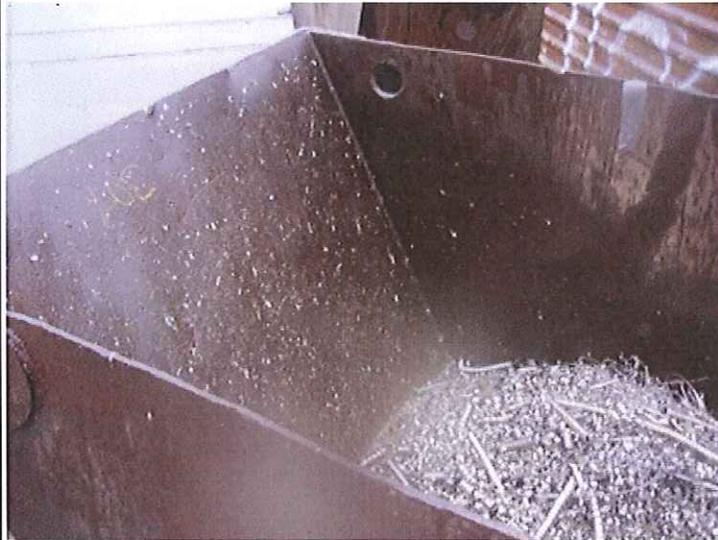
#11. **DESCRIPTION:** Metal turnings and cuttings must be stored in bins or dumpsters with a cover.

Metal turnings and cuttings must be covered, stored under cover or inside (see photos # 11, 12).

Metal turnings/cuttings must be covered, stored under cover or kept inside.

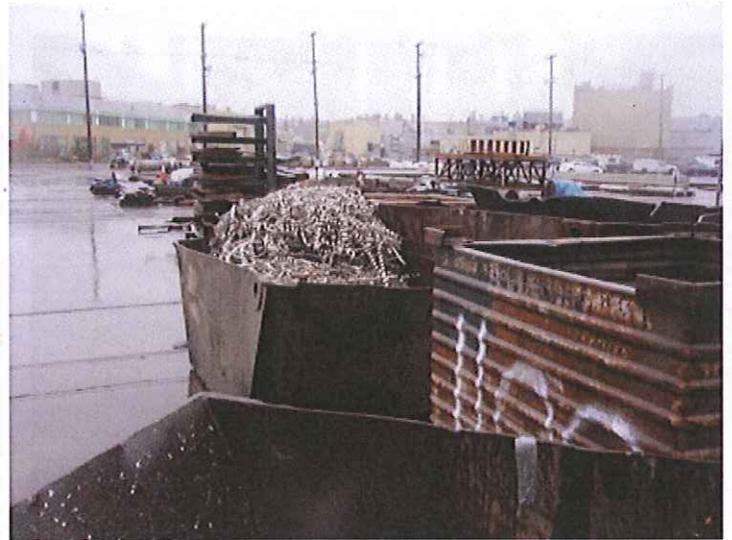
#12. **DESCRIPTION:** These scrap metal bins must be covered, stored under cover or inside.

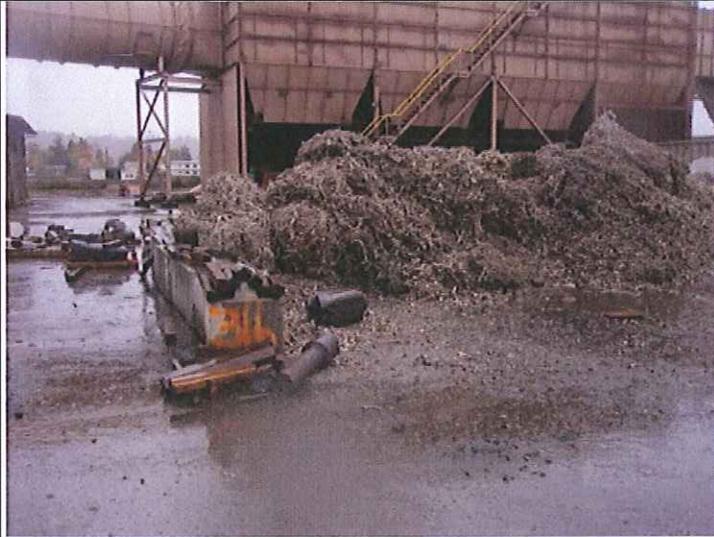
Stormwater run-off from the metal turnings/cuttings storage bunkers in photos # 13 and 14 is likely to be contaminated. Stormwater run-off from this area either flows to storm drains or infiltrates. Jorgensen must determine whether or not stormwater from this area can possibly get into the storm drainage system. The scrap metal storage bunkers seen in photos # 13, 14 must be provided with improved source control measures and pollution prevention practices. It is not clear where stormwater from this area flows. Infiltrating contaminated stormwater near the river with a high groundwater table is problematic.

#13. DESCRIPTION: Stormwater run-off from this area is likely to be contaminated. This area is within the Outfall 003 drainage basin. The facility must determine where stormwater from this area goes. This pile of metal turnings/cuttings must be provided with adequate source control.

Jorgensen must determine whether or not stormwater from the scrap metal storage bunkers near the melt baghouse can possibly get into the storm drainage system.

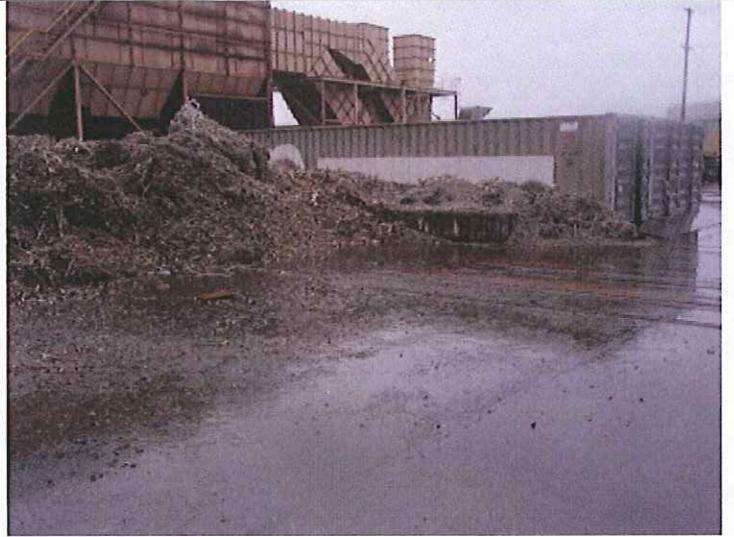
#14. DESCRIPTION: This scrap metal storage area must be provided with more adequate source control. It is not clear where stormwater from this area flows. Infiltrating contaminated stormwater near the river with a high groundwater table is problematic.

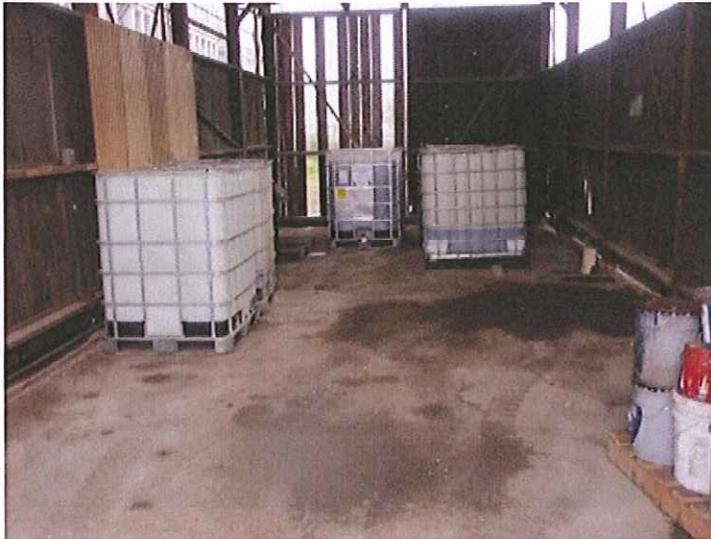
#15. DESCRIPTION: All liquid products and wastes must be provided with adequate cover and containment. The concrete floor of this storage area is recessed and has a lip around it.

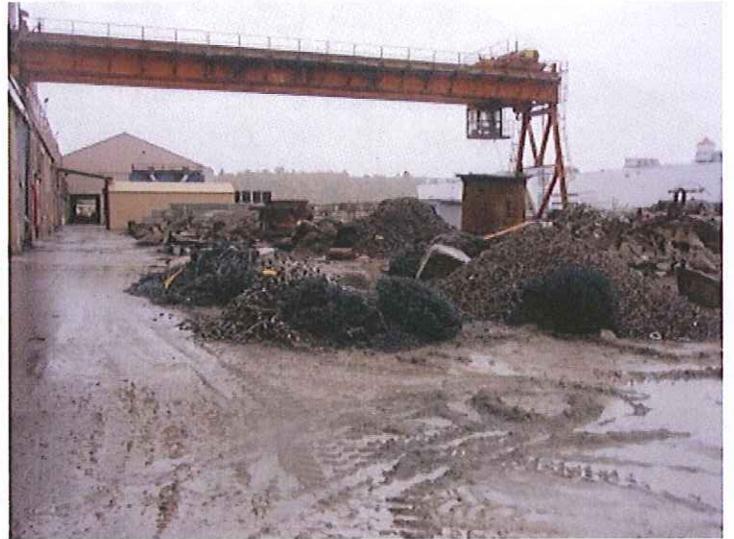
A variety of scrap metals and solid wastes are stored out in the open along the southern boundary of the facility (see Photos # 16, 19, 20, 21). Source control measures must be re-evaluated in this area. During rainy periods, stormwater from this area will flow towards storm drains or infiltrate.

#16. DESCRIPTION: The southern portion of the facility is partially paved and is used to store scrap metals and waste materials. Stormwater from this area either flows to Outfall 001 or Outfall 002 or infiltrates into the ground.

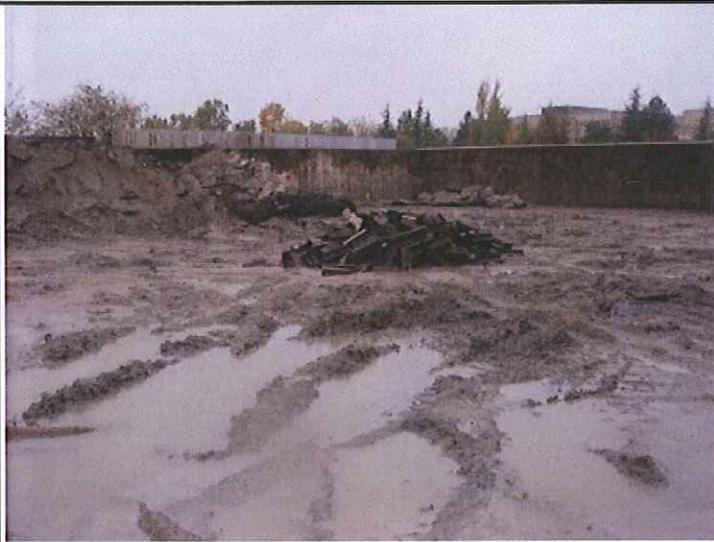
The southern portion of the facility is partially paved and is mostly used to store scrap metal and waste materials. Outfall lines # 001 and 002 flow under this area. The southwest corner of the facility is unpaved (see Photo # 17). There are no storm drains in the vicinity and most stormwater infiltrates into the ground. Given the close proximity to the Duwamish River, the facility must ensure that stormwater cannot flow overland towards the river between the concrete wall and the building (see Photo # 18). Contaminated stormwater infiltrating in this area may find a pathway to the river along the outside of storm drain lines # 001 and 002.

#17. DESCRIPTION: The southwest corner of the facility is unpaved. There are no storm drains in the vicinity and most stormwater infiltrates into the ground. The Duwamish River is on the other side of the concrete wall.

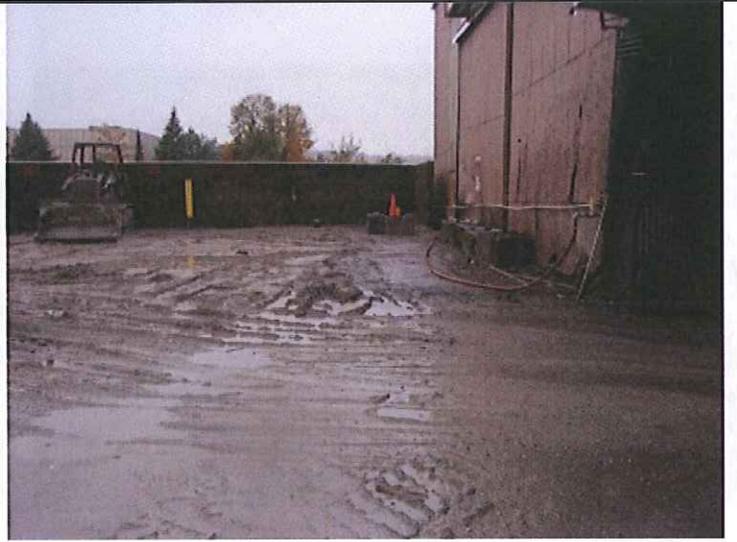
#18. DESCRIPTION: Storm drain lines 001 and 002 flow under this area. The facility must ensure that stormwater cannot flow overland towards the river between the concrete wall and the building (just to right of orange cone). Contaminated stormwater may infiltrate and then flow along the outside of storm drain lines 001 or 002.

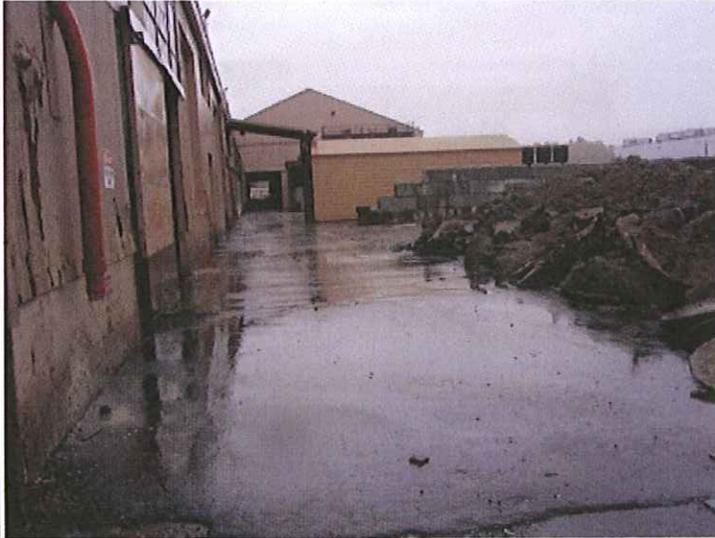
#19. DESCRIPTION: The southern portion of the facility is called the scrap storage area. A variety of scrap metals and solid wastes are stored here out in the open. Source control measures must be re-evaluated in this area. During rainy periods, stormwater from this area will flow towards storm drains or infiltrate in the ground.

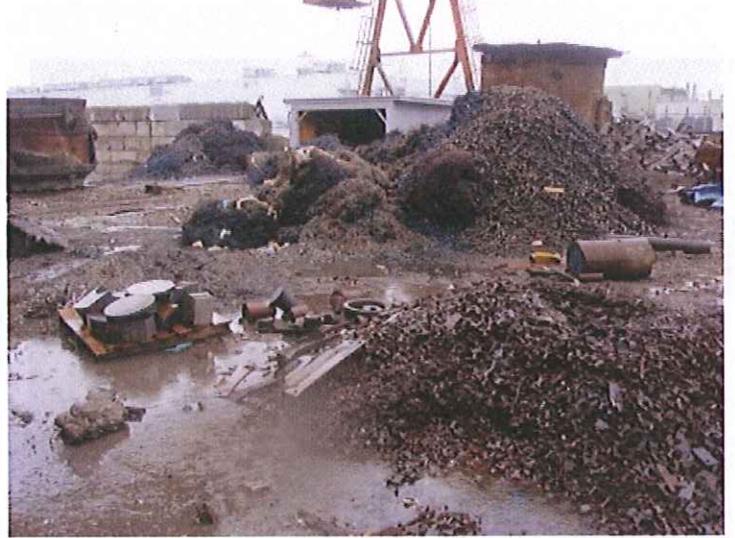
The Site Map shows there is at least one catch basin in the scrap material storage area. The facility must inventory wastes stored along the southern portion of the facility and implement necessary source control measures for the pollutants that will mobilize during storm events. The scrap metal stored in an ecology block bunker (see Photos # 21, 22) has enough petroleum in it to warrant the use of absorbent pads (see Photo # 22). This material needs to be stored under cover. Stormwater in this area was reddish brown and had a visible sheen on it. This stormwater is either infiltrating or flowing towards a storm drain (see Photo # 24).

#20. DESCRIPTION: The Site Map shows there is at least one catch basin in the scrap storage area. The facility must inventory wastes stored along the southern portion of the facility and implement necessary source control measures for pollutants that will mobilize during storm events.

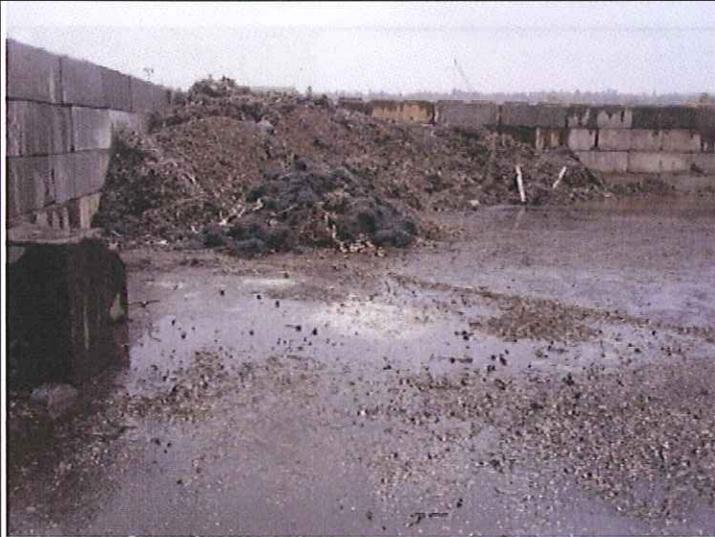
#21. DESCRIPTION: Scrap metal is stored in ecology block bunkers. This material is metal chips (or turnings or cuttings) and should be provided with cover.

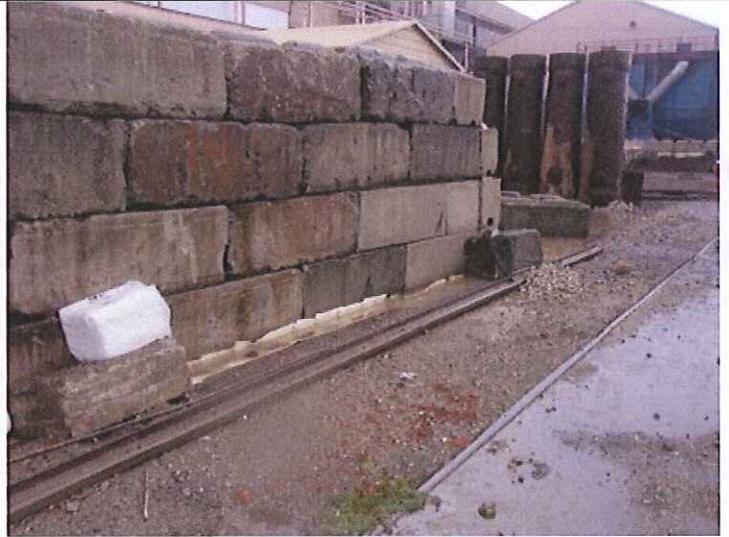
#22. DESCRIPTION: The scrap metal seen in photo # 21 is on the other side of this ecology block wall. Apparently the metal chips have enough petroleum on them to warrant the use of absorbent pads to control petroleum in the stormwater.

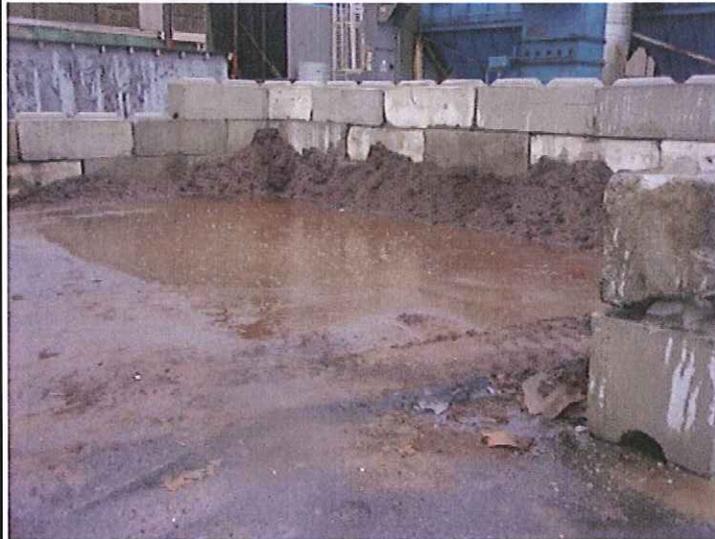
#23. DESCRIPTION: Materials stored outside in the scrap storage area must be covered.

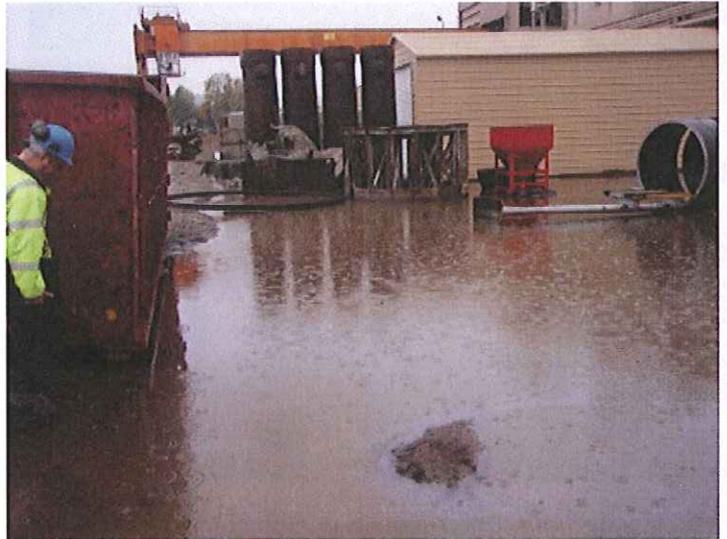
#24. DESCRIPTION: Stormwater will pool in areas without adequate drainage. Stormwater from this area may eventually find an avenue to flow towards the river. The stormwater pooling in this area was reddish brown and had a petroleum sheen visible on it.

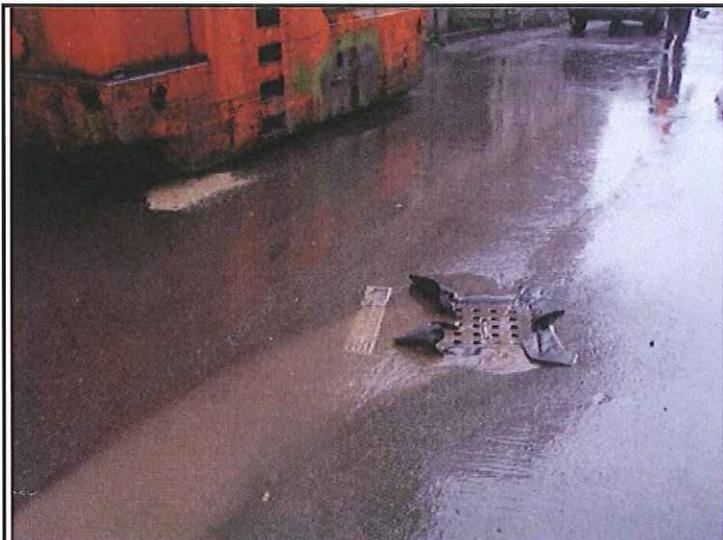
The unpaved area just south of the Aluminum Heat Treat Area was contributing to very turbid run-off flowing to the nearby storm drain catch basin (see Photos # 25, 26) which is tributary to Outfall 002. A visible petroleum sheen on stormwater flowing into a catch basin tributary to the Duwamish River must elicit a source tracing investigation to determine the source.

#25. DESCRIPTION: This storm drain is tributary to the Outfall 002. The nearby unpaved area was contributing very turbid stormwater to this catch basin. This area is at the southeast corner near the Aluminum Heat Treat building.

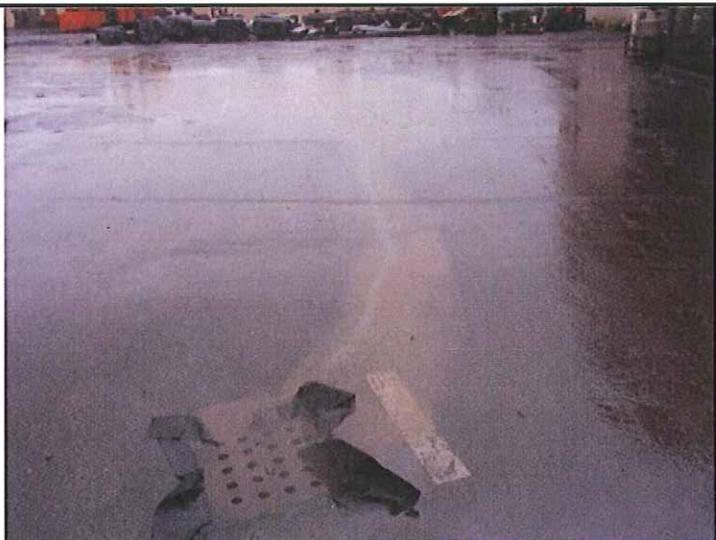
#26. DESCRIPTION: The turbid stormwater flowing to the storm drain catch basin had a visible petroleum sheen on it. A visible petroleum sheen on stormwater flowing to a catch basin tributary to the Duwamish River must elicit an investigation to determine the source.

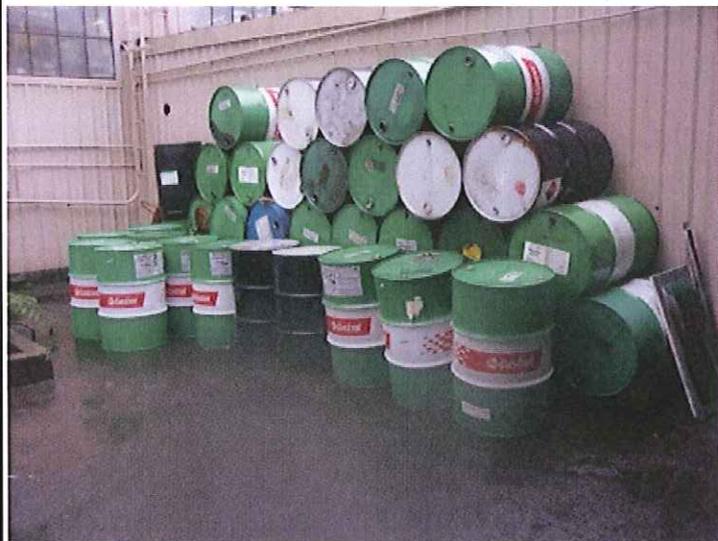
Empty drums may have residual petroleum and/or chemicals on them that will mobilize if left out in the rain (see Photo # 27). All containers of liquid products and wastes stored outside must be provided with adequate cover and containment (see Photo # 28).

#27. DESCRIPTION: Most of these drums were empty but residual petroleum and/or chemicals may mobilize if left out in the rain.

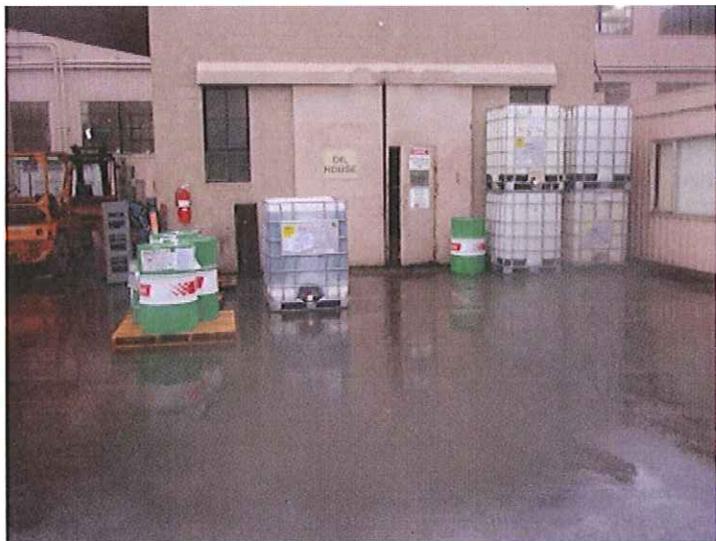
#28. DESCRIPTION: All liquid products and wastes stored outside must be provided with adequate cover and containment.
