State of Washington Department of Ecology WASTEWATER TREATMENT PLANT COMPLIANCE INSPECTION REPORT	Northwest Regional Office 3190160 th Ave SE Bellevue, WA 98008 (425) 649-7000 ph (425) 649-7098 fax (last update 6-11-07)
	Section A: General Information

Section B: Facility Data		
Name, Location, and Phone of Facility Inspected City of Oak Harbor Wastewater Treatment Plants 1501 SE City Beach Dr. Oak Harbor, WA 98277	Entry Time 12:30 pm	Permit Effective Date June 1, 2005
	Exit Time 5:00 pm	Permit Expiration Date May 25, 2010
Name(s)/Title(s) of On-Site Representative(s) Larry Michaels, Plant Supervisor; Scott Hubbard, Lab Coordinator; Rob Kelley, Lead Operator; Steve Bebee, Collections Operations Manager Cathy Rosen, Public Works Director; Eric Johnston, City Engineer	Ecology Staff On-Site Shawn McKone	
Name, Address, Title, Phone, and Fax Number of Responsible Official Cathy Rosen, Public Works Director 1400 NE 16 th Avenue Oak Harbor, WA 98277	Other Facility Data Last inspection was 1-30-08; Class 1 with Mark Toy – DOH. Additional site visit on 11-19-2009 to follow-up on lagoon flooding protection issues.	
Phone Number (360) 279-4751 Fax	Contacted? <input checked="" type="checkbox"

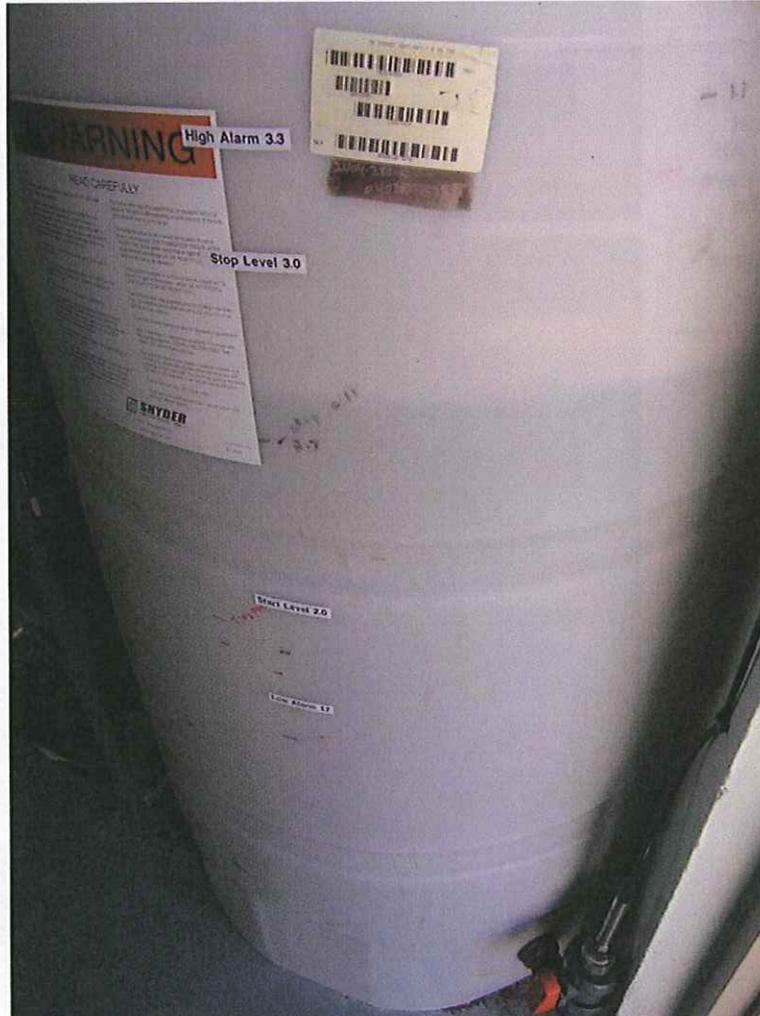
PHOTO NO. 1

Description: Chlorine solution tank in chlorine generation room with new labeling indicating alarm set points.

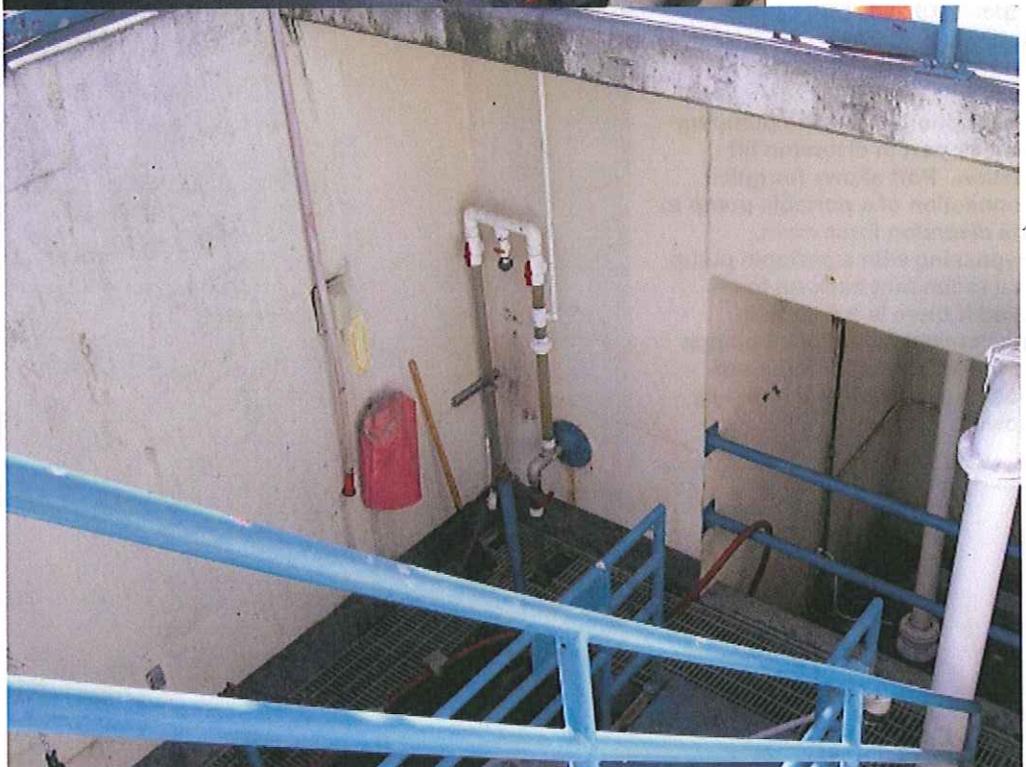
PHOTO NO. 2

Description: New scum pit siphon at RBC influent structure. The siphon was installed by the staff to help automate the decanting of the scum pit ant to help reduce odors by discharging decant water below the influent water line.

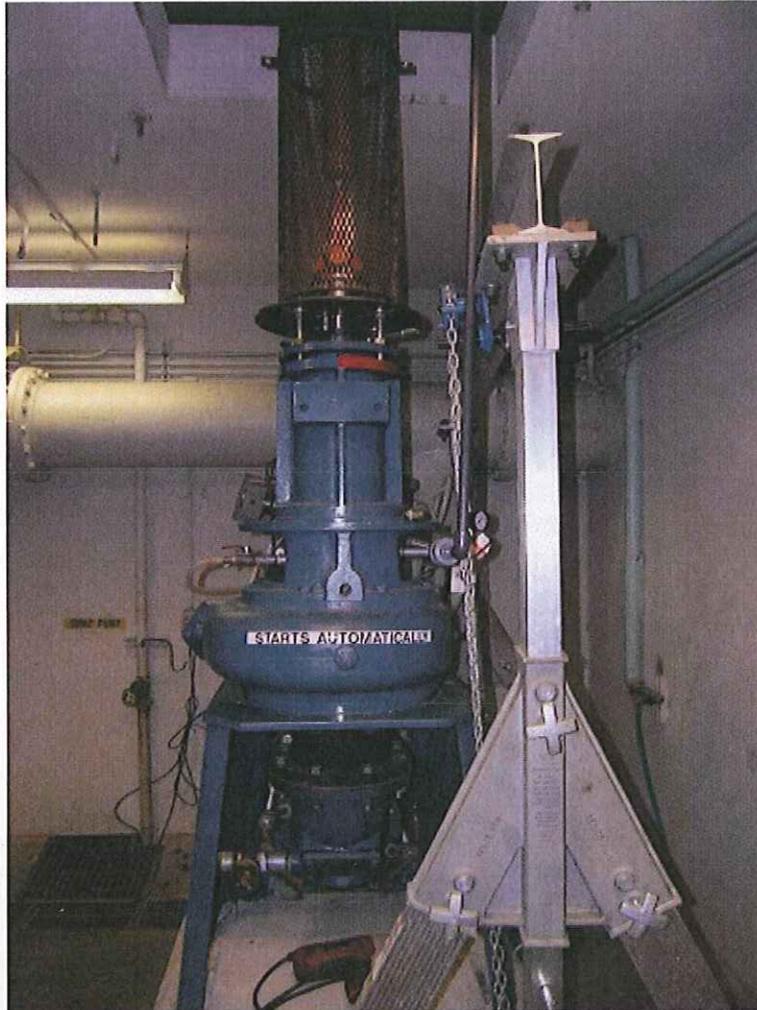
PHOTO NO. 3

Description: New pump at influent diversion station. All pumps in the station now have protective cages around the drive shafts, which were fabricated by plant staff (Dave Worley).

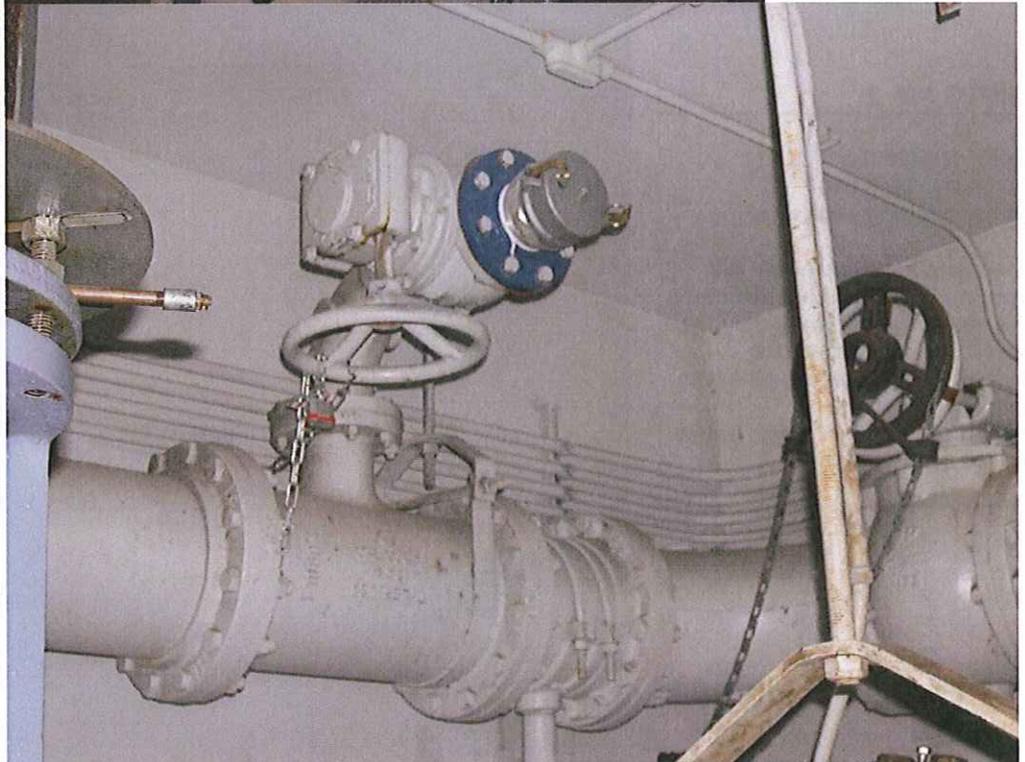
PHOTO NO. 4

Description: Bypass pumping access port in diversion lift station. Port allows for quick connection of a portable pump to the diversion force main. Bypassing with a portable pump is a redundant back-up to be used if there is a complete mechanical failure of all pumps in the lift station or failure of both main power and stand-by power.

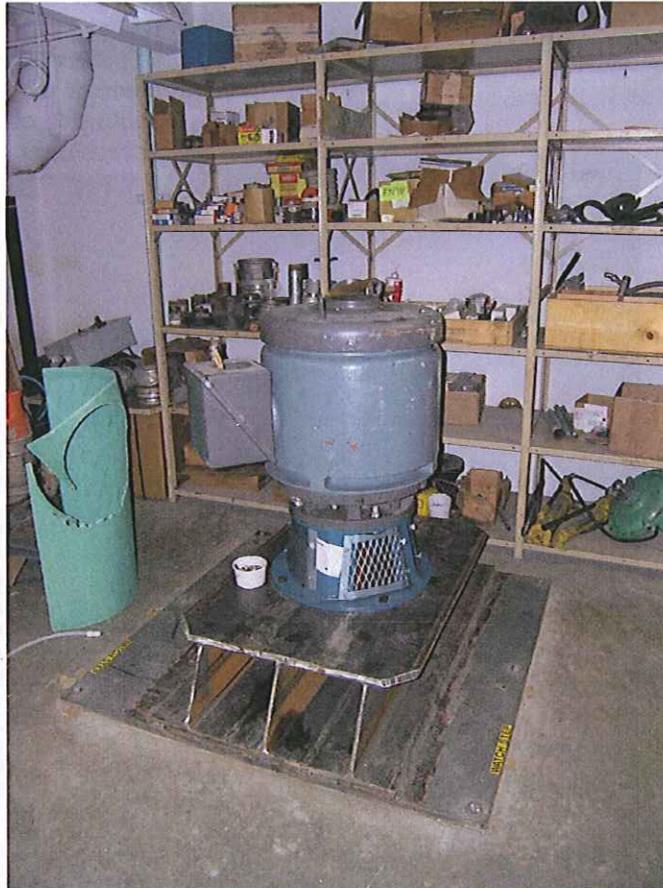
PHOTO NO. 5

Description: Diversion lift station pump motor with new mounting base. Mounting base fabricated by plant staff.

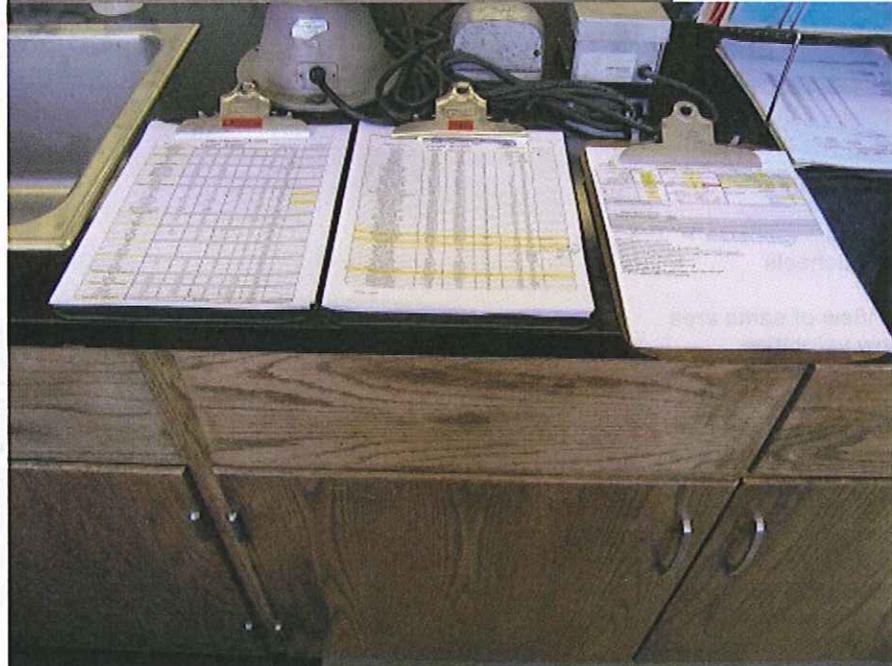
PHOTO NO. 6

City is migrating to electronic record keeping for daily process and equipment checks. To support this effort, new forms have been created for daily data collection (photo 6). The new system, which uses Excel-based spreadsheets, will flag values entered by operators that are outside of expected values. Operators are required to document corrective actions taken for each flagged parameter. If no corrective actions are taken, operators must include some sort of narrative to provide more information about the flag. This system is being used for operations at both the RBC and lagoon facilities.

Description: New daily log forms for plant inspections. Forms identify equipment and systems that require daily checks. Forms are an integral part of the plant's migration to electronic record keeping. Data recorded on the forms during daily checks is transferred into a spreadsheet that will flag values that are out of range and prompt operators to record corrective actions.

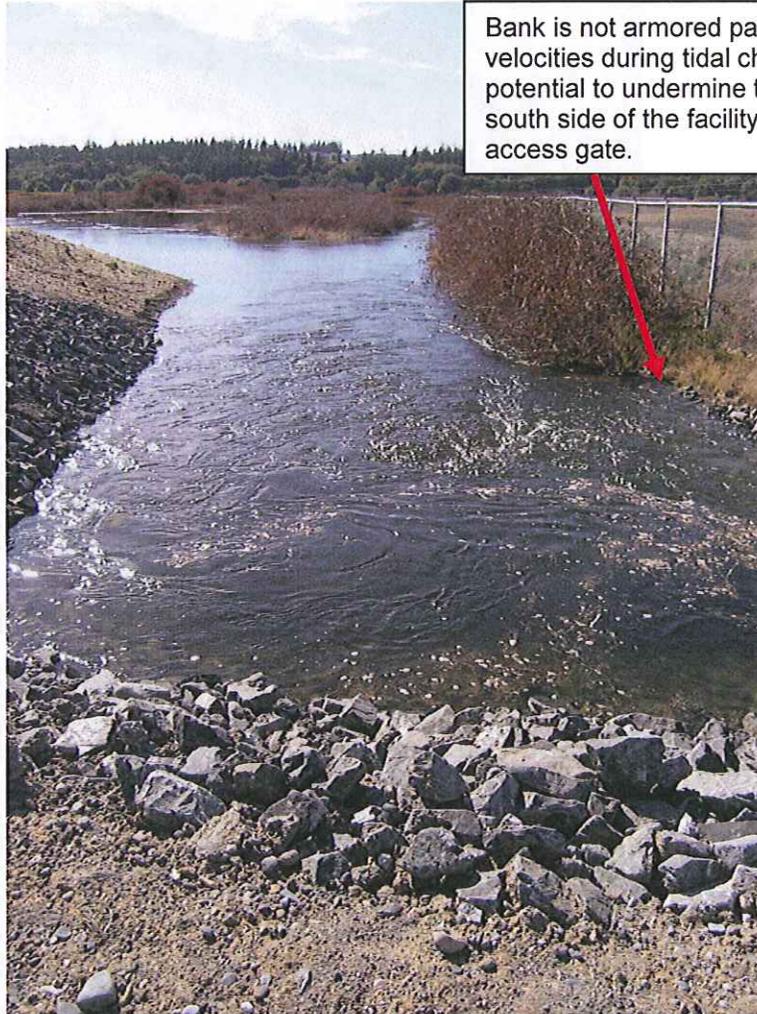
PHOTO NO. 7

Description: Water flowing at high velocity through culvert under access road to lagoon treatment plant. Culvert allows water from newly restored tidal marsh surrounding the lagoon facility to flow to the west side of the access road. High velocities could present a concern for increased scouring around the plant fence line that is not armored with rip rap.

Bank is not armored past this point. High velocities during tidal changes have the potential to undermine toe of dike on the south side of the facility near the plant access gate.

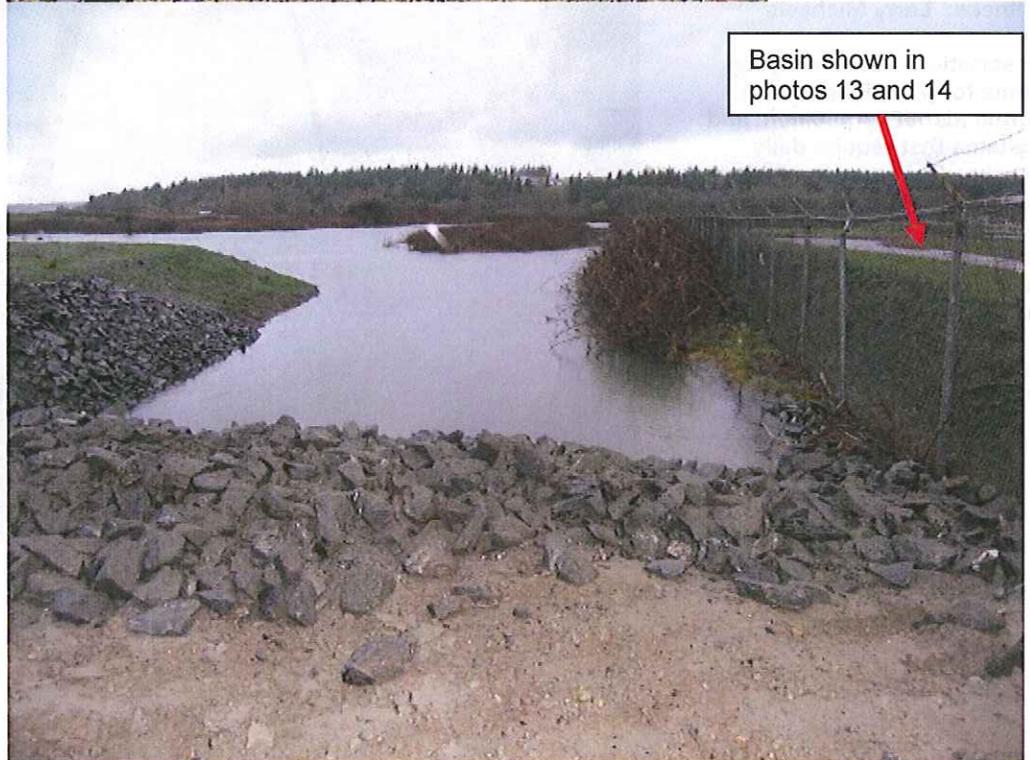
PHOTO NO. 8

Description: View of same area in photo 7. Flow velocities through culvert appear greatly diminished. This is possibly the result of timing (photo taken just after high tide rather than on an incoming tide, which was the case with photo 7). However the Navy added more rip rap along the edge of the access road. Unknown if that rip rap addition resulted in partially blocking the culver opening, thereby helping decrease flow to the west.

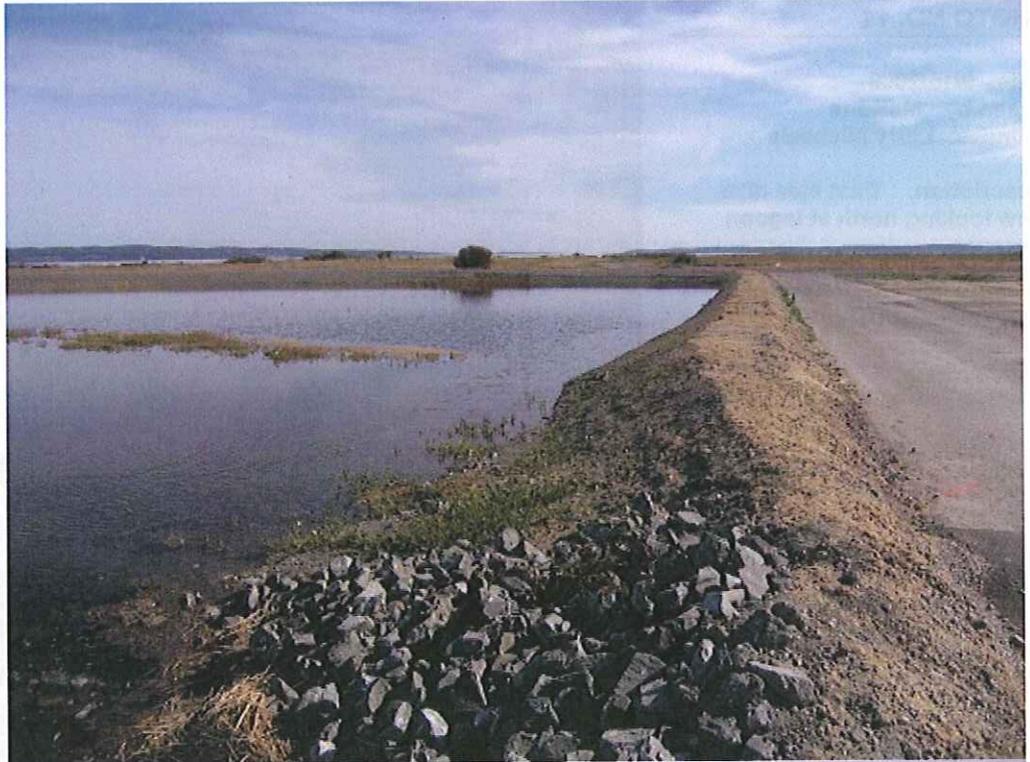
PHOTO NO. 9

Description: Tidal marsh water level on dike next to plant access road. View looking south from plant with Crescent Harbor in background. Tide level at time was approximately 11' 3".

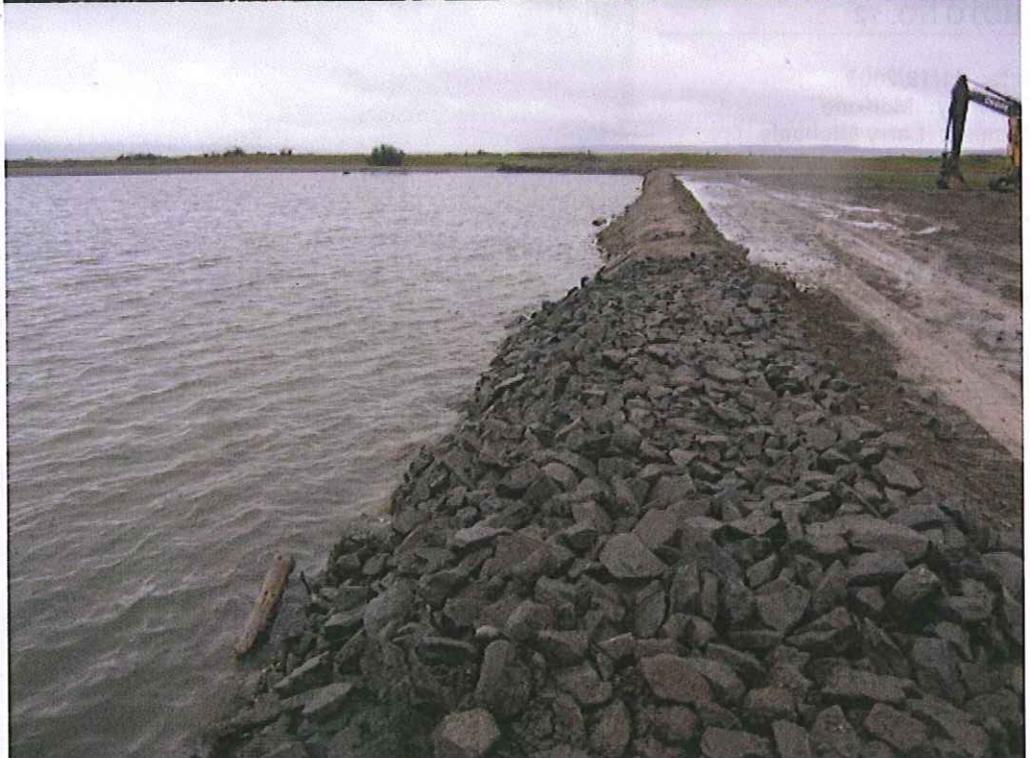
PHOTO NO. 10

Shortly after the restoration project was complete, City staff observed that water level in the marsh during peak high tides was approaching the top of the dike around the facility. This was especially evident at the south end of the facility, closest to Crescent Harbor. At tide levels near 12.5 feet on a calm day with little antecedent rain, water elevations were within 2-5 feet of the top of the dikes (photos 9, 11 and 15). Approximately 2 months later when maximum high tides were near 13.5 feet and there was considerably more upland runoff, water surface elevations were within 1-3 feet of the top of the dike on the south side of the facility (photos 10, 12 and 16). On November 17, 2009, when a high tide of more than 13 feet coincided with a strong storm that brought in heavy rains and high winds, the marsh level overtopped dikes near the roadway leading to the facility causing minor to moderate flooding.

Description: Same view from photo 9 taken at a higher tide level. Tide at the time of the photo was approximately 12' 5". Tide water over-topped the dike in this area and in an area adjacent to the main road (in background) on 11/17/2009 when a tide of 12' 4" coincided with a storm that delivered heavy rain and high southerly winds. Tides in excess of 13.5" are predicted in January and February 2010. Based on conditions observed on 11/19/2009, these tide elevations may be right at the top of the dikes or may overtop the dikes again, especially if an average winter storm occurs at the same time.

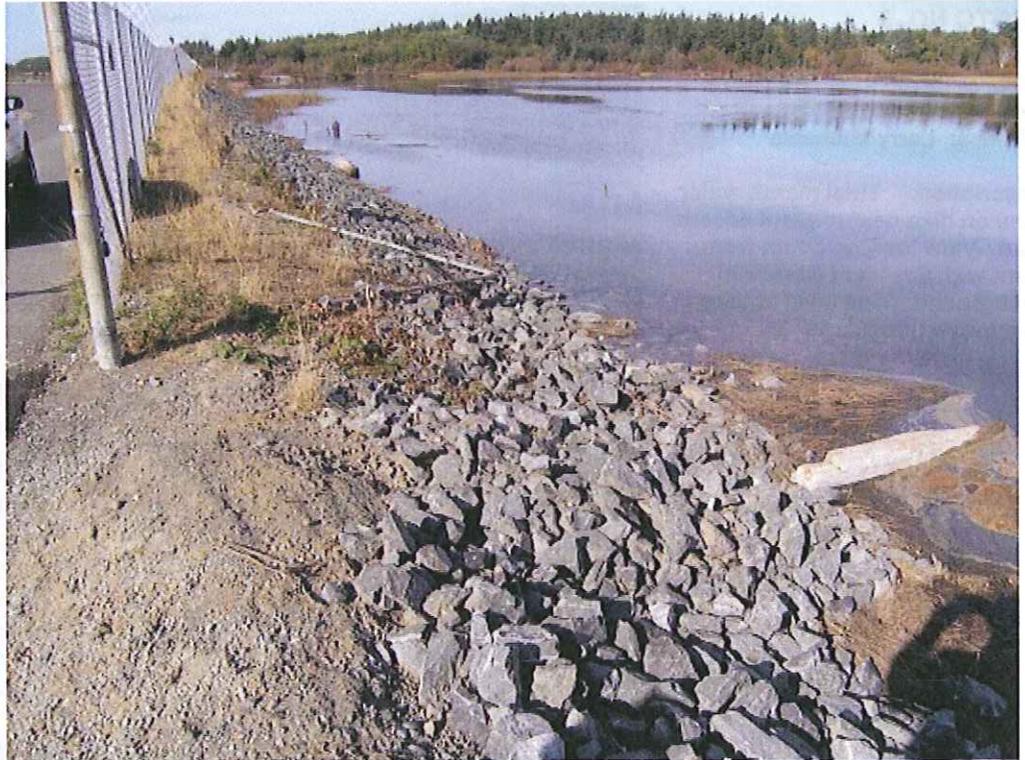
PHOTO NO. 11

Description: East side dike, view looking north at lagoon entrance.

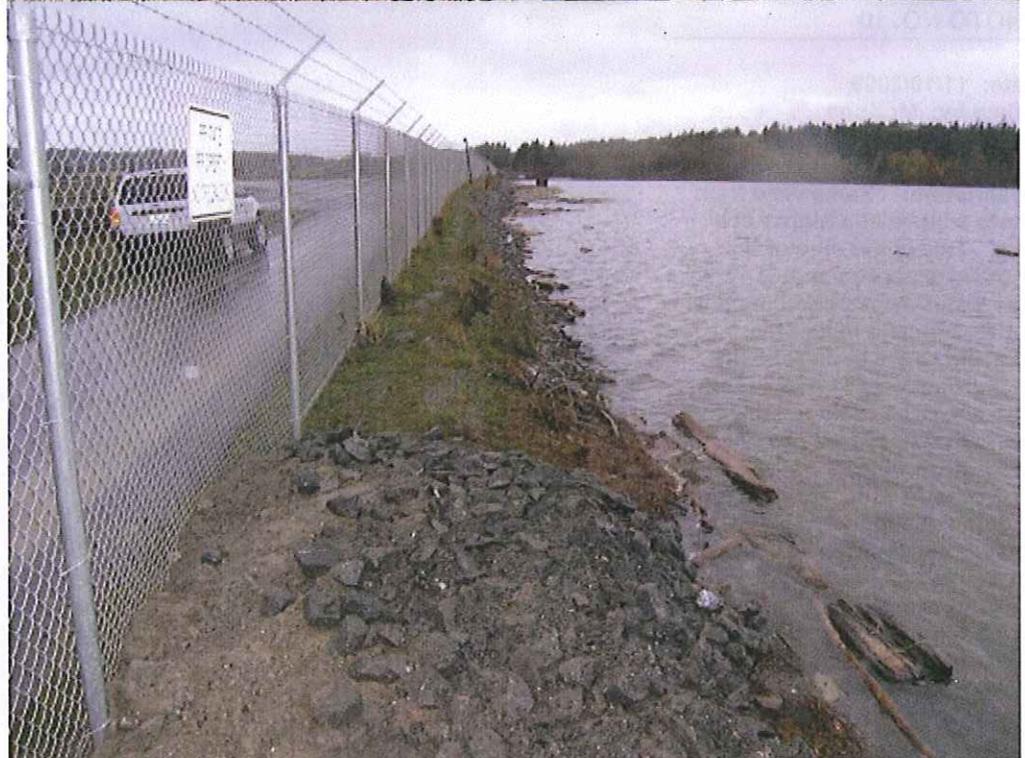
PHOTO NO. 12

Description: Comparison of water level on east side dike. Difference in tide between photo 11 and 12 is a little more than one foot. November condition is also influenced by upland runoff from recent storms.

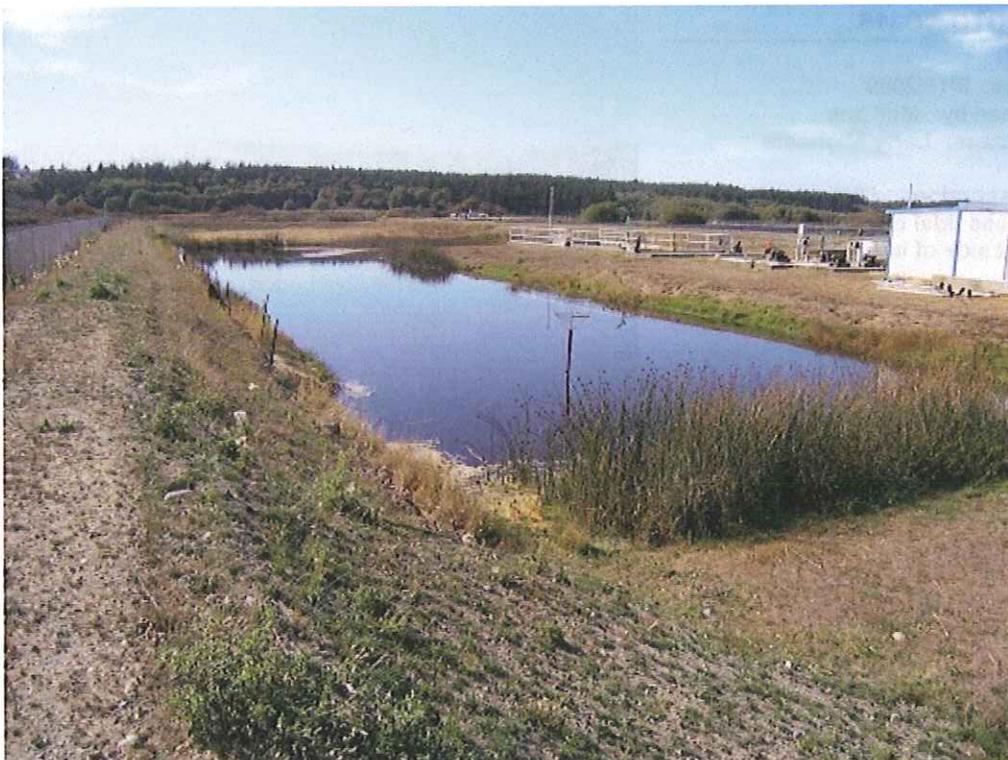
PHOTO NO. 13

to a conveyance line from the Navy's housing. Photos 13 and 14 provide evidence that groundwater levels may have significantly increased around the facility. The facility has an abandoned unlined basin near the plant entrance that generally serves as a stormwater detention pond. According to plant staff, this basin is typically dry in mid-September at the time of the initial site visit. As shown in photo 13, the basin now holds a significant amount of water now that the marsh is flooded. There had not been any significant rainfall prior to the visit that would account for the increase in water in the basin. Photo 14 shows an even larger amount of water now being held in the basin, although there had been significant rainfall that would account for some increase in the storage volume.

Description: Abandoned basin that has traditionally served as a stormwater detention basin. According to staff this basin, which is unlined, is typically dry at this time of year. Presence of such a large volume of water suggest that the marsh restoration has significantly raised the local groundwater elevation . Basin is adjacent to the dike at the entrance to the facility. South side of dike is shown in photos 7 and 8.

Along with concerns over the viability of a future facility, Ecology has concerns about the ability of the current lagoon facility to adequately protect surface water and groundwater quality. There is evidence suggesting that groundwater elevations due to the marsh restoration have risen to a point where there is no longer any separation between the existing lagoon bottoms and seasonal high ground water. Ecology's current design guidance for lagoon facilities requires a minimum 5-foot separation between the bottom of the lagoon and seasonal high groundwater when the lagoons use only a single liner. Given the suspected increased groundwater levels, Ecology will require the City to conduct groundwater quality and groundwater elevation monitoring in the next permit. Monitoring will utilize wells the City established in 2008.

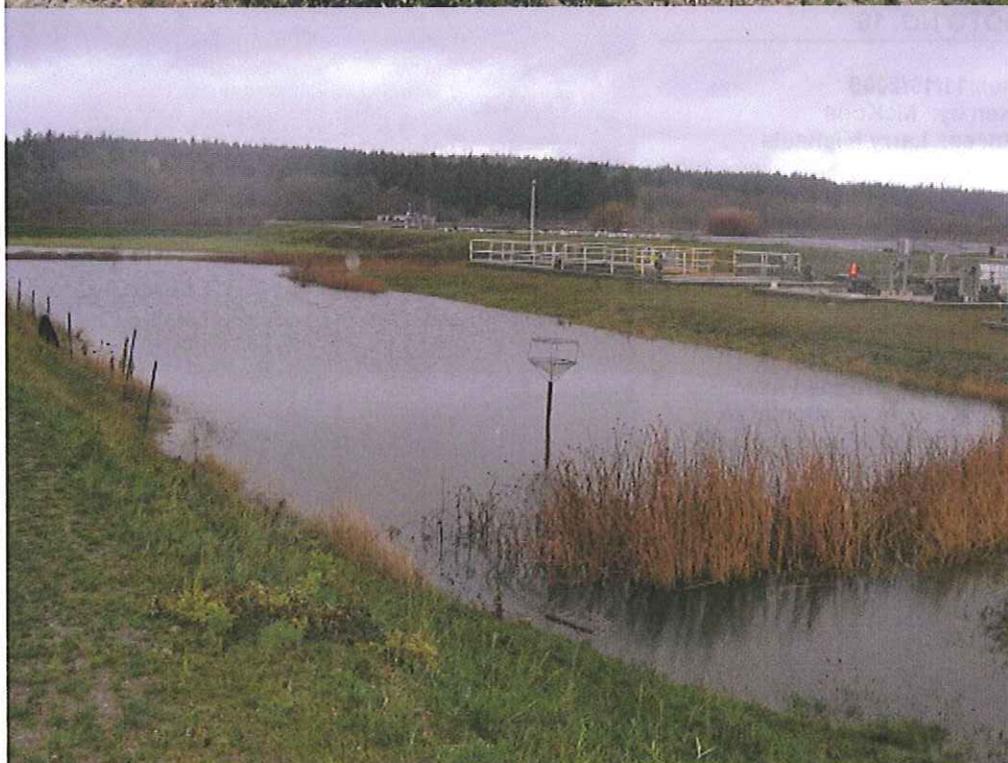
PHOTO NO. 14

Description: Detention basin two months later. Increase in water volume potentially the combined result of stormwater detention from recent storms and continuing increase in groundwater elevations due to marsh flooding.

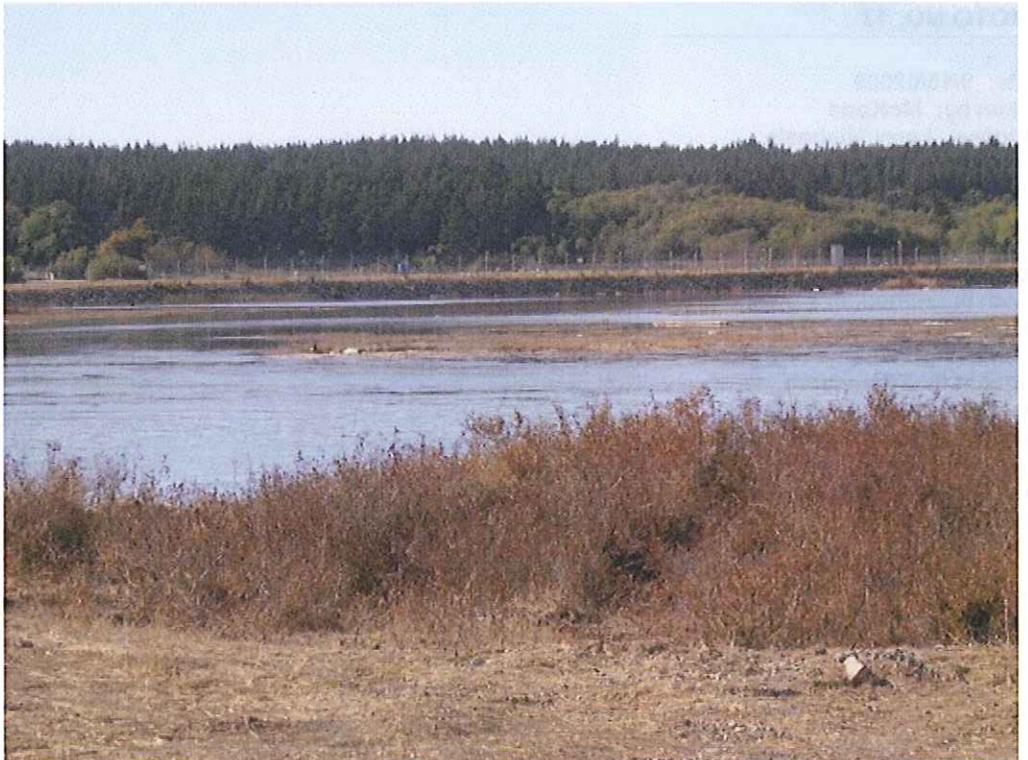
PHOTO NO. 15

Description: Distant view across tidal marsh of dike on east side of lagoon facility.

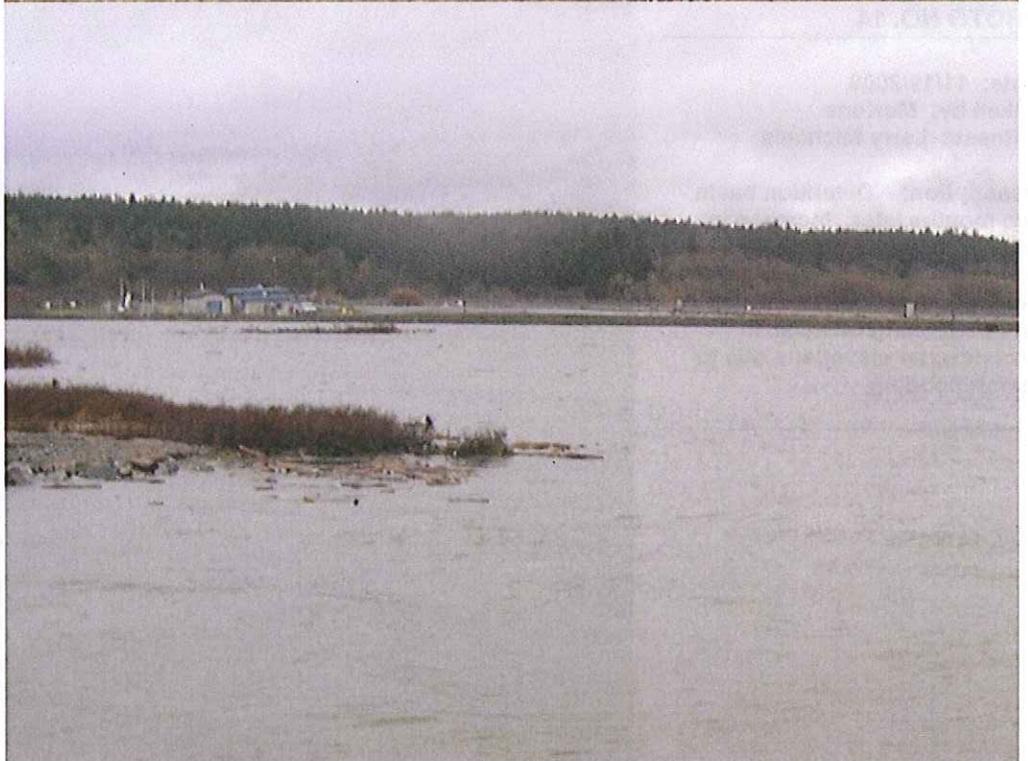
PHOTO NO. 16

Description: East side of lagoon facility. In comparison to photo 15, there is a significant increase in water surface elevation on the dike separating the marsh from the lagoons.

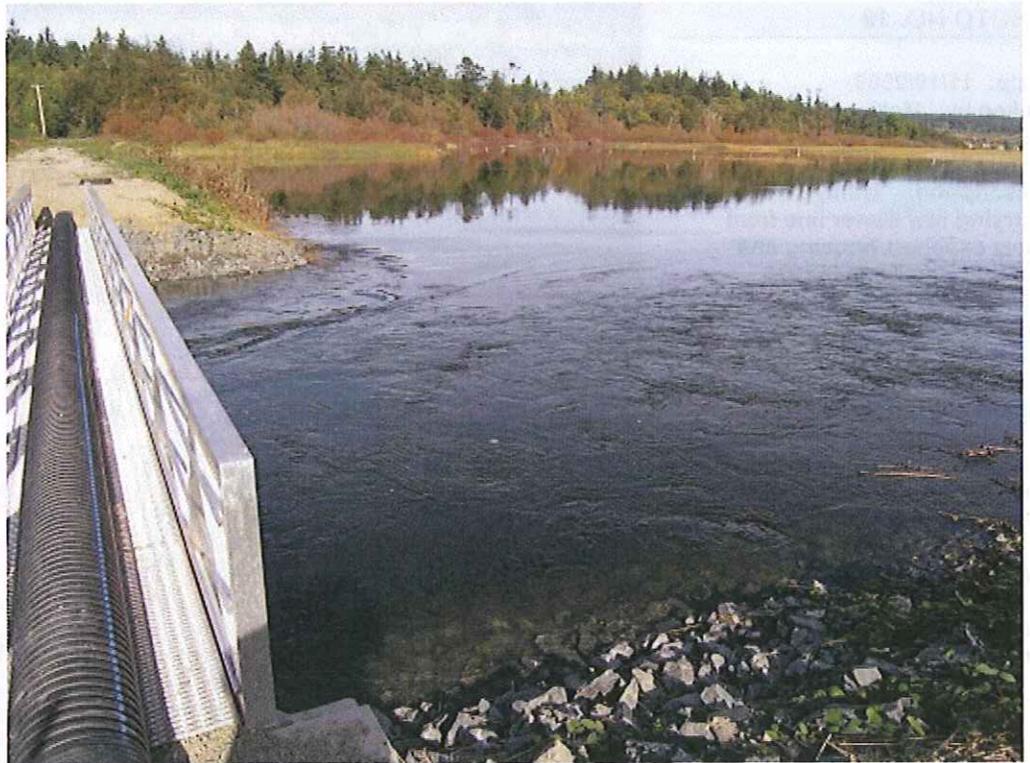
PHOTO NO. 17

A significant concern resulting from the restoration project involves the increase in risk to a sewer conveyance line that is owned by the Navy and discharges to the lagoon facility (photos 17-20). The line, which serves the Navy's Capehart housing area northeast of the treatment plant, runs through an old dike that cuts across the marsh area and connects to the lagoon facility at its northeast corner. The restoration project required that the dike be partially removed to allow water to flow to the northwest portion of the marsh. The pipeline in the area where the dike was removed is now suspended over a channel by a small bridge; there are also 2 new manholes installed on either side of the bridge. Water now flows under the bridge through the relatively narrow cut in the dike at fairly high velocity (photo 17). This high velocity increases the potential for bank erosion of portions of the old dike near the cut that were not armored (photo 18). The erosion puts the new manhole on the upstream side of the pipe at risk of failure due to loss of supporting material. There is also minor evidence of soils supporting the bridge footing on the southwest end of the bridge being washed away at high tides (photo 20). Finally, as evident by debris on the bridge (photos 18 and 19), the bridge deck becomes submerged when tides are at or above 13.5 feet will, placing the line at further risk.

Description: Marsh channel on northeast corner of lagoon facility. The restoration project required removal of a culvert and a portion of an existing dike through the area. The old dike was used as a utility corridor for a raw sewage line from the Navy's capehart housing. A potable water line for the treatment plant also runs through the dike. A small bridge was installed across the cut in the dike to carry the Navy's sewer line and the potable water line. Due to the high volume of tide water now flowing through the relatively narrow cut, velocities through the channel can be very high.

Along with the increased groundwater elevations, risks to the Navy's Capehart sewer line due to changes in the marsh near its route has increased the potential for that line to discharge raw sewage into surface waters. Although the Navy is ultimately responsible for this line and for any discharges that may result from failure of the line, the City has an obligation to take reasonable steps to alert the Navy to the potential hazards. Ecology will work with the City and the Navy as needed to minimize the potential discharge risk of this line.

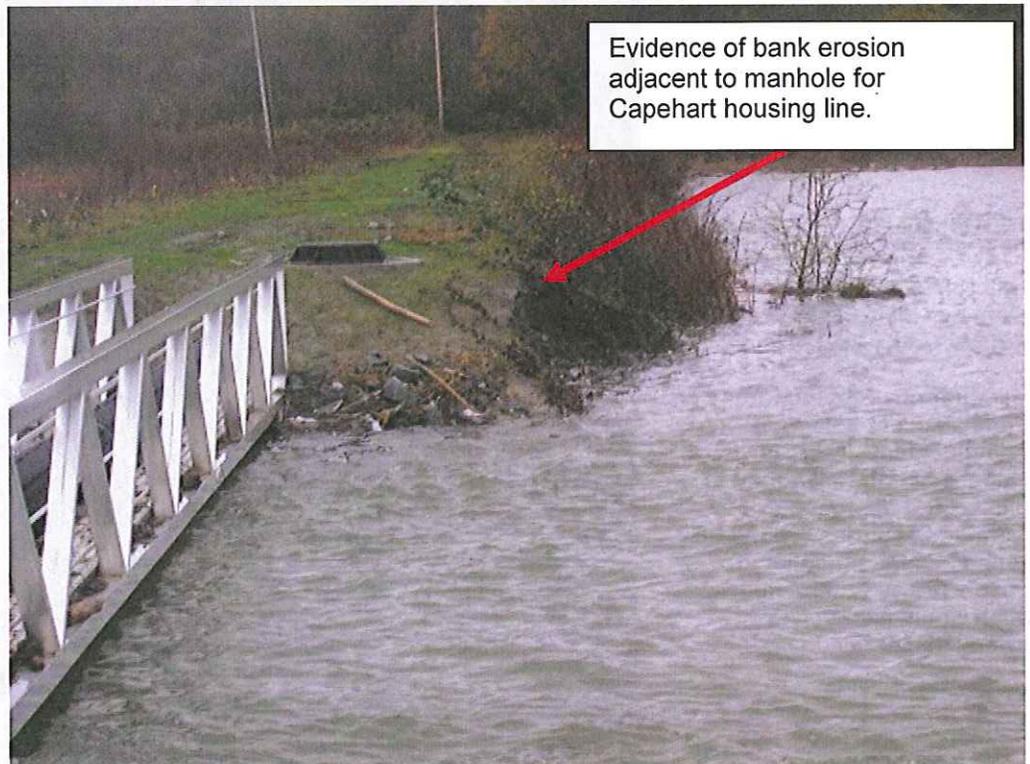
PHOTO NO. 18

Description: High flow velocities entering the new cut in the utility dike appears to be leading to significant bank erosion on the northeast side of the dike. Continued erosion of this bank has the potential to lead to undermining of the sewer manhole on the upstream side of the capehart line. Note also that the water surface at this tide condition is right at the bottom of the utility bridge. (photo lighting adjusted from original)

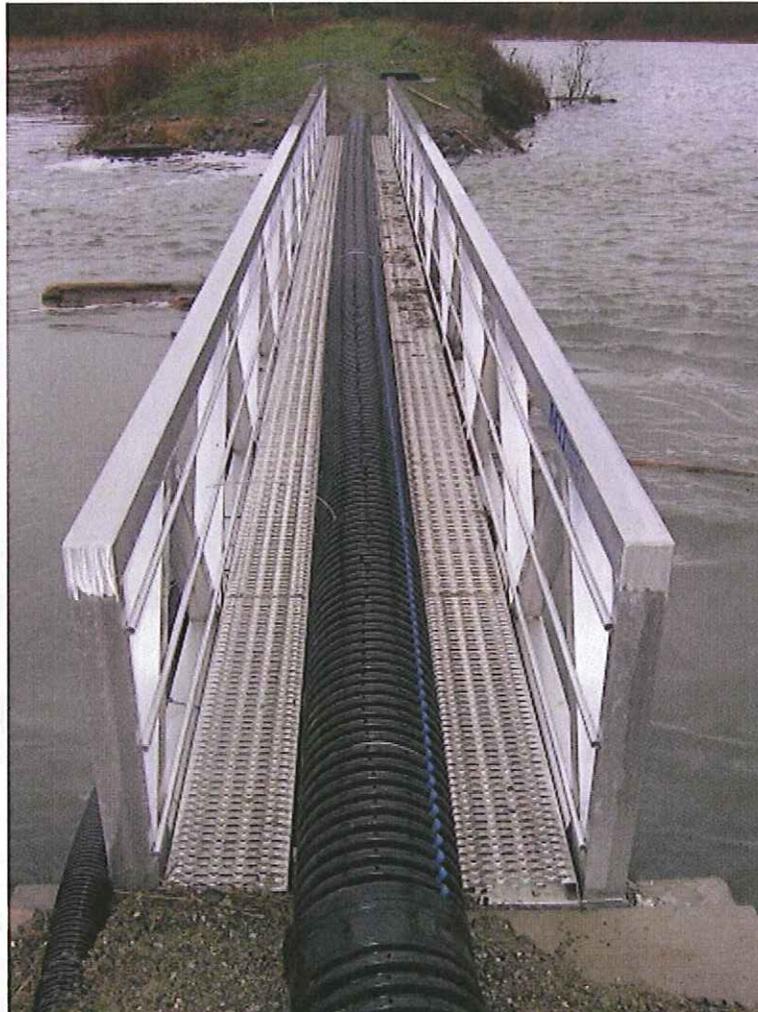
PHOTO NO. 19

Description: Utility bridge carrying raw sewer line from Navy capehart housing and potable water line for the treatment facility. Debris on bridge surface indicates that water elevation had been high enough to inundate the bridge. In addition, large driftwood becomes hung up on the bridge during high tides. The fact that this bridge has little or no separation with surface water at high tides indicates a significant risk for this bridge to fail, which would result in discharge of raw sewage and a loss of water necessary for plant operations.

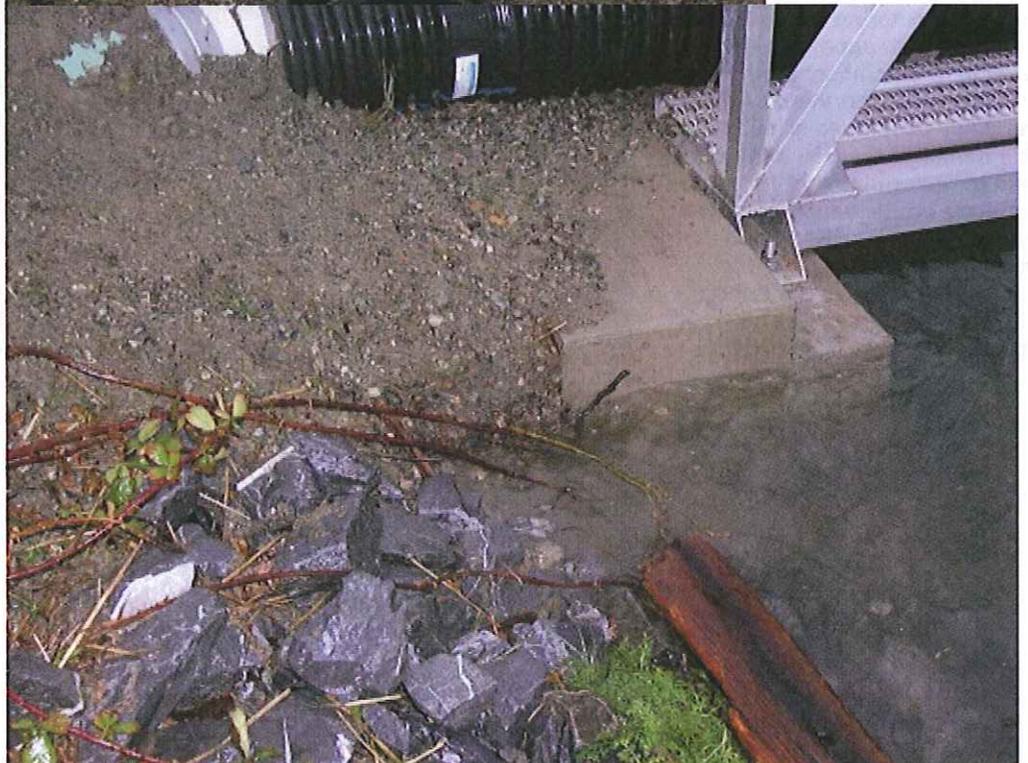
PHOTO NO. 20

Description: Footing for utility bridge adjacent to lagoon treatment plant. There is visual evidence of minor scouring of soils behind the footing. Continued scouring around this footing has the potential to cause a failure of the bridge, which would lead to a raw sewage discharge.
