Permit Compliance Inspection Report

Water Quality Program

Facility Name and Address: Burlington Lumber Facility
14353 McFarland Rd
Mount Vernon, WA 98273

Permit Number: WAR007765

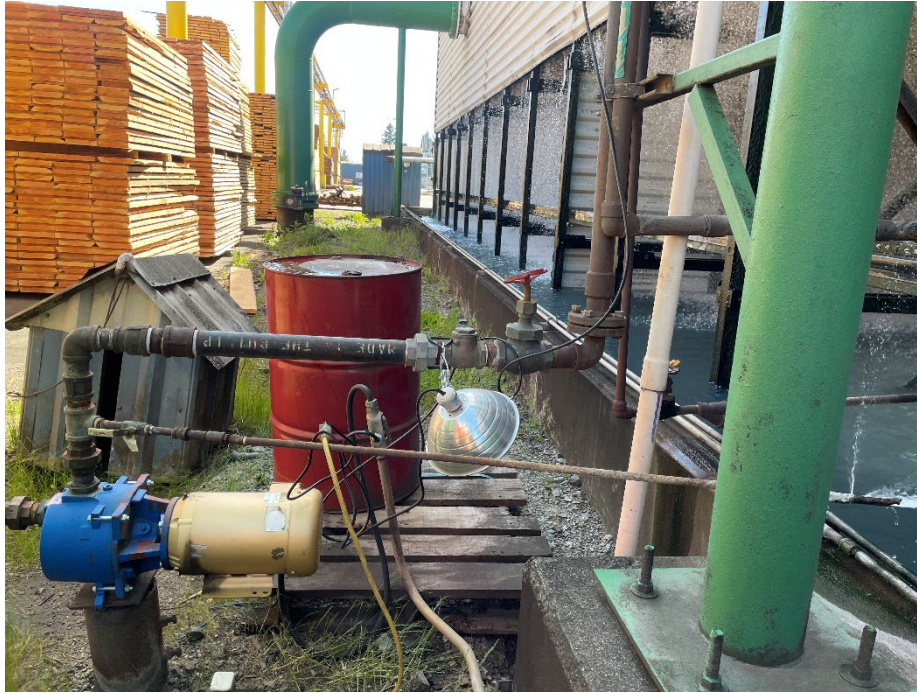
Photo 1 [IMG_0993]

- Multiple containers of chemicals and petroleum products stored outside without cover or secondary containment (Photos 1-13). One international bulk container (IBC) tote in the eastern equipment storage yard was missing the entire top and it was full of brown liquid (Photos 11-12).

Description: 55-gallon drum labeled 'turbine oil' stored without cover or secondary containment near the cooling tower. Photo faces south.

- 1) Provide cover and secondary containment for all chemical containers stored outside, as well as inside where a leak or spill could flow outside through a doorway, or get tracked out by equipment, in accordance with ISGP Condition S3.B.1.4.b.i.4.

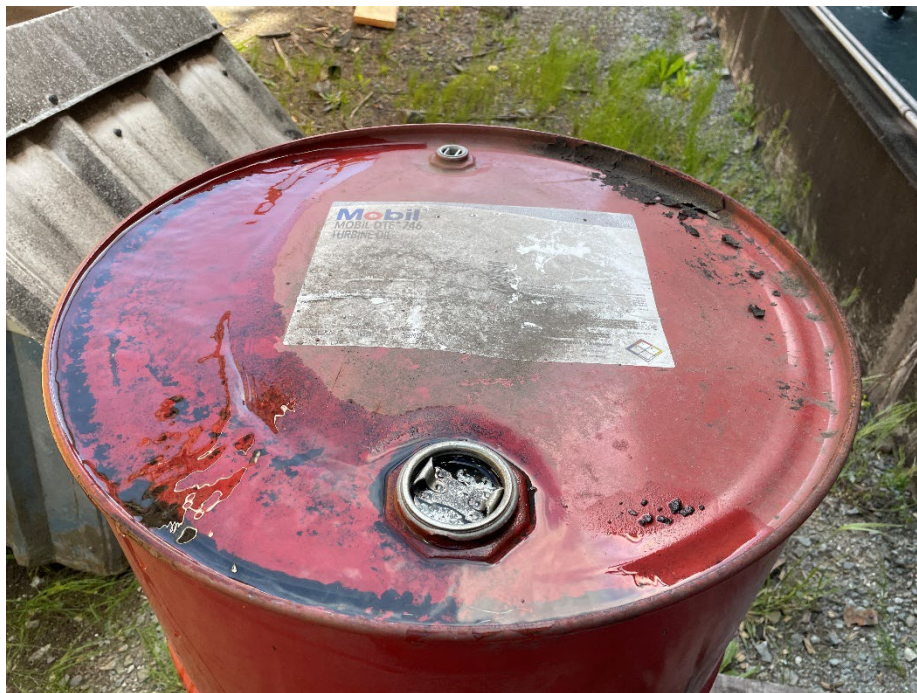
Photo 2 [IMG_0994]

Description: Label for 'turbine oil' on 55-gallon drum shown in Photo 1.

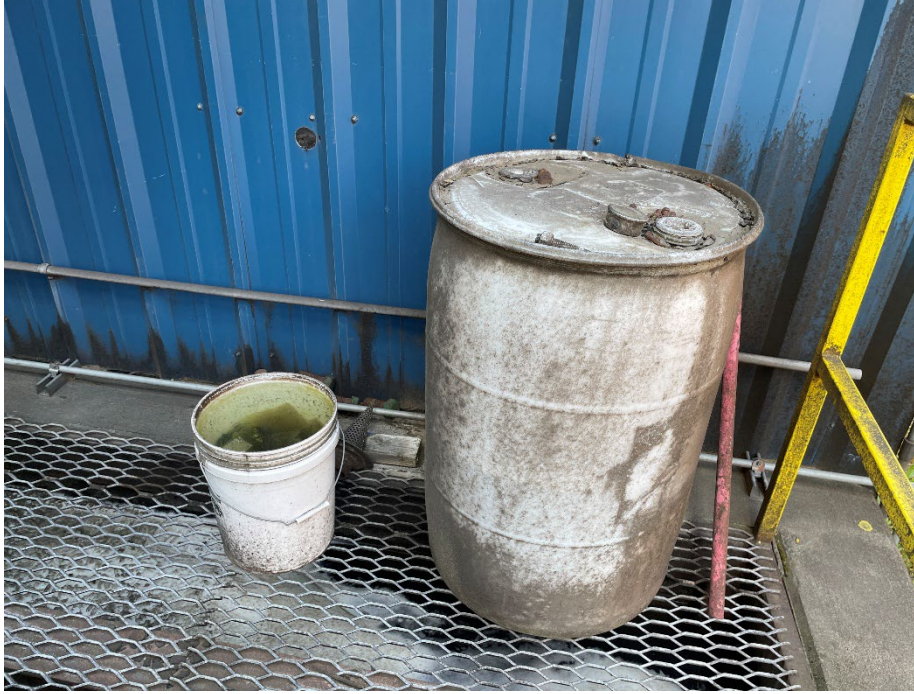
Photo 3 [IMG_0995]

Description: Unlabeled 55-gallon drum and open bucket, both containing unknown liquid, stored without cover and secondary containment near the cooling tower.

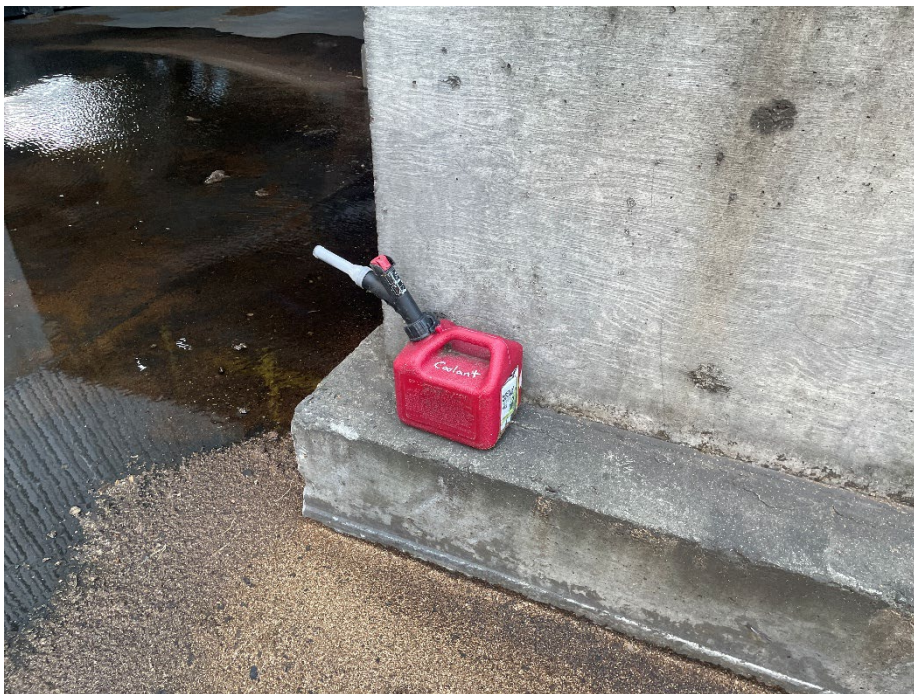
Photo 4 [IMG_1004]

Description: Fuel can stored outside without cover or secondary containment near the cogeneration plant.

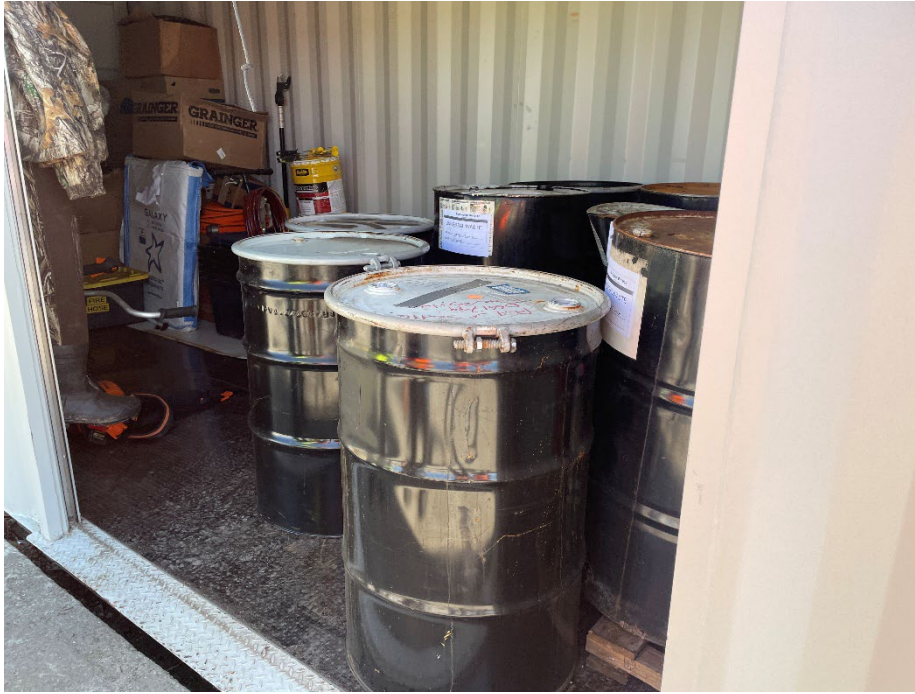
Photo 5 [IMG_1015]

Description: Multiple 55-gallon drums of Universal Waste, including oil water mixtures, stored without secondary containment in a shed in the southeast side of the facility.

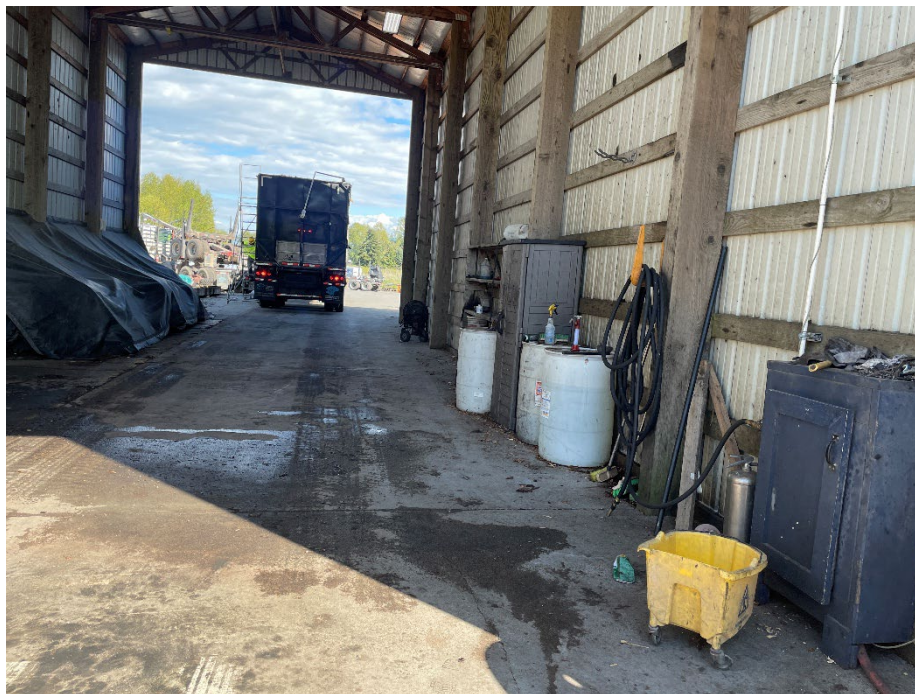
Photo 6 [IMG_1022]

Description: Three 55-gallon plastic drums of truck wash product stored without secondary containment in one of the truck wash racks.

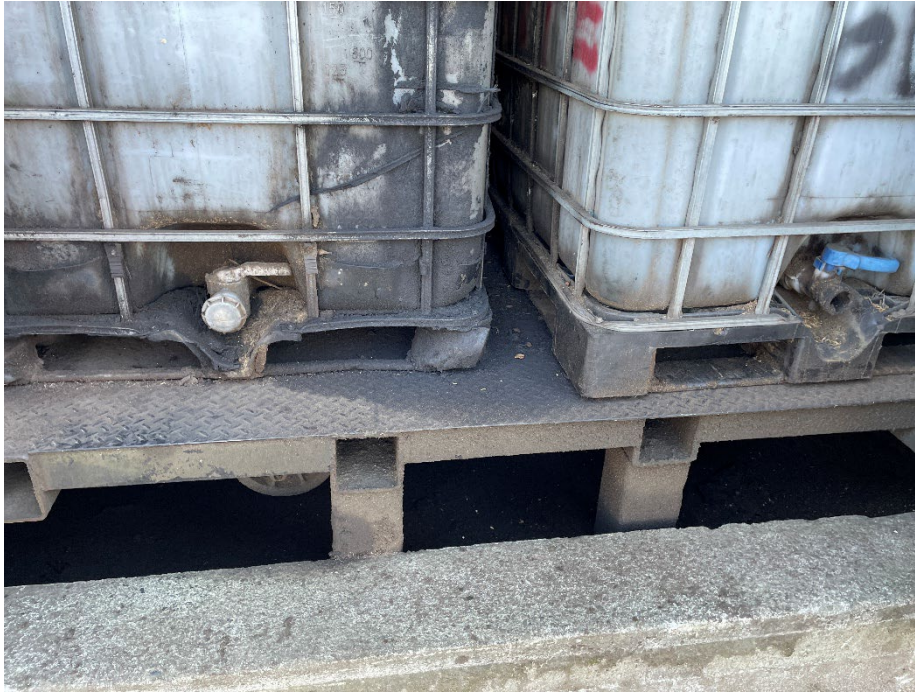
Photo 7 [IMG_1018]

Description: IBC totes on a solid metal platform over secondary containment in the diesel storage area. The platform extends almost to the edge of the containment, so a spill/leak may not drain into the secondary containment sump.

- Properly manage and/or dispose of liquids in the totes in the east laydown yard.
 - In the diesel/gas/oil storage area, modify the steel platform on both sides so that a leak or spill would flow into the containment instead of off the side.

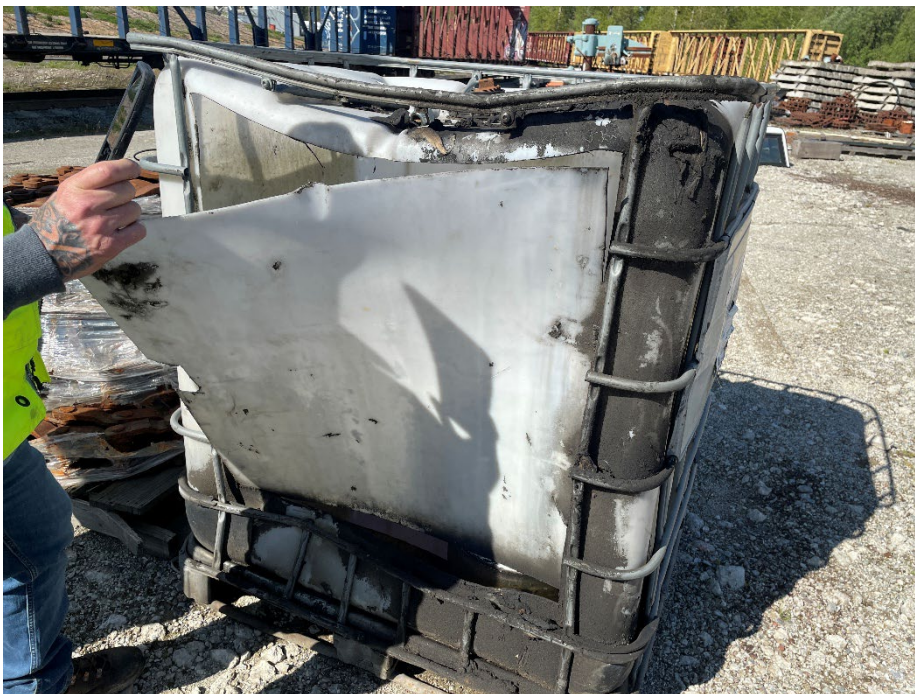
Photo 8 [IMG_1033]

Description: IBC tote with a cut open side, labeled 'saw guide oil,' stored on the ground without cover or secondary containment in the eastern equipment storage yard.

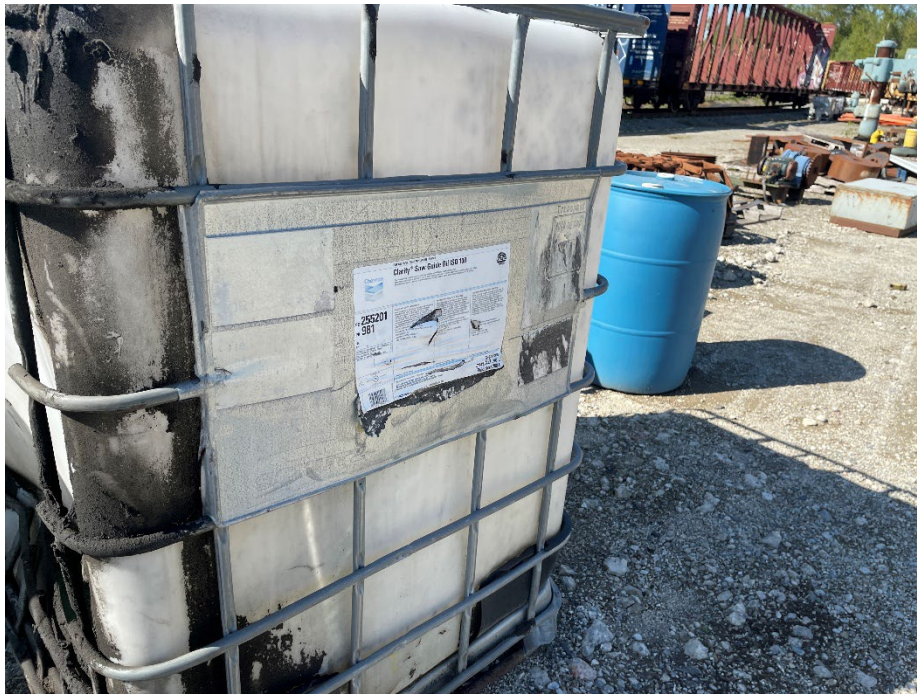
Photo 9 [IMG_1034]

Description: Label for 'saw guide oil' on the IBC tote shown in Photo 8.

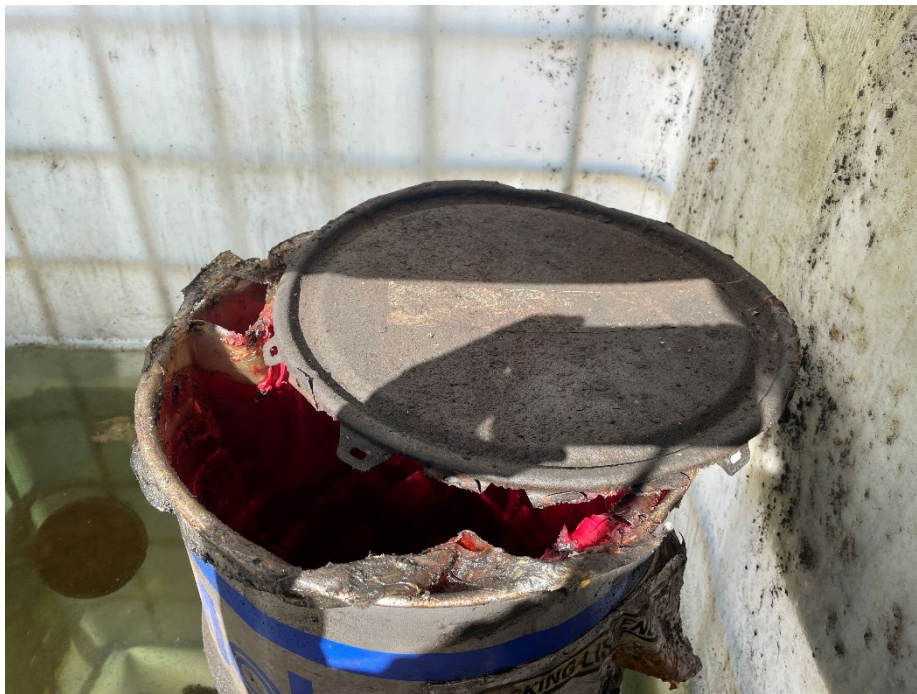
Photo 10 [IMG_1035]

Description: Open drum of grease stored inside the open IBC tote shown in Photos 8-9. Water was accumulated at the bottom of the tote.

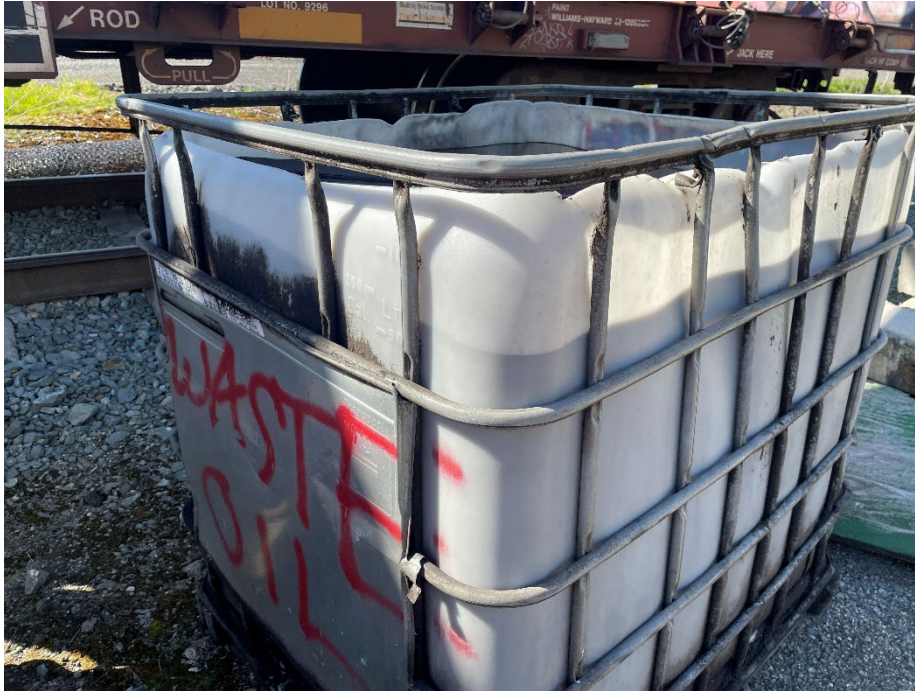
Photo 11 [IMG_1036]

Description: Tote with open top labeled 'waste oil' and full of brown liquid, stored on the ground without cover or secondary containment in the east laydown yard.

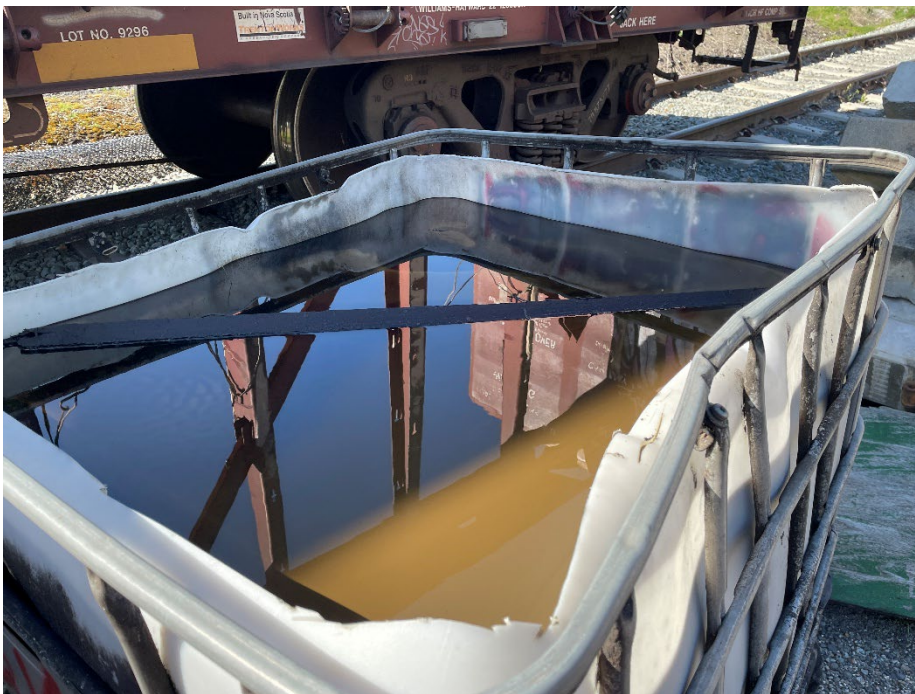
Photo 12 [IMG_1037]

Description: View of brown liquid in the tote shown in Photo 11.

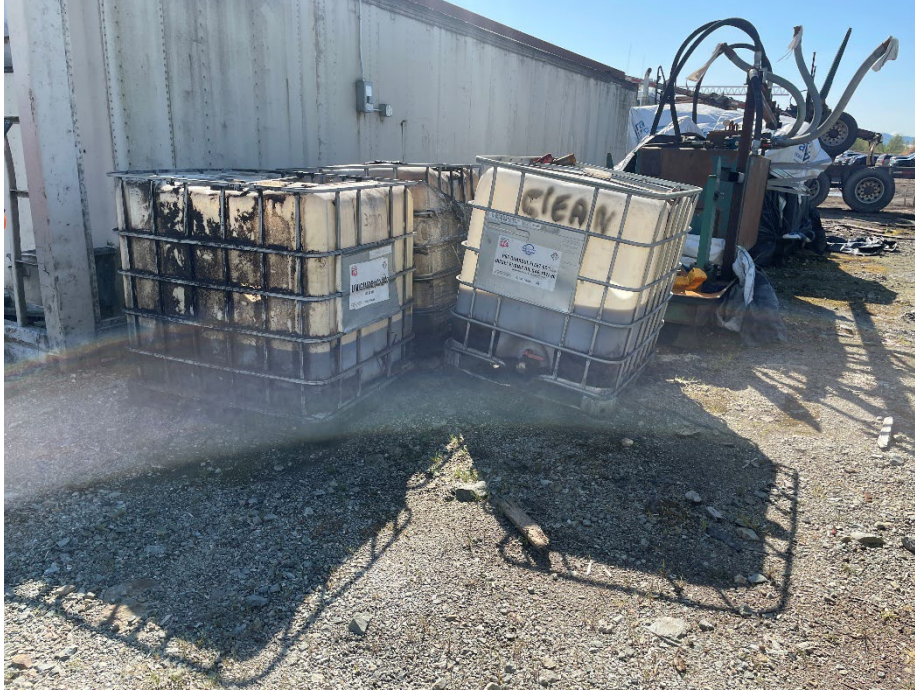
Photo 13 [IMG_1041]

Description: Three totes in the east laydown yard, partially full of dark-colored liquid, stored on the ground without cover or secondary containment. Totes are labelled 'diesel engine oil.' Photo faces west.

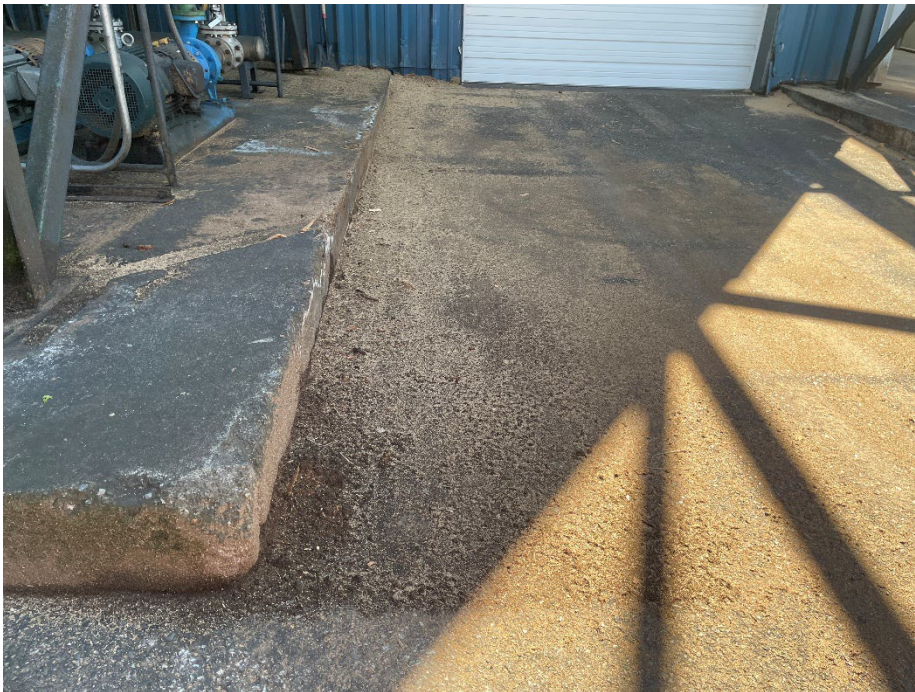
Photo 14 [IMG_0996]

- Much of the main yard was well swept, but a few areas had significant accumulated saw dust, wood chips, and sediment, including north of the Fuel House (Photos 14-16), around a catch basin in the south of the main yard (Photo 17), and on McFarland Road at the northeast side of the site (Photo 18).

Description: Hog fuel and sawdust accumulated on the ground north of the fuel house.

- Maintain facility buildings and fencing to prevent the escape of wood chips, saw dust, etc.
 - Increase sweeping north of the Fuel House and a few other spots with accumulated sediment and saw dust noted in this report.

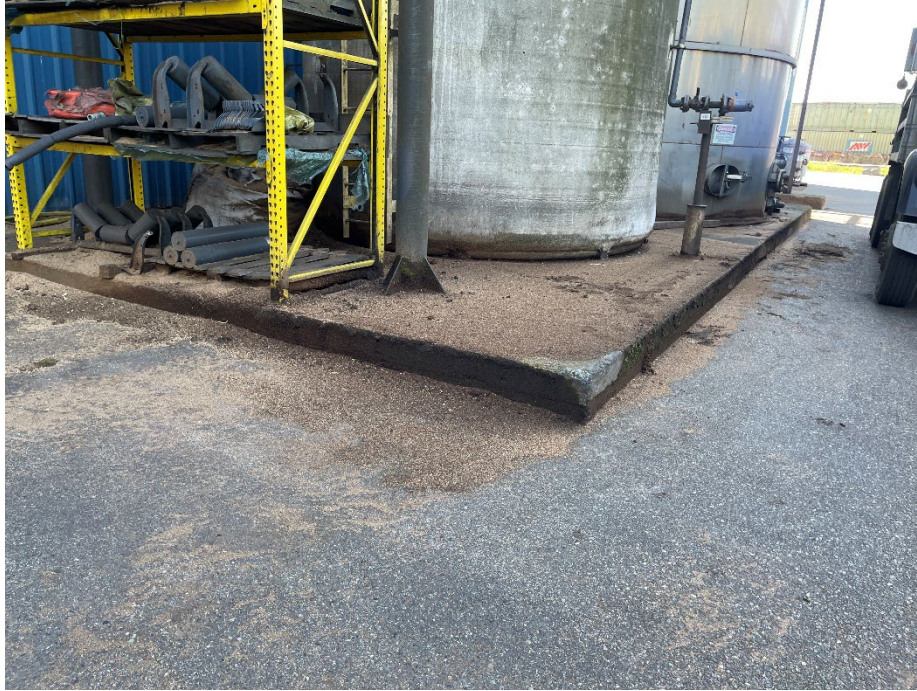
Photo 15 [IMG_1002]

Description: Hog fuel and sawdust accumulated on the ground north of the fuel house. Photo faces west.

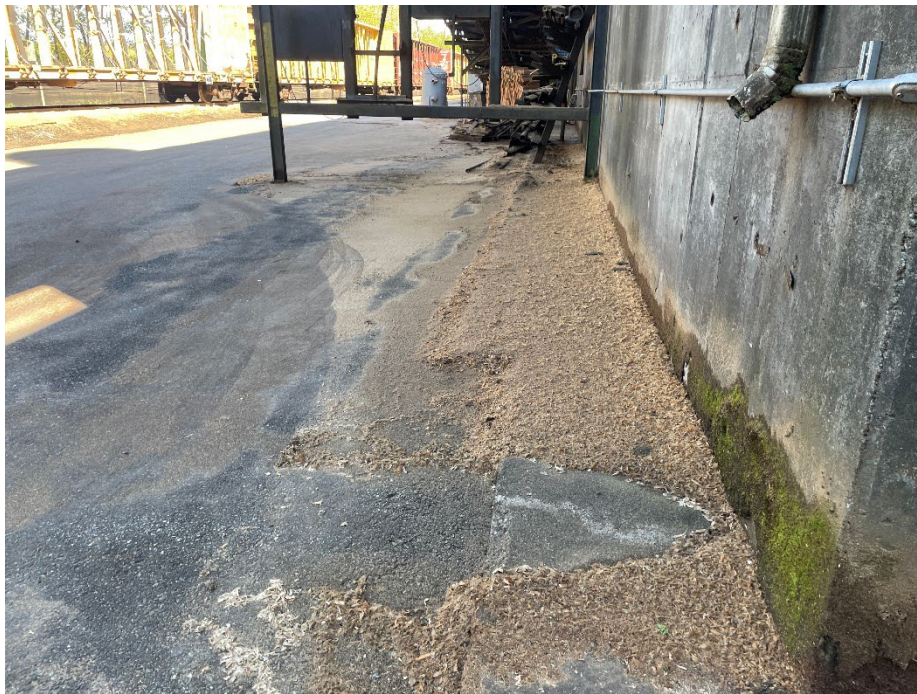
Photo 16 [IMG_1005]

Description: Hog fuel and sawdust accumulated on the ground north of the fuel house. Photo faces east.

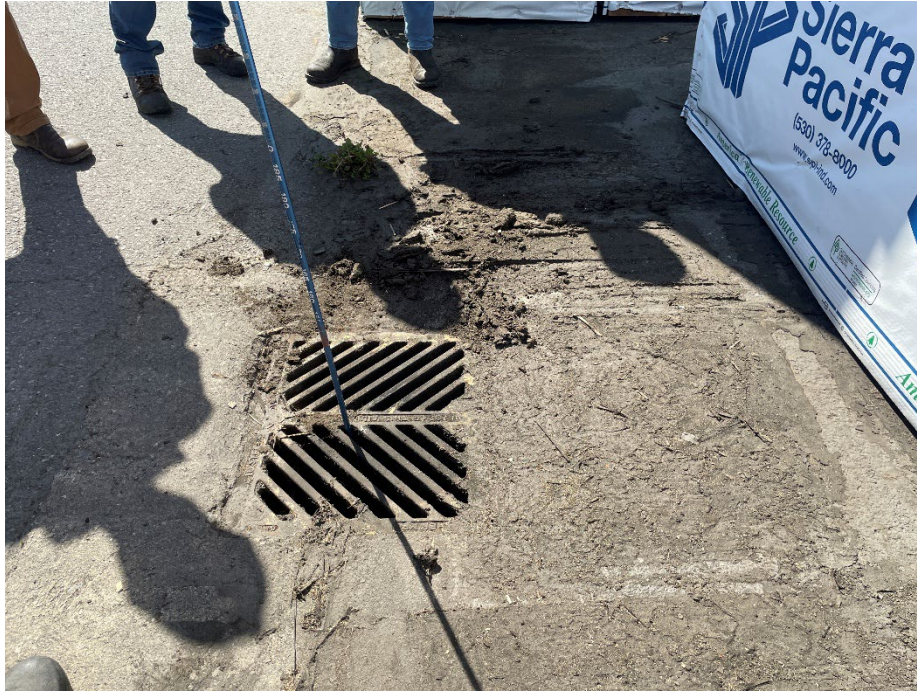
Photo 17 [IMG_1012]

Description: Sediment accumulated around catch basin at the south side of the site.

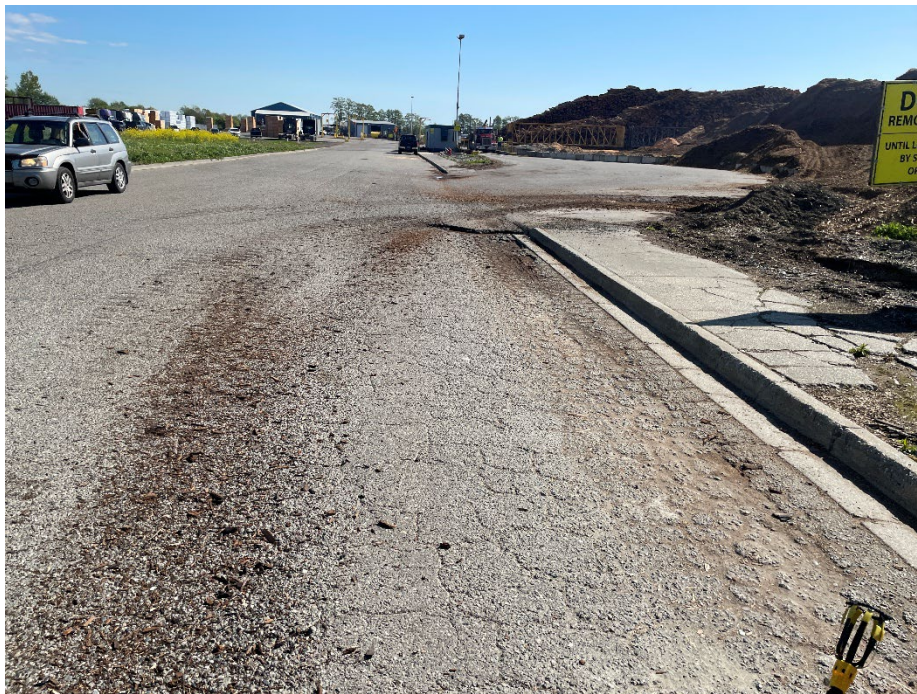
Photo 18 [IMG_1032]

Description: Wood chips scattered across pavement on McFarland Road at northeast side of site. Photo faces south.

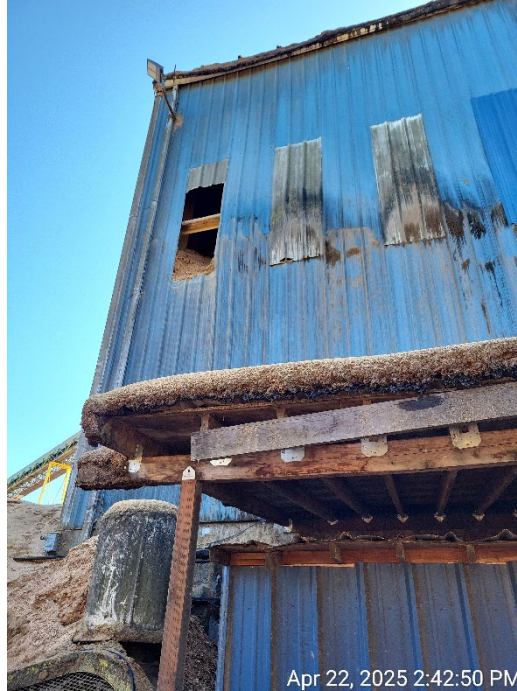
Photo 19 [IMG_144250]

- The Fuel House walls on the north side of the building had multiple gaps and, on the east side, one panel was completely missing, allowing significant hog fuel to escape the building and accumulate outside to the north of the building (Photos 19-20). A wooden fence on the north side of the chip pile was broken, allowing hog fuel to accumulate on the ground north of the fence (Photo 21).

Description: Missing panel on the north side of the Fuel House through which hog fuel had spilled out of the building, as shown in Photo 20. Photo by Jamie Halpin. Photo faces south.

- 4) Implement and maintain good housekeeping in accordance with ISGP Condition S3.B.4.b.i.2, including the following:
 - Repair the north and east sides of the Fuel House and nearby wood fence to eliminate hog fuel from escaping the area.

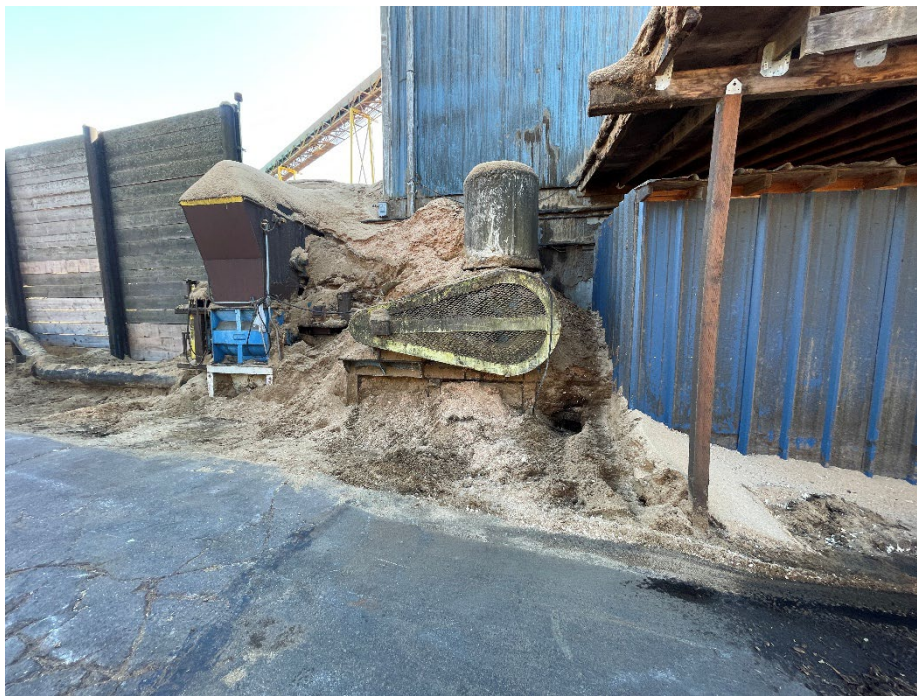
Photo 20 [IMG_1008]

Description: Accumulated hog fuel below the missing side panel to the Fuel House shown in Photo 19. Photo faces south.

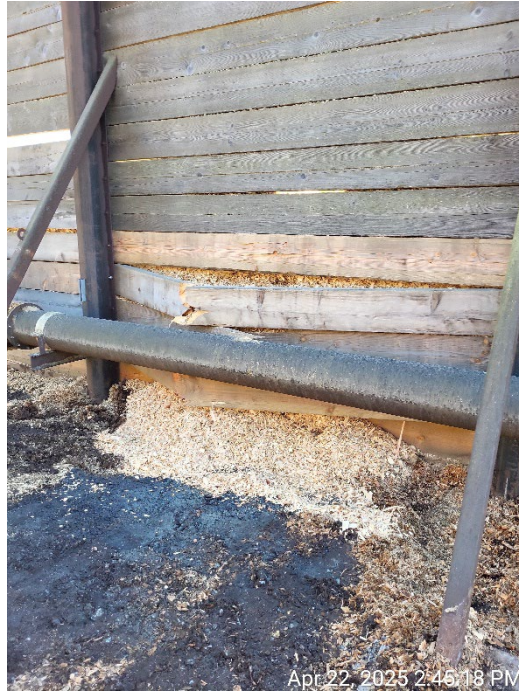
Photo 21 [IMG_144518]

Description: Broken fence panel at fence north of chip pile, east of Fuel House. Chips were spilling through broken section. Photo faces south. Photo by Jamie Halpin.

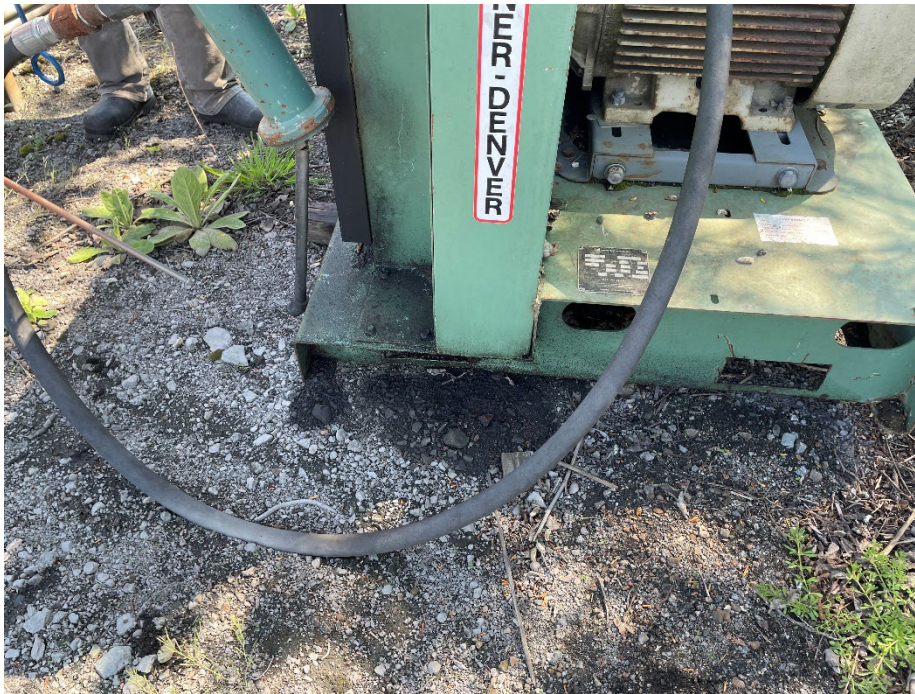
Photo 22 [IMG_0990]

- Two dark stains on the ground in the western gravel equipment storage yard, one of which was under an air compressor (Photos 22-23).
 - Multiple small spills on concrete next to the diesel storage area in the southeast of the facility (Photo 24).

Description: Dark stain on the ground underneath an air compressor stored in the western equipment storage yard.

- The facility sent photos of this correction on 4/25/2025.
- 3) Clean up spills/leaks immediately in accordance with ISGP Condition S3.B.4.b.i.3.d, including the stains on the ground in the east equipment storage yard and on the concrete next to the diesel storage area. For the spills to ground, follow the guidance in Ecology's [Small Spills to Soil](#) focus sheet, sent with this report.

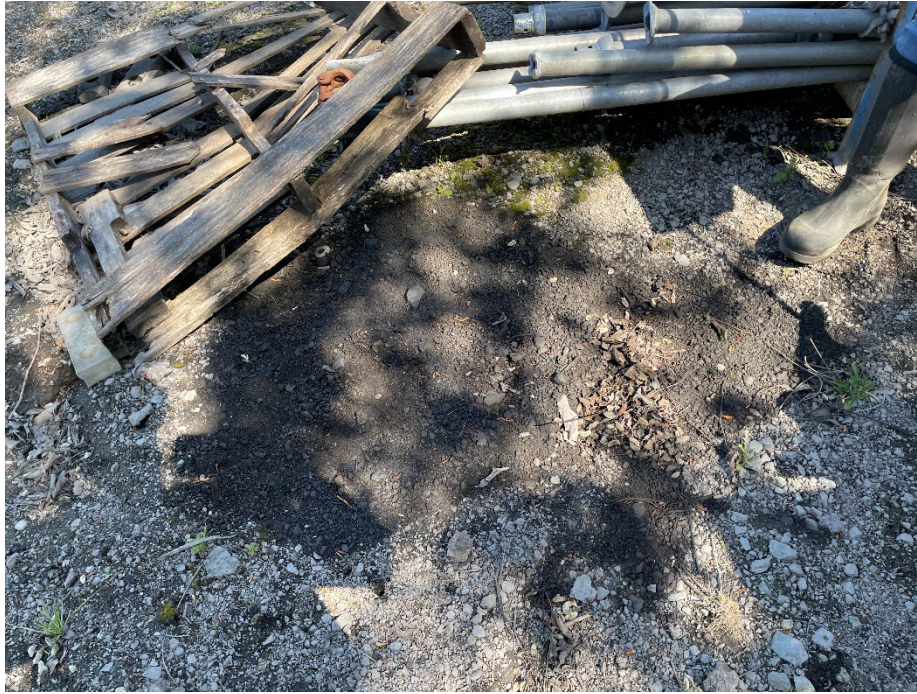
Photo 23 [IMG_0991]

Description: A second dark stain on ground in the western equipment storage yard.

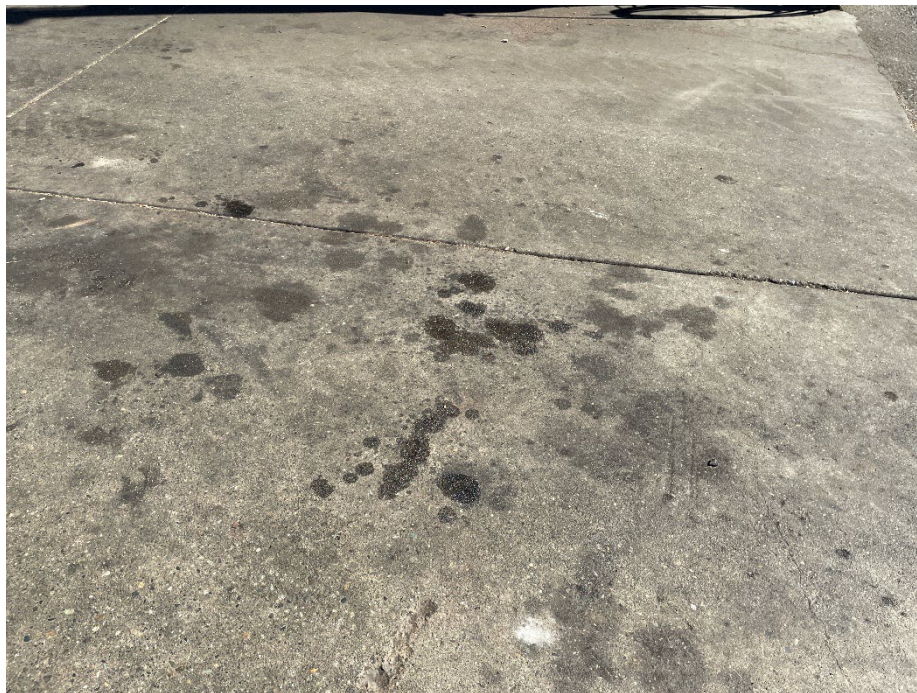
Photo 24 [IMG_1017]

Description: Multiple small spills on concrete pad next to the diesel storage area in the southeast of the facility.

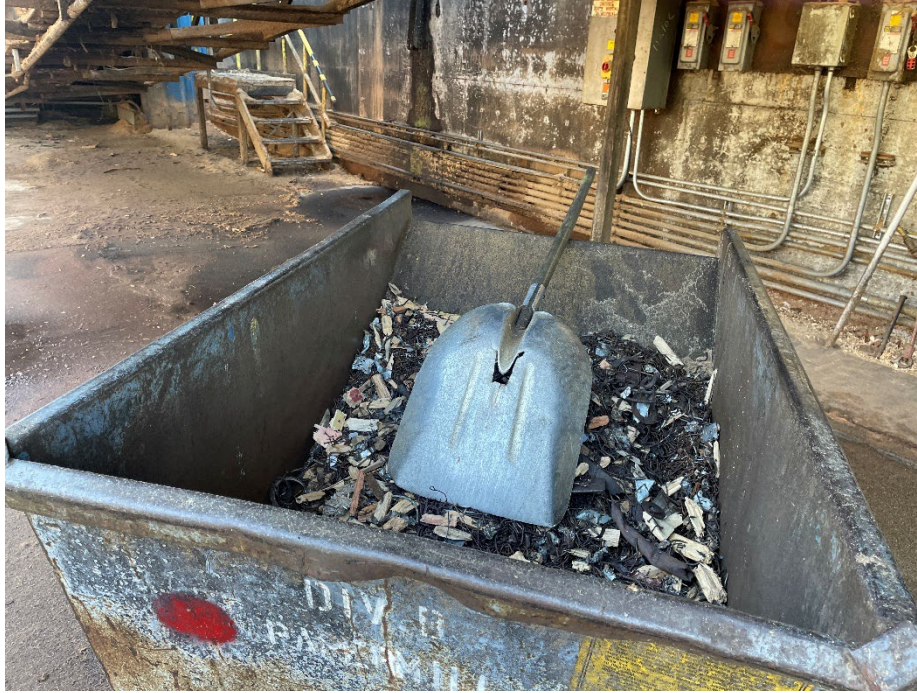
Photo 25 [IMG_1006]

- There were no drip pans located next to either fueling area.
- Multiple dumpsters lacking solid cover or storm-resistant lids (Photos 25-27).
- Uncovered storage of tires outside the truck shop (Photo 28). Justin said they were working on a solution to address tires under the new 2025 ISGP requirement.

Description: Uncovered dumpster for scrap metal located at the north side of the facility.

- 6) Cover all dumpsters (for solid waste, recyclables, scrap metal, etc.) in accordance with ISGP Condition S3.B.4.b.i.2.d. Covers may be open during use, but must be closed at the end of the day.

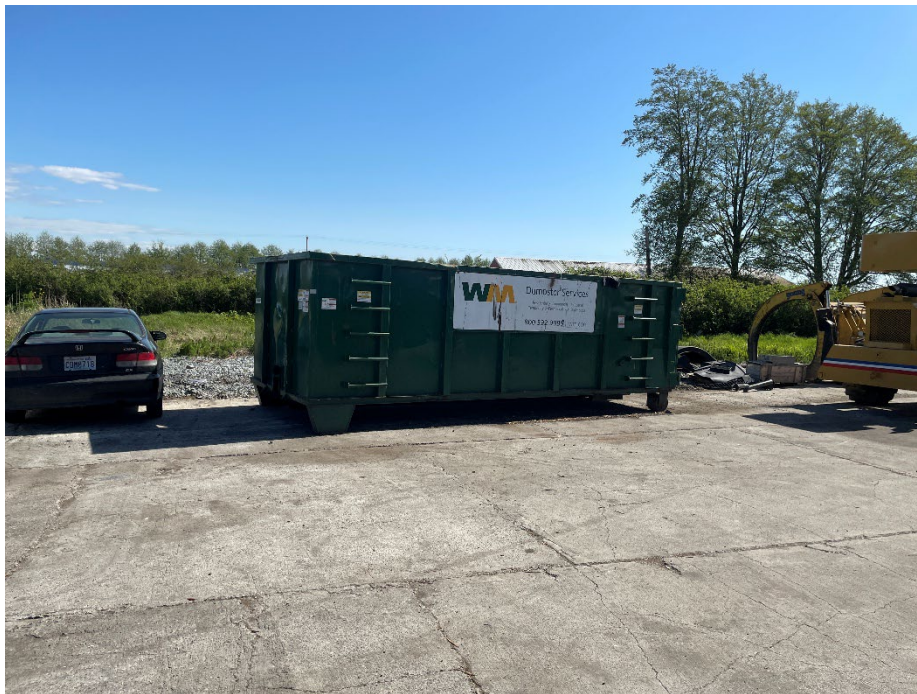
Photo 26 [IMG_1019]

Description: Uncovered dumpster located at the southeast side of the facility.

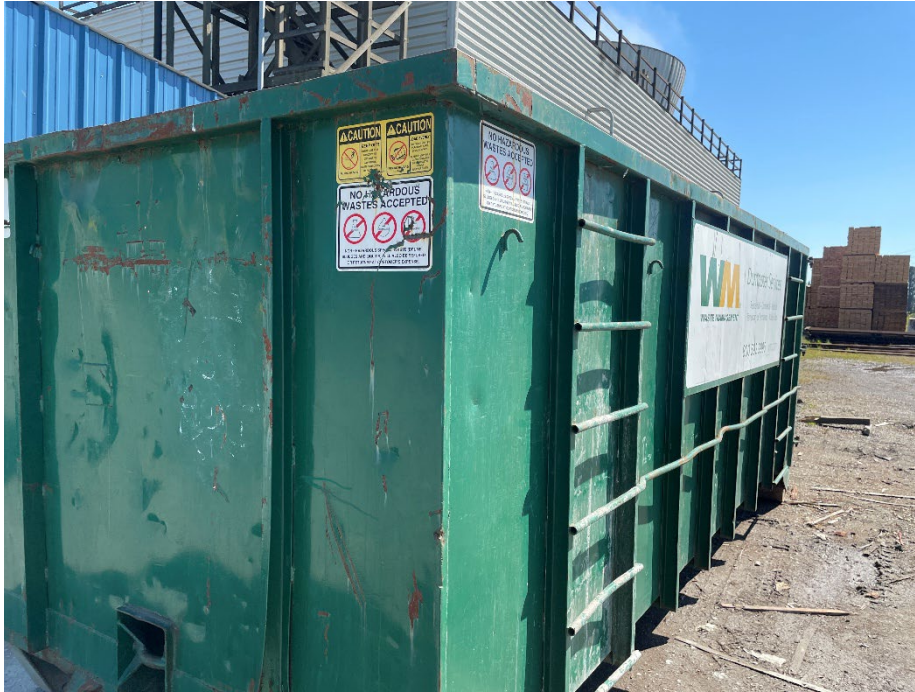
Photo 27 [IMG_0992]

Description: Uncovered dumpster located near the cogeneration plant.

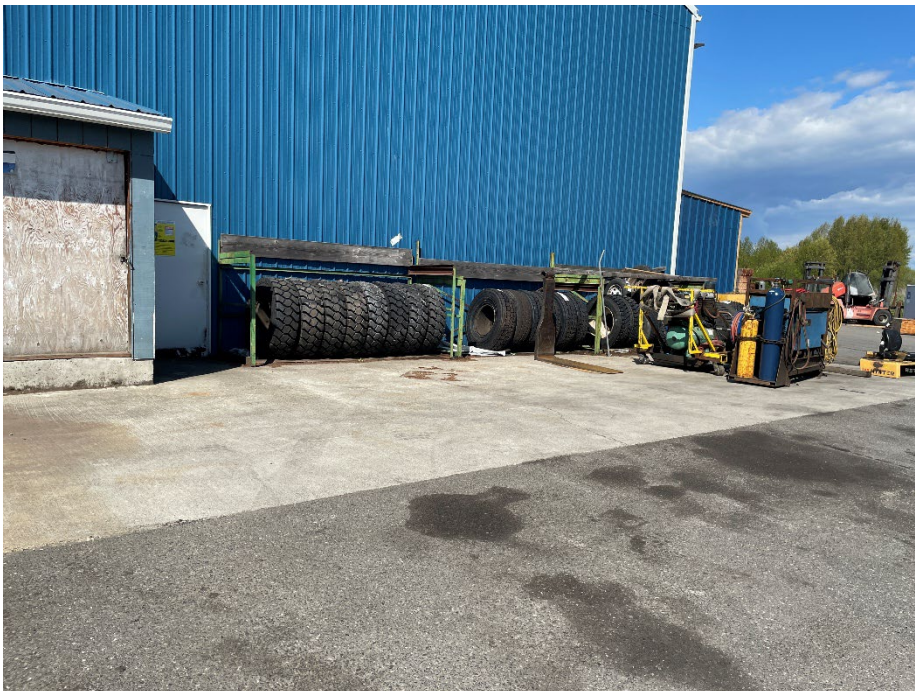
Photo 28 [IMG_1021]

Description: Tires stored without cover and multiple dark stains on the ground next to the truck shop.

- Move all tires under cover and up off the ground.
 - The facility sent photos of this correction on 4/25/2025.
- 5) Stabilize all the exposed soil in the NW corner of the pond such as seeding, netting/blankets, mulch, etc. in accordance with ISGP Condition S3.B.4.b.v and erosion control options described in the [Stormwater Management Manual of Western Washington](#).

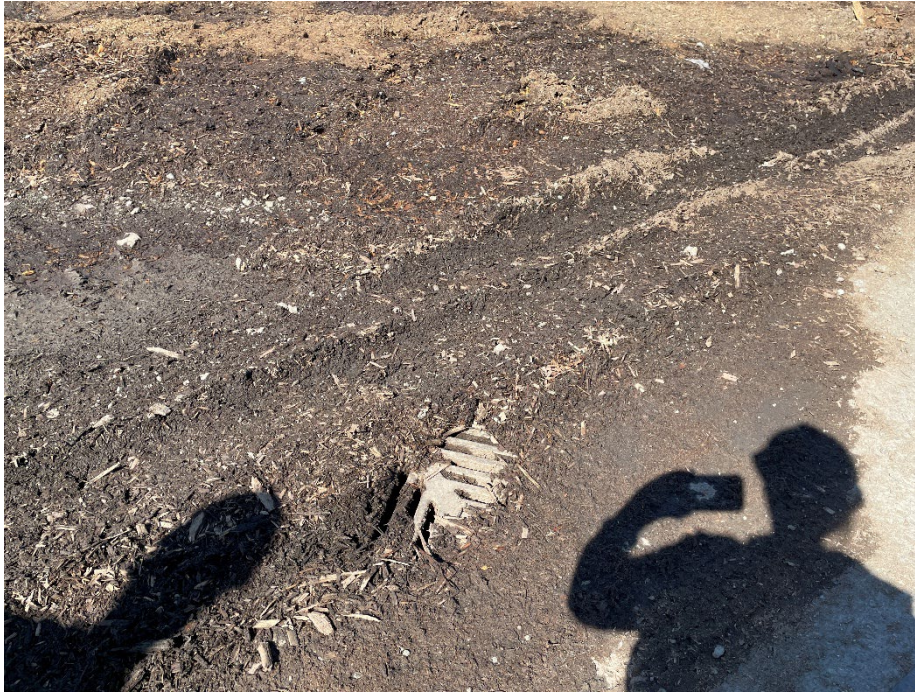
Photo 29 [IMG_1023]

- A catch basin with significant wood waste accumulated around and on top of the grate, located at the southeast corner of the northeast chip pile (Photo 29).

Description: Catch basin with significant wood waste and sediment accumulated around and on top of the grate, located at the southeast corner of the northeast chip pile.

- 7) Implement and maintain source control BMPs in accordance with ISGP Condition S3.B.4.b.i.3, including:
 - Install protection around catch basins around the Chip Pile so they don't get inundated with chips and sediment.

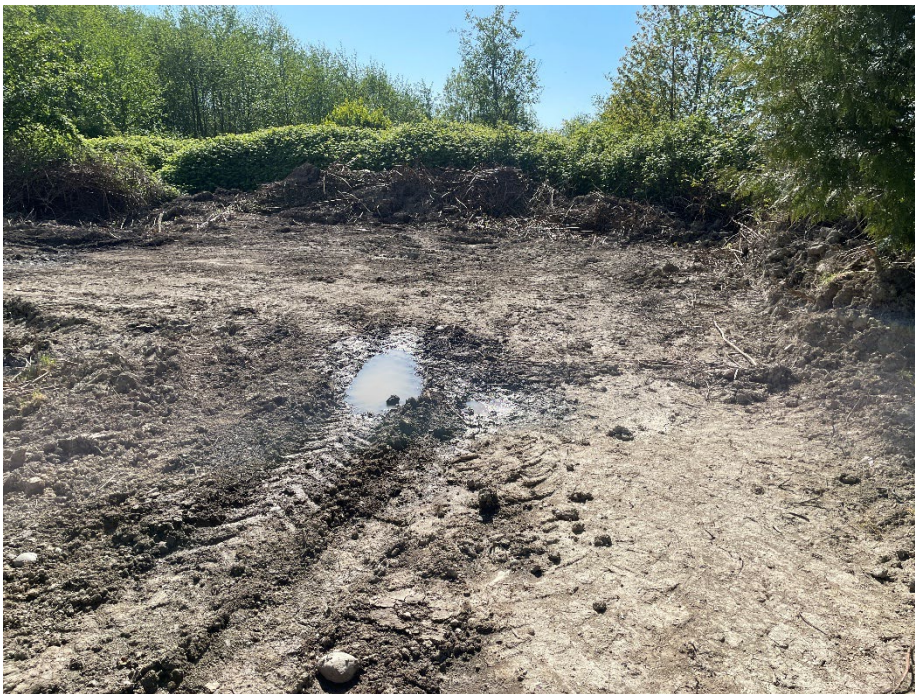
Photo 30 [IMG_1027]

- Areas of exposed soil at the northwest corner of the stormwater pond (Photos 30-31). The ditch north of the pond had overtopped the berm between it and the stormwater pond during this past winter and the exposed soil was not stabilized following repair of the berm

Description: Exposed soil along the northwest corner of the berm between the ditch and the stormwater pond. Photo faces west.

- The facility sent photos of temporary stabilization on 4/25/2025, which is adequate for short-term stabilization. The facility should plan to implement permanent stabilization, such as seeding grass.

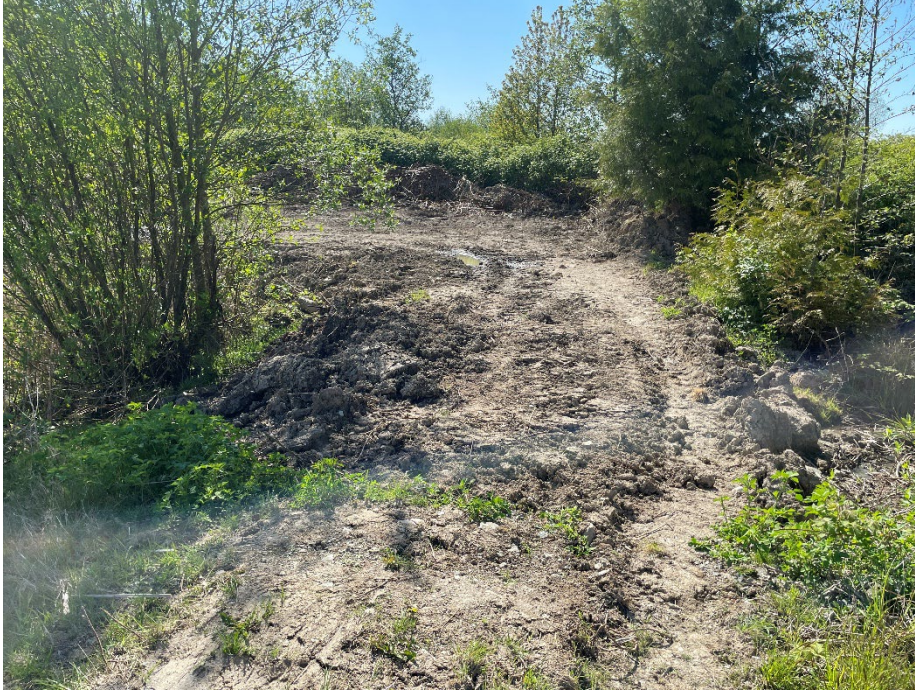
Photo 31 [IMG_1030]

Description: Exposed soil along the northwest corner of the berm between the ditch and the stormwater pond. Photo faces west.

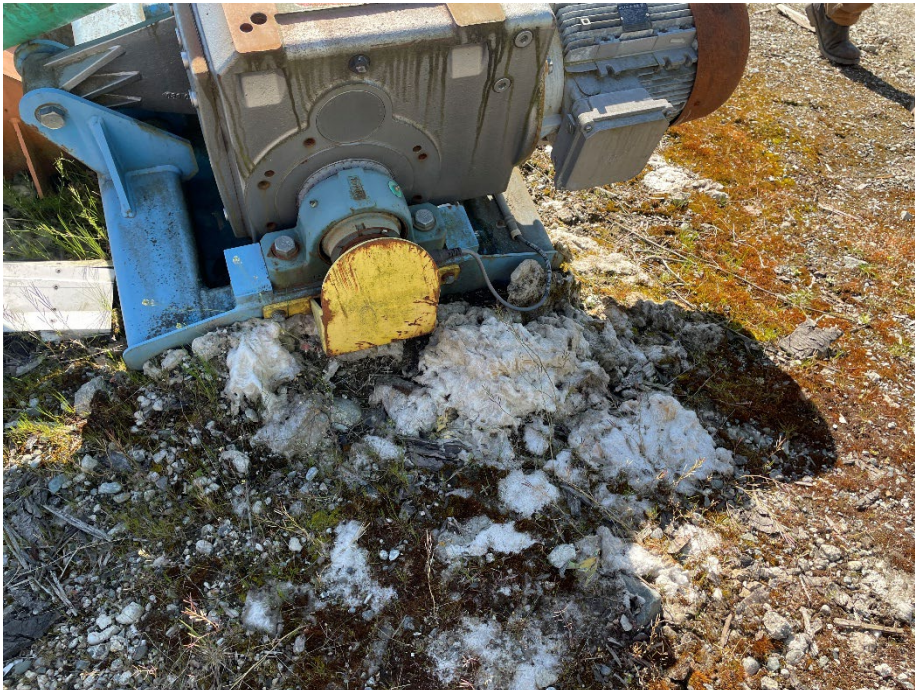
Photo 32 [IMG_1038]

- Some debris scattered on the ground in the eastern equipment storage yard, including building insulation (Photo 32).

Description: Building insulation debris scattered on the ground in the eastern equipment storage yard.

- Clean up solid waste in the east yard, such as insulation and pieces of plastic sheeting.
 - The facility sent photos of this correction on 4/25/2025.
