Permit Compliance Inspection Report

Water Quality Program

Facility Name and Address: Burlington Lumber Facility
14353 McFarland Rd
Mount Vernon, WA 98273

Permit Number: WAR007765

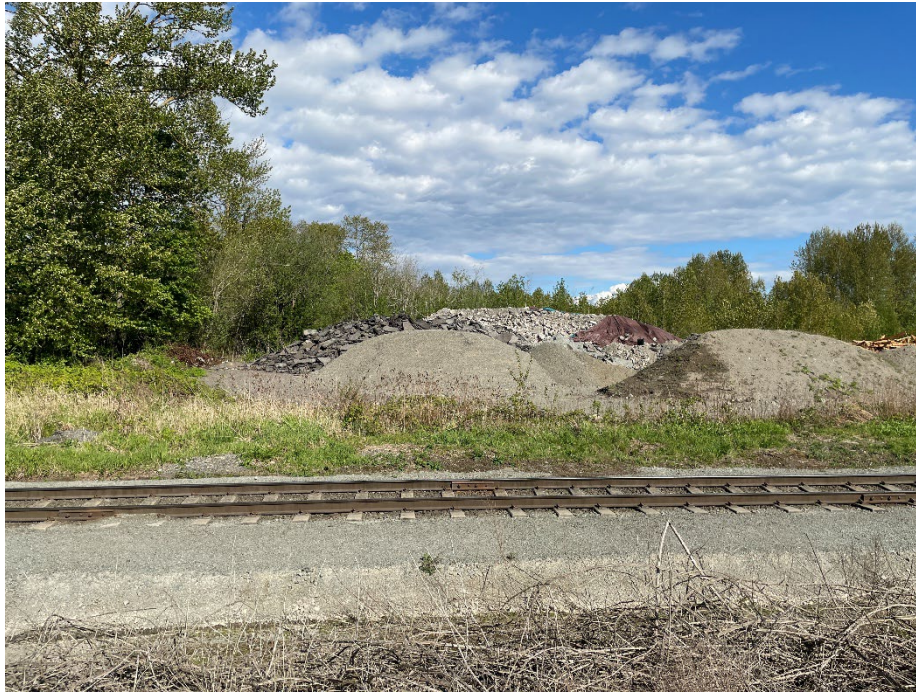
Photo 33 [IMG_1040]

- Uncovered stockpiles of soil and concrete and asphalt rubble east of the eastern rail tracks (Photo 33). This material is from prior construction projects at their site. This area is not part of the permitted facility or shown on the site map.

Description: Uncovered stockpiles of soil and concrete and asphalt rubble, located east of the eastern rail tracks. Photo faces east.

- 12) For the stockpiles of concrete and asphalt rubble and fill material east of the facility:
 - It's best to remove the concrete and asphalt rubble. If you hire a portable crusher to process this material, confirm the operator has an active Sand & Gravel General Permit. If you wish to keep this material or receive additional concrete and asphalt rubble, contact the Skagit County Public Health Department for potential permitting requirements.

- Stabilize the fill stockpiles with hydroseeding, mulch, plastic sheeting, or another BMP from the [Stormwater Management Manual for Western Washington](#) (SWMMWW).
