BALLARD
MARINE CONSTRUCTION

Graymont Tacoma Effluent Outfall

Ballard Project Number 125088

RE: Graymont Treated Effluent Outfall Inspection

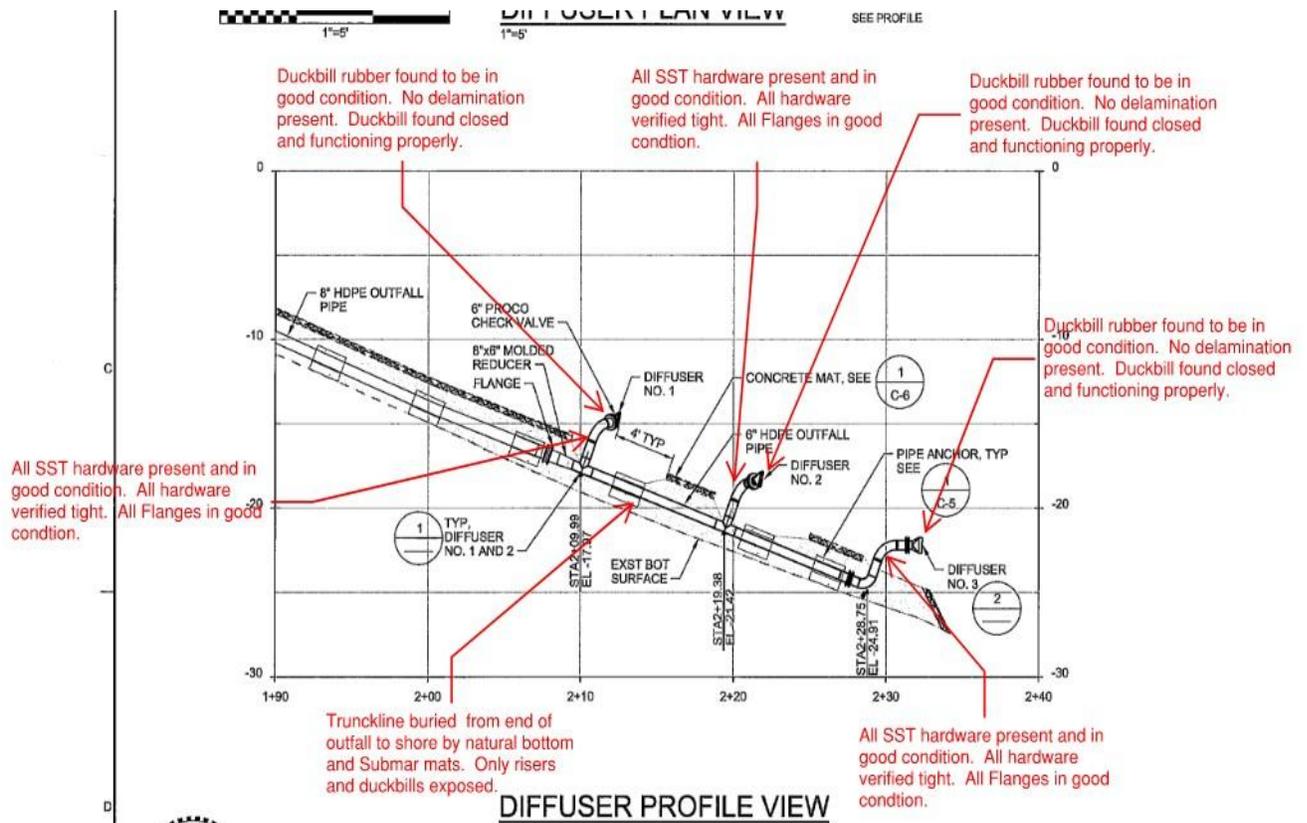
Figure 1: Graymont Treated Effluent Outfall

Outfall found overall to be in good condition. Entirety of the trunkline is buried and protected with Submar matting. Only risers and duckbills exposed. All SST flanges and SST hardware appear to be in good condition with no corrosion found. All hardware present and tight, verified by diver. Duckbills appear to be in good condition with no delamination or damage present. With no flow in the outfall, duckbills were found closed and operating properly. Diver manually opened and closed all 3 duckbills to check functionality.

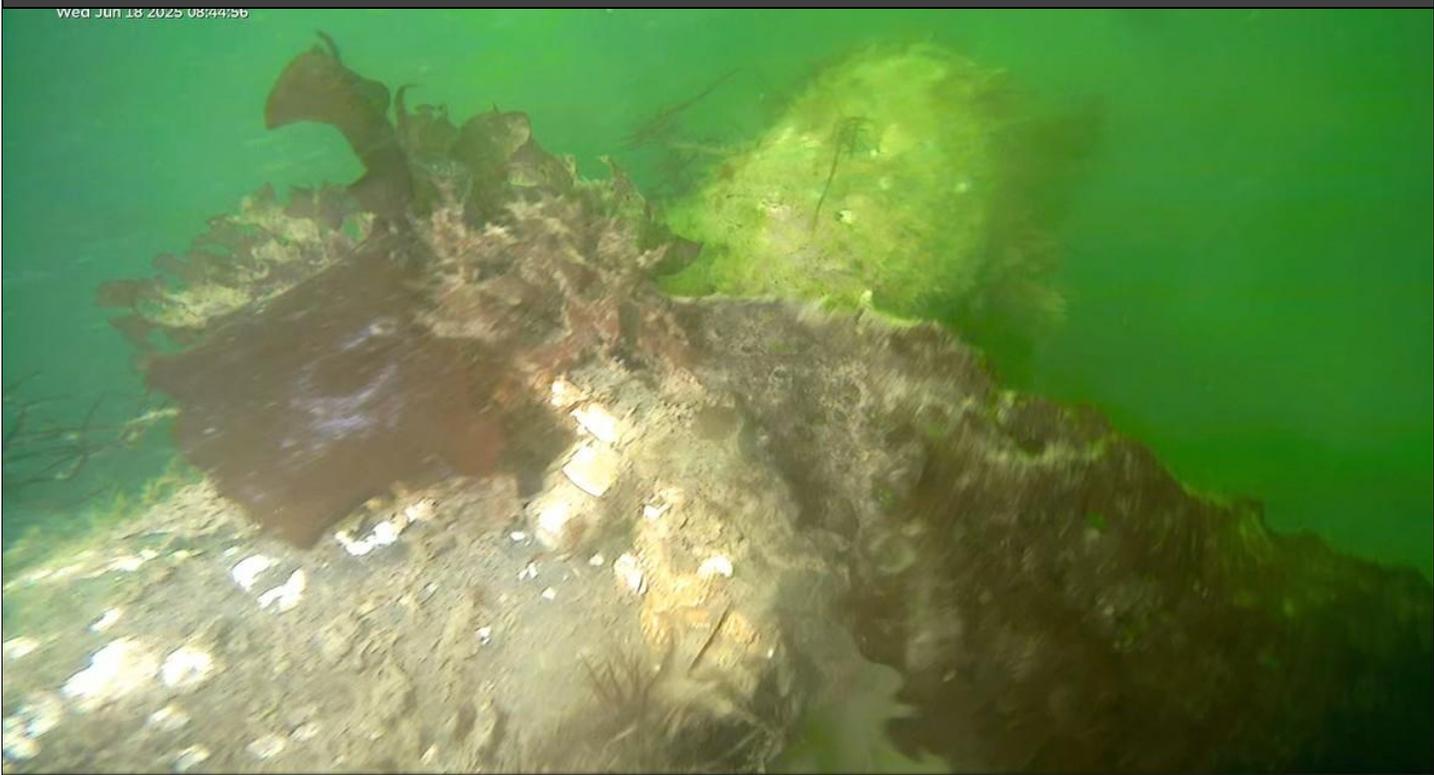
Photo #2: Riser and Duckbill

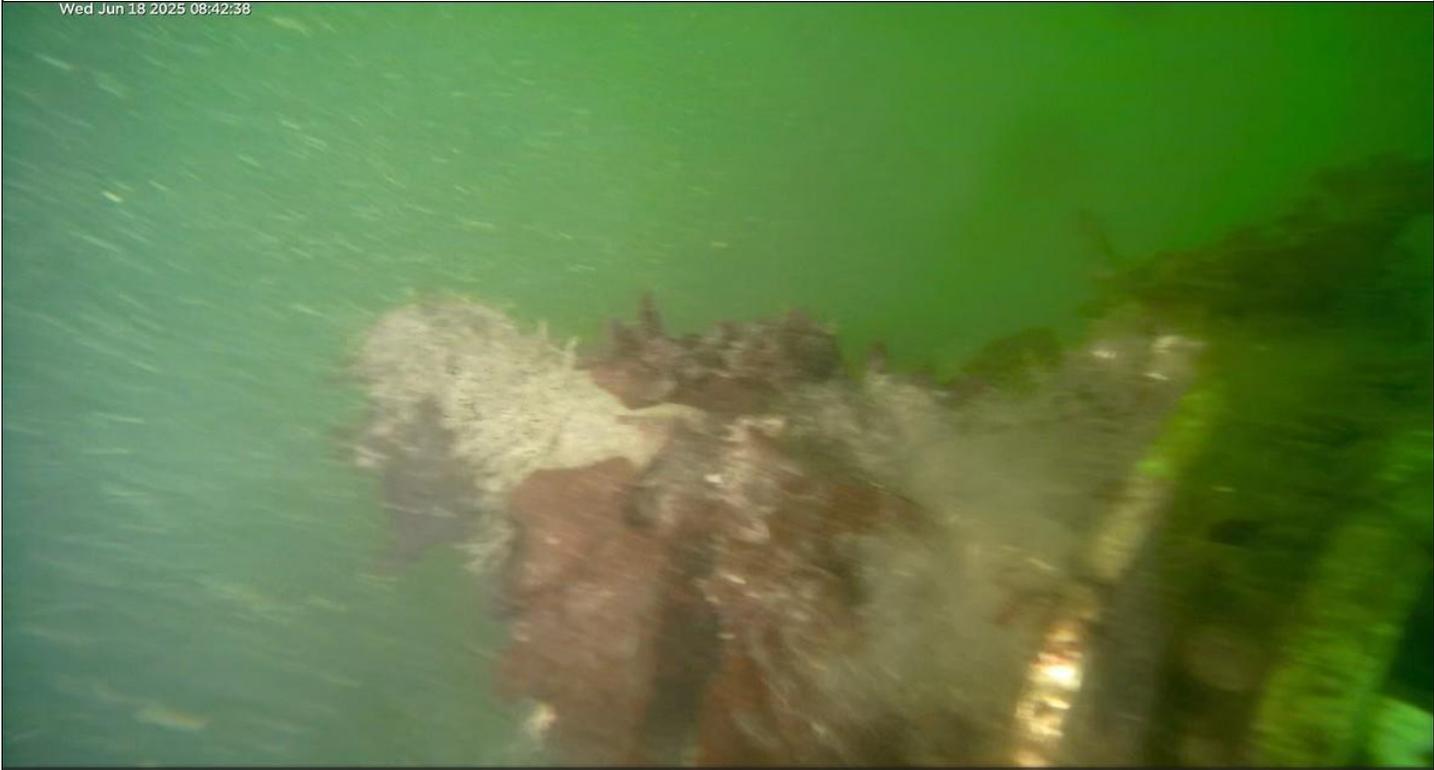
Photo #4: Offshore Duckbill Flange

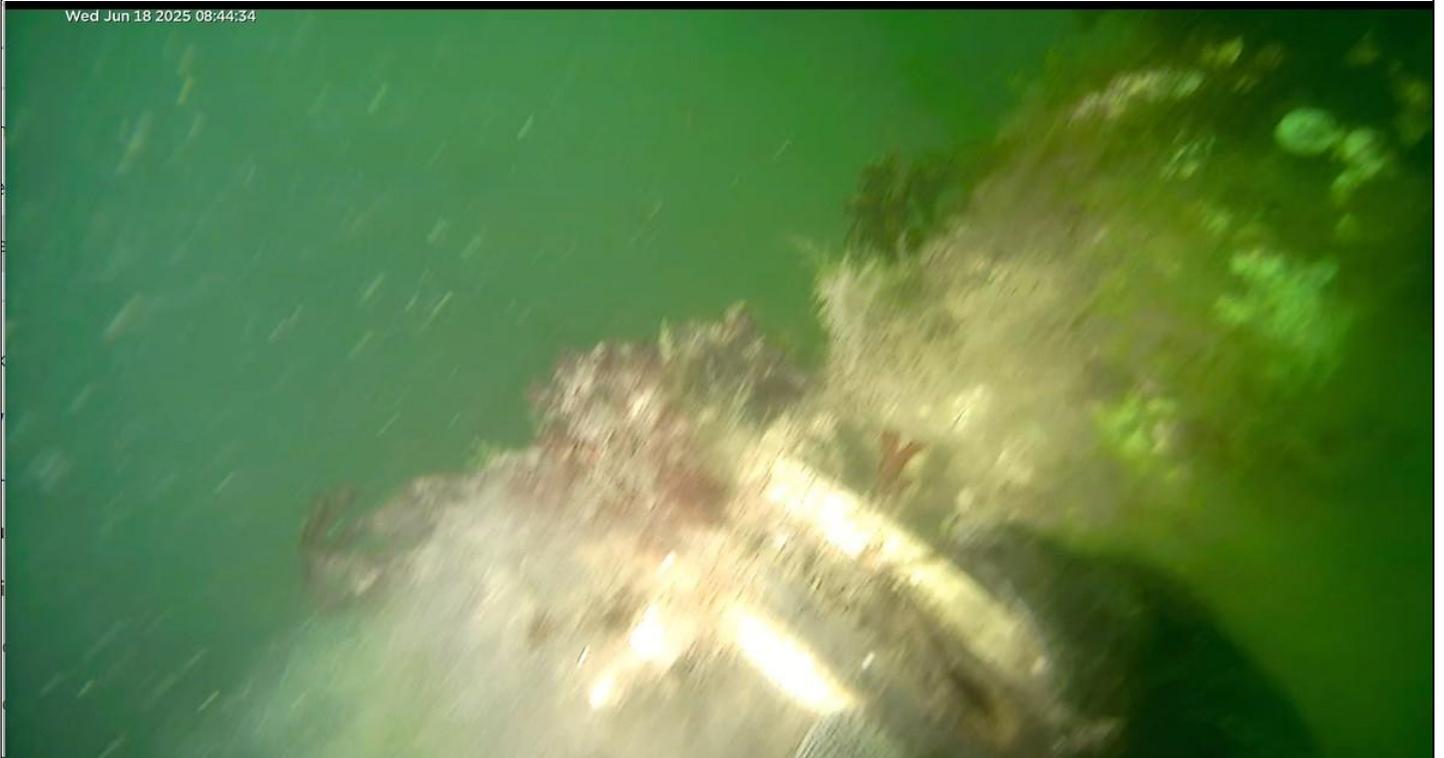
Photo #5: Flange Duckbill to Riser

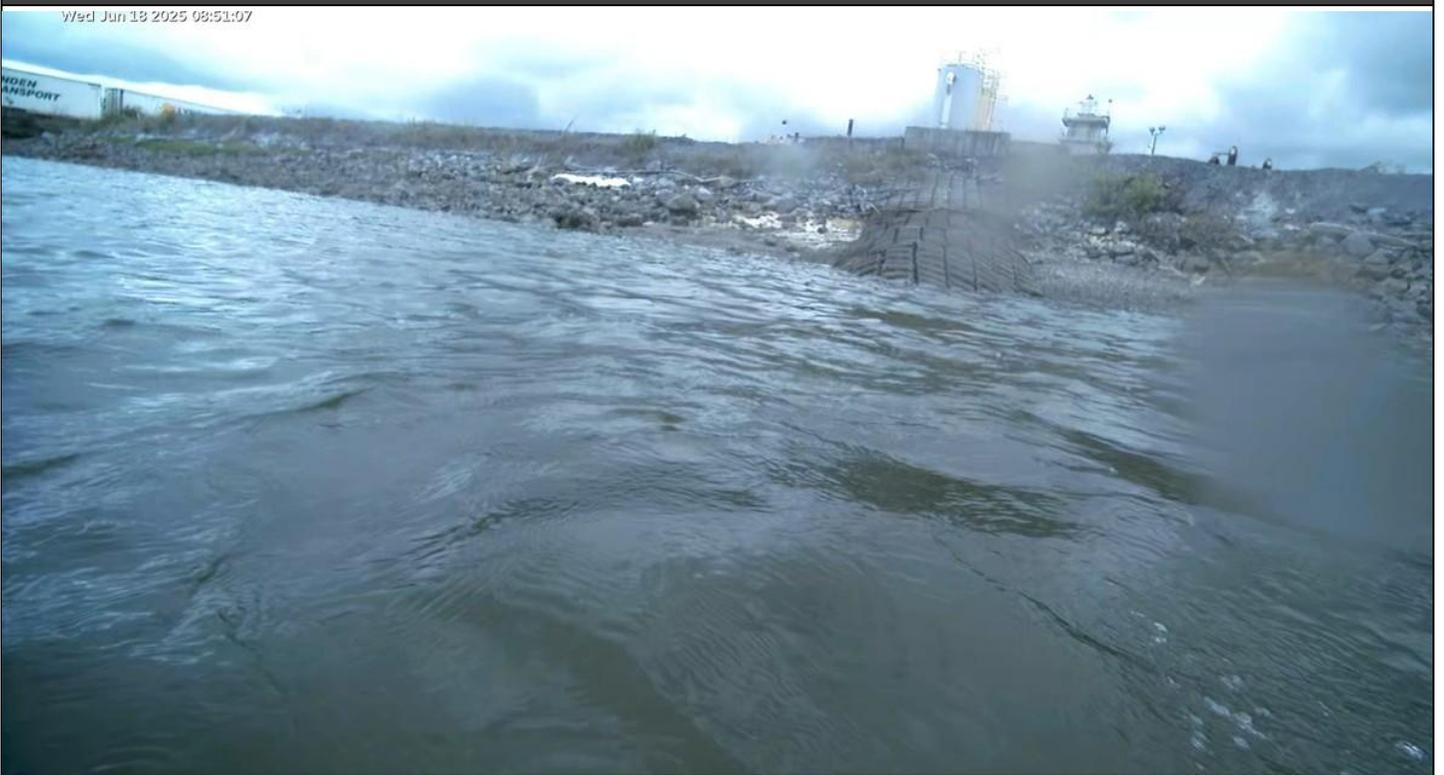
Photo #6: Submar Matting
