TREE TOP, INC.

Reference: Industrial Stormwater General Permit No. SO3-000566D (Selah Facilities)
Fourth Quarter of 2005

INDUSTRIAL STORMWATER GENERAL PERMIT
DISCHARGE MONITORING REPORT

SELAH FACILITIES STORM WATER
FOURTH QUARTER 2005
LEVEL 3 RESPONSE REPORT

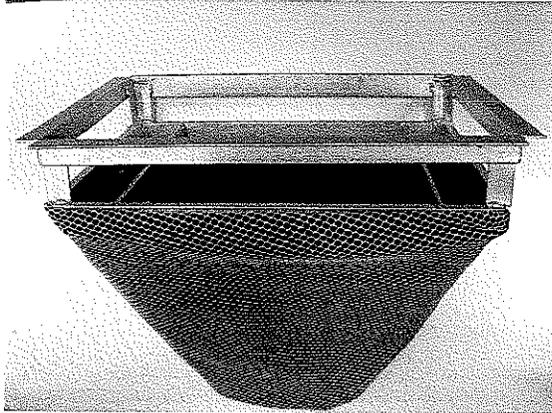
A variety of inlet filters are commercially available for stormwater catch basins. These filters are basket screens that hang from the inlet frame. The screens are cleaned by lifting the basket out of the basin. The baskets will typically overflow directly into the catch basin at very high flows or if the screen is blinded with debris. A typical basket is illustrated below.

Inlet filters will be considered further, as described below.

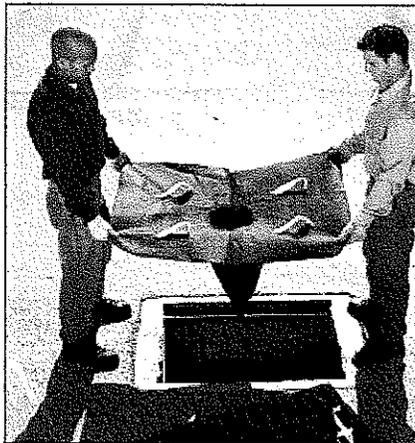
Tree Top's Selah campus depends upon intense vehicular activity at all times. Fruit is brought onto the site in bins that are carried by flatbed trucks and is then transported from storage to processing areas by forklifts. Turbidity is created by the mud that falls off of trucks, especially in winter, and by tire wear.

Much of the turbidity appears to be related to tire wear. During dry weather trucks are generally mud-free and tire wear is the primary source of turbidity. This is apparent from the definite black color of runoff that has been observed in dry weather samples.

Tree Top purchased and installed an inexpensive fabric catch basin inlet filter in Catch Basin D10 on January 16, 2006. The fabric filter is as shown below, and will provide the same degree of filtration achieved with the basket-type device shown above.

Stormwater samples will be collected both above and beneath the screen and the results will be summarized in the first quarter report.

If the test indicates that zinc and turbidity are sufficiently reduced and that the device has reasonable maintenance requirements, then Tree Top will install them on all catch basins that discharge directly into the City storm sewer on Railroad Avenue and will maintain them as required.
