The BARGE 101

OVERVIEW

Prevention Bulletin

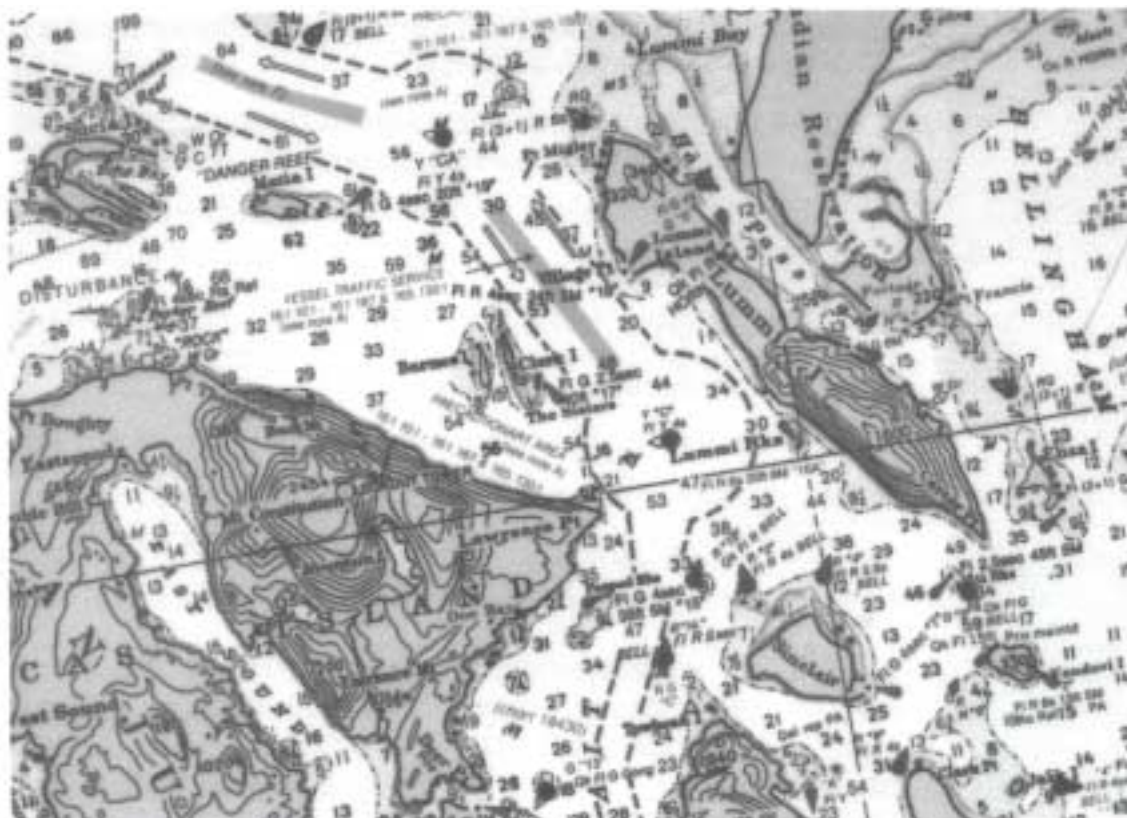
-- Chart section showing the area transited. (Not for navigational use.) --

While it could not be established with certainty, BARGE 101 most likely grounded in the vicinity of Clements Reef (a charted navigation hazard) en route to Jack Island, Washington. The U.S. Coast Guard Vessel Traffic Center (VTC) sector operator described tug MERCURY to be at the southern edge of the southbound traffic lane approaching the Clements Reef area.

Shortly after passing the Reef the sector operator found the tug and barge to be approximately 1/2 mile out of the traffic lane, just north of Matia Island. As the tug and barge were passing the Reef, the tide was ebbing, which would have the tendency to set the vessels south toward the reef.
