The PACIFIC EXPLORER

This bulletin was prepared to share lessons learned with industry and interested public, and to make recommendations to prevent similar occurrences. The company operating the M/V PACIFIC EXPLORER at the time of the incident was invited to provide comment on this bulletin. They did provide comment.

OVERVIEW

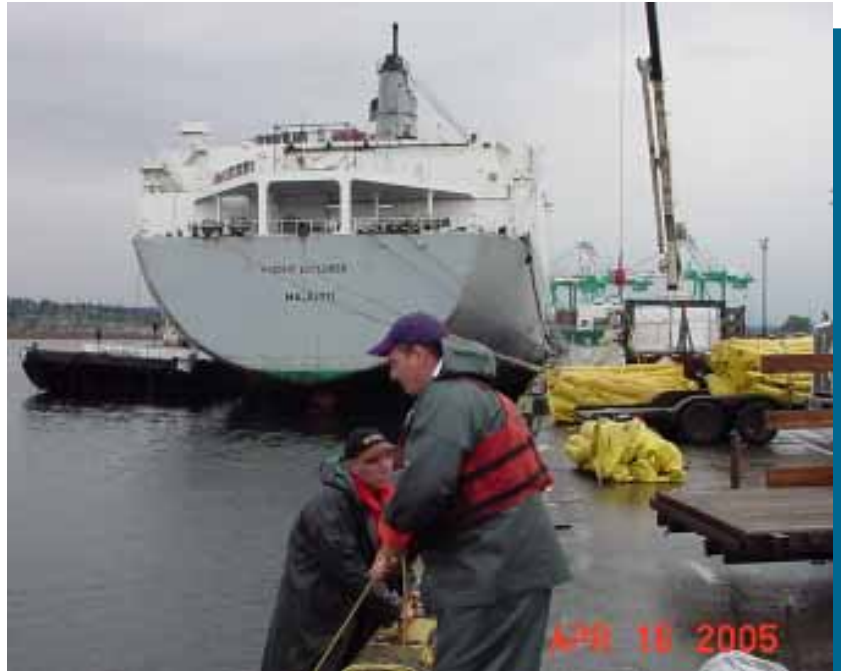
*Figure 1.
M/V PACIFIC
EXPLORER
alongside at the Blair
Waterway with spill
response crew at
work. Note the tank
barge 185-P2 moored
along side.*

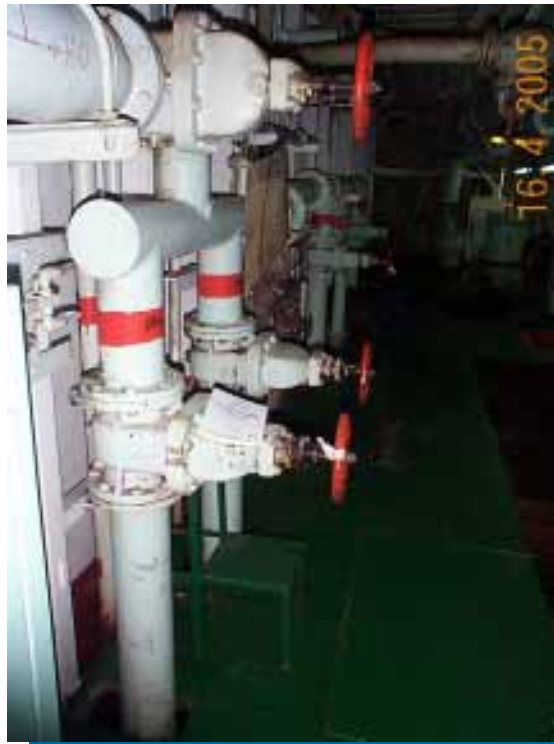
*Figure 2.
Fuel manifold at
front bulkhead of
the lower engine
room of the
PACIFIC
EXPLORER
[Note: The small
piece of cloth
tied to the valve
handle was used
to mark those
valves being used
during the
transfer.]*

forward engine room bulkhead was a fuel manifold (see Figure 2) along with a panel of fuel level monitoring gauges (reported by the Chief Engineer to be inoperative at the time of the spill) (see Figure 3).

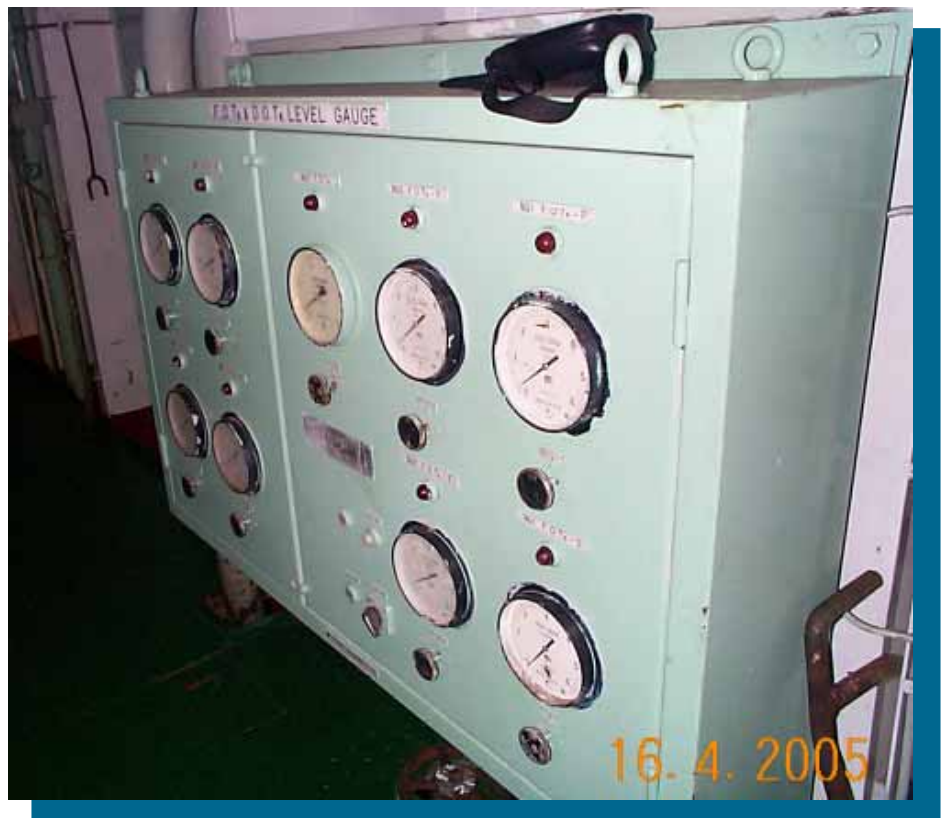
*Figure 3.
Heavy fuel oil
and diesel oil
level gauging
panel reported
by the Chief
Engineer to be
inoperative at
the time of the
spill*

The heavy fuel oil and diesel oil level gauging panel (see Figure 4) was reported by the Chief Engineer to be inoperative at the time of the spill. This reduction in monitoring capability heightened the responsibility of the Chief Engineer to closely monitor the tank levels, transfer rate, and transfer pressure by manual means in order to ensure a safe and spill-free transfer. Given the high transfer rate that occurred and the Chief Engineer's limited use of sounding notes in combination with this reduced monitoring capability, this additional responsibility was not met by the Chief Engineer.

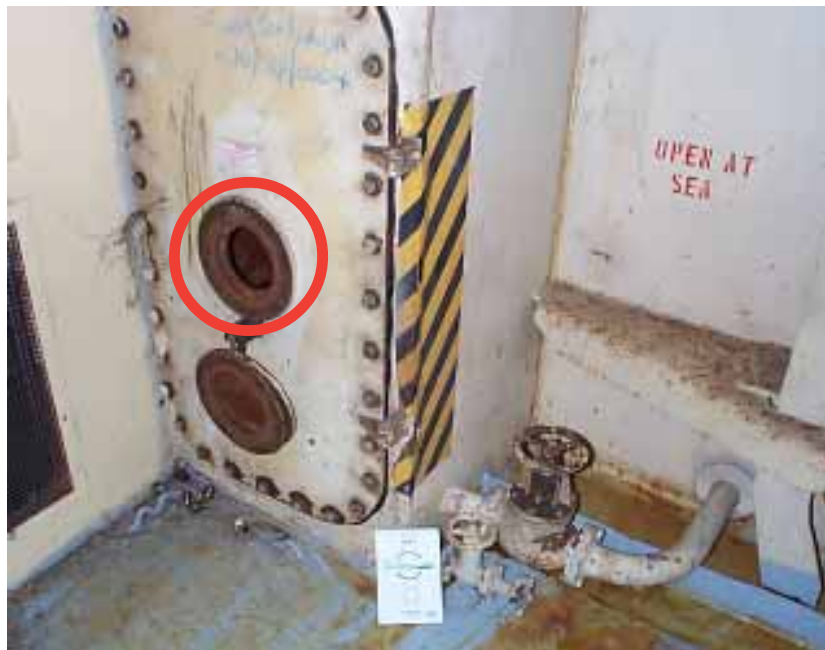
The interior of the containment box around the fuel oil tank vents on the car deck could not be visually examined unless the bolted access ports were opened (see Figure 4). The No. 2 port fuel oil tank that overflowed had two vents: one located forward and one located aft (about one-half the hold length apart). Only the aft access port had been opened for the oil transfer operation, as access to the forward vent containment for the No. 2 port fuel oil tank was blocked by the cargo of passenger automobiles (see Figures 4 & 5).

*Figure 4.
No. 2 port fuel
oil aft tank vent
containment.
Red circle
highlights bolted
access port for
inspecting the
interior of the
containment box.*

The vent containments on the No. 2 port fuel oil tank had two pipes that could be used to drain them. One drain pipe had a valve that led to a blank flange on the car deck, and the other had a valve that allowed the contents of the vent containment to flow overboard. The Tankerman-PIC of the delivering barge reported that oil flowed from two openings following the emergency shutdown of the transfer. Stenciling noted on the bulkhead above the overboard indicated that the overboard valves should be open when the ship was at sea (see Figure 4).

According to the Chief Engineer, the overboard drain valves for the No. 2 port fuel oil tank vent containments were found open after the spill.

The Chief Engineer investigated how the oil had gotten over the side and found that the overboard valves on the 2-inch overboard pipes from the No. 2 port fuel oil tank vent containment boxes had been left open. The Chief Engineer indicated it was the First Engineer's responsibility to close these valves prior to bunkering and that the Chief Engineer would normally then check that they were closed as part of his procedure. In this case he indicated that the vent containment access plates were open, but he did not check the tank vent containment overboard valves.

- Examine your procedures for transferring oil (internal and over-the-rail) to ensure that tank vent containment is checked prior to transfers.
- Ensure that work hour records are maintained up-to-date for all bunkering team members, including the Chief Engineer, and that they accurately reflect the hours actually worked and rest periods.

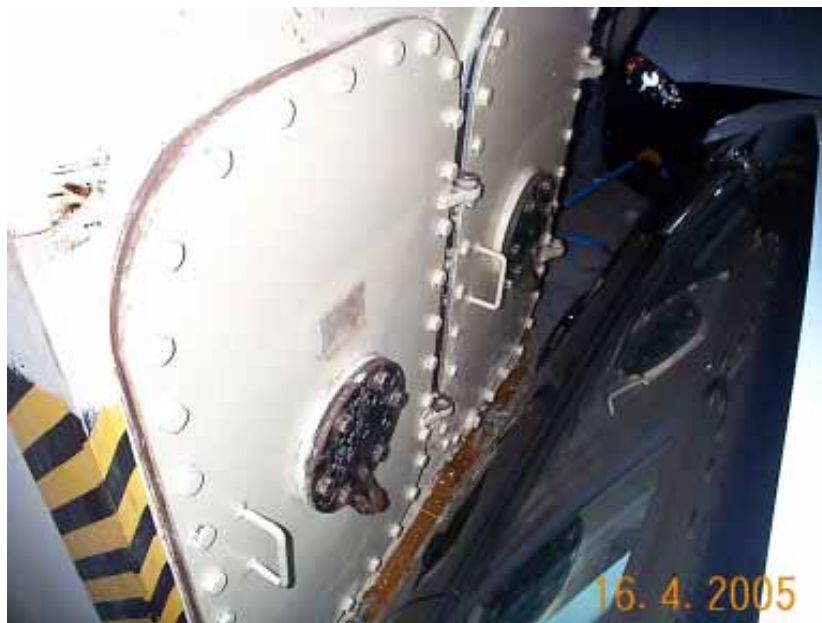
*Figure 5.
No. 2 port fuel oil
forward tank
vent
containment.
[Note passenger
automobile
blocking access.]*

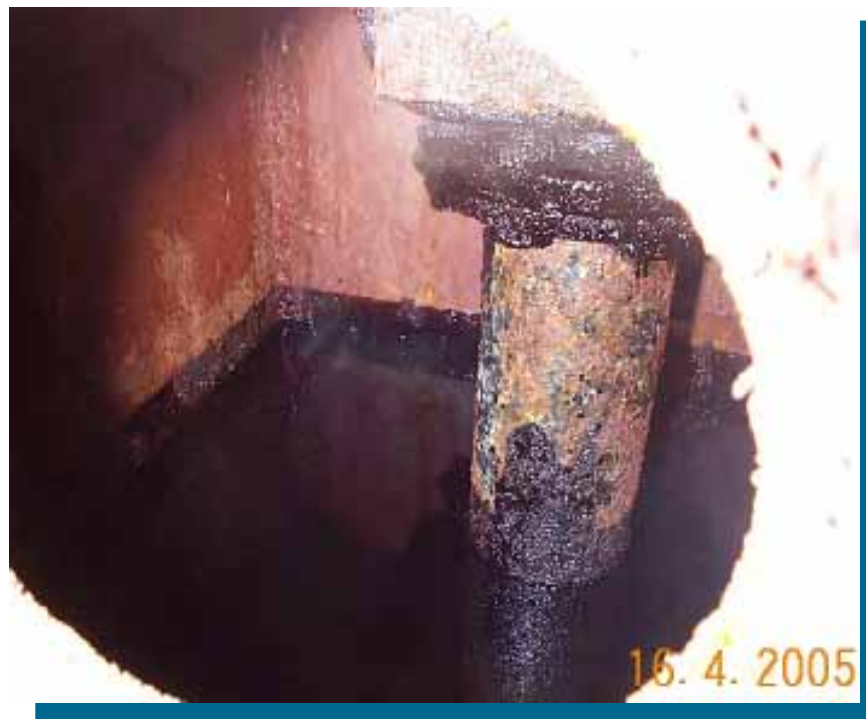
The interior of the No. 2 after port fuel oil vent containment was examined and the level of oil inside was photographed (see Figure 6). There was no staining to indicate that the level of the oil in the vent containment rose high enough to spill out through the containment access port.

Figure 6. View through No. 2 port fuel oil tank after vent containment viewing port. Note maximum level of oil was about 2.5 centimeters higher than when the photograph was taken.
