# The SEA SYNERGY

*This bulletin was prepared to share lessons learned with industry and the interested public, and to make recommendations to prevent similar occurrences. The company operating the M/V SEA SYNERGY has provided comment.*

## OVERVIEW

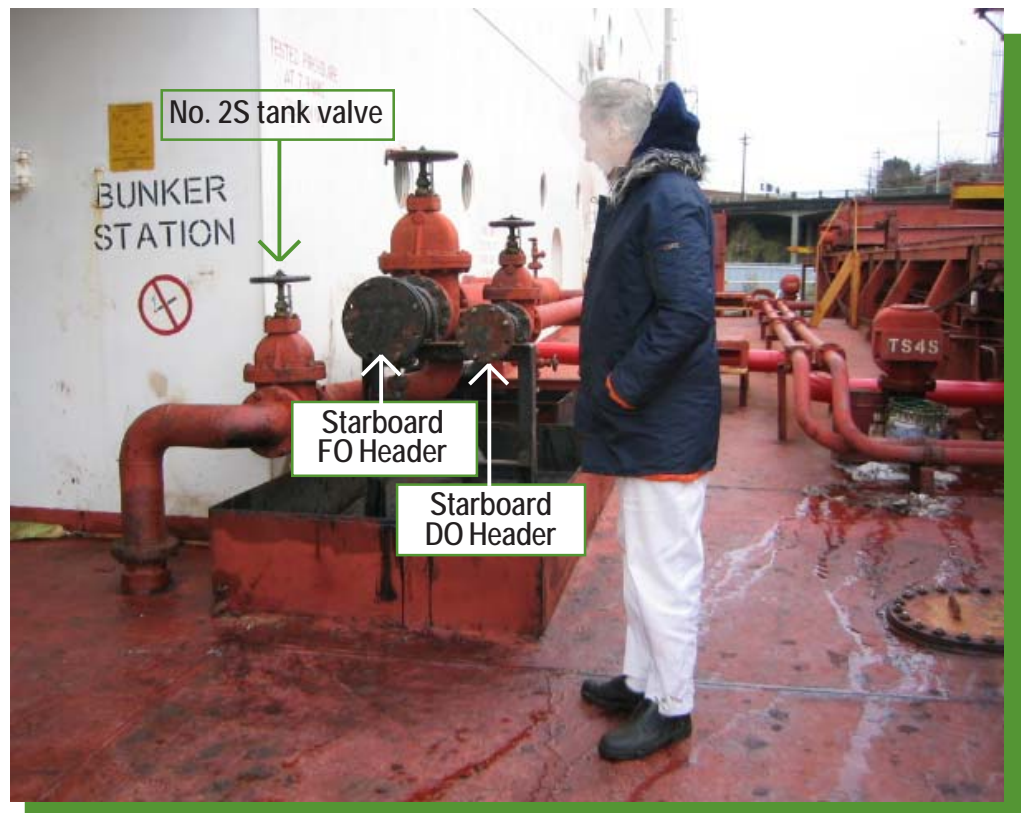
**Figure 1.**  
**SEA SYNERGY's starboard side fuel manifold, pictured here with the ship's Chief Engineer. [Note: All photos taken after the ship had shifted to a berth.]**

While at anchor waiting for bunker fuel on December 6, the ship discharged ballast water. Between 1505 and 1620, the ship received lubricating oil from a stores barge moored to its port side. At 1630, with the stores barge still alongside to port, the tank barge INVESTIGATOR came alongside to starboard to deliver 100 metric tonnes of diesel oil and 880 tonnes of IFO via the ship's starboard side fuel manifold (see Figure 1). The stores barge cast off at 1650.

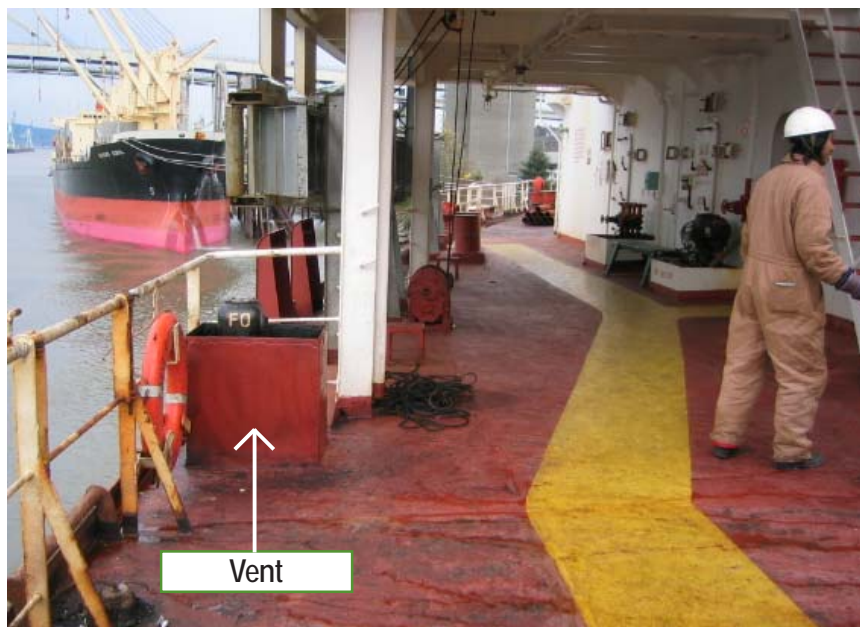
*Figure 2.  
No. 2S FO tank  
vent, view  
looking aft on  
starboard side.*

According to the Second Engineer, when he reached the planned final ullage (the approximate height of free space in the tank) of one meter in the No. 2S tank he partially closed the No. 2S tank valve, and went to the port side of the ship's house to fully open the valve to the No. 2P tank. No request was made to the Tankerman to slow or stop the loading. When the Second Engineer returned to fully close the No. 2S tank valve he found that the tank had overflowed the No. 2S fuel oil tank vent (see Figures 2 & 3), and sounded the air horn to notify the barge to immediately stop the transfer.

Approximately 264 gallons (1,000 liters) of IFO was found spilled on the deck of the SEA SYNERGY from the overflowing No. 2S fuel oil tank via the vent located near the starboard deck edge just forward of the ship's house (see Figures 2 & 3). The oil overflowing the vertical steel plate at the deck edge landed on the deck of the barge, because the position of the barge alongside the ship was under the curve of the ship's stern and the No. 2S tank vent was located directly above.

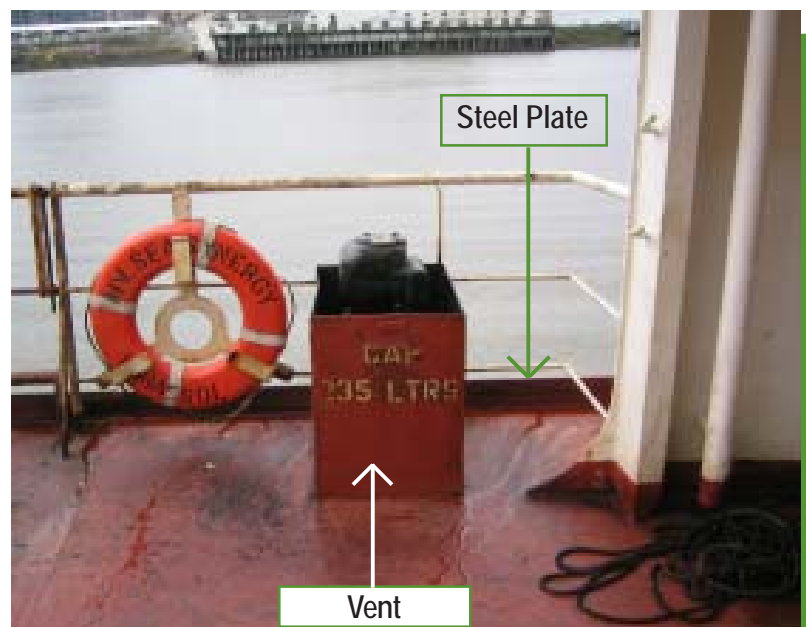
*Figure 3.  
No. 2S FO tank  
vent, view  
looking  
outboard on  
starboard side,  
from  
approximately  
the location of  
the starboard  
fuel manifold.*
