The DEFENDER

OVERVIEW

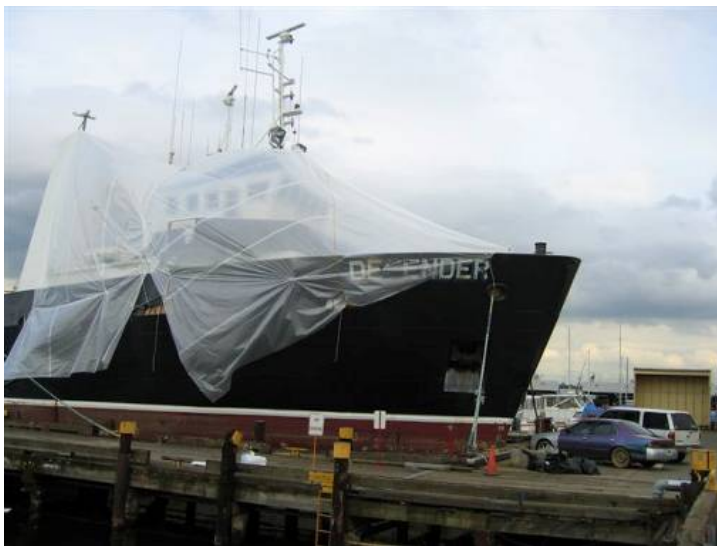
Figure 1 - Fishing vessel DEFENDER at a former shipyard site on March 29, 2006.

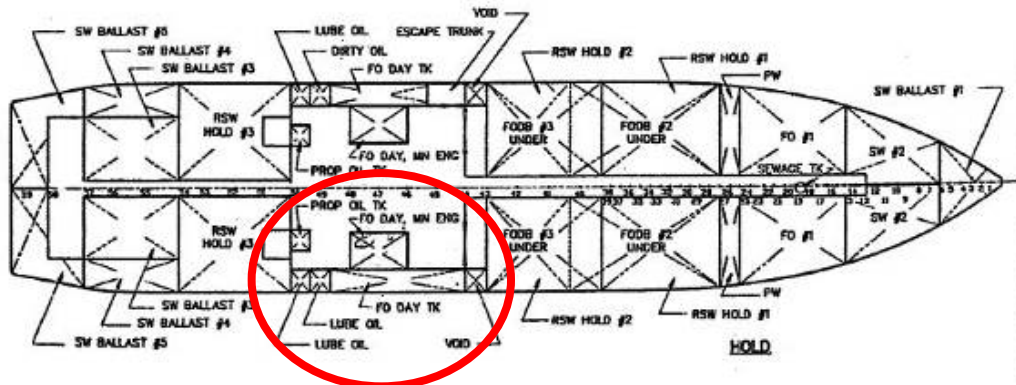
DEFENDER's tanks.

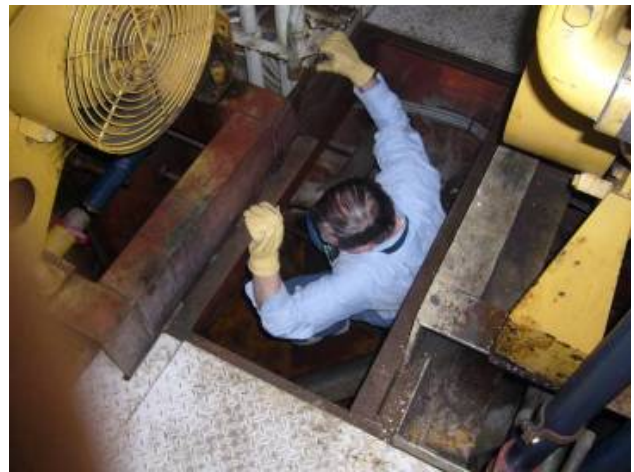
The starboard main engine day tank had cracked. Attempts were made to weld a steel plate over the crack to seal it, but the crack grew past the margins of the plates. Neither of two added steel plates adequately sealed the leak. A year to eighteen months before the spill, the starboard main engine day tank was taken out of service. It was reported to have contained only water after that.

The removal of the starboard main engine day tank from service was incomplete. A manual gate valve that would have securely isolated the tank from the fuel oil system was not closed. Instead, isolation of the tank

Figure 2 - Access to the starboard main engine day tank just aft of the starboard main engine.

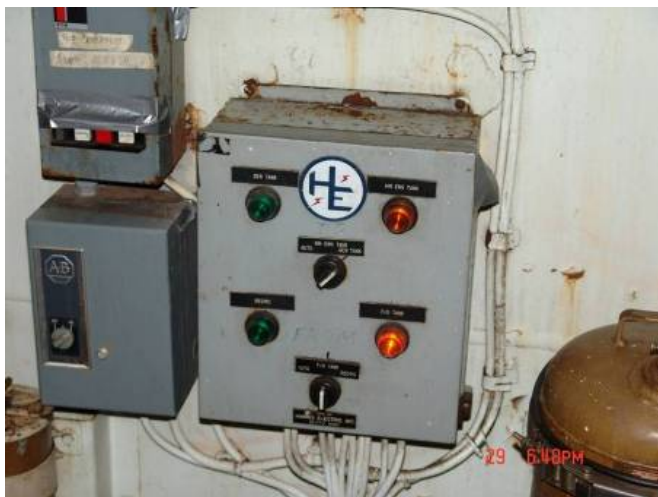
Figure 3 – Control panel for the fuel oil purifier aboard DEFENDER taken March 29, 2006. Note the (upper) switch is in ‘normal’ position but that the top green light (at left) for the larger day tanks is off. [Photo courtesy USCG]

Lights on the purifier controller box indicated the position of the switches for positions other than automatic. As seen in Figure 3, the top green light indicating valve positions set to pump oil to the larger day tanks was not operational on the day of the spill.

Following the spill it was noted that the upper switch on the purifier panel was not in its normal position. Instead of being set to pump to the larger day tanks, it was set to the smaller main engine day tanks.

The explanation initially given for the purifier panel switch being miss-set was that someone must have bumped it. Further inquiry indicated that the Chief Engineer had changed the switch position to silence a humming or buzzing sound coming from the controller box electronics.

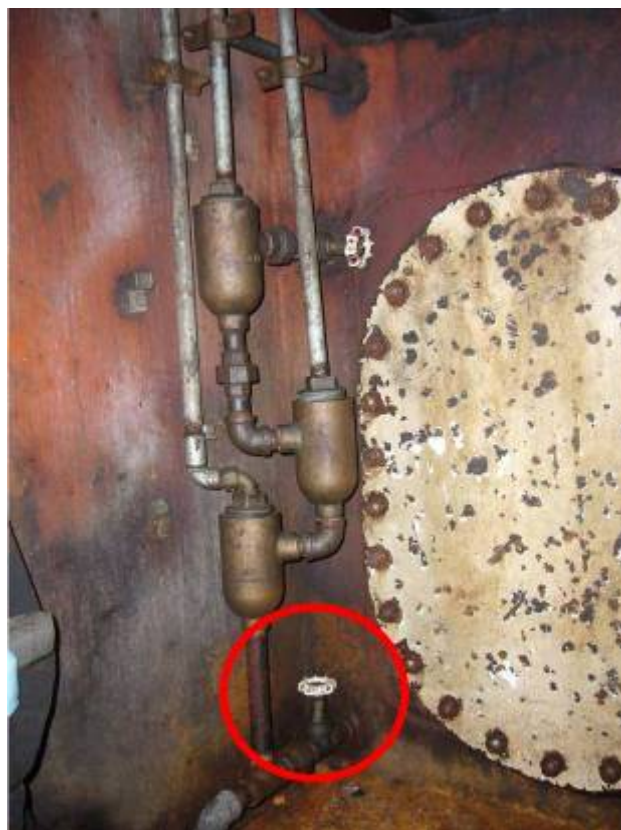
The starboard main engine day tank manual valve was inspected about a month after the spill. It was found to be closed and in working order (Figure 4). One of the engineers involved in the transfer that resulted in the spill indicated that the valve was only closed after the spill.

Figure 4 - Photo showing the location of the starboard main engine day tank manual isolation valve.

The tank was taken out of service for fuel, and it was initially reported that all piping connections were closed. But the starboard main engine day tank manual isolation valve, which could have been used to securely isolate the tank, was not closed. The result was a marginal isolation of the tank as long as the purifier controller panel's upper switch was set to the larger day tank position.

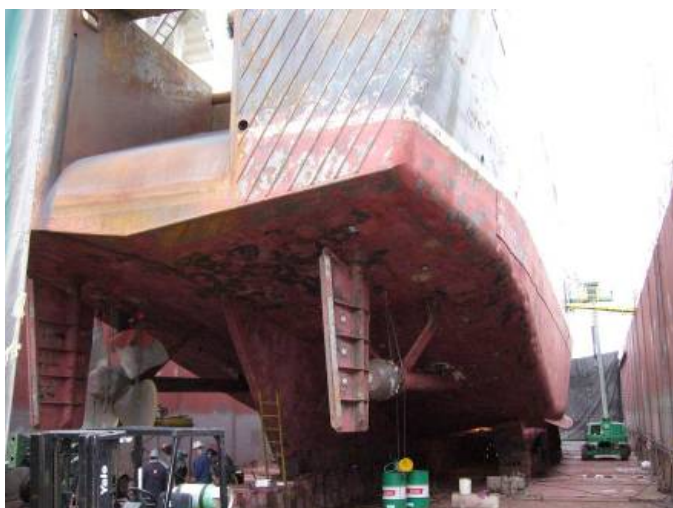
Figure 5 - DEFENDER in dry-dock on May 12, 2006. Light on starboard side under the hull shows location of the fracture and repair.

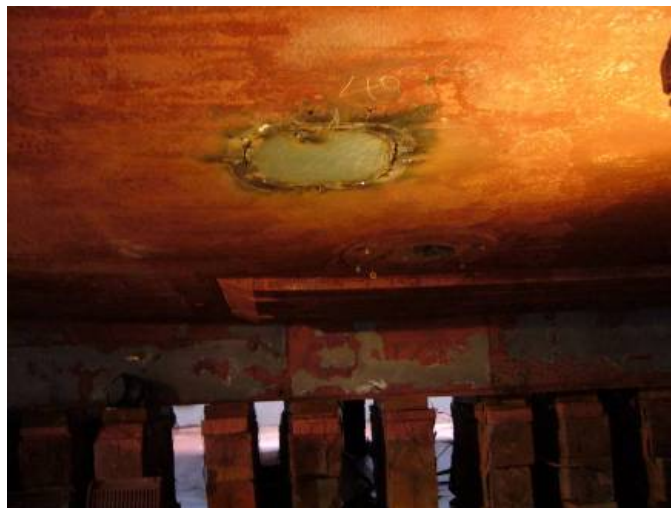
Figure 6. Looking inboard from starboard side at the replacement steel patch that has been tack-welded into place where the fracture had been cut out.

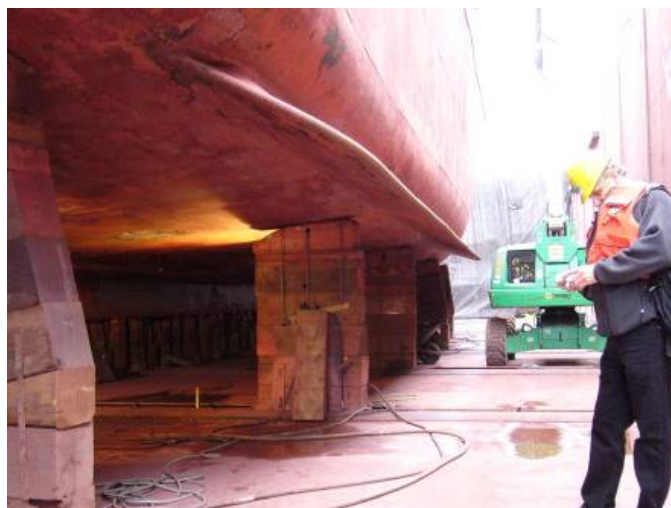
Figure 7 - View of damage location looking forward on the starboard side.

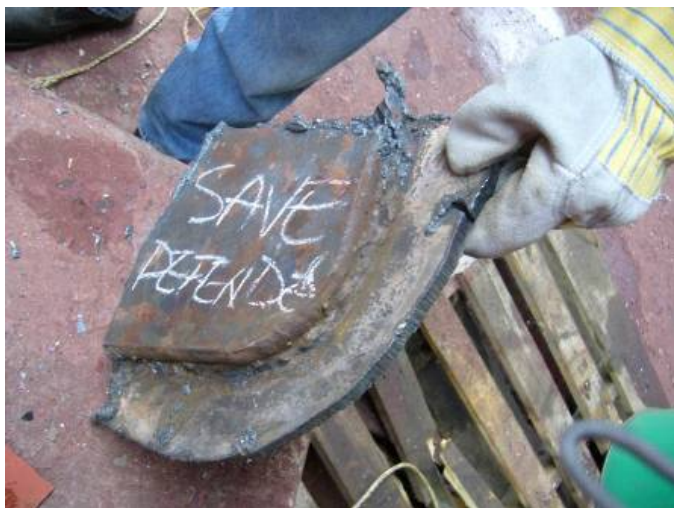
Figure 8 - Retained portion of hull plating.

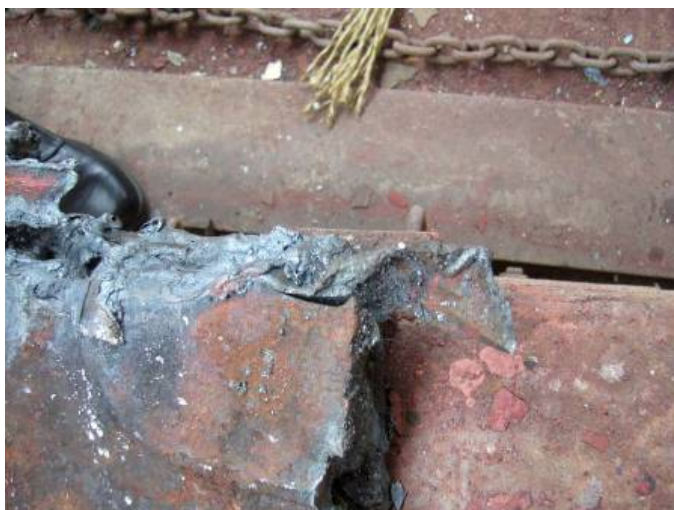
Figure 9 - Close-up of the portion of steel cut from the hull showing the location of a two to three inch fracture through the shell plating and a doubled-up plate used as an attempted repair.

The shipyard master indicated that he found a series of indentations parallel to the keel running fore and aft at the same distance outboard from the keel as the fracture. The shipyard master noted the fore and aft steel stiffeners on the inside of the deformed shell plating were also bent. He believed the dry-dock blocks that were meant mainly to steady

the ship had instead improperly borne significant weight during a past shipyard period. That error caused the bending of the shell plating and steel stiffeners. Combined with vibration from the main engines, the deformed plating and stiffeners resulted in the fracture of the hull and the failed repairs.

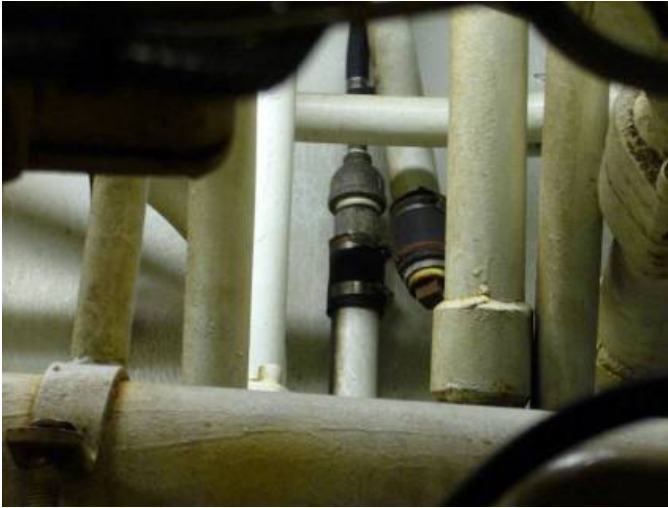
Normally the main engine day tanks overflowed to the larger day tanks. In the case, the starboard main engine day tank overflow line was plugged by the Chief Engineer with an arrangement used to pressurize the tank with compressed air (Figure 10). The tank's vent valve was tied closed.

Figure 10. Top of the main engine day tank vent pipe in engine room, starboard side, showing fittings used for injecting compressed air into the tank.

- The closing of the starboard main engine day tank overflow and vent. These actions prevented the starboard main engine day tank from overflowing into the larger starboard day tank. This caused pressurization of the tank, forcing diesel from the tank against the pressure of the surrounding water.
- Failure to ensure a secure out-of-service status for the starboard main engine day tank, through a failure to close the tank's manual isolation valve.
- Inadequate communication between the Chief and First Engineers regarding the internal transfer.
- Inadequate internal transfer procedures that did not include specific guidance for conducting an internal transfer using the purifier.
- An improper dry docking that resulted in damage to the ship's hull.
