## The CICLOPE

### Overview

### WHY THIS MATTERS

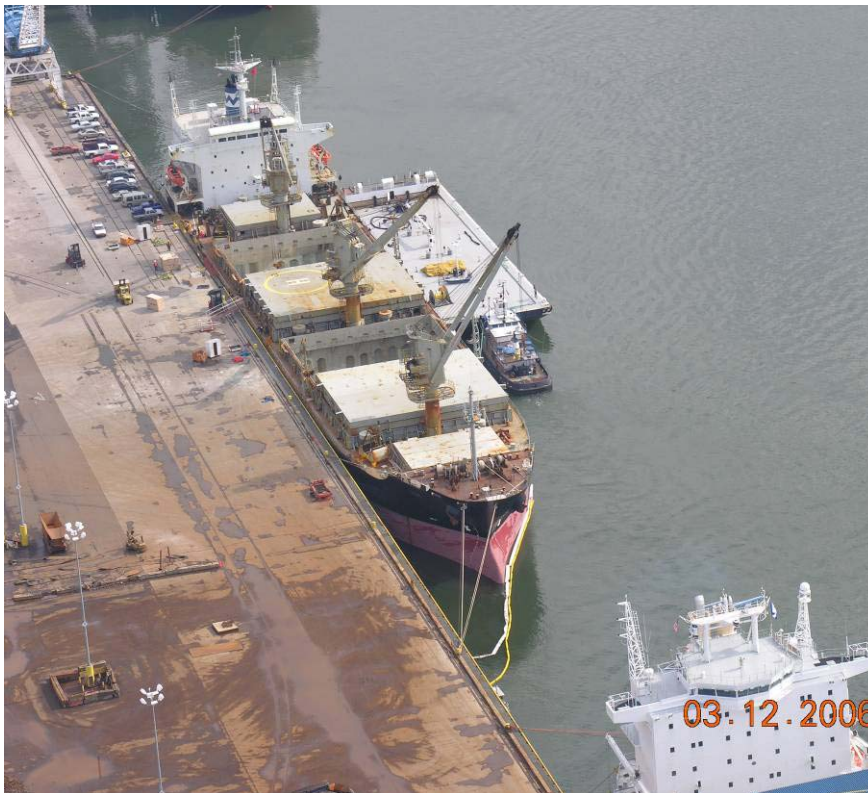
Figure 1 - CICLOPE at Vancouver, Berth 1 on March 12, 2006 with tank barge INVESTIGATOR alongside.

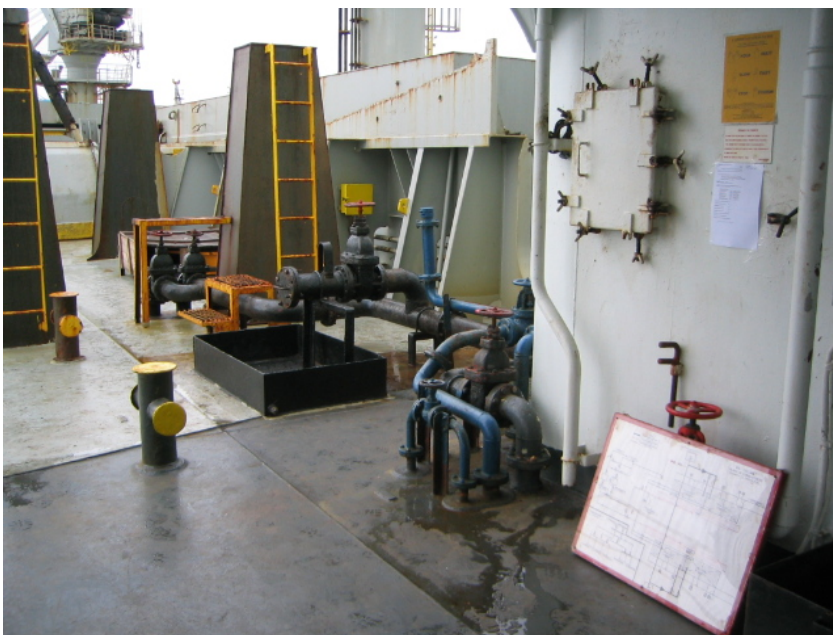
The CICLOPE had port and starboard fuel oil headers (oil transfer hose connection points) located just forward of the house on the main deck. The port fuel oil header was used for the transfer (Figure 2). The 150 mm (six-inch) fuel oil pipelines on deck led to pipelines down through the deck. These through-deck pipelines went to port and starboard pairs of fuel oil tanks located just forward of the house called No. 1 and No. 2. Each tank in the No. 1 pair of fuel oil tanks had a capacity of 263 cubic meters. Each tank in the No. 2 pair had a capacity of 326 cubic meters. The starboard side piping was equipped with a pressure gauge.

Figure 2 - Port side fueling station showing fuel oil header and tank drop line valves.

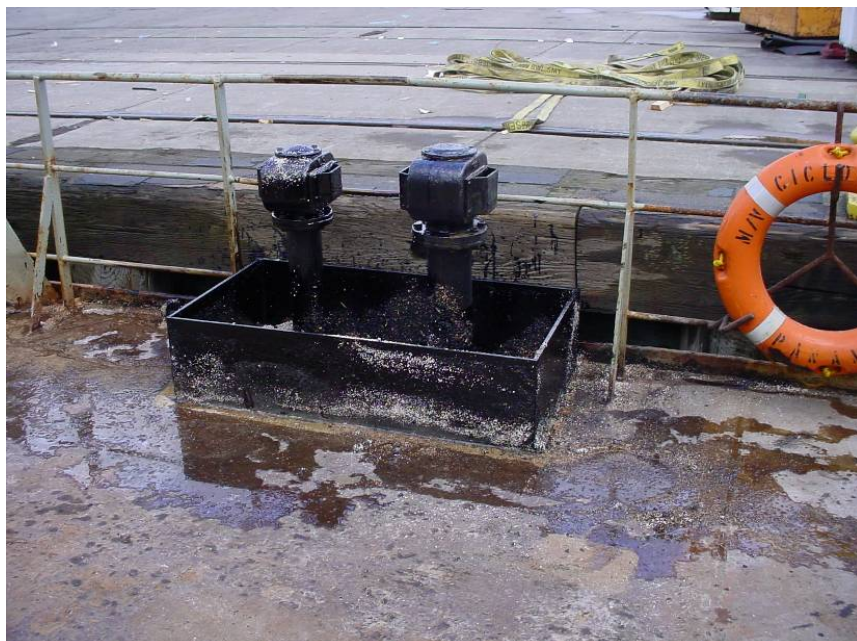
Each tank was equipped with a forward and an after vent leading to the outboard main deck edge. Vent pairs were equipped with fixed on-deck containment (Figure 3).

*Figure 3 - No. 1 starboard fuel oil tank vents from which oil spilled.  
Note: Oil splattering on pier.*

Ecology analyzed the sounding information obtained and accounted for the post-spill transfer of oil from the No. 1 starboard tank to the No. 2 starboard tank. Based on analysis of the sounding information, the C/E’s belief that the No. 1 starboard tank burped (sprayed a small amount of oil from the tank vent due to air pressure being released) at 75 percent of capacity was incorrect, and the tank was instead overfilled.

Based on the information gathered, the immediate cause of the spill was a loss of situational awareness on the part of the C/E with regard to the status of the No. 1 starboard fuel oil tank. This allowed the No. 1 starboard fuel oil tank to overflow. Factors contributing to the spill included:

- Ensure the ship's Person-in-Charge compares the calculated bunkering rate to the planned rate and, if the rate is higher than planned, contacts the delivering vessel or facility immediately to reduce it.
- Ensure bunkering checklists include a requirement that the transfer rate be periodically calculated, recorded, and monitored by the Person-in-Charge of the transfer.
- Emphasize teamwork during bunkering training to help maintain situational awareness.
- Ensure your company policies and procedures place safety and environmental protection over commercial considerations in order of precedence.
- Emphasize the dangers of complacency during oil transfers to crews by publicizing lessons-learned from this spill throughout the company's fleet.

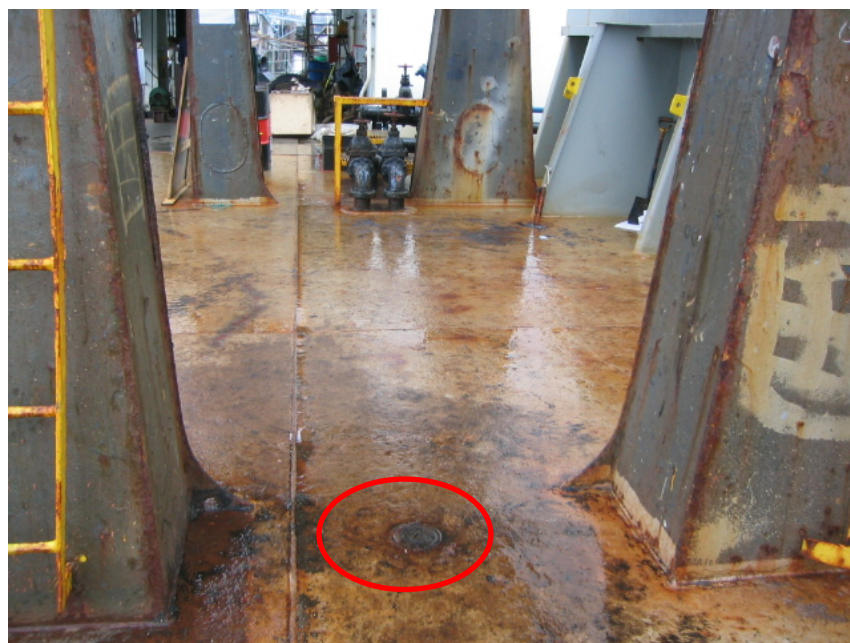
The tank sounding tubes for the four tanks were installed flush with the main deck just forward of the tank valves.

*Figure 4 - Location of recessed starboard sounding tube cap  
(view looking aft toward starboard fuel oil header).*
