The COSMOS EXPRESS/ INVESTIGATOR

Overview

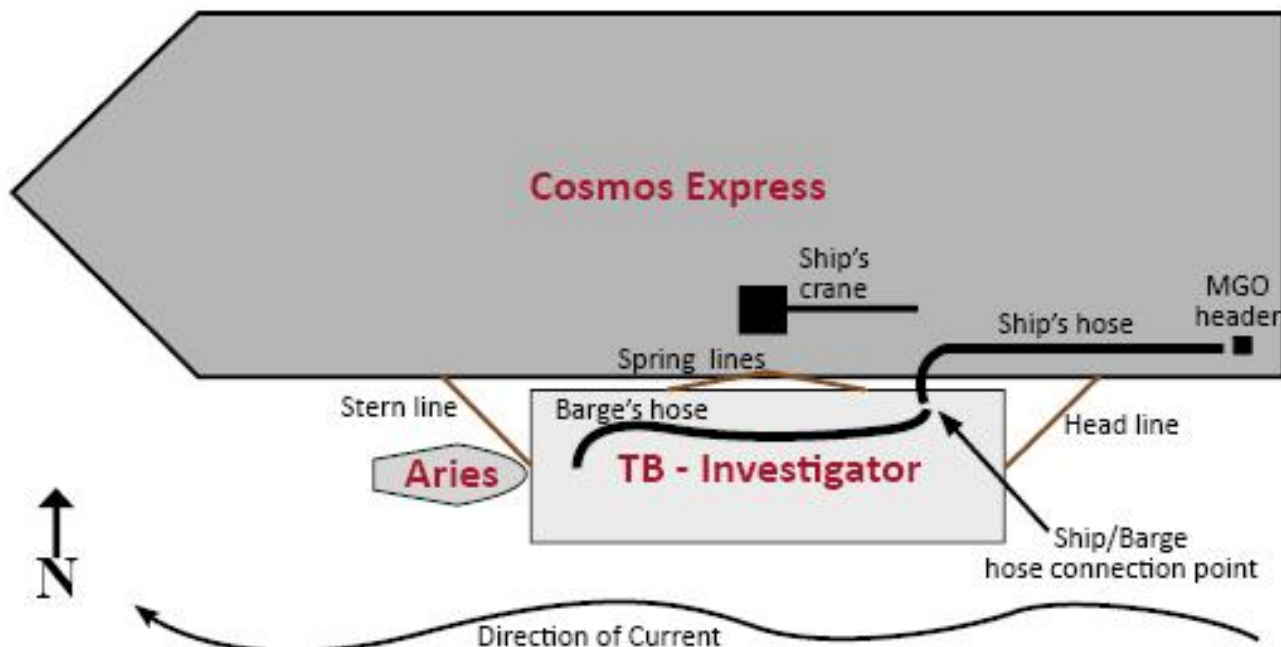
Figure 2 – Diagram based on a sketch by the Tankerman-PIC [not to scale] showing the approximate orientation of the COSMOS EXPRESS, INVESTIGATOR, and tug ARIES. North is up.

The information gathered indicated that the hose connection between the ship and barge hoses was positioned a few meters beyond the reach of the ship's crane. The connection point was at the deck of the barge. If the barge had moved aft (from the perspective of the tug and barge, forward from the perspective of the ship) a few meters the connection between the ship and barge hoses would have been supported by the ship's crane. A bollard (mooring point) was set in the side of the ship just aft of amidships, and the bollard was adjacent to the amidships point on the barge, so it appears the mooring configuration of the barge and ship would have supported a shift in position of the barge to allow the crane to reach the connected hoses.

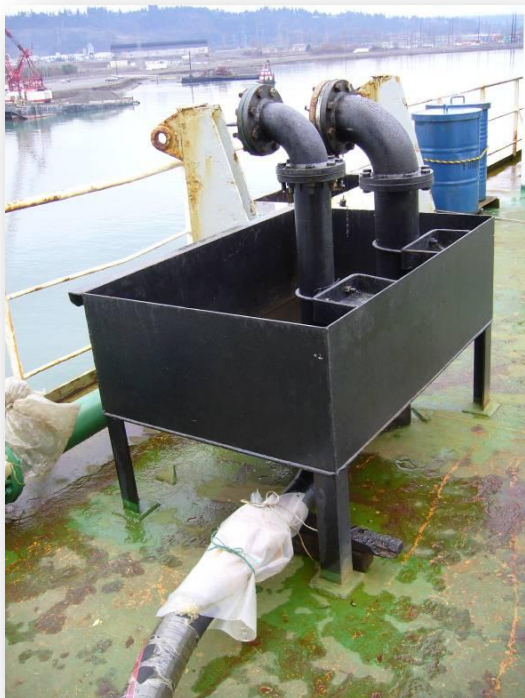
Figure 4 - Port side midship fuel oil bunker station aboard the COSMOS EXPRESS.

[Note: On December 4, 2006 only the right (forward) of two header pipes existed. The second pipe at left connected to hose was added after the spill.]

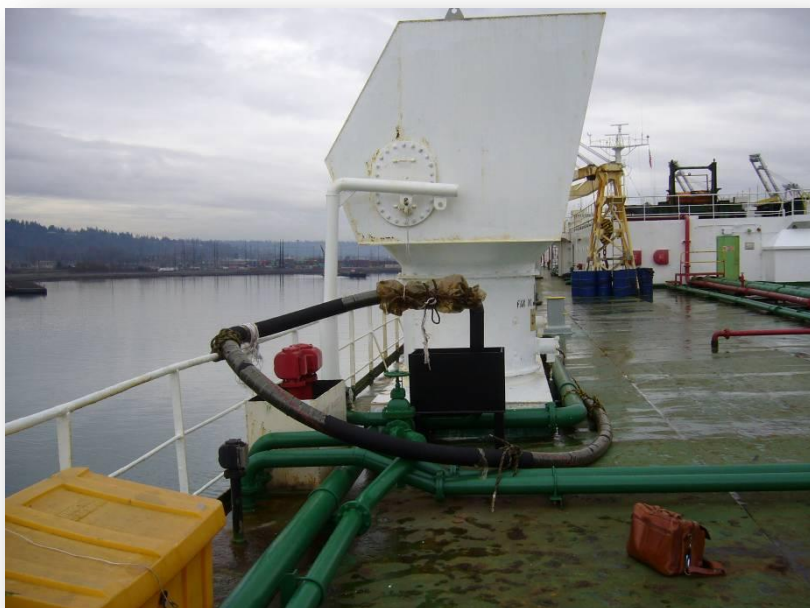
Figure 5 - Port side diesel/marine gas oil fuel header located on the ship's upper deck. On the day of the spill, the ship's transfer hose was led forward between the large white hold ventilator fan housing (center of photo) and the ship's rail.

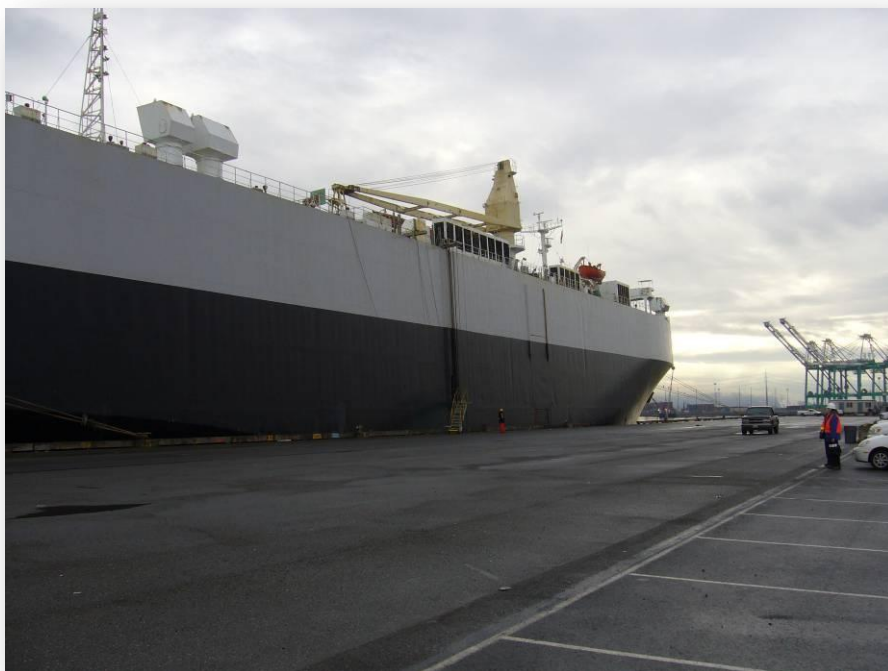
Figure 6 - Location of the starboard side crane aboard the COSMOS EXPRESS. The port side crane, used for the transfer of December 4, 2006, was located directly across the ship on the port side. [Photograph taken February 13, 2007.]

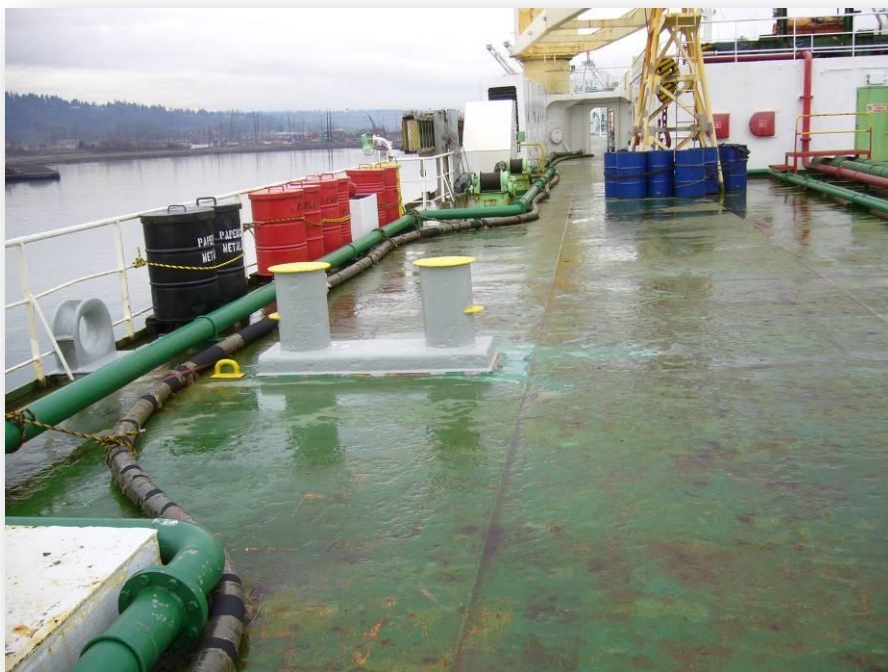
Figure 7 - Port side crane aboard the COSMOS EXPRESS. Photo was taken from just forward of the port side diesel/marine gas oil header looking forward. [Photograph taken on February 13, 2007.]

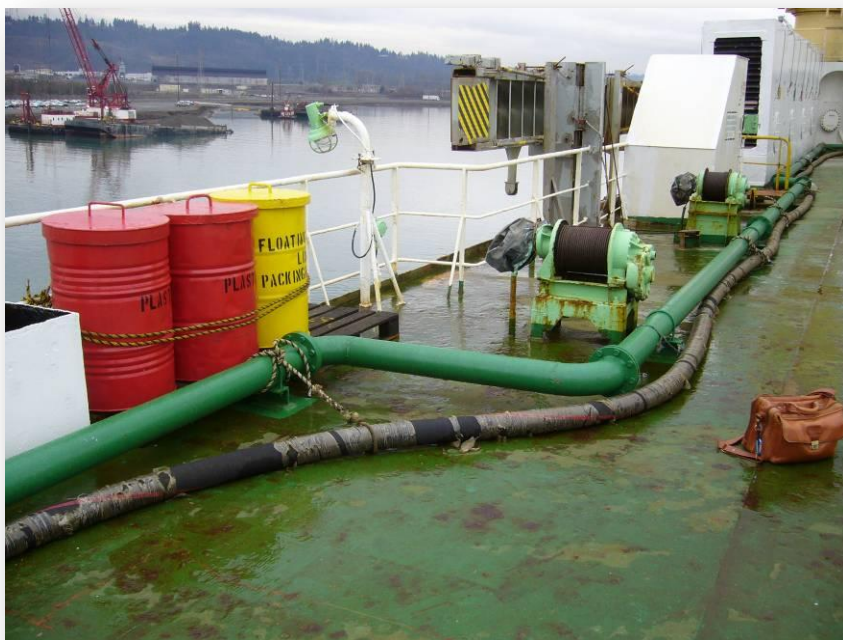
barge. A 52-foot (16-meter) section of hose hung, unsupported, over the ship's side to the deck of the barge (Figure 8).

Figure 8 - The ship's rigid transfer hose was led over the side of the ship at the bend in the deck rail for the gangway's stowage. [The end of the gangway is highlighted at the upper center of this photograph with yellow and black diagonal striping.]
