## Blomquist Residence

Project Type: **Large Woody Debris  
Minor Nourishment**

## ***Driftwood Beach, Blakely Island***

## Alternative Bank Protection Methods on Puget Sound

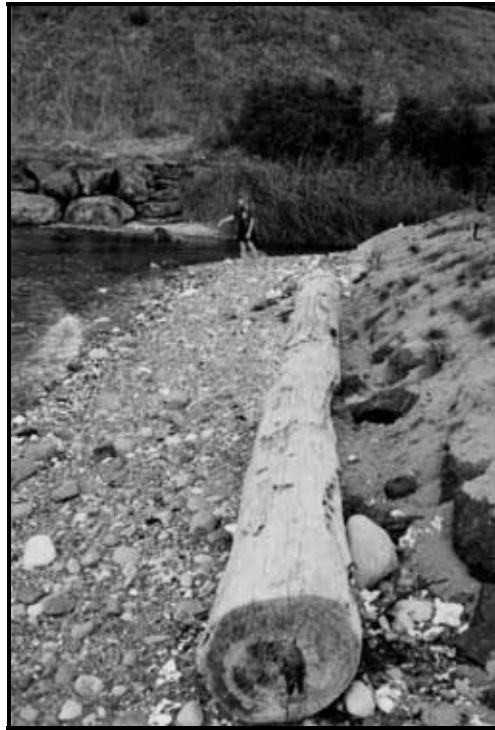
Figure 1. View north toward mouth of Kinman Creek, prior to construction. One concern was that waves reflecting off of bulkhead north of creek impacted the Blomquist beach.

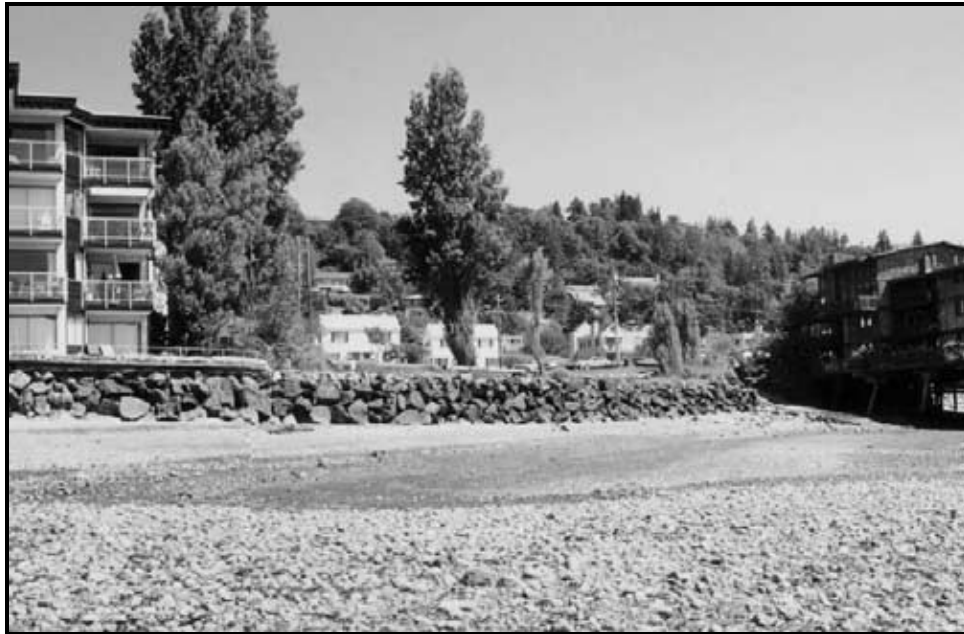
Figure 1. View of Cormorant Cove site from the beach at low tide. Much of the rock bulkhead will be removed when the project is constructed.

The project will begin by removing all but the lowest tier of the existing vertical rock bulkhead. This last level of rock, which is presently found below beach grade, will be left in place to act as a sill for the new pocket beach. A new rip-rap revetment will be built up to 45' landward of the present bulkhead. The structure will be no more than 30" tall and the face will be angled at a minimum of 2H:1V.

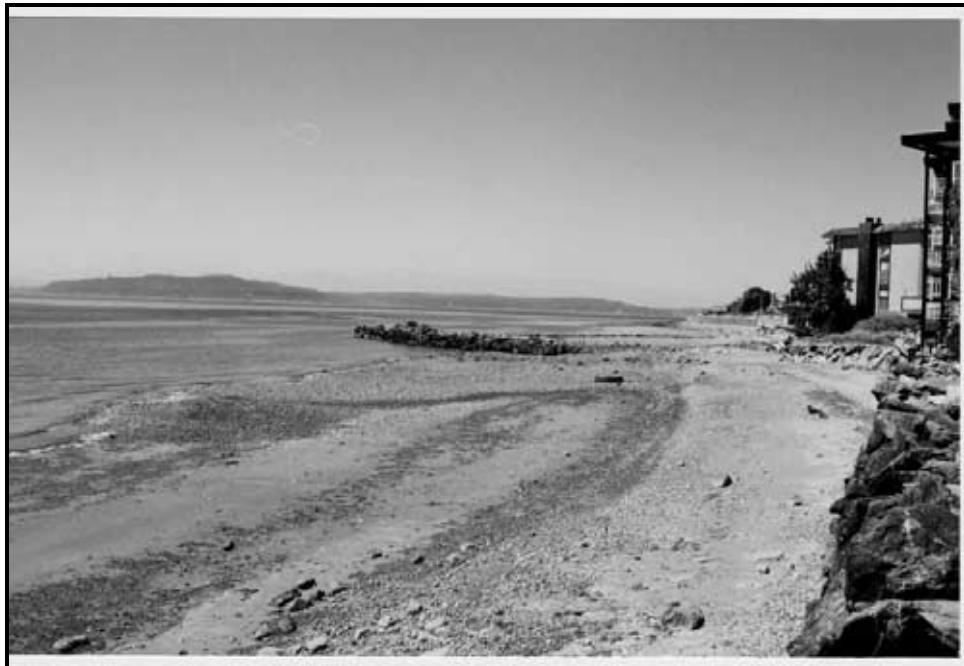
Figure 2. View to the north from 3701 Beach Drive, showing hardened shoreline and intrusion of bulkhead onto upper beach.

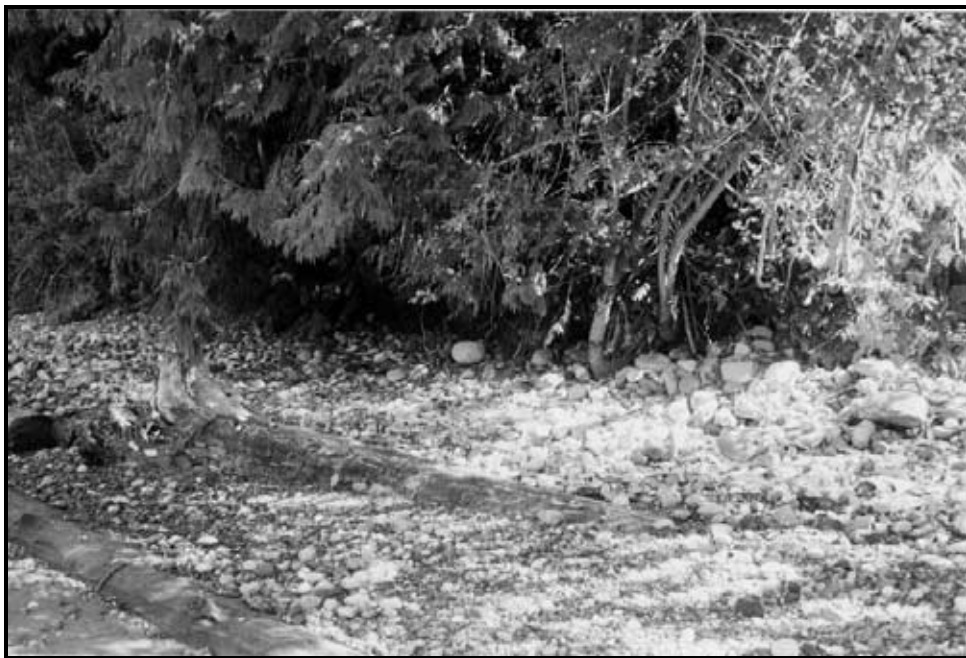
Prior to this project a short segment of the bank spanning the south property line was slumping and at least two sections were being undercut by wave action. The property owner applied for a rock bulkhead, but was persuaded by the Department of Fish and Wildlife to select a more environmentally sound approach.

Figure 2. The toe of the bank had been undercut prior to construction. Quarry spall was placed in undercut area and logs anchored into the beach. Anchor cables are just visible.

The project was constructed in several stages. The undercut areas were protected with geotextile and hand-packed 4-6 inch basalt quarry spalls. Bank protection was accomplished by burying and anchoring logs into the beach. The beach and spalls were then capped with sand and gravel that slightly increased beach slope and elevation. The logs helped retain the beach sediment. American dune grass (*Elymus*) was planted to help stabilize the upper portion of the beach and the toe of the bank.

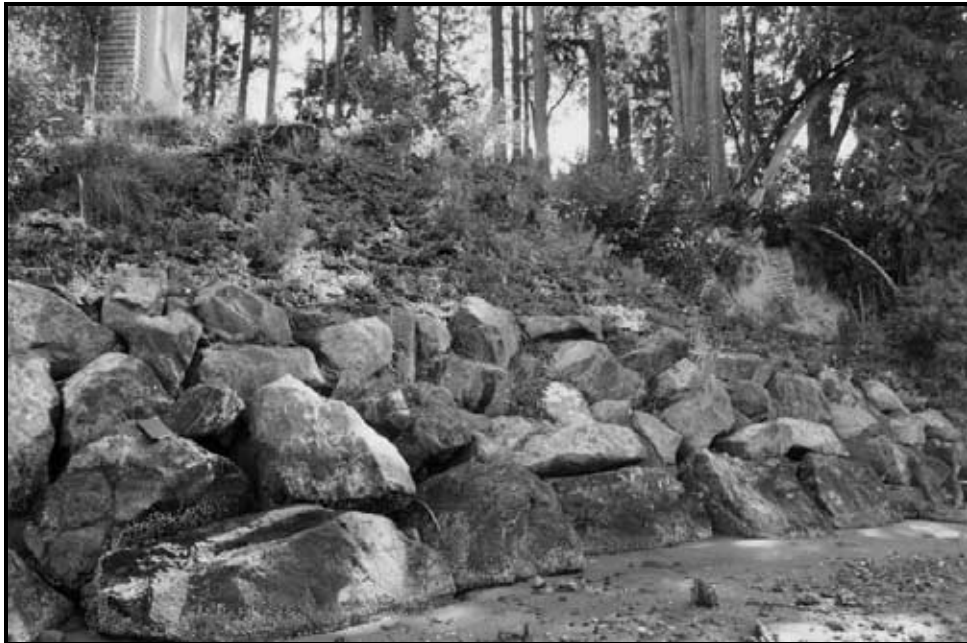
Figure 4. Riprap bulkhead/revetment located on northern end of Dick property and neighboring property.

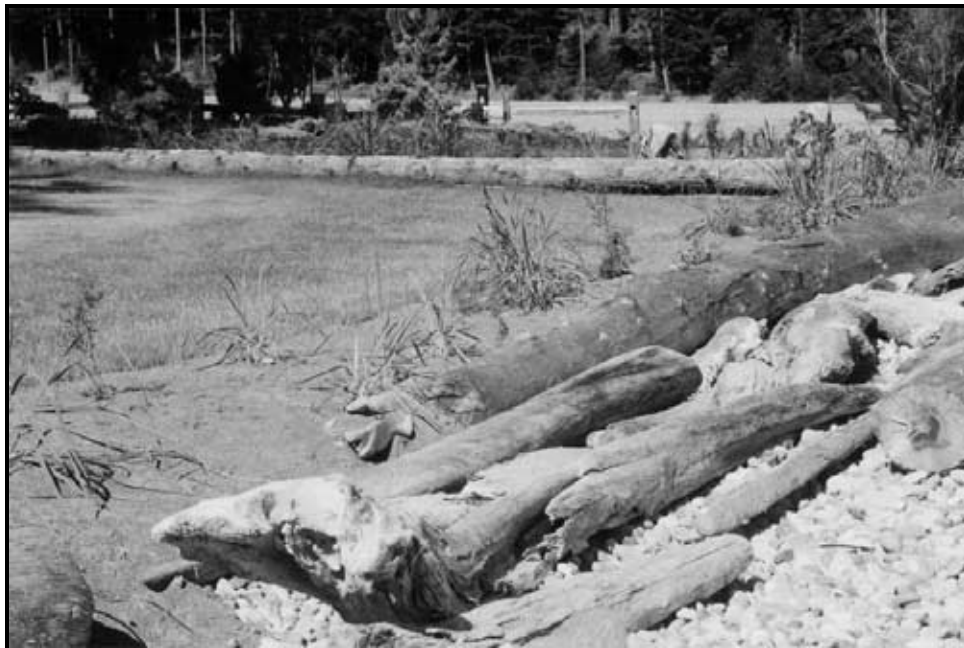
Figure 2. Close up view of berm and backshore. Note coarse gravel berm and drift logs. Also, a sandy berm has been created farther landward and planted with American Beach Grass.

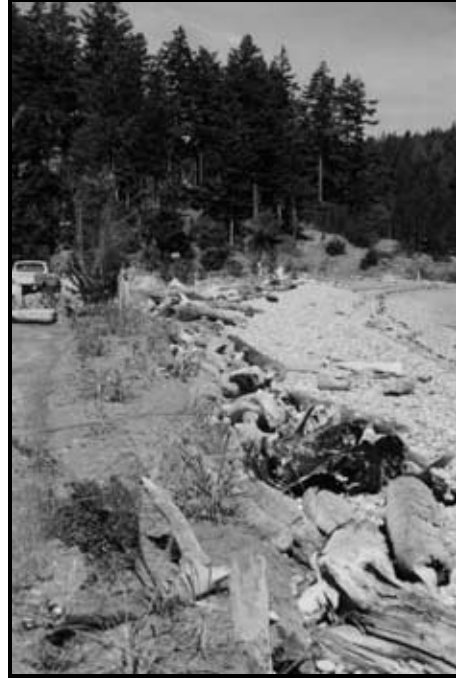
Figure 4. View north showing gravel berm, drift logs, and vegetated backshore. Road has been relocated landward.

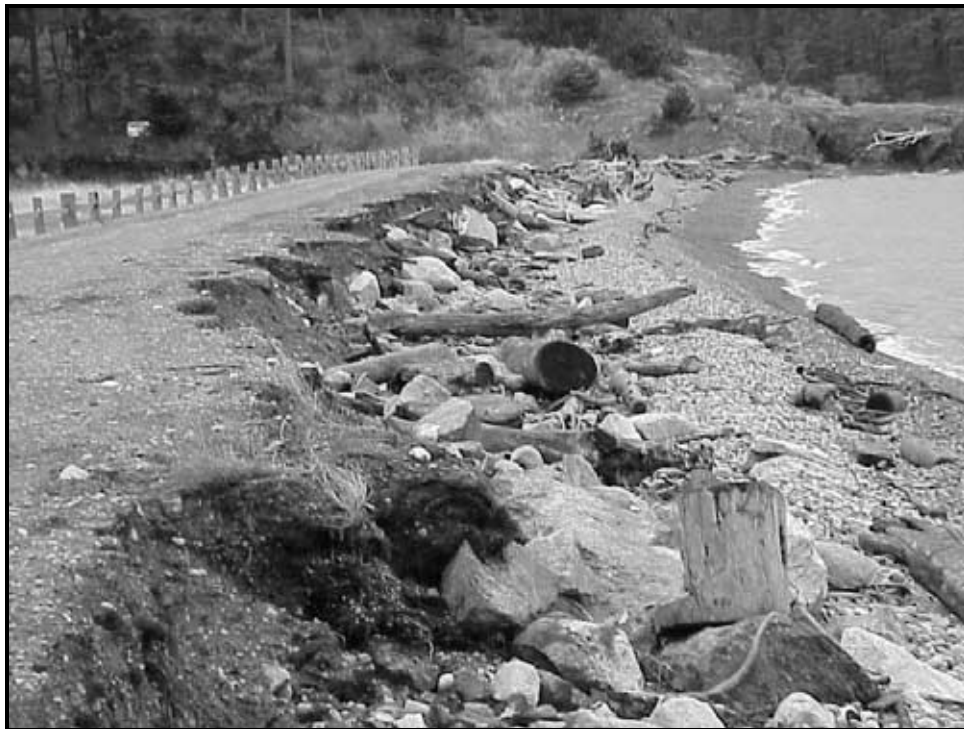
The beach was subject to significant erosion during the winter of 1996-1997. Most of the backshore was scarped which reduced the width of the beach access road. Before the nourishment the majority of beach sediment was cobble (1.25" – 10.0") and pebble (1/8" – 1.25").

Figure 5. View north of project area prior to construction, showing erosional scarp in old fill, damage to road, and riprap (*Photo: provided by Jim Johannessen, Coastal Geologic Services, and Blakely Island Maintenance Commission*).
